CITY OF KEOKUK, IOWA TRAFFIC SAFETY STUDY

TRAFFIC SAFETY STUDY

KEOKUK, IOWA

Prepared by: KIRKHAM, MICHAEL AND ASSOCIATES
Architects - Engineers
Omaha - Minneapolis

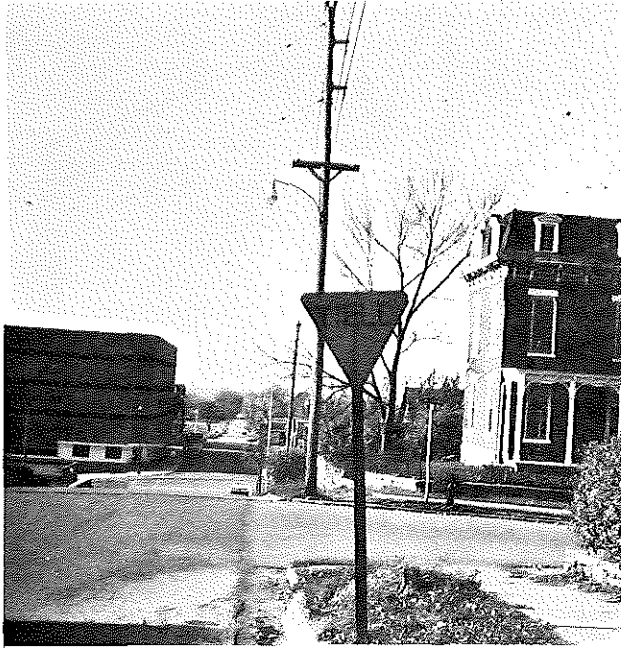
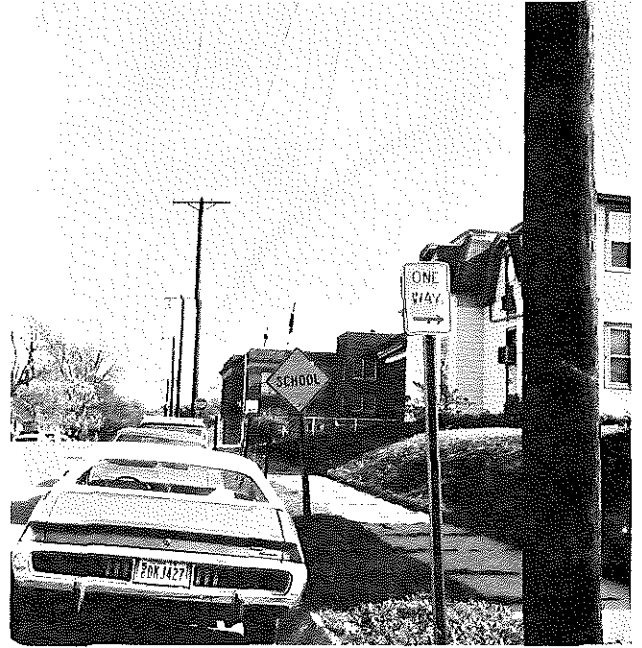
There are several yield signs within the street network, excluding the streets on the highway system, that are of the old style, that is yellow background with black lettering. (See Photo Plate 9). These should be phased out and replaced with the red and white triangular sign that meets the standing yield sign criteria. Also there are some intersections where a yield sign controls the minor movements where normally a stop sign is used for this purpose. The Uniform Manual states that yield signs should not ordinarily be placed to control traffic flow at an intersection, however, in some cases where a stop may not be necessary it is permissible.

A few of the one-way street designation signs on minor streets and alleys are of an older style (See Photo) and should be replaced with the larger signs which conform to the Uniform Manual. The "Do Not Enter" signs at the termination of the major one-way streets are of the red and white standard design and apparently there has been little problem with motorists traveling in the wrong direction. Approximately 8 one-way signs need to be replaced.

The yield, school and one-way signs shown above are typical signs that should be replaced with standard signs.

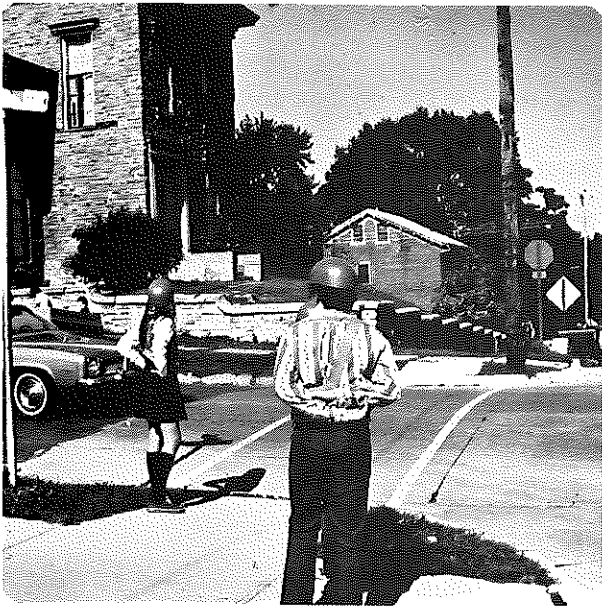
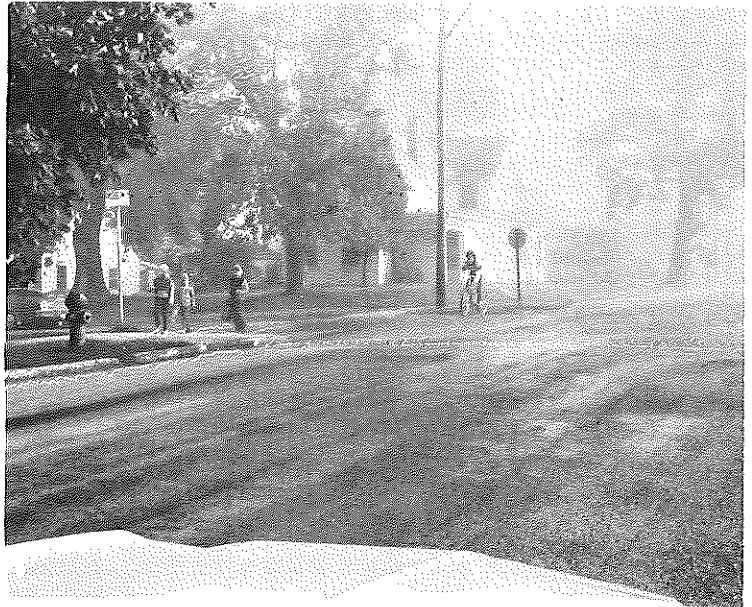
Existing school crossing markings are generally two white lines outlining a four foot space at the street intersections (See Photos below).

Larger and bolder parallel strips not less than 6 inches in width and not less than 6 feet apart are required at all crossings. It is recommended that the mid-block crossing on 7th Street at the Lincoln School and the mid-block crossing on 14th and 15th Street for the Junior High School be cross hatched as well as striped. It is also recommended a word message as shown below be used on 7th

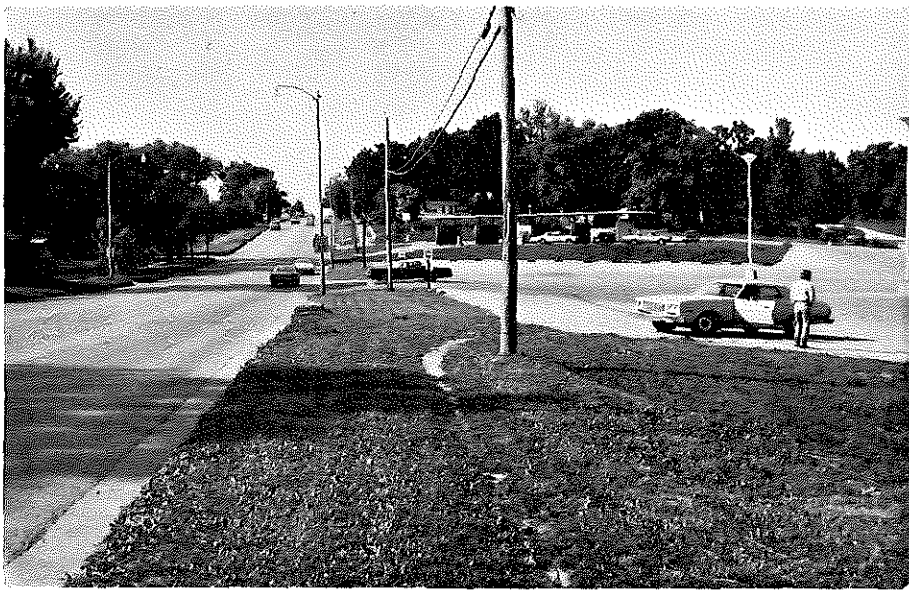
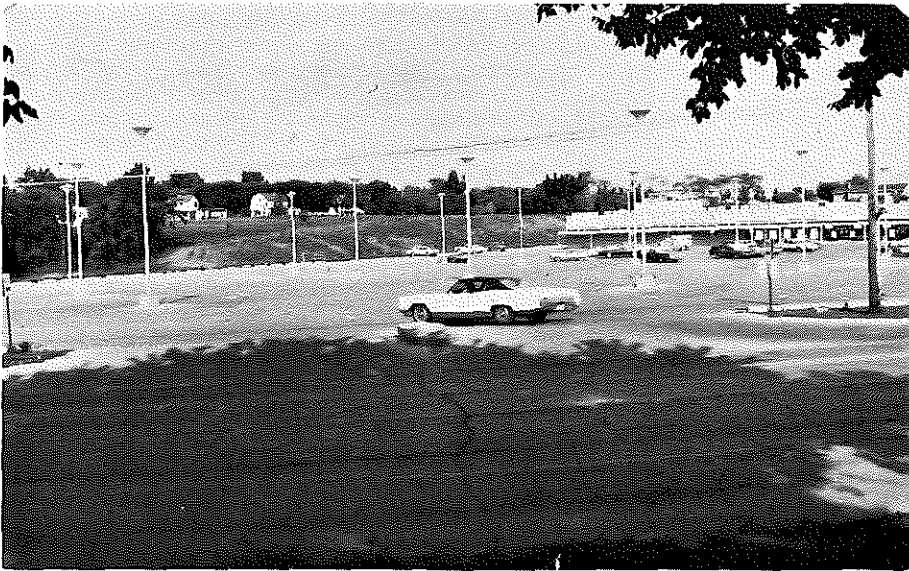
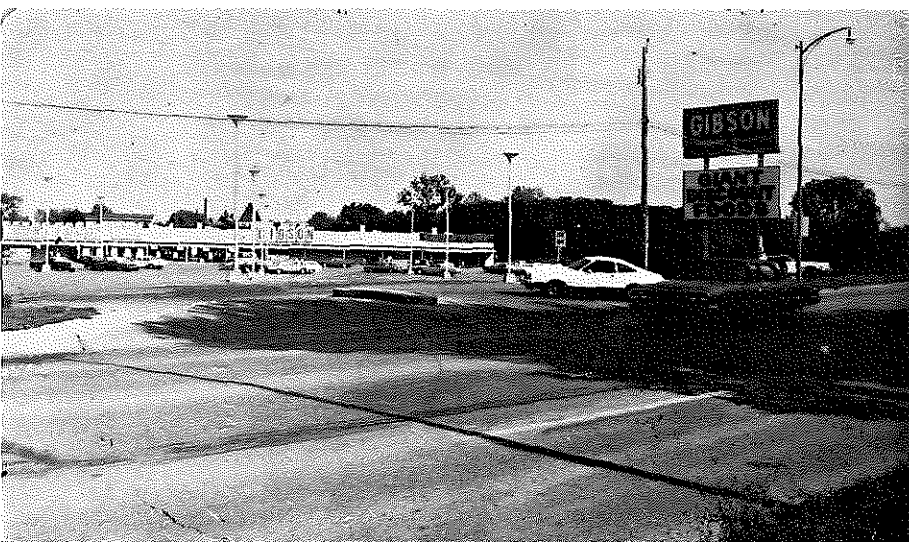
Main Street Road at the Belknap Boulevard and Boulevard Road Intersection. This is a high rate accident intersection in Keokuk with 12 accidents occurring in 1974, nine of which were serious enough for written reports. Five accidents were the result of rear end collisions, two vehicles were struck in the rear while waiting to turn left and three were struck in the rear while waiting for the signal light to change. There was one vehicle out of control that went through the light and struck an oncoming car, two accidents involved motorcycles one in which the motorcycle was hit while turning left and the other in which a motorcycle hit a left turning car. Another accident involved a side-swipe as a result of an improper lane change. The area is probably one of the most complex areas in the Keokuk Street System as the streets intersect at a sharp angle. The area is fully developed with practically unlimited access, and other streets intersect close to the major intersection on the north and northwest legs. (See Plate 19.) Recommendations for improvement of this intersection are included in the intersection analysis section of this study.

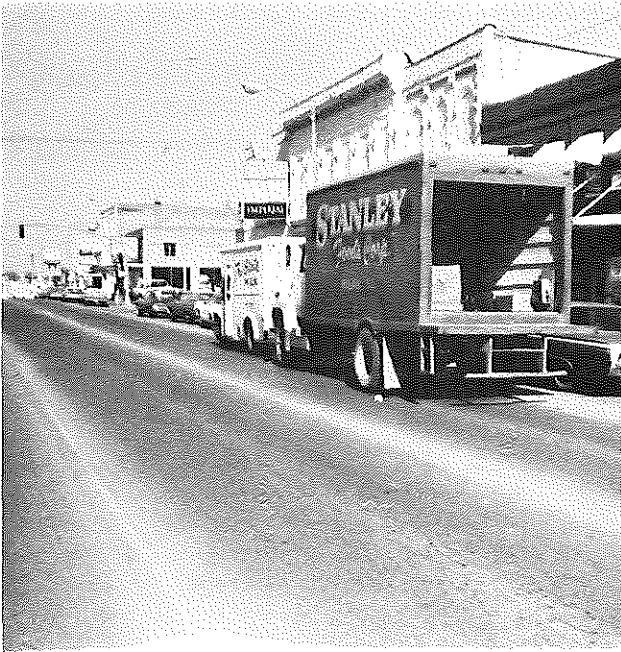
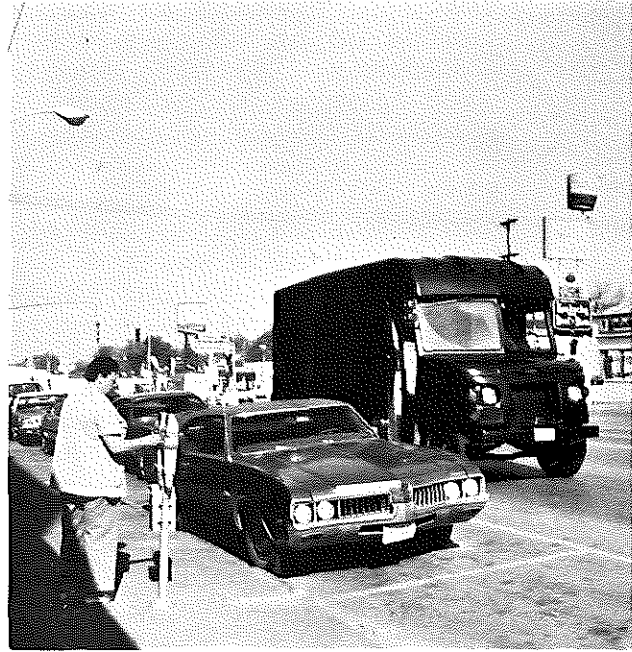
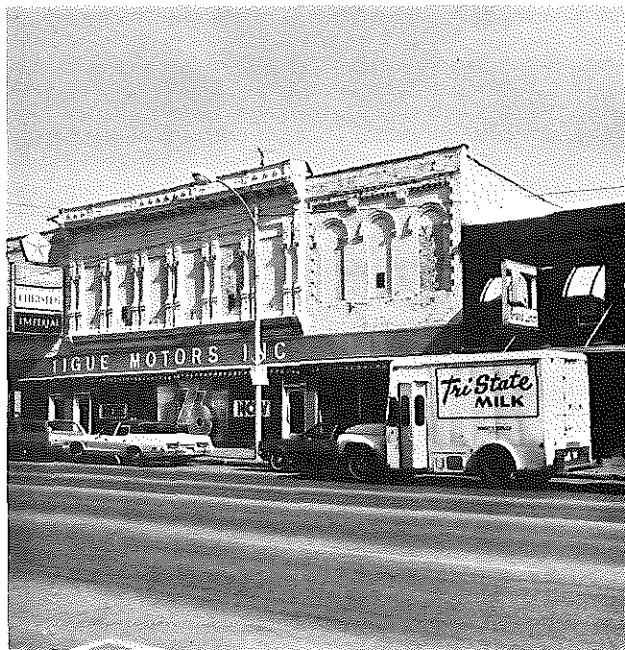
trucks which is common on Main Street. The photos below illustrate typical situations. Again, this problem is difficult to control as deliveries and pickups have to be made for a business to operate. It may be wise to require future establishments to provide a delivery access at the rear of the stores.

Main Street in the Keokuk Business District.

Some examples of double parking.

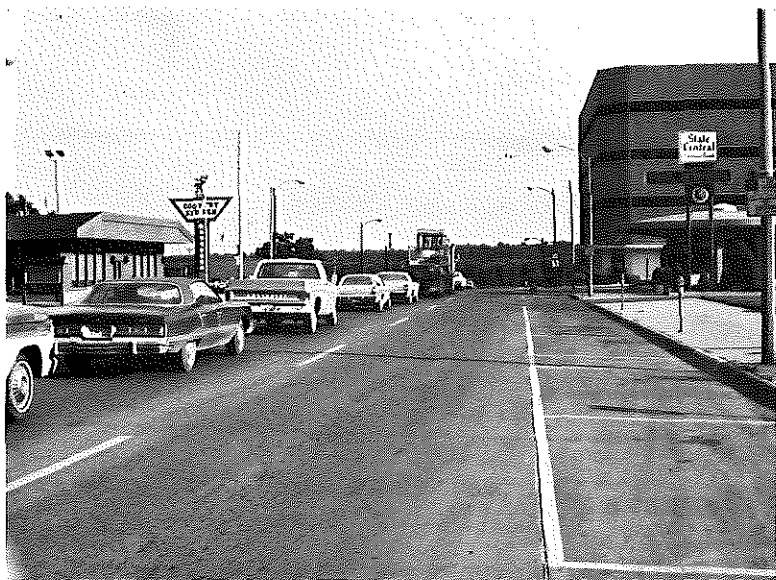
Traffic backed up on Main Street during bridge opening.

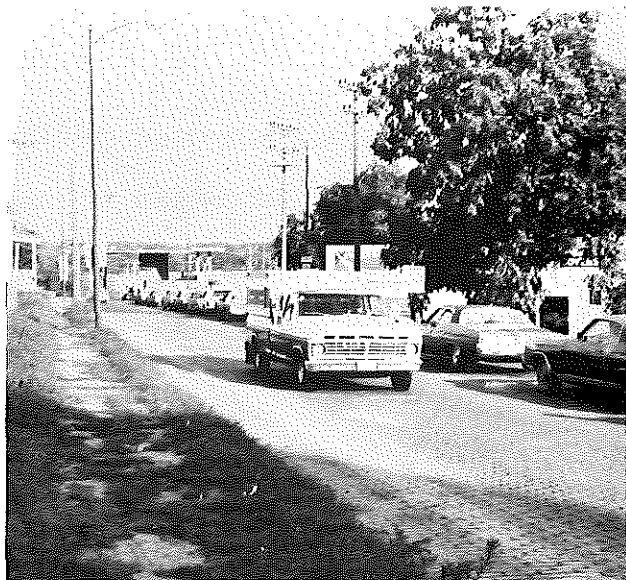
Traffic backed up from Municipal Bridge Tollgate.

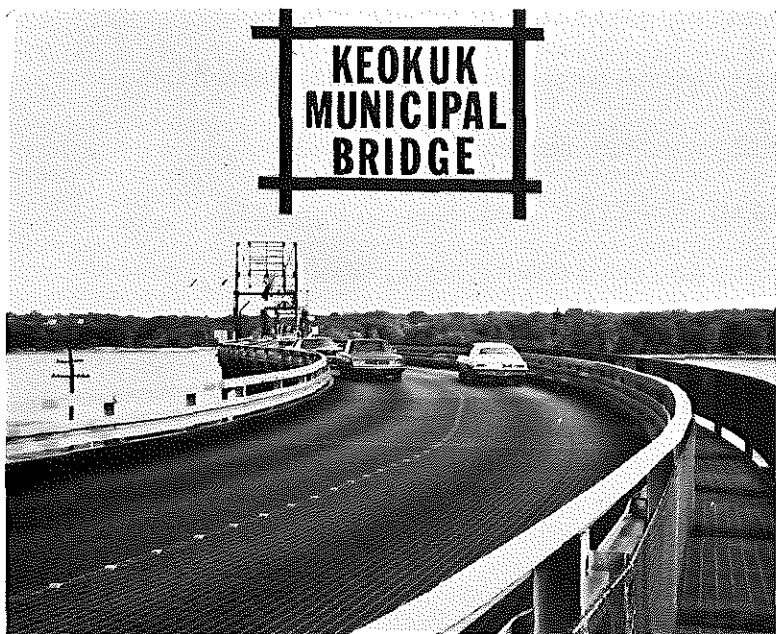
Reverse curve on Bridge at Iowa side.

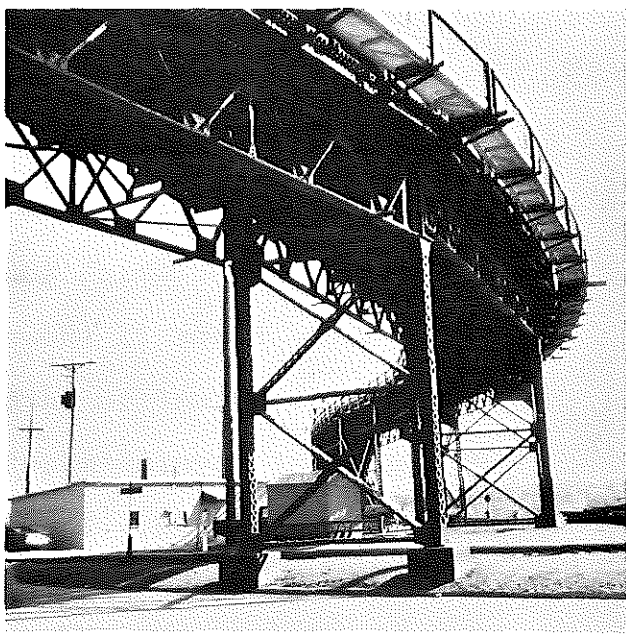
Reverse curve as viewed from below.

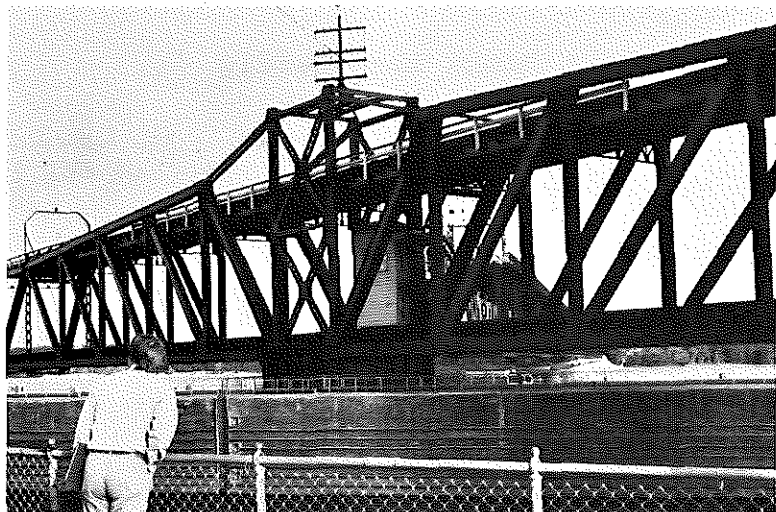
Swing span during opening maneuver.

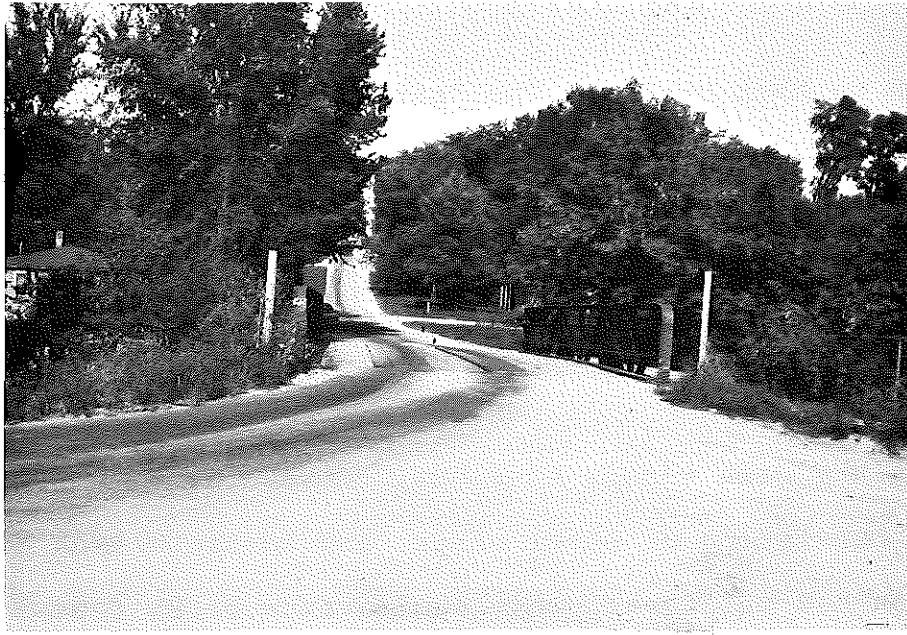
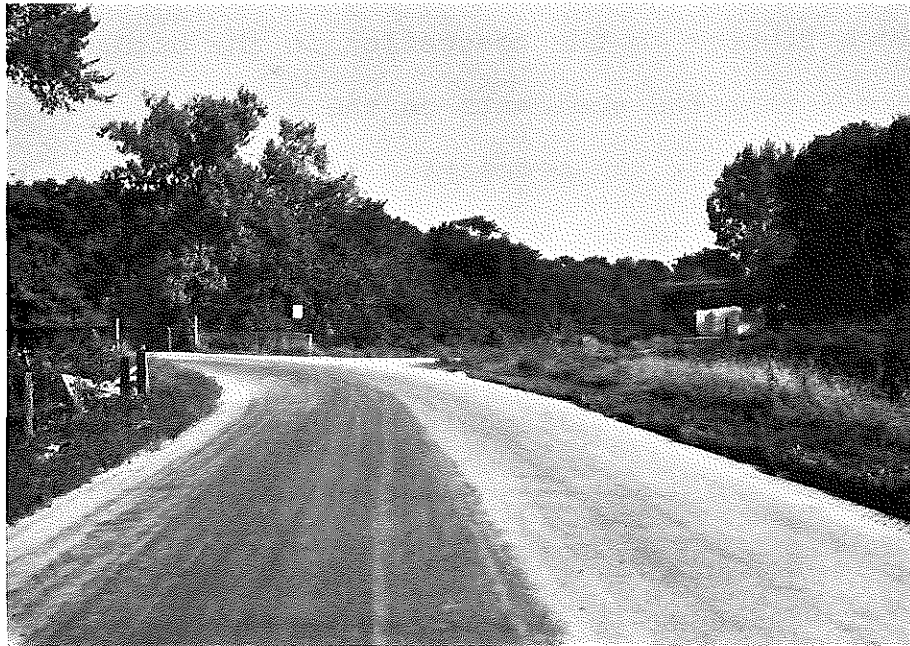
The 10th Street Bridge (See Plate 26) is an old style structure located at the 10th and Cedar Street Junctions. Tenth Street terminates at the bridge and the street continues to the north on Cedar and then to the west on Missouri Avenue. The present bridge, rebuilt in 1938, is a single span pony truss with a plank floor. The bridge, pictured below, has an eighteen foot clear distance between steel lattice rails, which protect the trusses limiting traffic to a single lane only. Accident records show there have been no serious accidents at the bridge in the past 3 years, however, the bridge is still a potential hazard and should be replaced. Also, 10th Street is expected to be an important east-west collector street as shown on the future primary streets plan. Replacement of the bridge and straightening of the street should be accomplished in the near future even though the primary street system update may be years away. There should be immediate action taken to indicate to motorists that the hazard exists. A standard ONE LANE BRIDGE sign and a turn sign with an advisory speed sign indicating 15 mph should be placed at each approach. A hazard indication such as type 3, 3C-1, marker which has broad, relectorized striping should be installed at the west

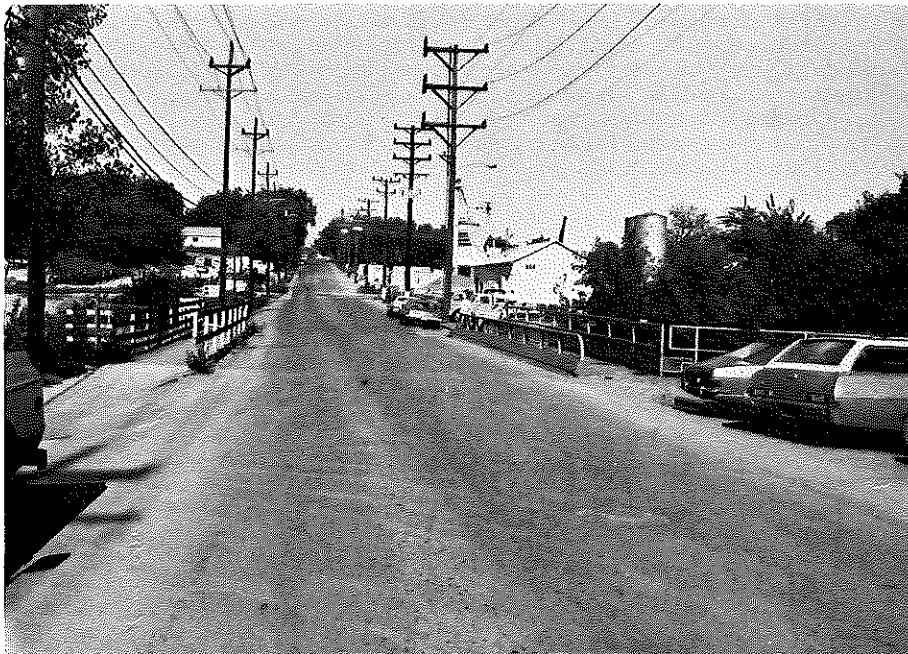
(Fifth Street Bridge, looking east.)

Solution to the congestion and elimination of the safety hazards in this area will be costly. A major construction project including the widening of 5th Street would be required. The bridge should be replaced with a wider structure. Congestion will not be eased without a complete rehabilitation of 5th Street. The entire street contributes to the quality of traffic flow.
