**OZARK LEAD TAILINGS DAM
REYNOLDS COUNTY, MISSOURI
MO 30166**

**PHASE 1 INSPECTION REPORT
NATIONAL DAM SAFETY INSPECTION**

APRIL 1981

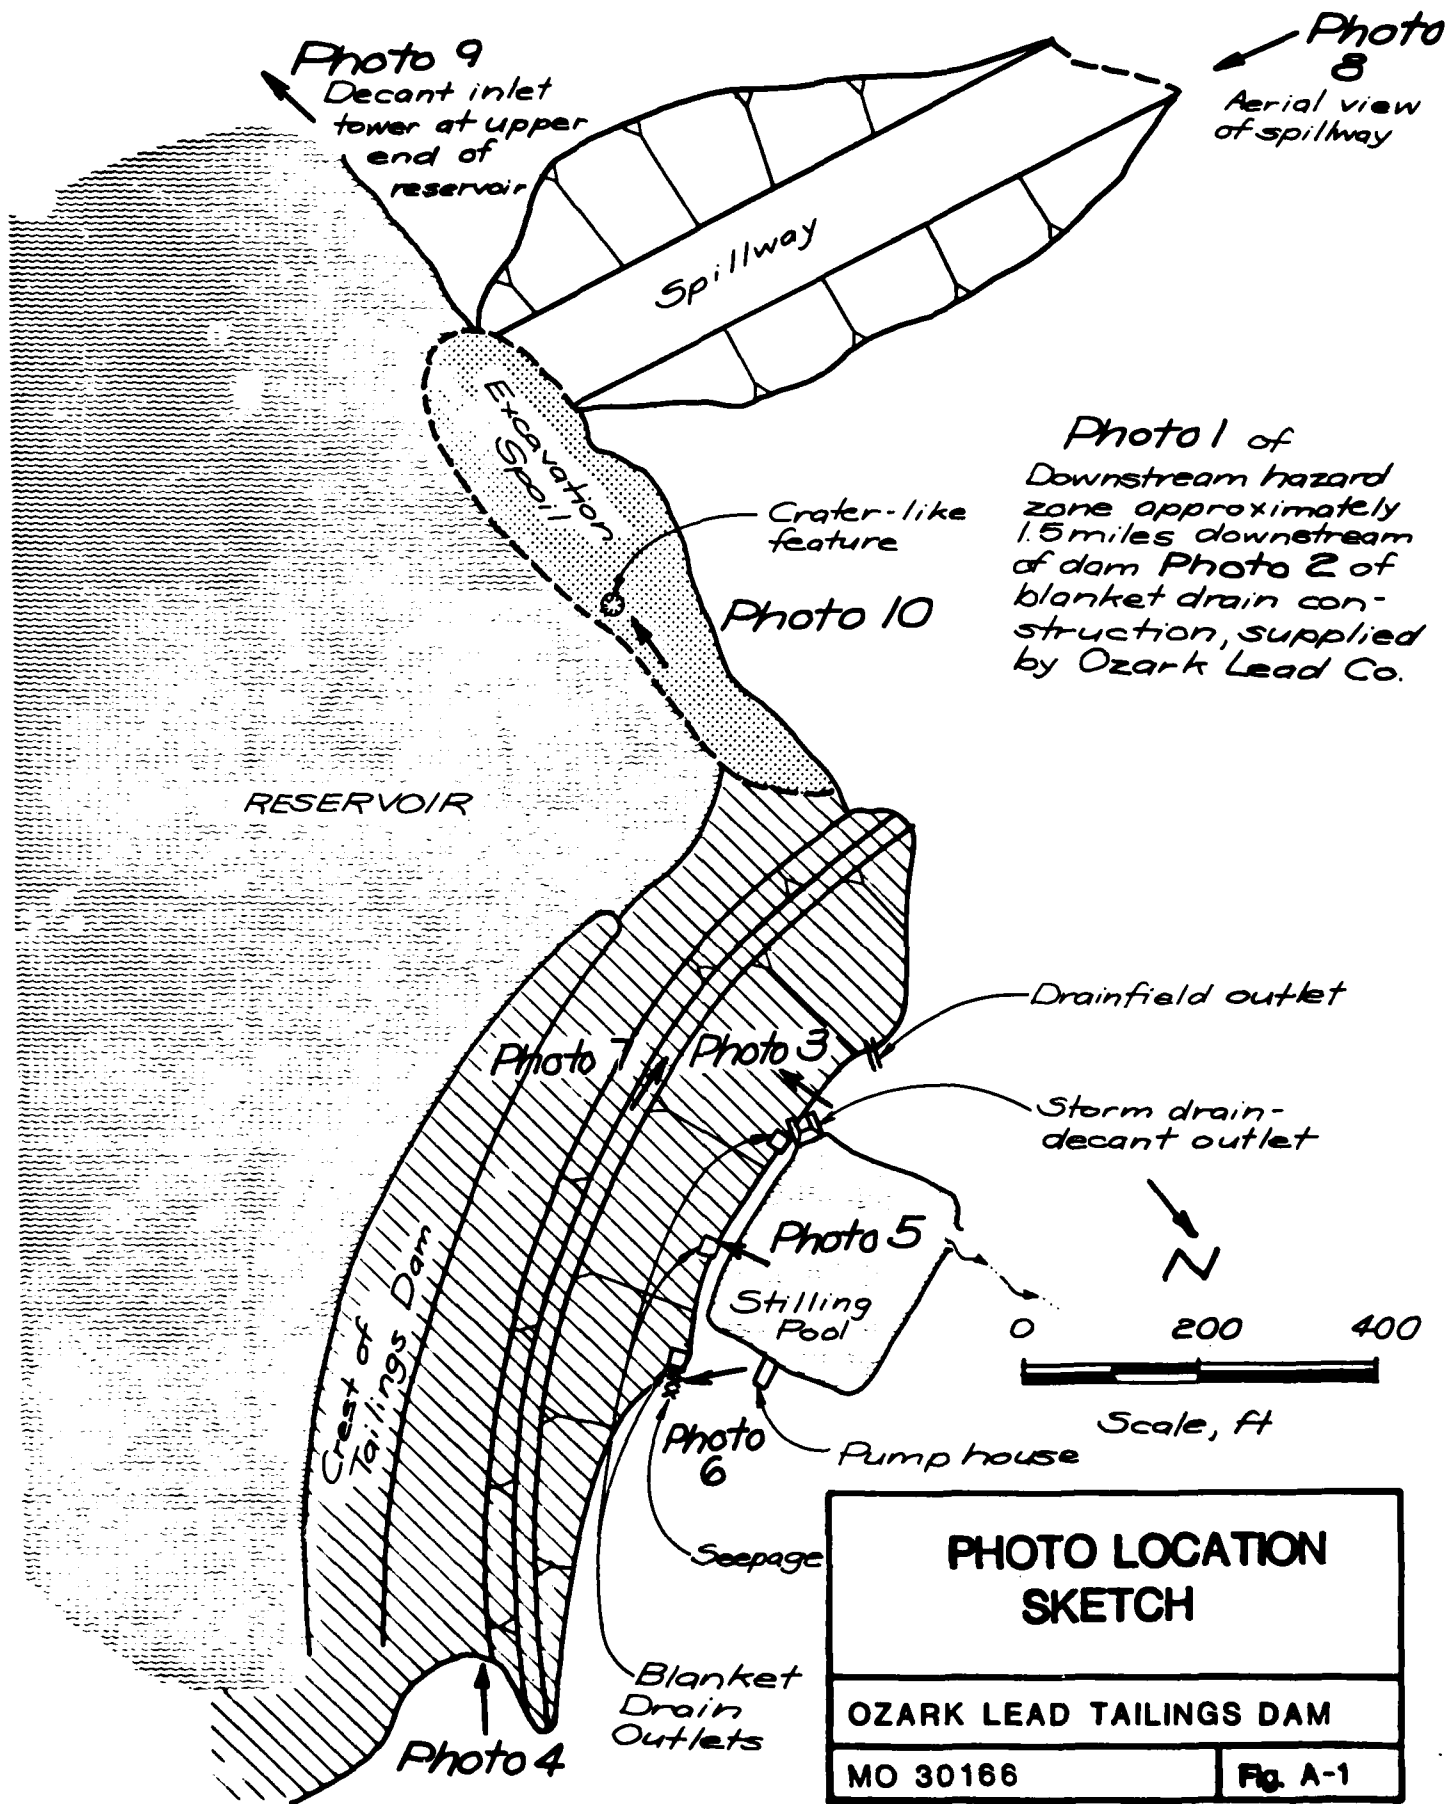
- d. Reservoir area. The reservoir for this dam is nearly filled with fine sandy to silty tailings (Overview Photo). Portions of the reservoir at the upstream end have water covering the tailings deposits. The tailings appear quite soft when first deposited. In the area of the reservoir adjacent to the spillway, some of the spillway excavation spoil was pushed out onto the tailings surface. A crater-like feature, approximately 6 ft in diameter was noted, apparently where a boulder in the spoil material sank into the unconsolidated tailings (Photo 10).

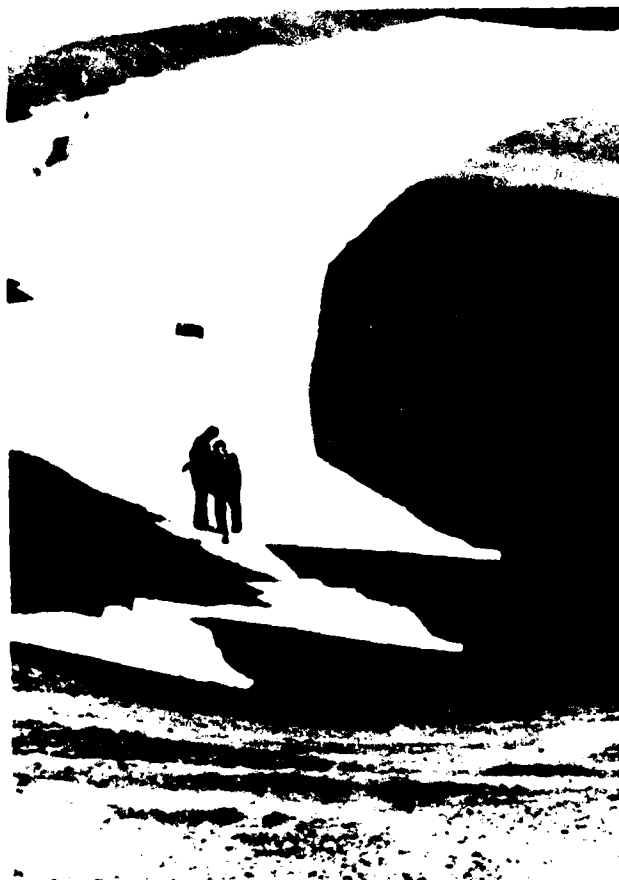
2. Filter fabric and gravel drain being installed during modifications to dam. Note abundant seepage (dark area below fabric) and erosion due to seepage water. Looking east from right abutment. Photo by Ozark Lead Company (1979 or 1980).

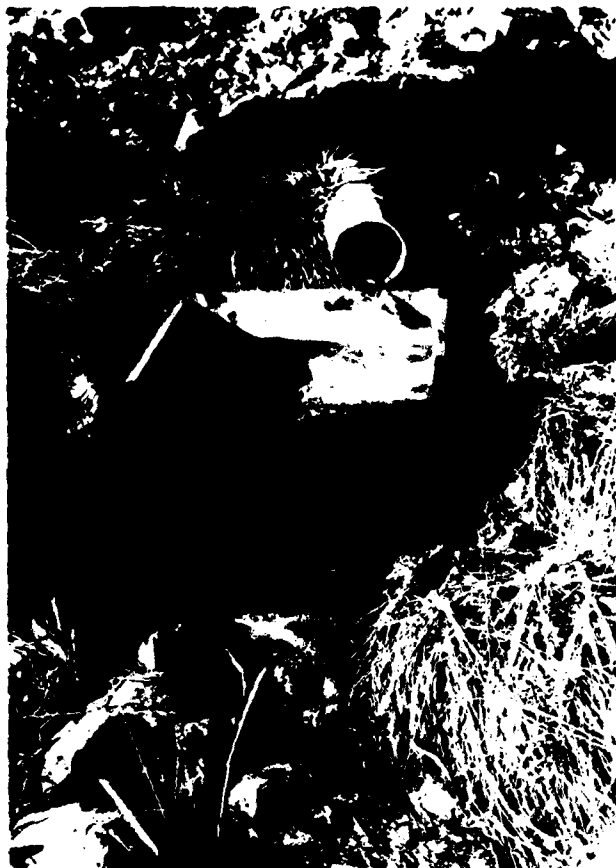
Three outlet pipes for a blanket drain system were noted near the toe of the embankment. These consisted of 6-in. diameter PVC pipes, and were each flowing at an estimated rate of 15 gal/min (Photo 5). The pipes discharged into wooden weir boxes to allow measurement of flow. The total flow was described by Ozark personnel as being nearly constant at the observed rate.

No records were available of maintenance performed on the operating facilities. All facilities appeared to be in generally good condition. The weir boxes recently installed at the blanket drain outlets are made of wood, and will probably require fairly frequent replacement.

5. Discharge pipe and weir box for blanket drain. Flow estimated at 15 gal/min at time of inspection.

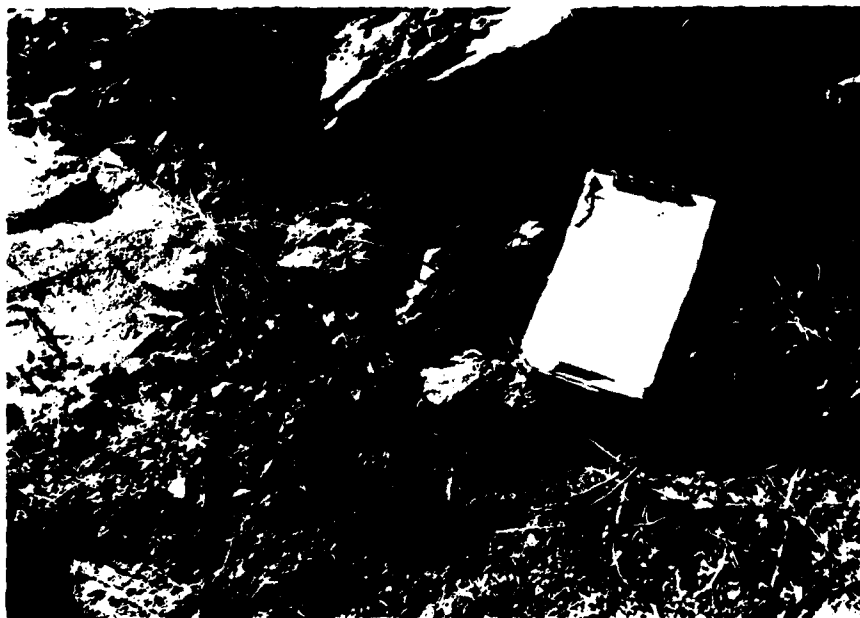
One area of seepage and spongy ground was noted near the center drain (Photo 6). Seepage was estimated at approximately $\frac{1}{4}$ gal/min and was not transporting any soil.

Seepage was limited to a small area adjacent to one of the outlets for the blanket drain. The seepage did not appear to be carrying any soil and did not appear to be a hazard to the dam at the time of the visual inspection.

6. Seepage area near toe of right abutment. Flow estimated at less than $\frac{1}{2}$ gal/min.

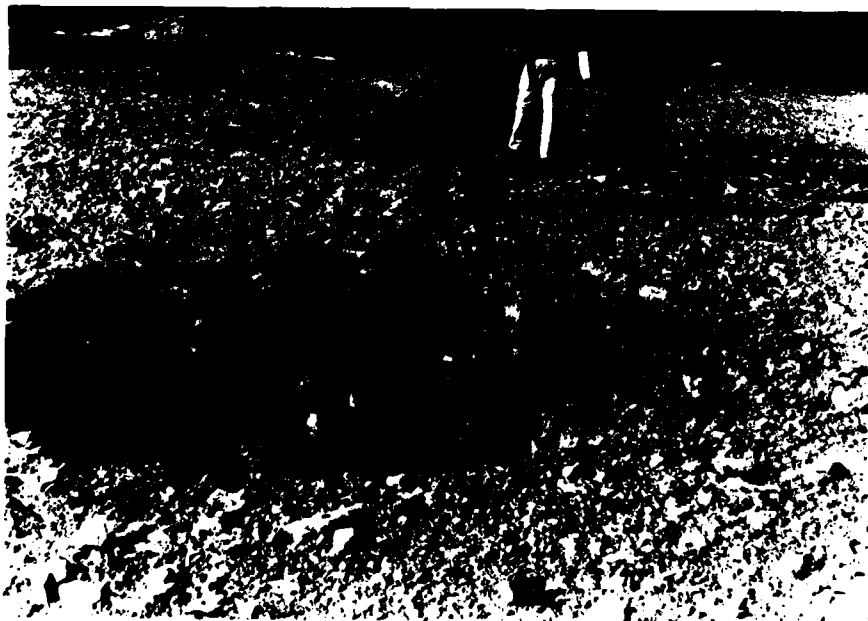
The other possible item of concern is the crater-like feature noted on the spoil pushed onto the tailings surface adjacent to the spillway excavation. It appears this crater-like depression is where a boulder in the spoil sank into the unconsolidated tailings. However, the 60-in. diameter storm drain pipe runs along the floor of the reservoir in this area. If settlement, corrosion or overburden pressure has

deformed or damaged this pipe, some loss of material could be occurring in the overlying tailings. Some sedimentation was described by Lagergren and Griffith in the settling pond - stilling basin at the discharge end of this pipe at the downstream toe of the dam. Loss of materials in the tailings reservoir would not represent an immediate hazard to the dam but could indicate this conduit is deteriorating which could affect the dam. Periodic inspection of this 60-in. diameter pipe is recommended to assess its condition and any necessary remedial measures.

10. Crater-like feature on surface of spoil from spillway excavation. Apparently a result of boulder in spoil sinking into soft tailings underneath. Located about half of the way between left end of dam and spillway.
