MERRIMACK RIVER BASIN
BRADFORD, NEW HAMPSHIRE

TODD LAKE DAM

NH 00288

PHASE I INSPECTION REPORT
NATIONAL DAM INSPECTION PROGRAM

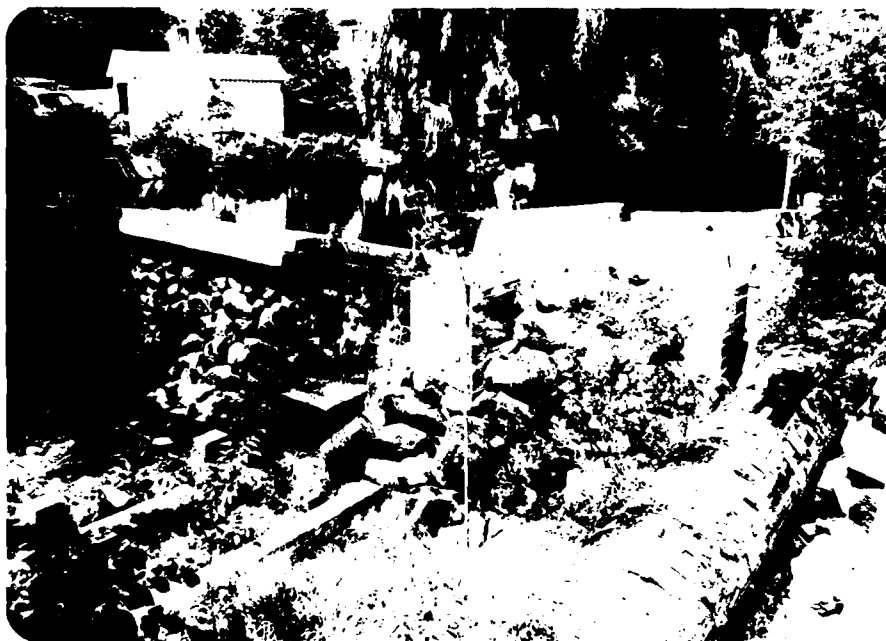
Overview from left side downstream (8 July 78)

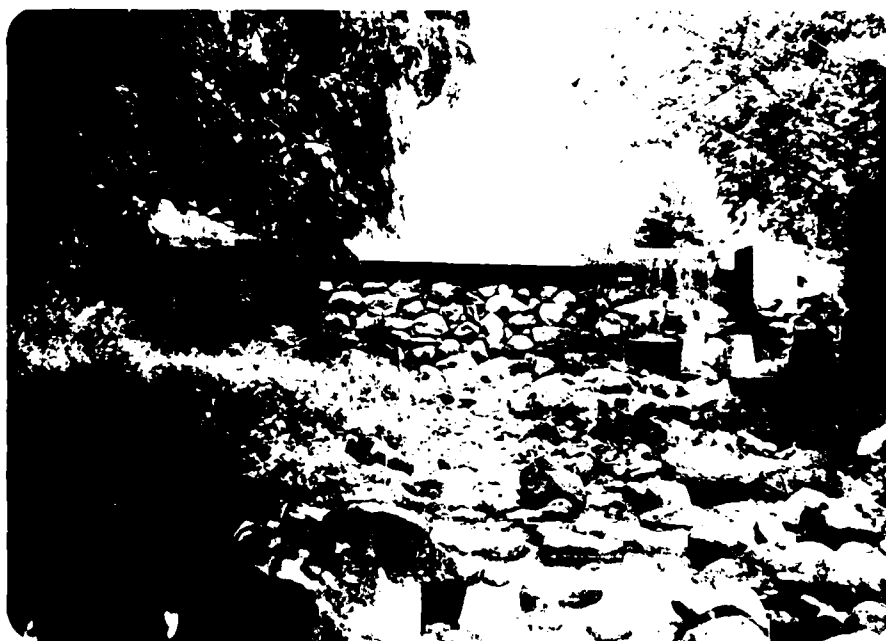
Overview from downstream channel (8 July 78)

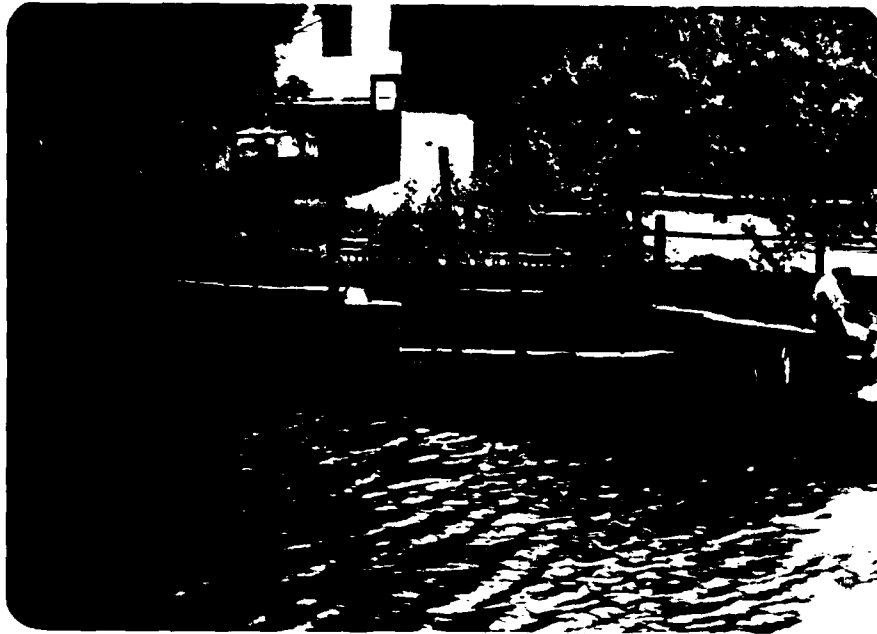
The left abutment, as shown in Photo 3, is of concrete, and overtopping flows would deflect into an open area to the east of the converted mill. A concrete outlet is integral to the left abutment and internal dimensions are approximately 7 feet wide and 11 feet long. The structure is approximately 9 feet deep. The concrete contains medium random cracking and efflorescence. The water level within the structure was approximately 1 foot below lake level on June 1, 1978. The structure has two inlets and one outlet. One inlet is on the upstream face of the structure and the other is in the right wall. The upstream inlet consists of a 4 foot by 4 foot opening. It was not possible to measure the dimensions of the right inlet. Both inlets are sealed with wood. The outlet, which has stop-logs set in place, is on the downstream end of the structure. The top of the stop-logs are 5.3 feet below the top of the structure. Due to their submerged condition, visual inspection of the stop-logs is not possible, however a representative of the owners indicated that they are 4 inches in nominal thickness. There is leakage at the inlet end of the penstock, probably due to faulty seating of the stop-logs. The wood stave penstock is in poor condition and beyond salvage. At least 50 percent of the staves are completely deteriorated (Photo 6).

3. View of outlet structure from right abutment
(1 June 78)

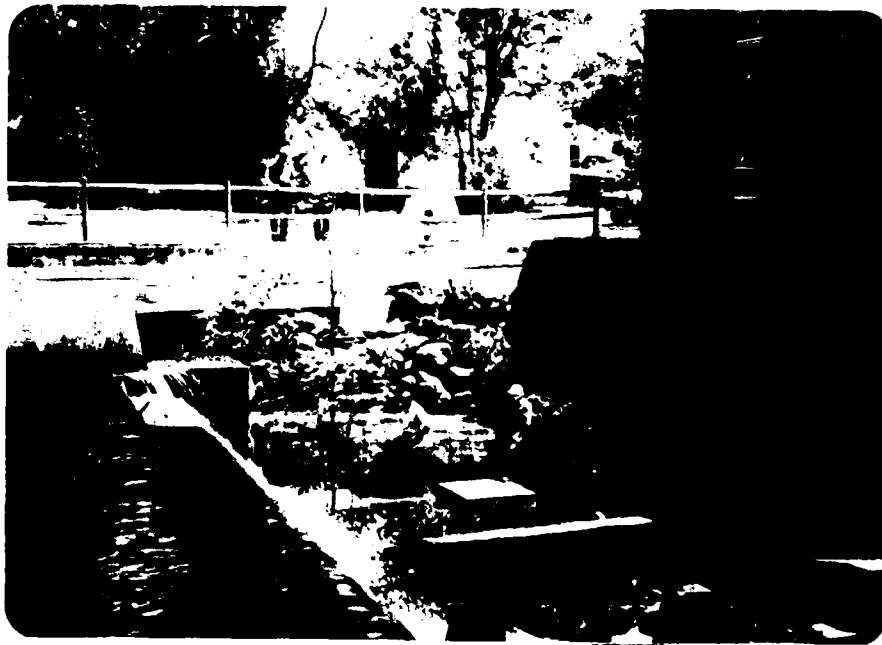
6. View of penstock from right abutment
(1 June 78)

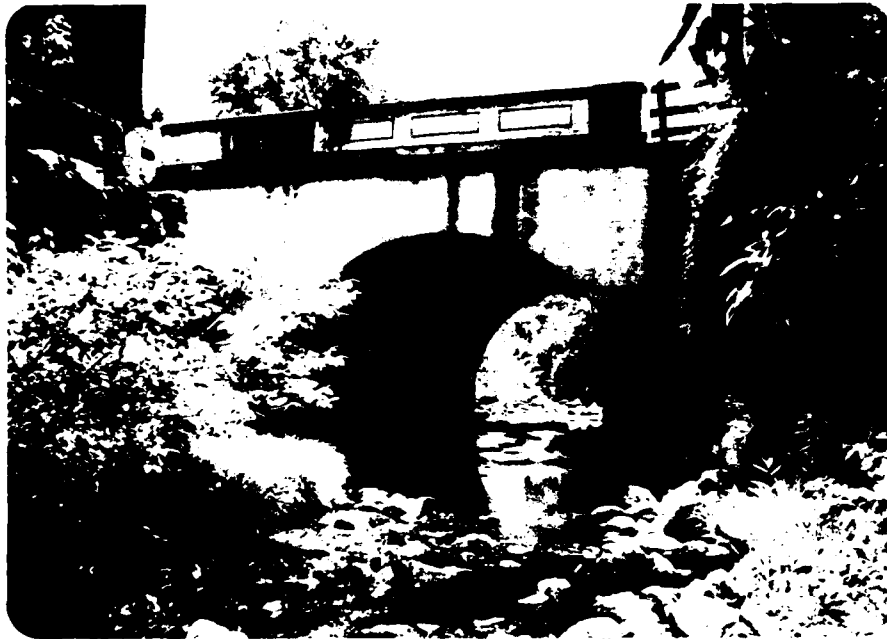
The existence of the road bridge just downstream of the dam would create significant backwaters at the dam in the event of the STF, a situation more beneficial than harmful in terms of the dam's structural stability. The bridge is a concrete arch with a width of approximately 16 feet and a maximum height of approximately 16.5 feet. The narrow, steep channel for some distance downstream virtually assures high water levels around the channel, but the lack of any significant downstream development indicates that property damage is the greatest danger.

7. View looking downstream of road bridge just below dam
