SWANNANOA LAKE

DAM NO. 1 LEVEL

NJ 00311

PHASE 1 INSPECTION REPORT NATIONAL DAM SAFETY PROGRAM

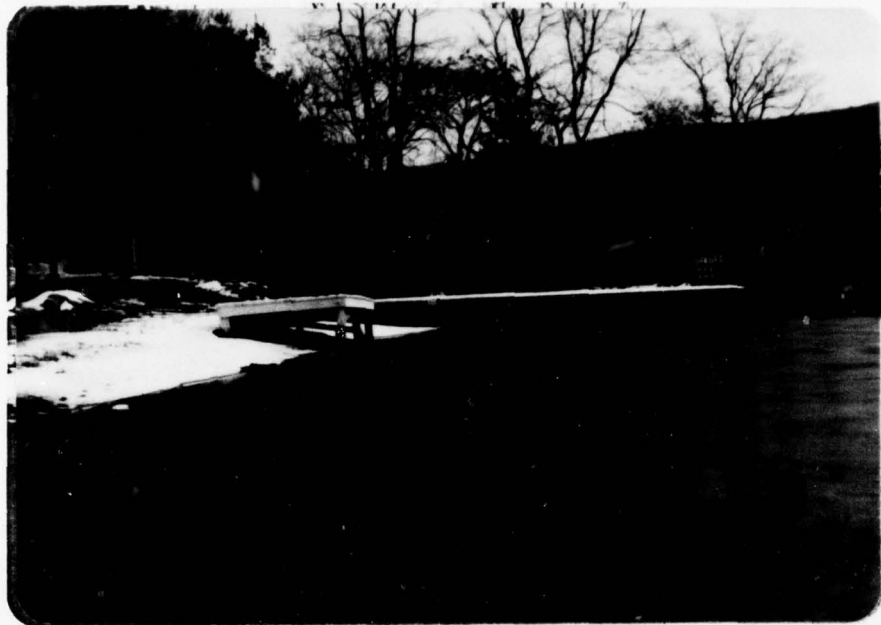
Left Abutment and left side
of spillway.

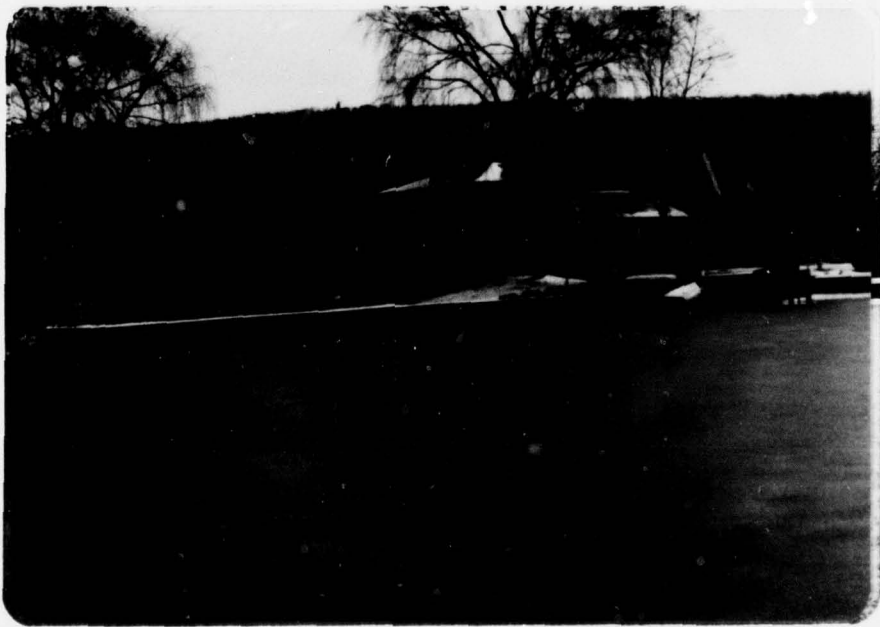
Right side of dam. Looking downstream.

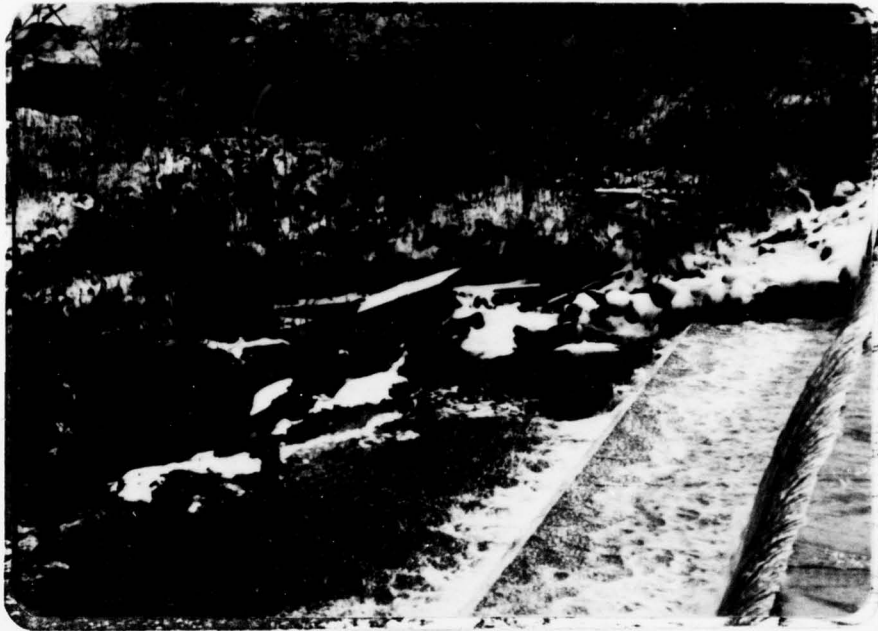
The spillway right downstream channel side wall has collapsed and the left sidewall is deteriorating. There are trees and bushes in the downstream channel and erosion has occurred along the sidewalls. There is cracking and spalling of the masonry concrete and cobble stones have fallen from the side walls of the downstream channel.

Deteriorated downstream spillway
right sidewall.

(2) Repair the downstream sidewalls of the spillway and discharge channel.

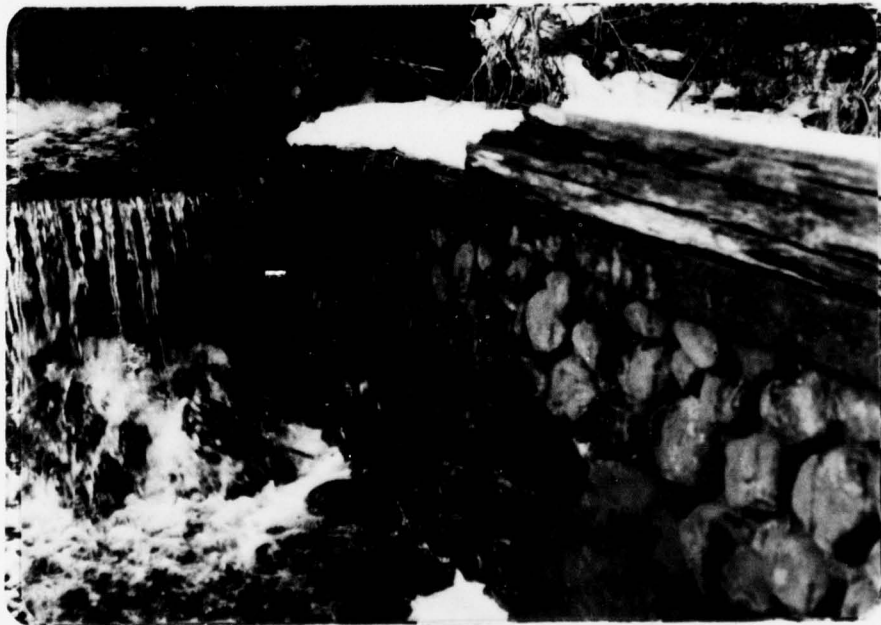
Cobbles loosened and removed from
left downstream spillway sidewall.

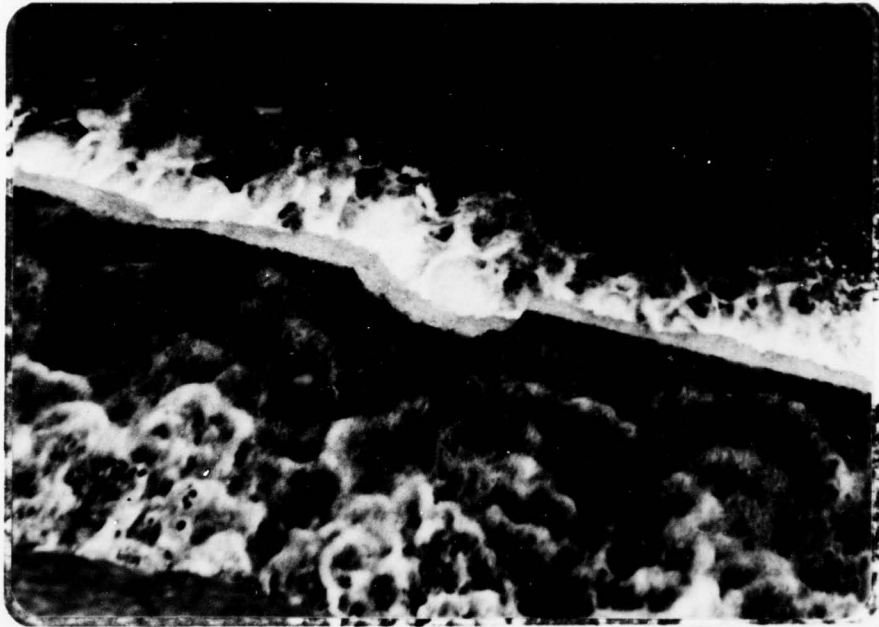
VISUAL EXAMINATION OF	OBSERVATIONS	REMARKS OR RECOMMENDATIONS
CONCRETE WEIR	Algae covers most of concrete. Trash-rack & flashboard support connected to spillway crest has nuts missing.	
APPROACH CHANNEL	Appears Satisfactory	
DISCHARGE CHANNEL	Debris, trees & brush in channel. Channel side walls have deteriorated. Cavities are present.	Remove debris, trees & brush. Repair sidewalls.
BRIDGE AND PIERS	Berkshire Valley Road Bridge across discharge channel.	
	Right spillway d/s sidewall deteriorated. Left spillway d/s sidewall has missing cobbles. Splash bench lip is broken.	Sidewalls should be repaired.

Broken concrete lip of splash
bench at toe of spillway.

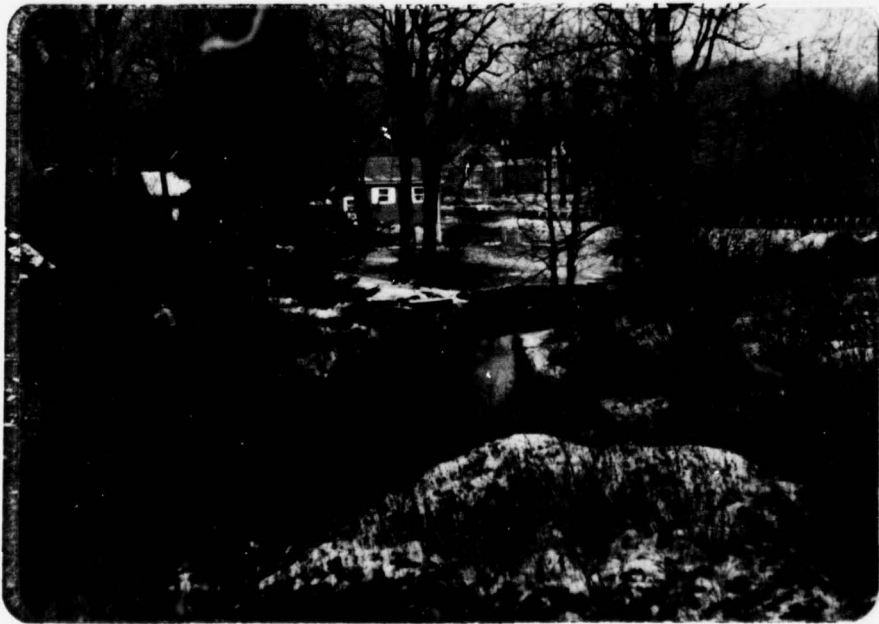
Discharge channel. Looking downstream. 30 November 1978

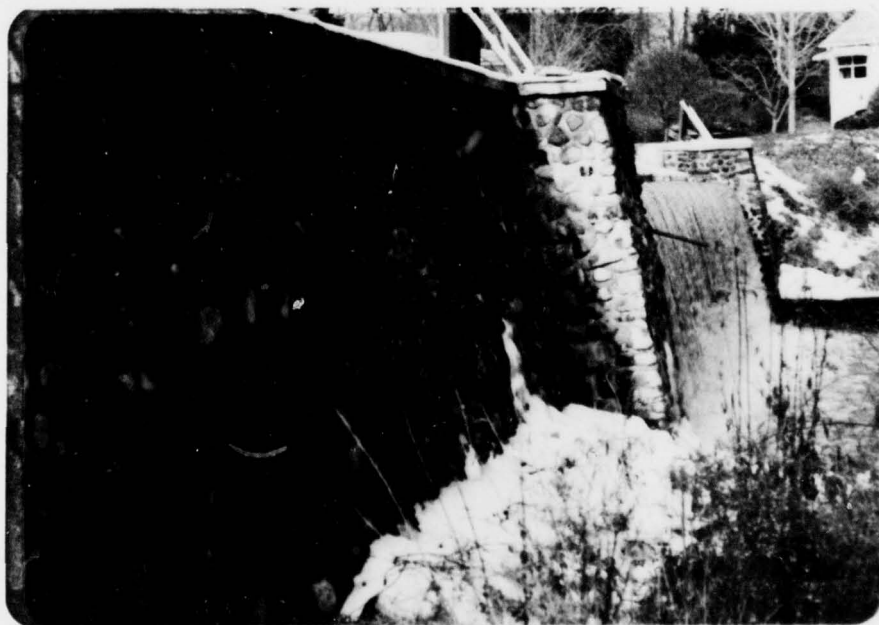
Weep pipes in face of right
side of dam.

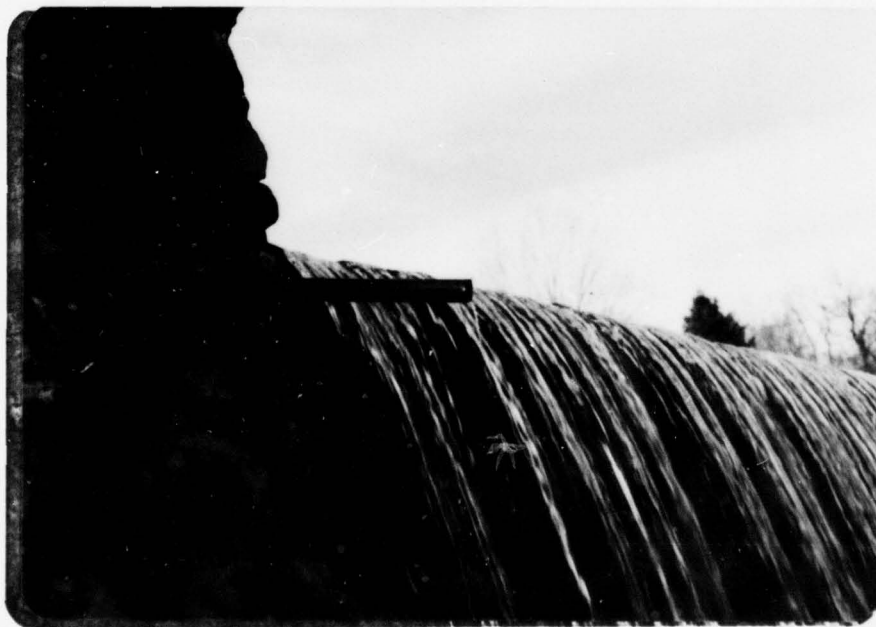
Weep pipe at right spillway
retaining wall.

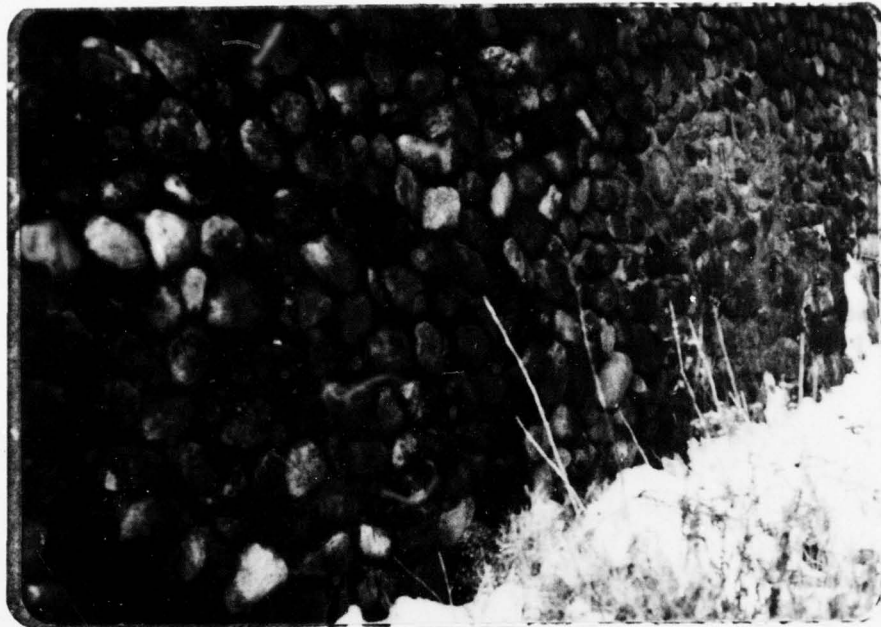
The results of our inspection indicate Swannanoa Lake Dam is in poor overall condition. The lower part of the right downstream face of the dam is bulging over a significant portion of its length. The bulge varies from about 1 inch to 3 inches. Leakage is occurring through the face of the dam and along the toe. The immediate downstream area is wet and spongy.

Repaired right downstream face of dam. Note slight bulging of face.

4. Evaluate the need for additional downstream support of the dam and measures for relieving hydrostatic pressure from within and below the dam. This should be done very soon.

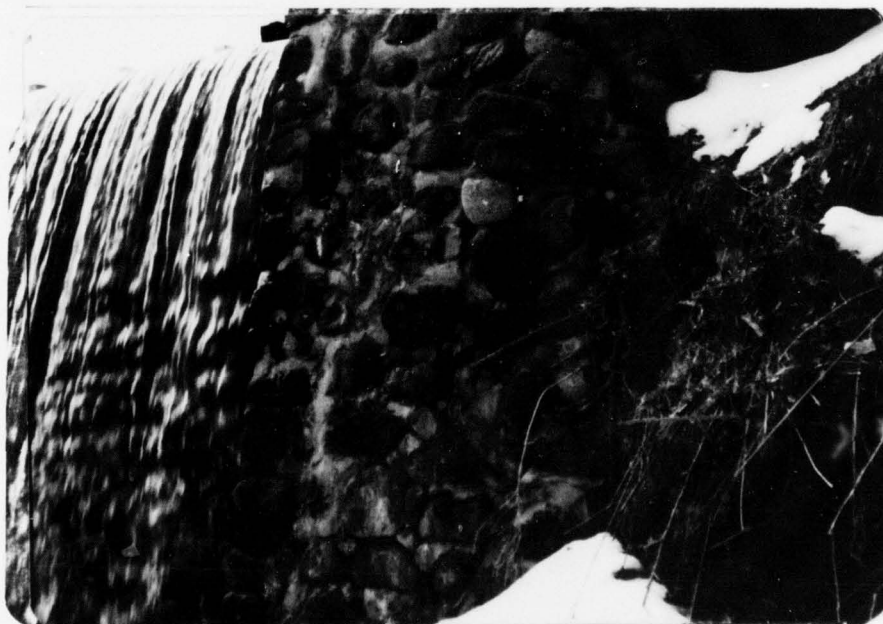
Left retaining wall of spillway.
Note replaced cobbles and weep pipe.

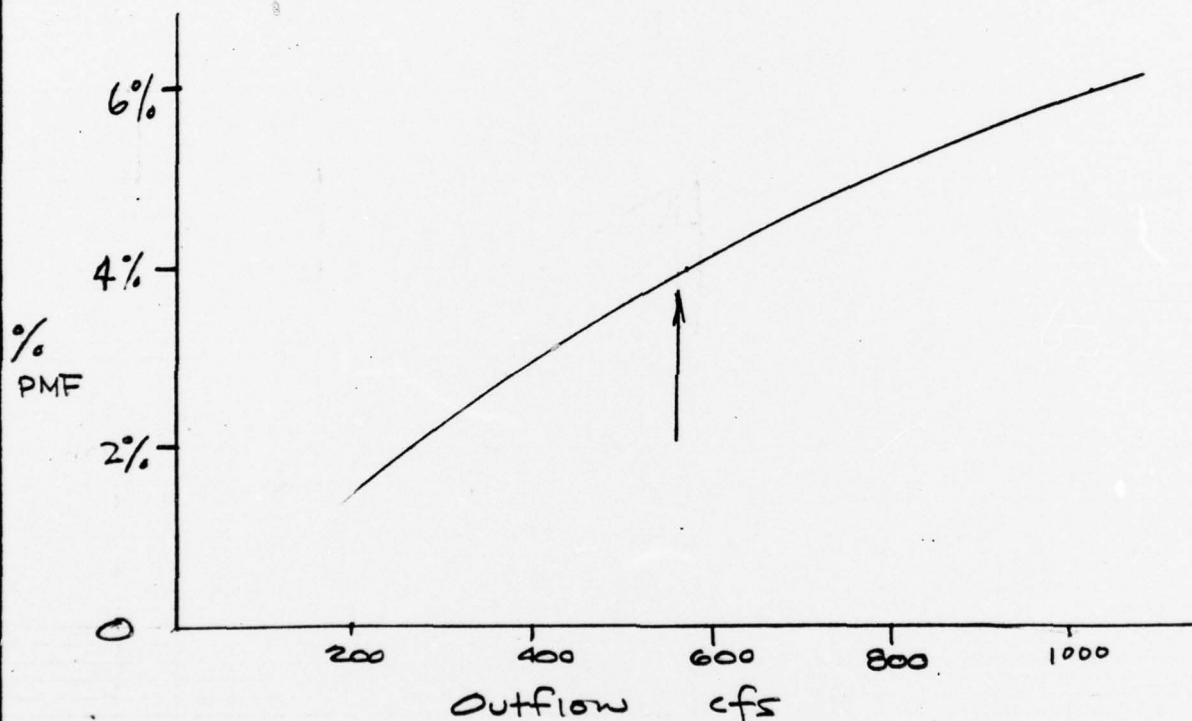
OVERTOPPING POTENTIAL

3. Dam overtops at approx el 773 with $Q = 560$ cfs
 \therefore dam can pass approx 3.9% the PMF
