**RED DAM
MA. 00170**

**PHASE I INSPECTION REPORT
NATIONAL DAM INSPECTION PROGRAM**

**DEPARTMENT OF THE ARMY
NEW ENGLAND DIVISION, CORPS OF ENGINEERS
WALTHAM, MASS.**

SEPTEMBER 1978

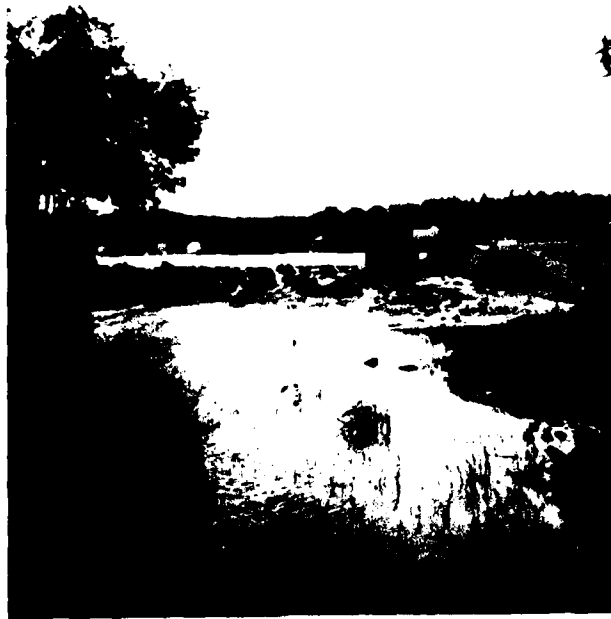
Photograph #2
Downstream View of Red Dam,
Spillway & Sluiceway
