BRIDGE NO.00315

73070 - STAMFORD
US ROUTE 1
over
NOROTON RIVER

Routine and Underwater Inspection

4/03/2018

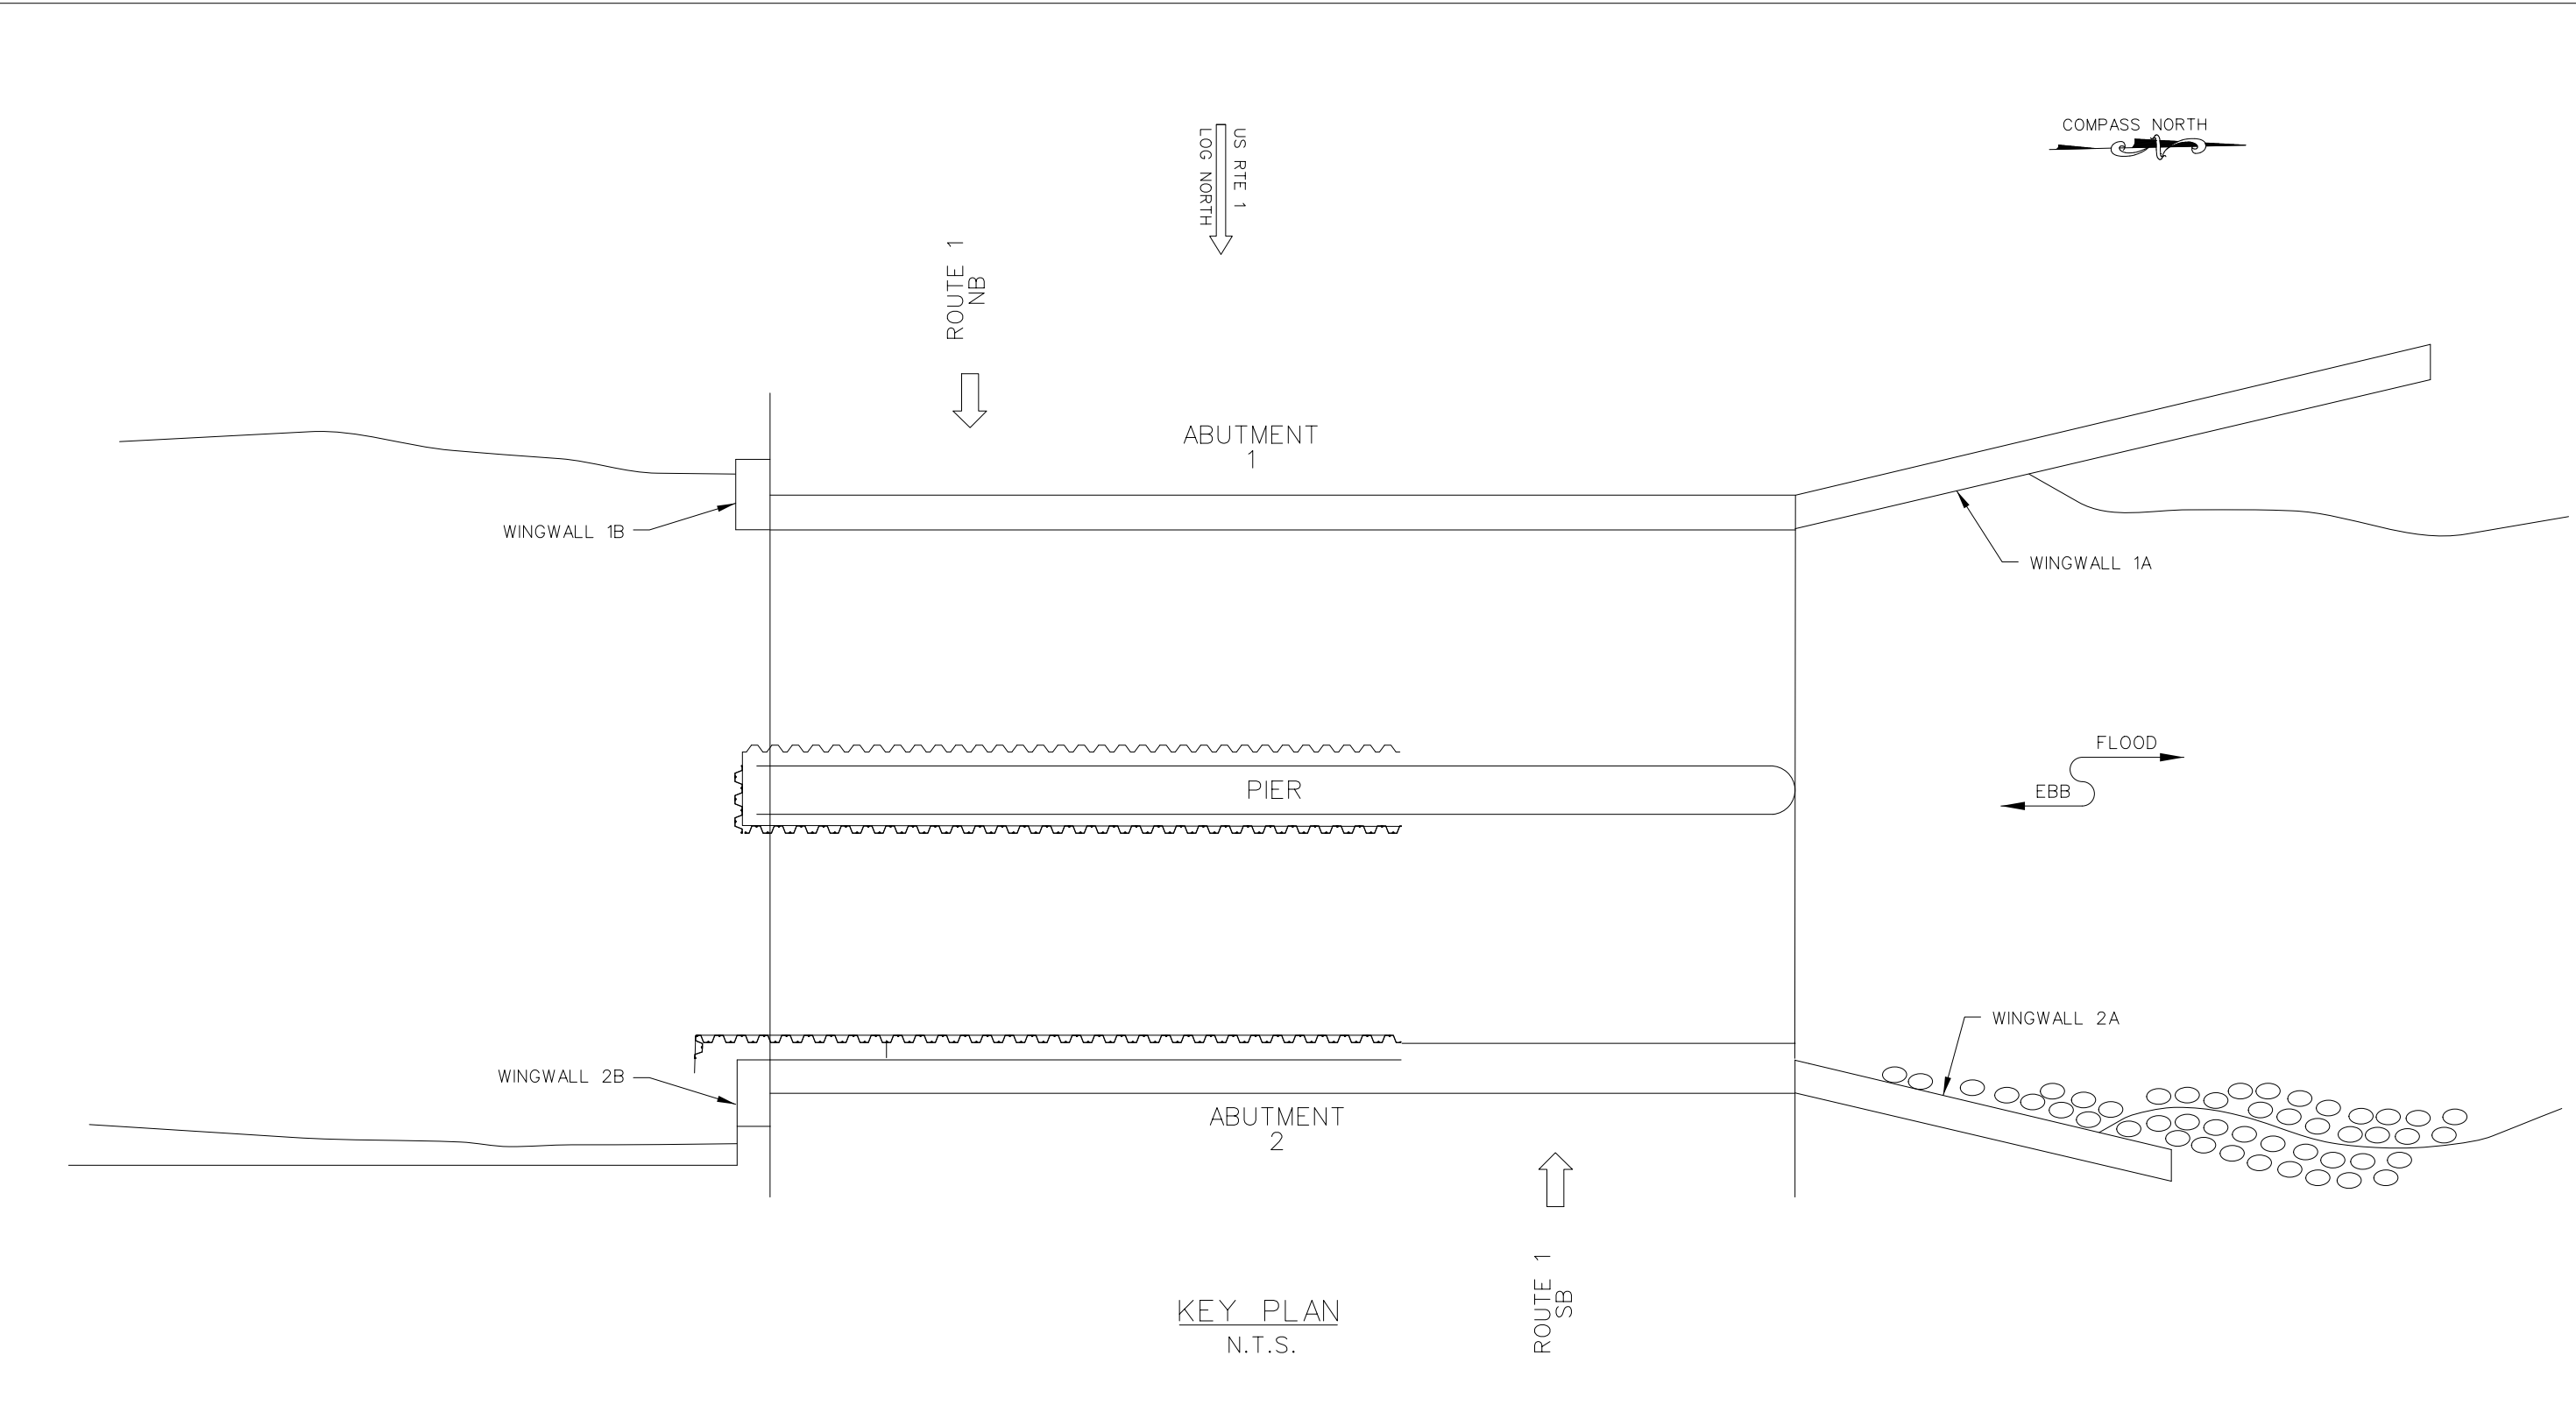
CONNECTICUT DEPARTMENT OF TRANSPORTATION			
BRIDGE NO. 00315			
US 1 (EAST MAIN STREET) OVER NOROTON RIVER			
STAMFORD			CONNECTICUT
KEY PLAN			
INSPECTED BY: CC REVISED BY: PR	SCALE: AS SHOWN	DATE OF INSPECTION 04/03/18	DRAWING NO. 00315A

(1) MISSING/
SHEARED OFF
NUT AND (1)
LOOSE NUT

GUARDRAIL CABLES
(2) LOOSE -
RANDOM
POSTS
LEANING

ALL JERSEY
BARRIERS RANDOM
SPALLS AT
BOTTOM UP TO
1'L x 6"H x 3'D
AND ISOLATED
HAIRLINE CRACKS

APPROACH SIDEWALK
SPALLED/MISSING 3' LONG
x 2' WIDE AND UNDERMINED
UP TO 8"D x FULL
LENGTH DUE TO EROSION
AND HAS A TEMPORARY
BARRIER PLACED OVER
UNDERMINING.

2"W CRACK IN SIDEWALK &
2-1/2'L x 2'W SECTION IS
SETTLED UP TO 1" AND IS
LOOSE

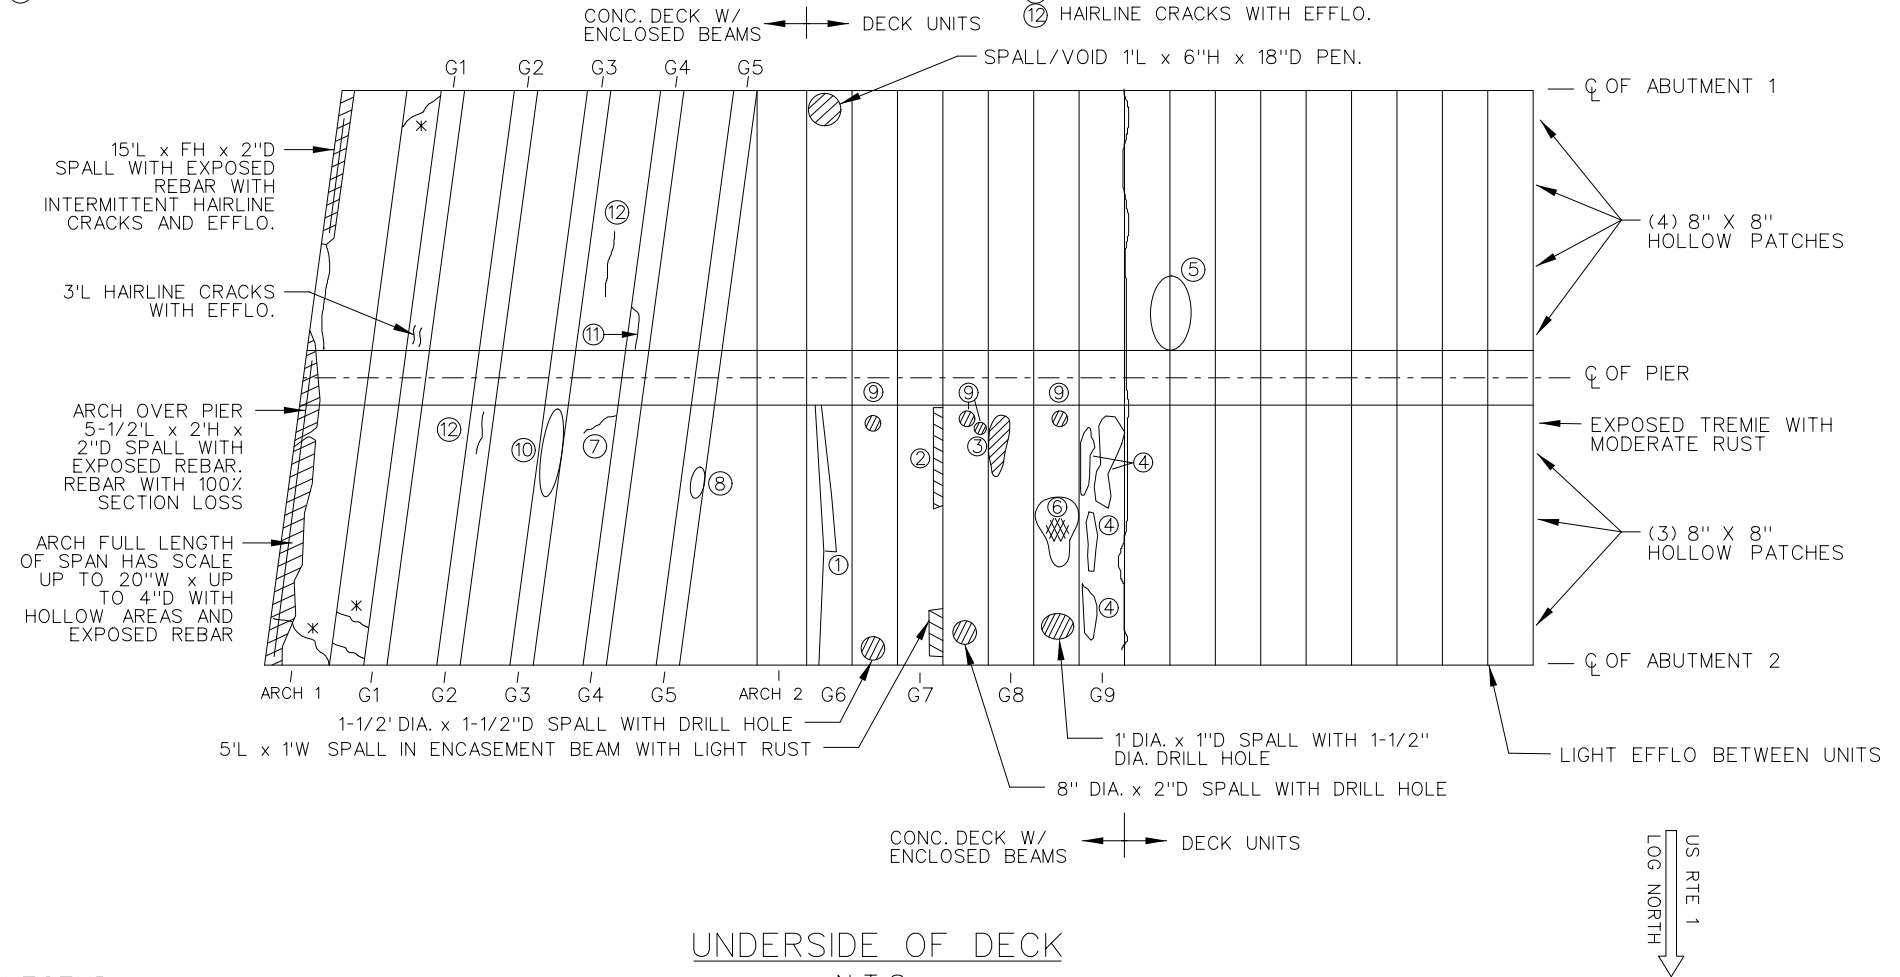
- ① G6 EAST EDGE WITH RANDOM SCALE TO 2" DEEP.
- ② G7 CONC. ENCASEMENT W/ 10'L x 1'W SPALL EXPOSED BEAM WITH LIGHT RUST.
- ③ G8 4'L CONC. ENCASEMENT SPALL WITH RUST STAINS.
- ④ G9 85% OF ENCASEMENT IS SPALLED EXPOSING BOTTOM FLANGE. BOTTOM FLANGE W/ MOD. RUST AND PITTING UP TO 1/16"D.
- ⑤ ACTIVE LEAKAGE AND EFFLO. +/- 10'L.

- ⑥ 6' x 3' AREA OF DAMPNESS ON G9 ENCASEMENT W/ 4'L x 1'H HONEYCOMBING
- ⑦ G4 AT PIER - BASE OF WEB W/ 1'L HORZ. HLC WITH RUST STAINS.
- ⑧ G5 BOTTOM FLANGE 4" x 3" HOLLOW CORNER WITH HAIRLINE CRACK
- ⑨ UNDERSIDE WITH SPALL UP TO 1-1/2' DIA. x 2"D WITH DAMPNESS AND EFFLO. AND 1-1/2" DIA. DRILL HOLES.
- ⑩ 2'L x 1'W HOLLOW AREA WITH EFFLO.
- ⑪ 2'L HAIRLINE CRACKS WITH RUST
- ⑫ HAIRLINE CRACKS WITH EFFLO.

1. ARCHES HAVE RANDOM TRANSVERSE CRACKS TO 1/8" WIDE WITH ACTIVE LEAKAGE (SPAN 2 ONLY), HEAVY EFFLO., SCALE UP TO 3"D AND SPALLS IN SKIM COAT.
2. END DIAPHRAGMS BETWEEN CONC. ENCASED BEAMS HAVE EDGE SPALLS ON THE BASE UP TO 1/2" DEEP.
3. SPALLED CONC. ENCASEMENT FOR G6-G9 WITH RANDOM HAIRLINE CRACK.
4. EFFLO. STAINS ALONG JOINT BETWEEN G1-G5 AND PIER.
5. UNDERSIDE OF DECK HAS ISOLATED AREAS OF MAPCRACING (<2%).
6. ARCHES IN SPAN 2 AT PIER HAVE AREAS OF EFFLO.

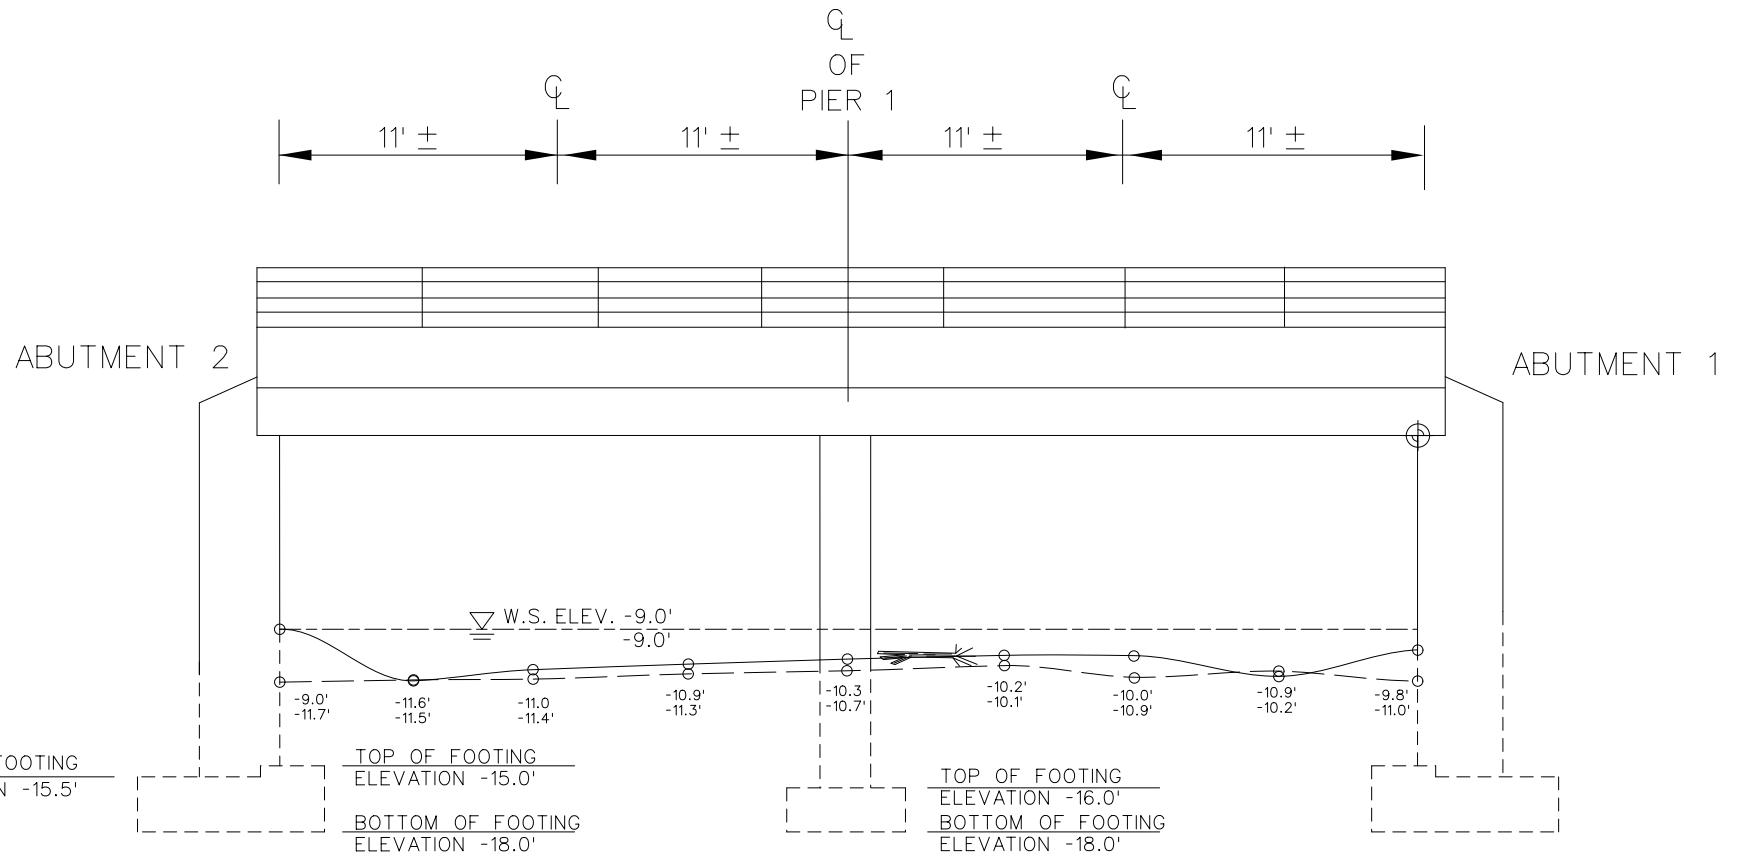
UPSTREAM PROFILE (WEST ELEVATION)
N.T.S.

1. RANDOM VERTICAL HAIRLINE CRACKS.
2. (12) RANDOM POPOUTS UP TO 2" DIAMETER X 1/2" DEEP.
3. RANDOM AREAS OF DELAMINATED GROUT POCKETS.

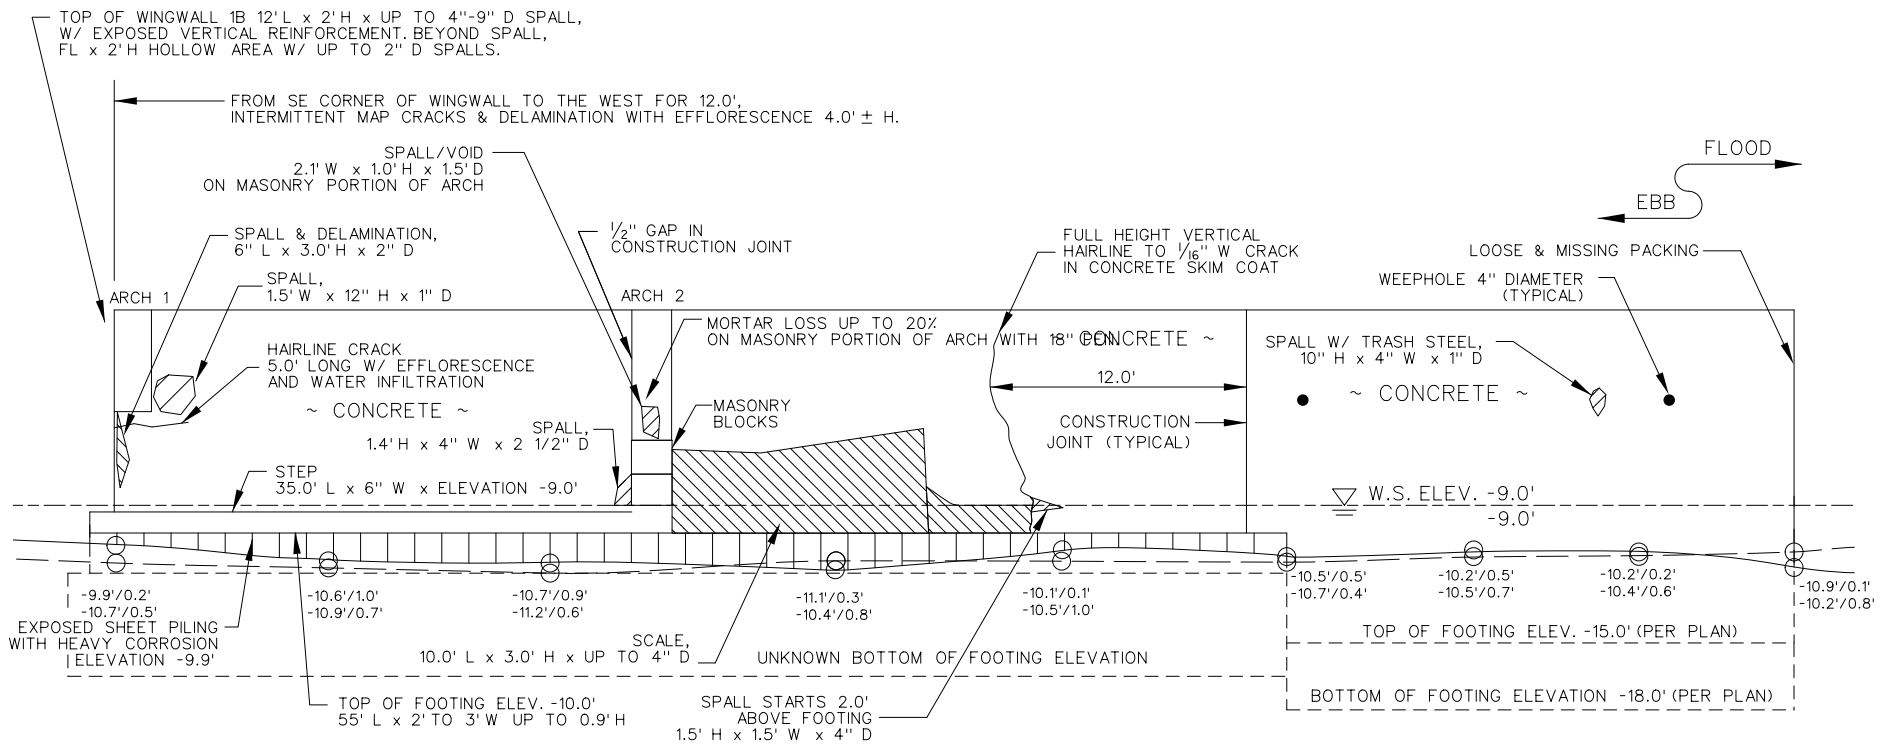
CONNECTICUT DEPARTMENT OF TRANSPORTATION			
BRIDGE NO. 00315			
US 1 (EAST MAIN STREET) OVER NOROTON RIVER			
STAMFORD			CONNECTICUT
ABUTMENT 1			
INSPECTED BY: CC	SCALE: AS SHOWN	DATE OF INSPECTION 04/03/18	DRAWING NO. 00315G
REVISED BY: PR

1. BAND OF UP TO 1.5" D SCALE FROM ELEV. -7.0' TO THE MUDLINE.
2. INTERMITTENT HAIRLINE CRACKS, MAP CRACKING, AND DELAMINATIONS THROUGHOUT.
3. WINGWALLS HAVE UP TO 1" D SCALE AND DELAMINATIONS AND SPALLS, WITH LIGHT EFFLORESCENCE.
4. WINGWALL 1B HAS A FULL HEIGHT 1/8" WIDE CRACK WITH EFFLORESCENCE STARTING 5' SOUTH OF ABUTMENT 1. ADJACENT CONCRETE EXHIBITS A 10' H x 1' W x 1" D AREA OF SPALLING AND DELAMINATION.
5. HORIZONTAL CRACK 7' L x HL TO 1/8" W AT WINGWALL 1B 3' ABOVE MUDLINE WITH LIGHT EFFLORESCENCE.

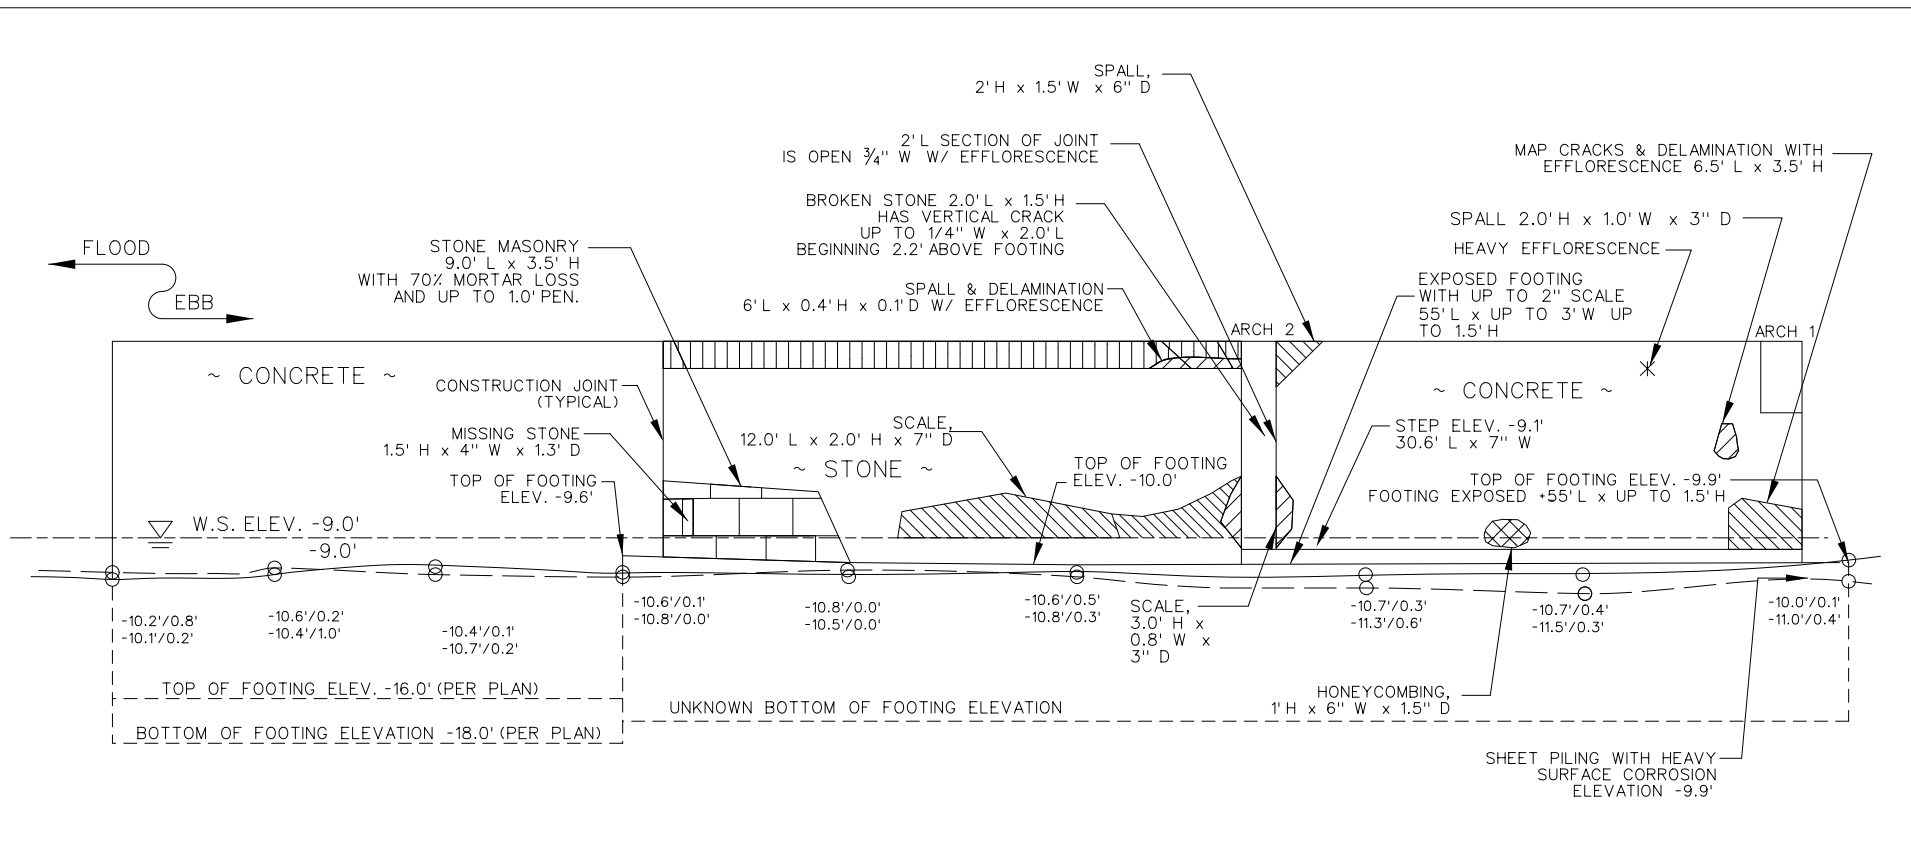
PIER 1 (SOUTH ELEVATION)
N.T.S.

1. SCATTERED HAIRLINE CRACKS THROUGHOUT.
2. BAND OF UP TO 1" D SCALE FROM ELEV. -7.0' TO MUDLINE WITH INTERMITTENT UP TO 1/4" D HONEYCOMBING.
3. SCATTERED DRIFT AND DEBRIS THROUGHOUT CHANNEL.
4. EXPOSED FOOTING HAS SCALE UP TO 3" DEEP.

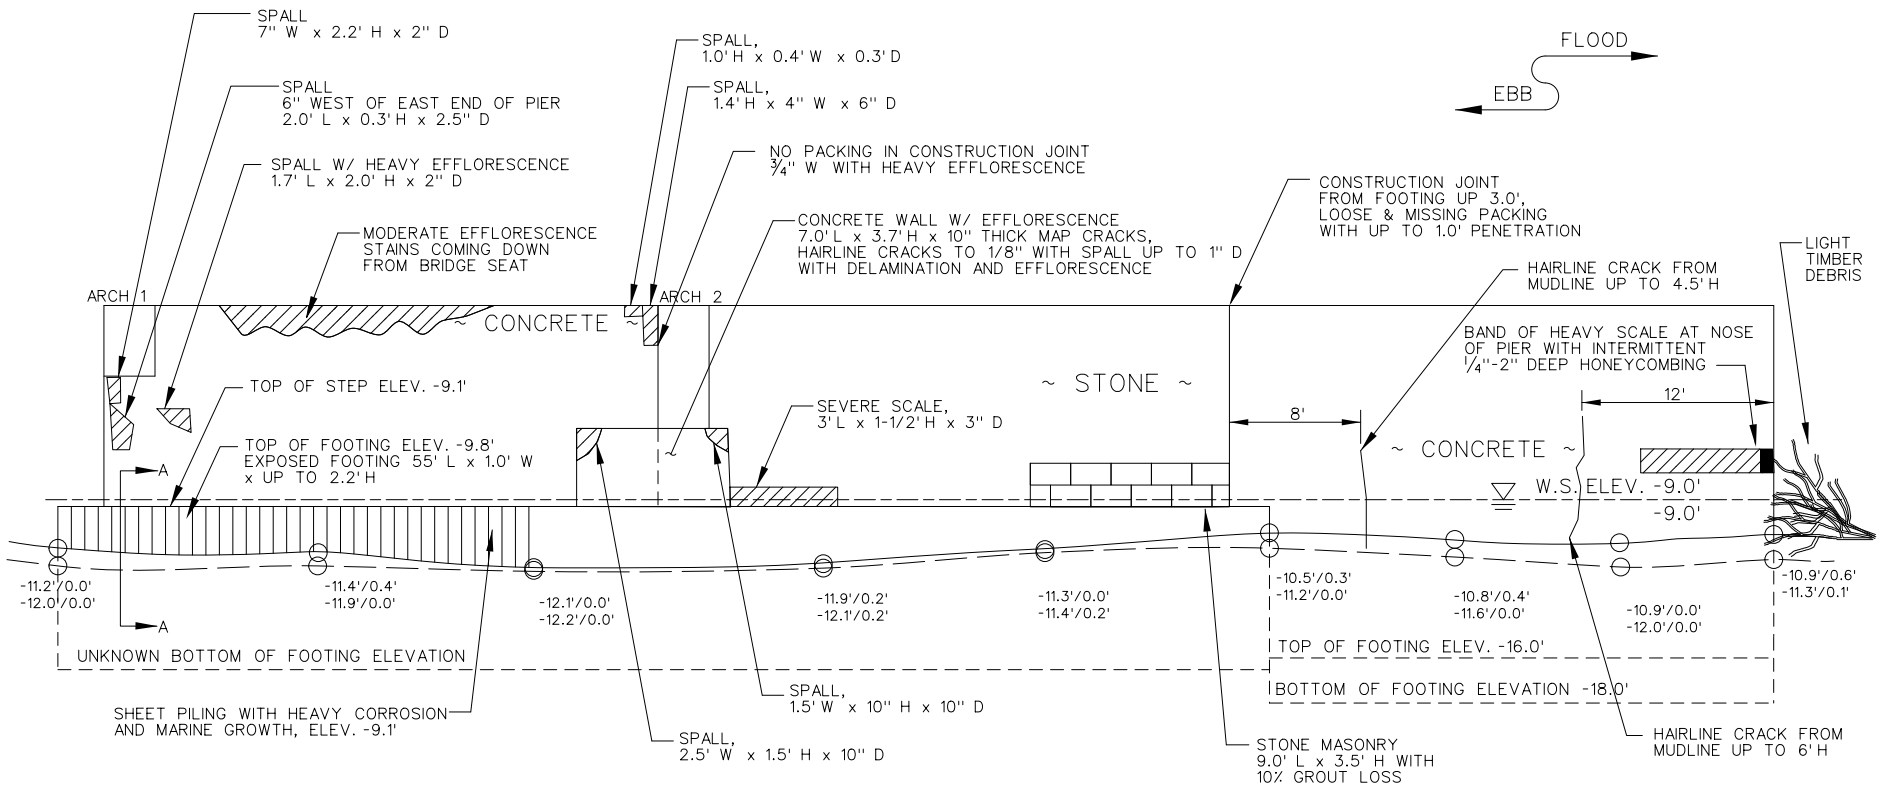
CONNECTICUT DEPARTMENT OF TRANSPORTATION			
BRIDGE NO. 00315			
US 1 (EAST MAIN STREET) OVER NOROTON RIVER			
STAMFORD		CONNECTICUT	
PIER 1 (NORTH ELEVATION)			
INSPECTED BY: CC	SCALE: AS SHOWN	DATE OF INSPECTION 04/03/18	DRAWING NO. 00315I
REVISED BY: PR

1. SCATTERED HAIRLINE CRACKS THROUGHOUT.
2. BAND OF UP TO 1/2" D SCALE FROM -7.0' TO THE MUDLINE, WITH INTERMITTENT 1/4" - 1/2" D HONEYCOMBING.

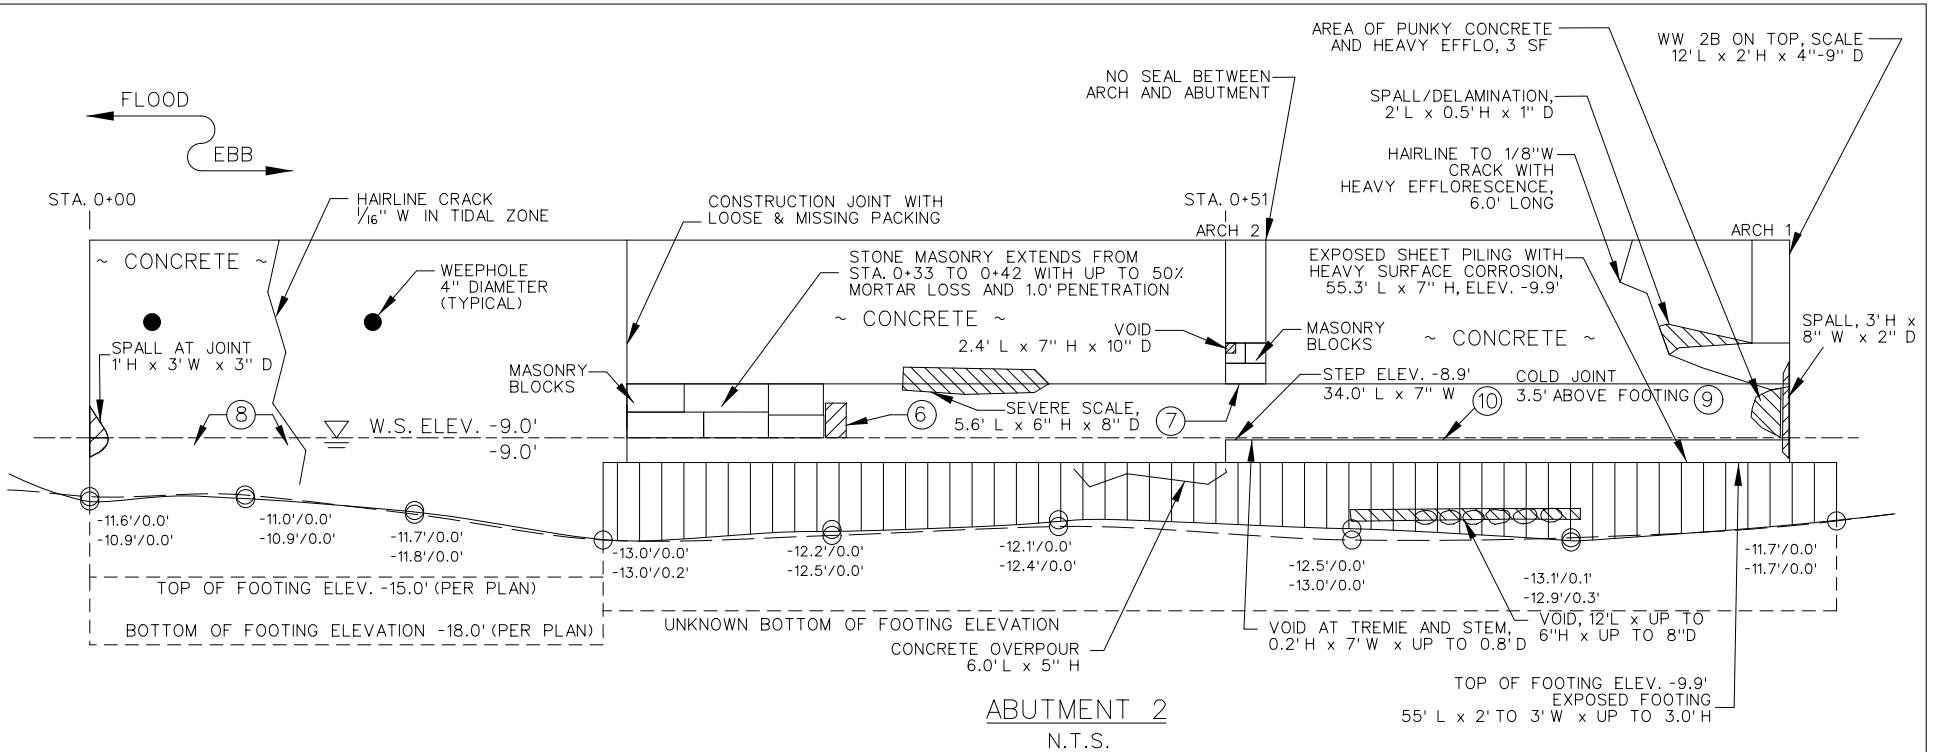
1. WINGWALL 2B HAS SEVERE SCALE, SPALLS AND CRACKS WITH EFFLORESCENCE.
2. STEM HAS INTERMITTENT HAIRLINE CRACKS, MAP CRACKING, AND DELAMINATIONS.
3. FOOTING ELEVATIONS WERE FIELD MEASURED.
4. CHAMFER SPALLS UP TO 2" D WITH EFFLORESCENCE ON WINGWALL 2B COLD JOINT.
5. VERTICAL AND HORIZONTAL HAIRLINE CRACKS WITH EFFLORESCENCE ON WINGWALL 2B.

- ⑥ SPALL 3.0' H x 7" W x 5" D.
- ⑦ AREA WITH 90% MORTAR LOSS BETWEEN STONE AND CONCRETE WITH 1.0' PENETRATION.
- ⑧ FROM ELEV. -7.0' DOWN TO MUDLINE, UP TO 1/2" D SCALE AND UP TO 1.5" D HONEYCOMBING.
- ⑨ UP TO 1.5" D SCALE FROM ELEV. -7.0' TO MUDLINE.
- ⑩ 12' WEST OF E. FASCIA HORZ. VOID IN FACE OF STEP 2.0' W x 3" H x 3" D.

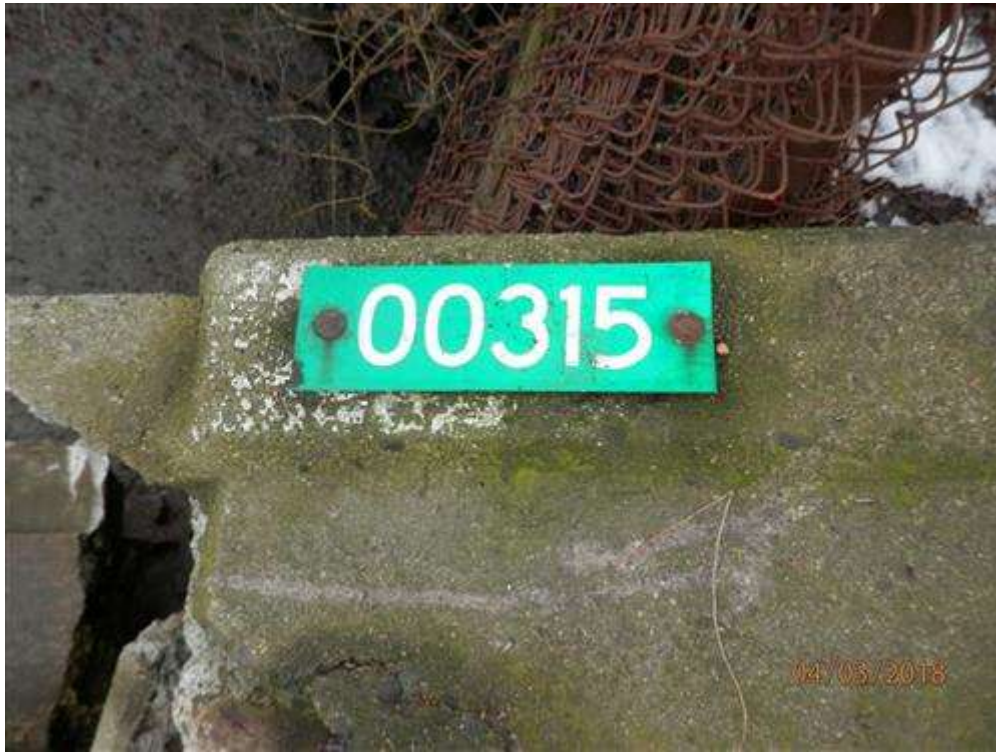
Photo Number: 1

Bridge identification number on fallen piece of east parapet.

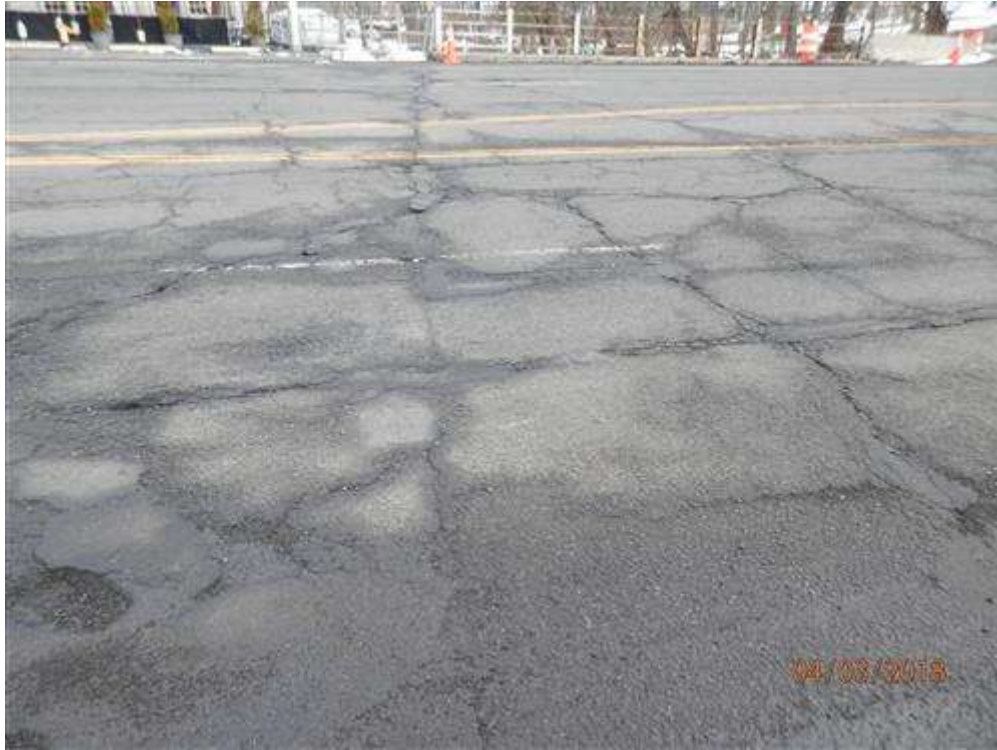
Photo Number: 9

Top of deck at abutment joint, looking west. Note potholes and full width cracks.

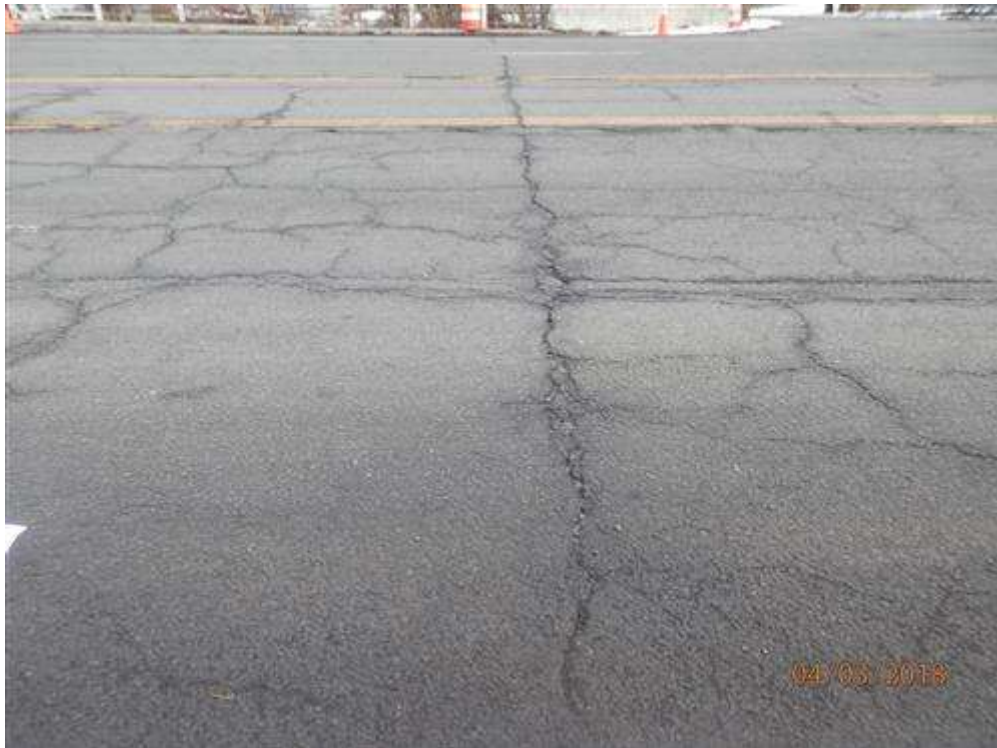
Photo Number: 10

Top of deck at abutment 2 joint, looking west. Note full width crack.

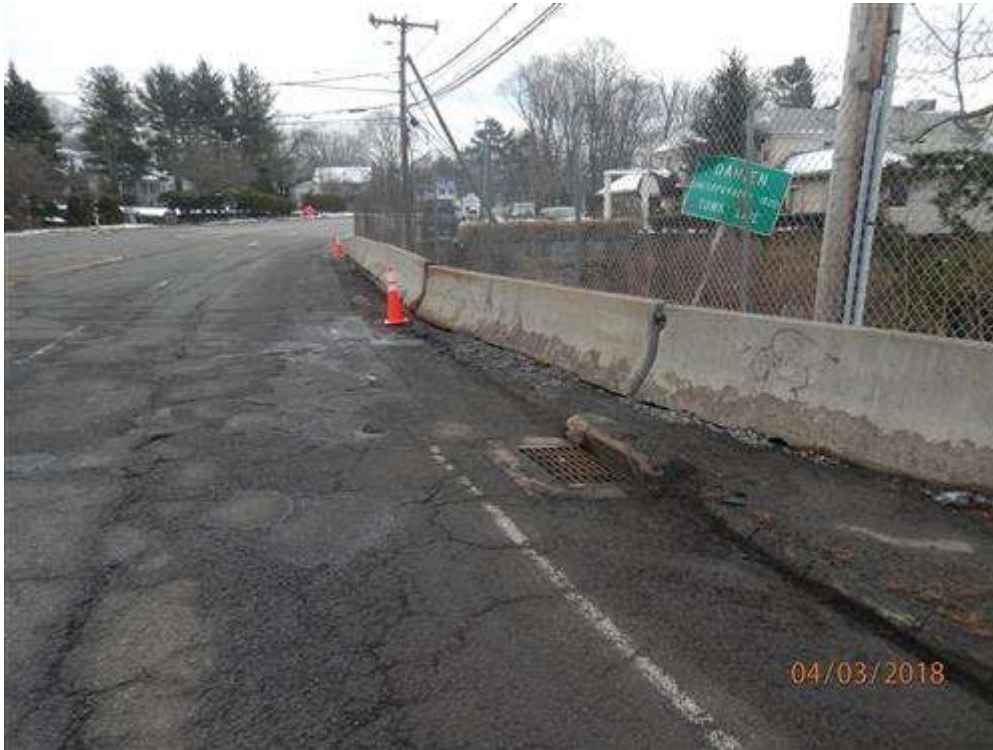
Photo Number: 11

Concrete jersey barrier and chain link fence blocks access to deteriorated east sidewalk and fallen east parapet.

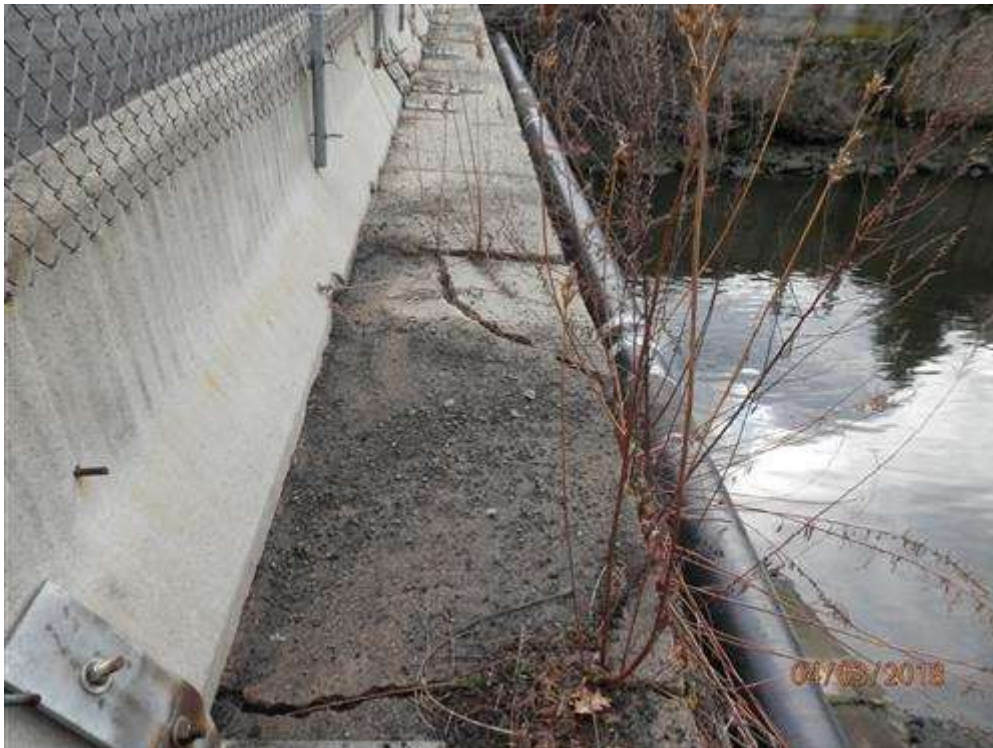
Photo Number: 12

The east sidewalk in span 1 has a 2-1/2' long x 2' wide section that is settled up to 1" and is loose with a 2" wide crack.

East sidewalk is cracked, settled and loose. Note access to east sidewalk is blocked by jersey barrier and chain link fence.

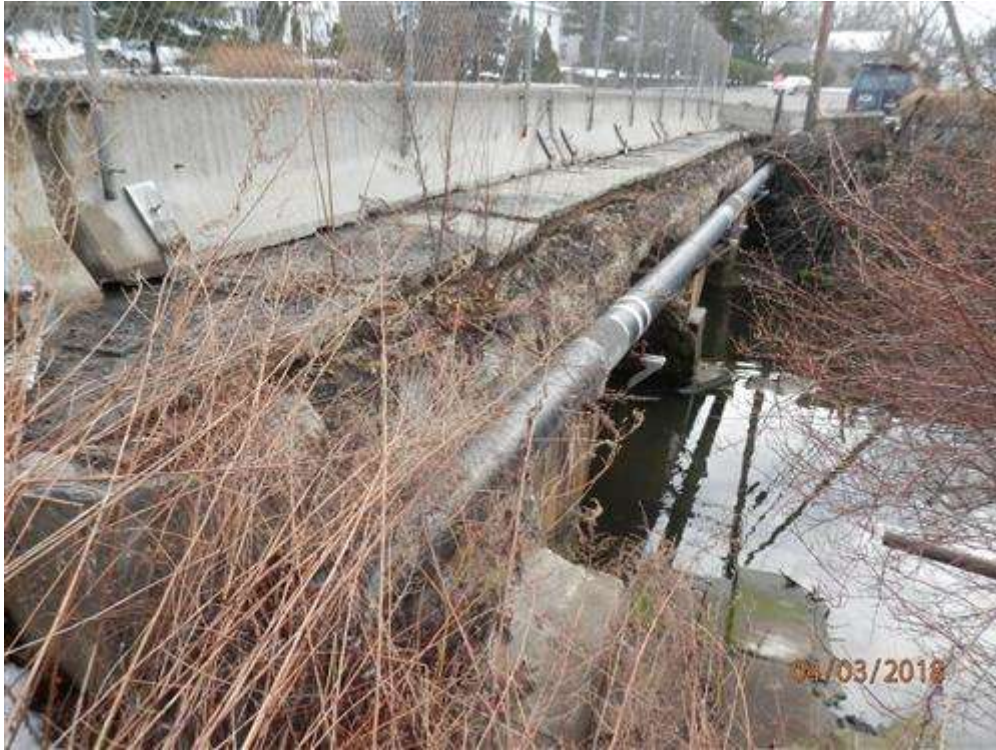
Photo Number: 13

East fascia, looking north. Note missing parapet and heavy deterioration with undermining of sidewalk.

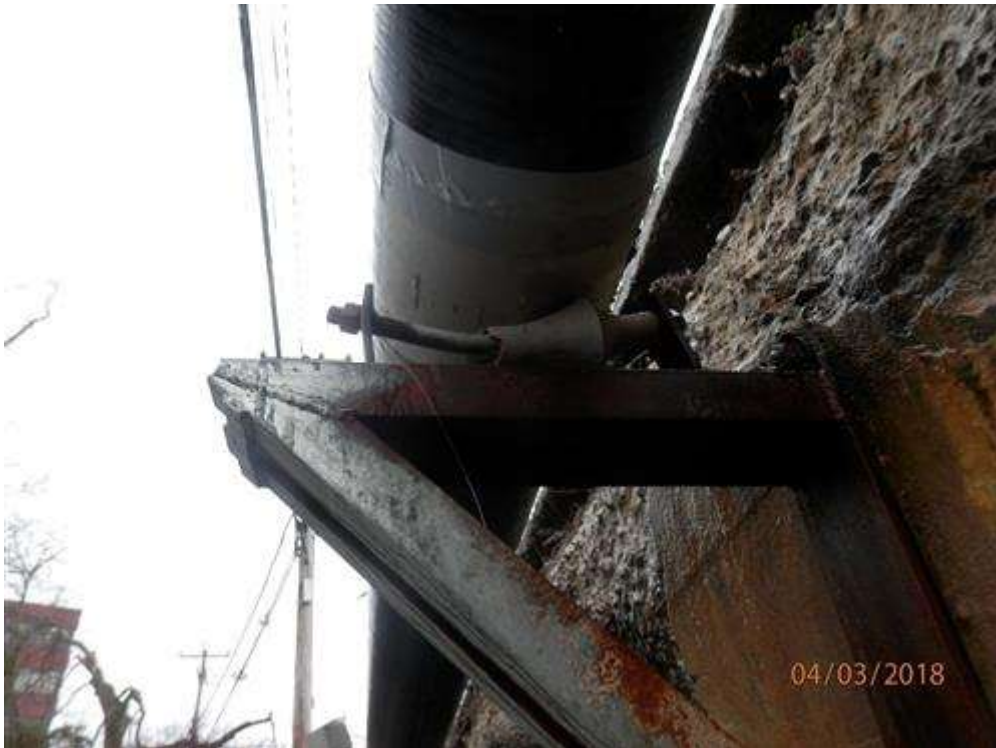
Photo Number: 14

1 Gas	There is a 24" diameter utility pipe supported by brackets mounted to the east fascia. The support plates that are bolted to the fascia have areas of moderate to heavy corrosion. 2 of 3 utility supports are broken and the utility pipe is not properly seated.
2 Water	Per the plans there is a 12" diameter water main buried in the fill (over deck units 5 and 6) that is not visible.
4 Telephone	Per the plans there are communication ducts buried in the fill (over deck units 5 and 6) that are not visible.

East fascia utility pipe bracket broken and utility pipe not seated properly.

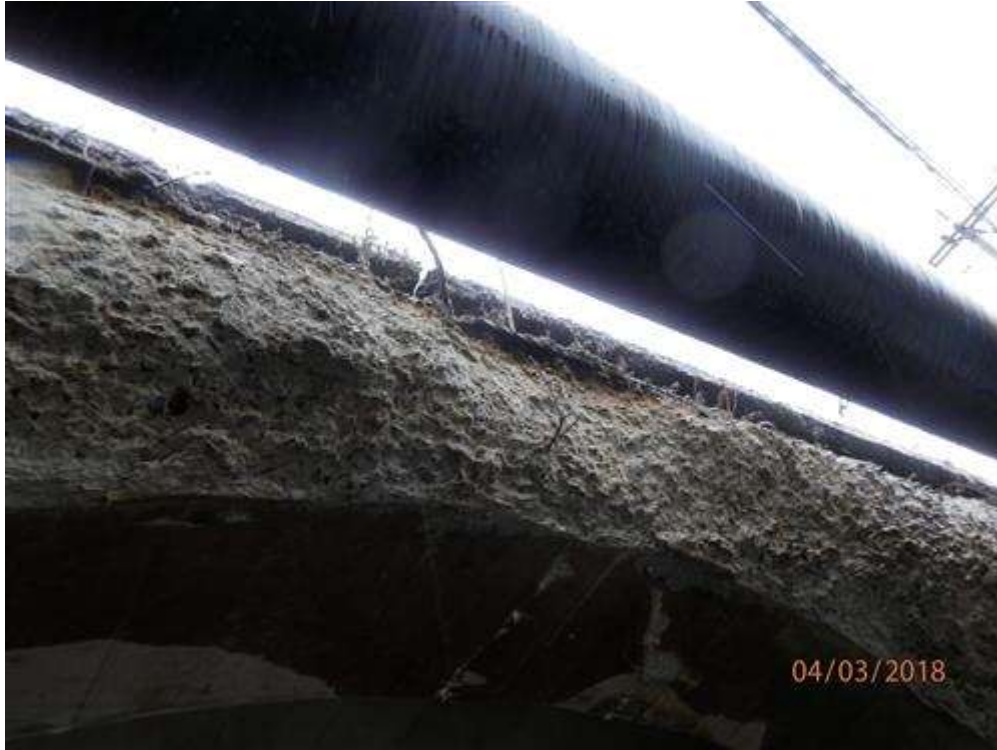
Photo Number: 15

Span 1 east fascia arch exhibits heavy deterioration and spalls with exposed rebar.

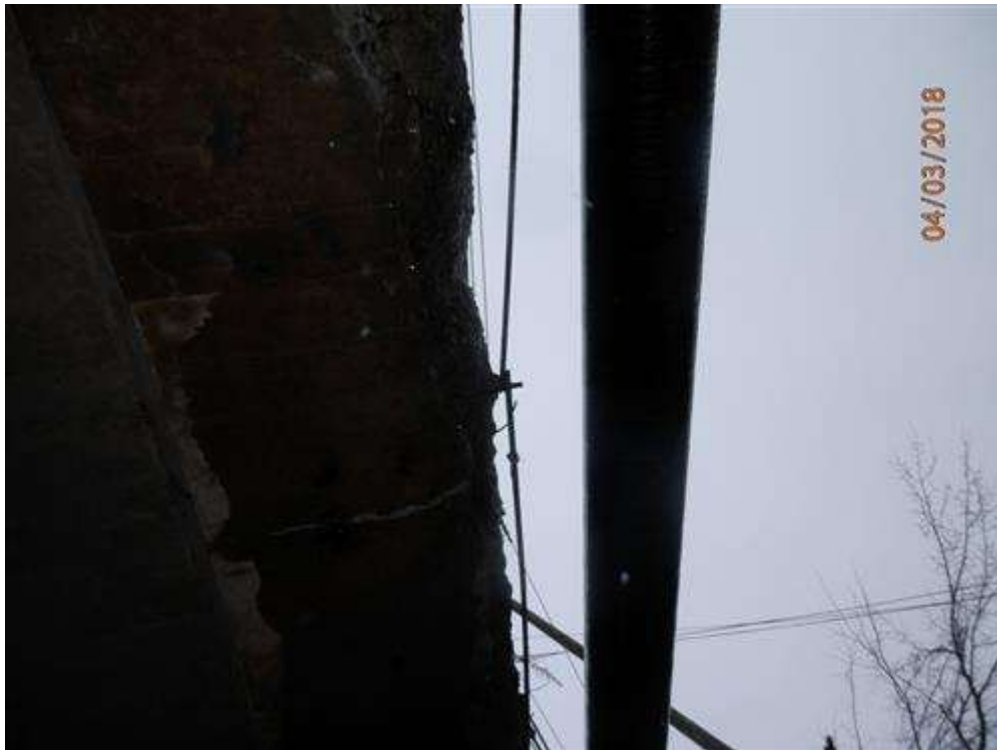
Photo Number: 16

Underside of span 1 east fascia. revealing spalls and exposed rebar.

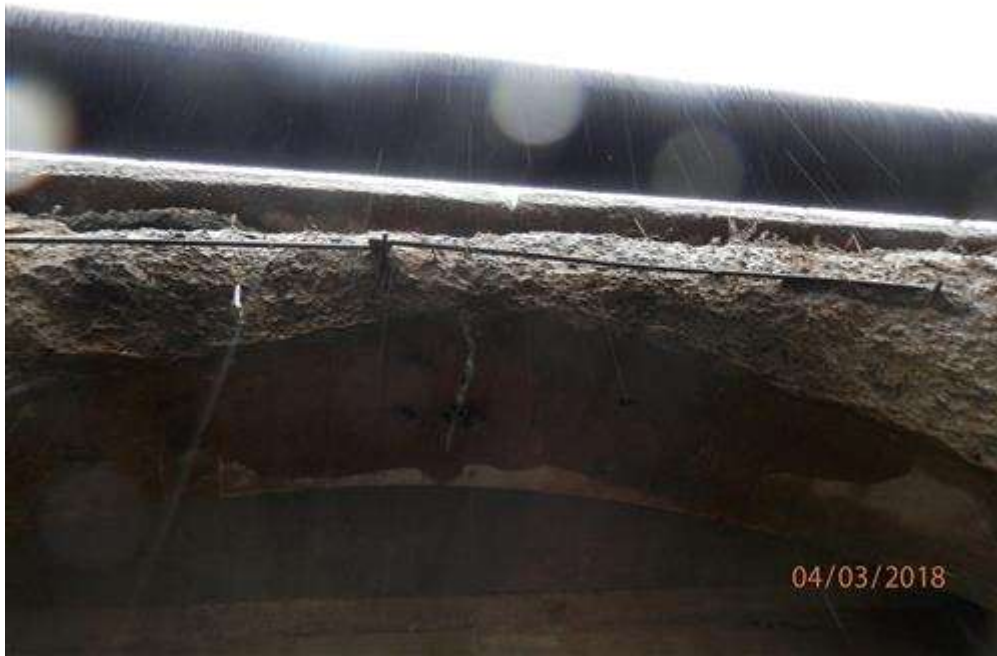
Photo Number: 17

Span 2, east fascia arch exhibiting heavy scale with hollow areas and exposed rebar.

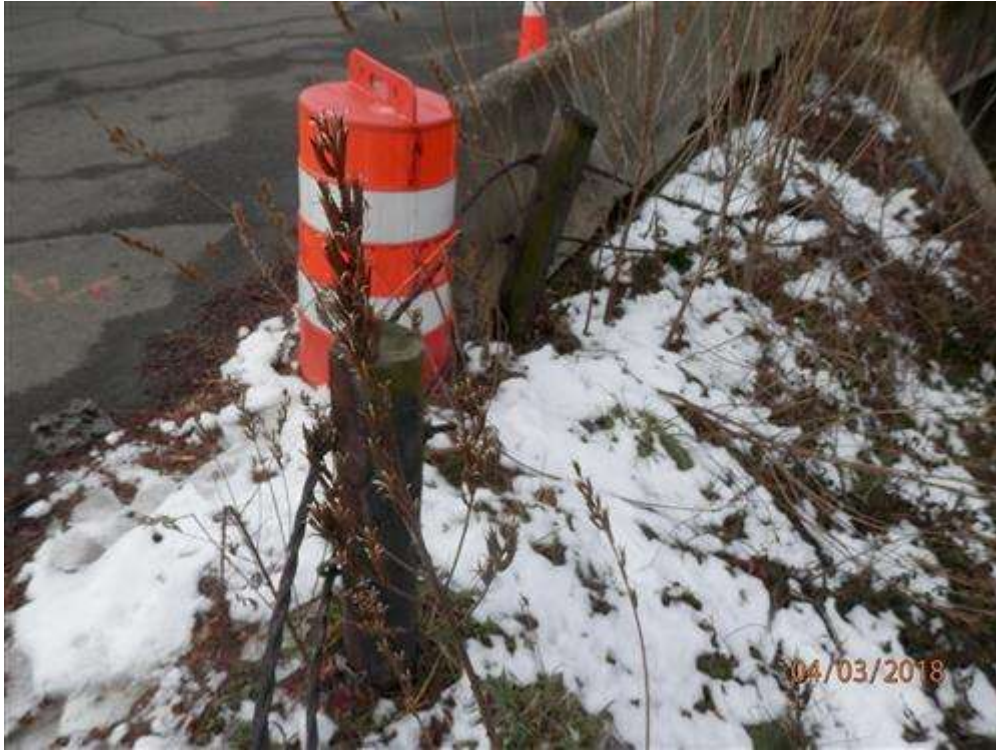
Photo Number: 19

2 Cable guide rail at northwest approach. Both cables are loose and timber posts leaning.
