BRIDGE NO.00315

73070 - STAMFORD
US ROUTE 1
over
NOROTON RIVER

Routine and Underwater Inspection

4/03/2018

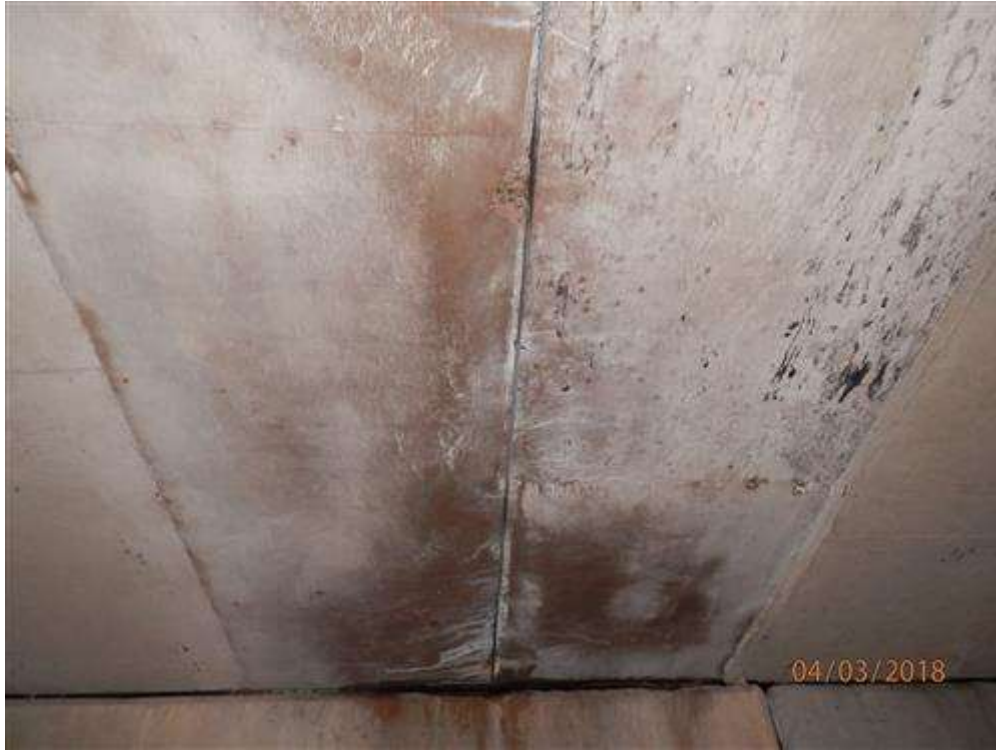
Photo Number: 23

Girders: 6 Prestressed concrete deck units rated here.
The prestressed concrete deck units in both spans have isolated areas of efflorescence leakage between units and minor chips at the edges.
In span 1 there is evidence of water leakage between units 9 and 10 at the pier (±10' long).

Joint between deck units 9 and 10 in Span 1 at pier. Note evidence of leakage and efflorescence.

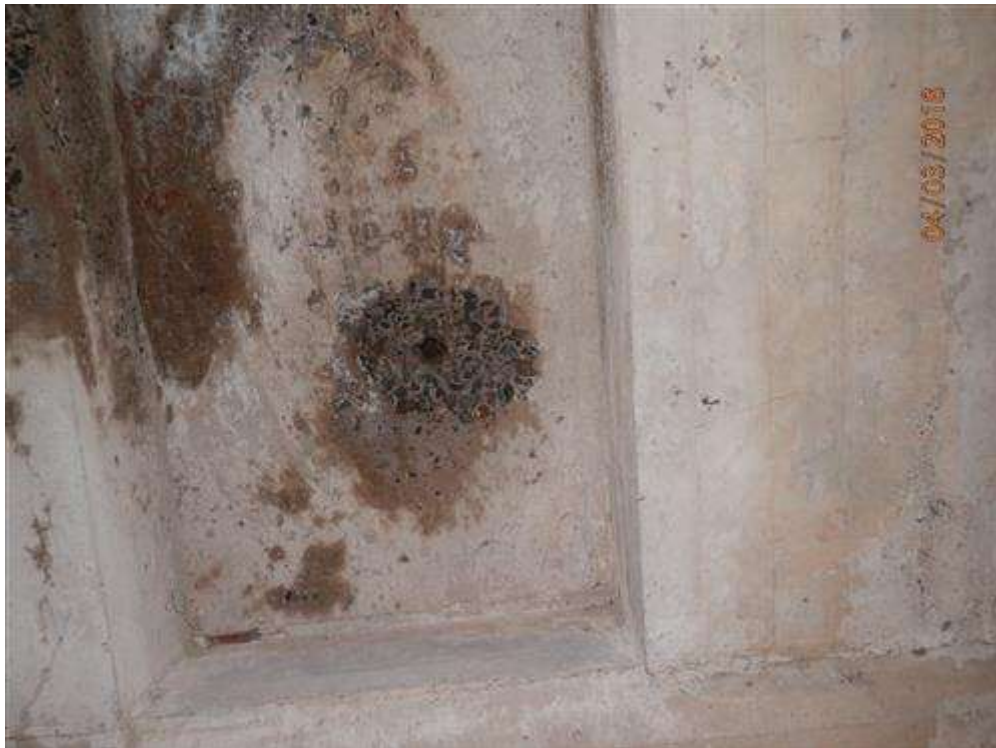
Photo Number: 24

Underside of deck between girders 8 and 9 in span 2 near abutment 2. Note spall with drill hole.

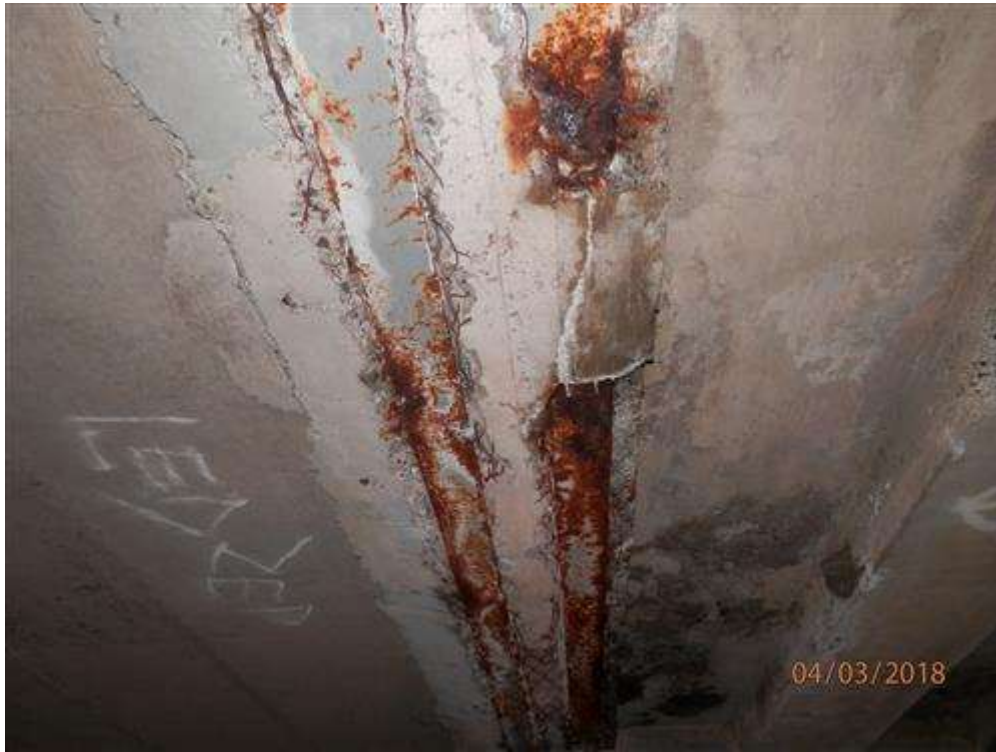
Photo Number: 25

Span 2, girder 9 at midspan with spall in concrete encasement and exposed flange of steel girder.

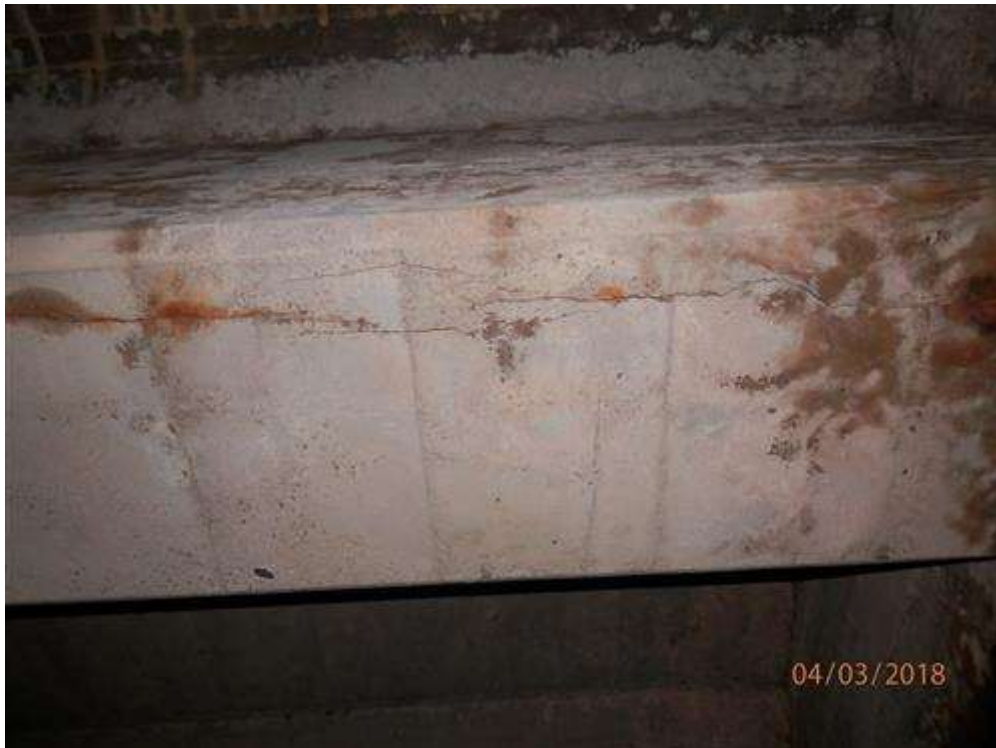
Photo Number: 26

Span 2, girder 5 near pier exhibiting a hollow corner and hairline cracks with rust.

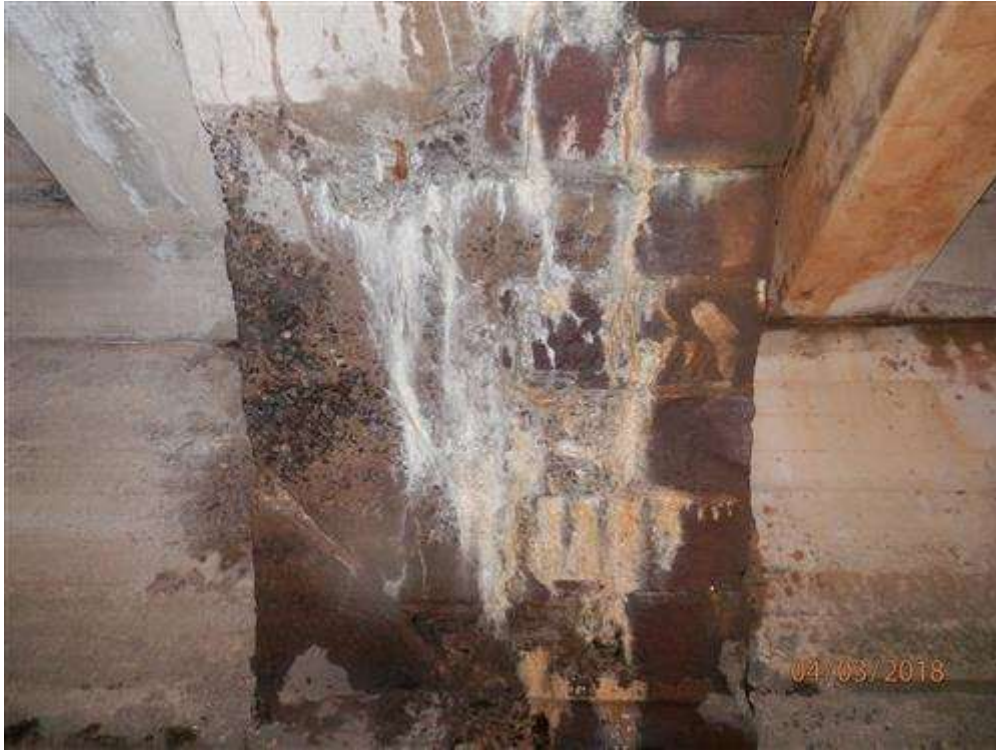
Photo Number: 27

Span 2, arch 2 near abutment 2 with scaling, spalls and efflorescence.

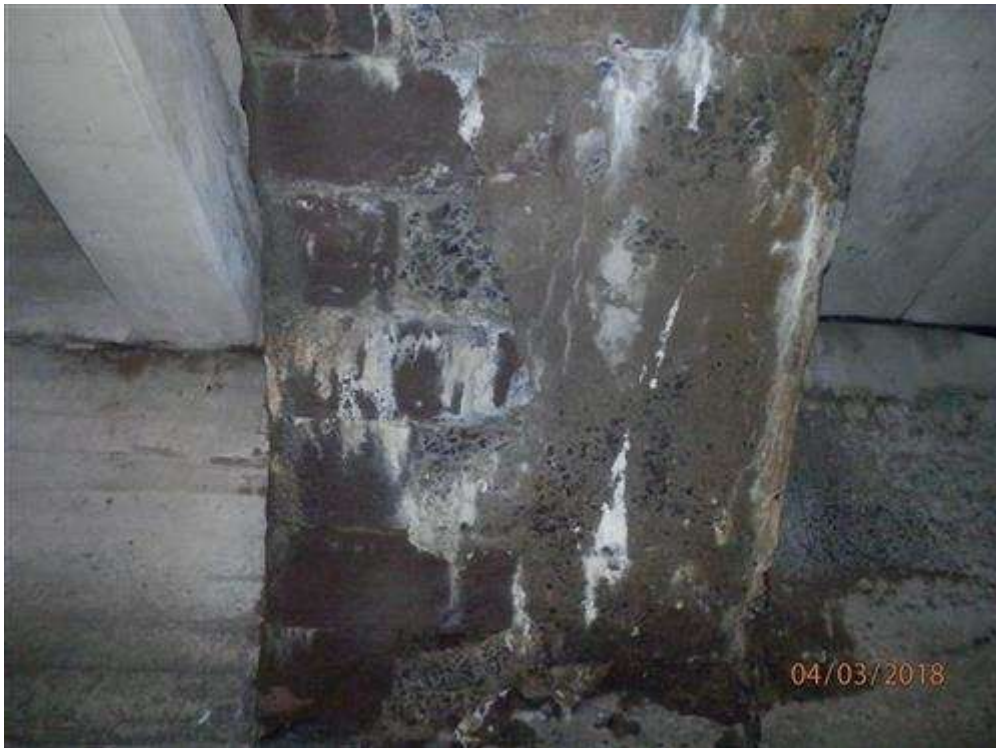
Photo Number: 28

Span 1, arch 2 at abutment 1 exhibiting end spall with penetration.

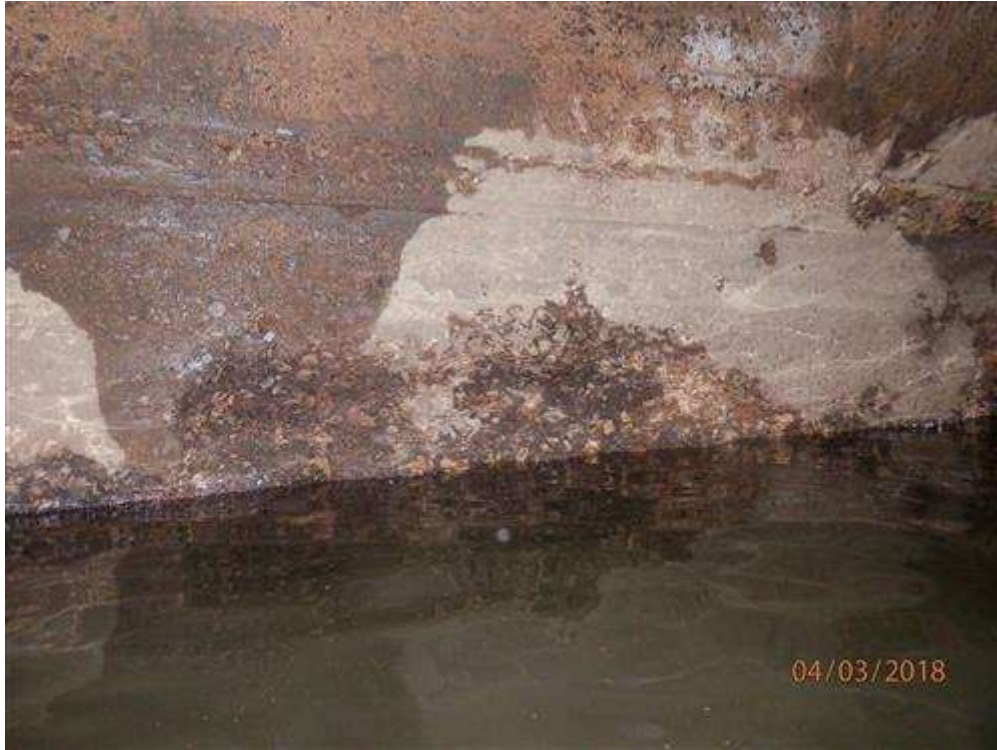
Photo Number: 35

Pier south elevation with heavy scale and spalls in tidal zone.

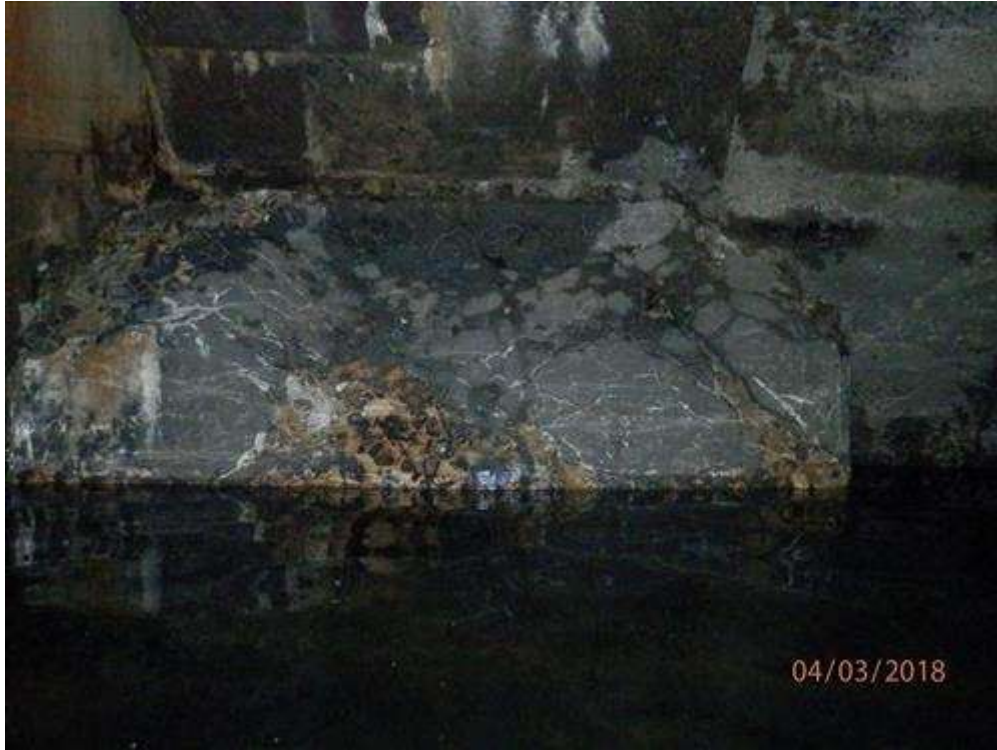
Photo Number: 37

Pier north elevation at arch 2 buttress with heavy scale.

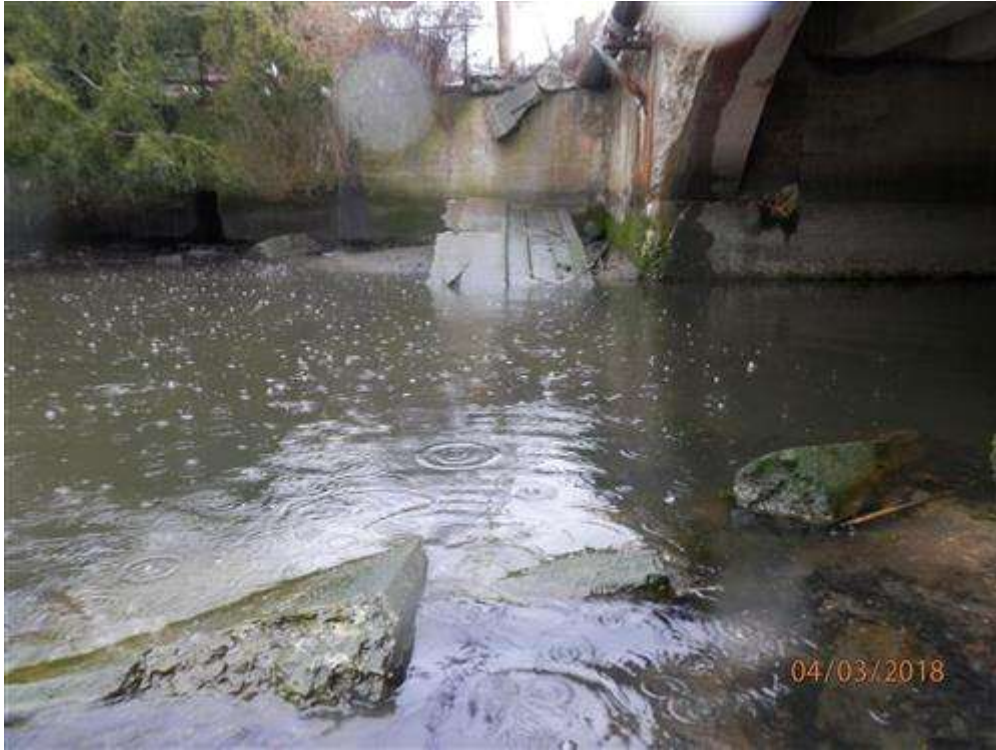
Photo Number: 39

Span 1 east channel with parapet laying in water.
