Subject: ESB E201: PACCAR MX-13 MY2017 Potential Incorrect PTO Gear Installation
Expiration date: 04/01/2019

Technical Information Bulletin

E201

PACCAR MX-13 MY2017 Potential Incorrect PTO Gear Installation

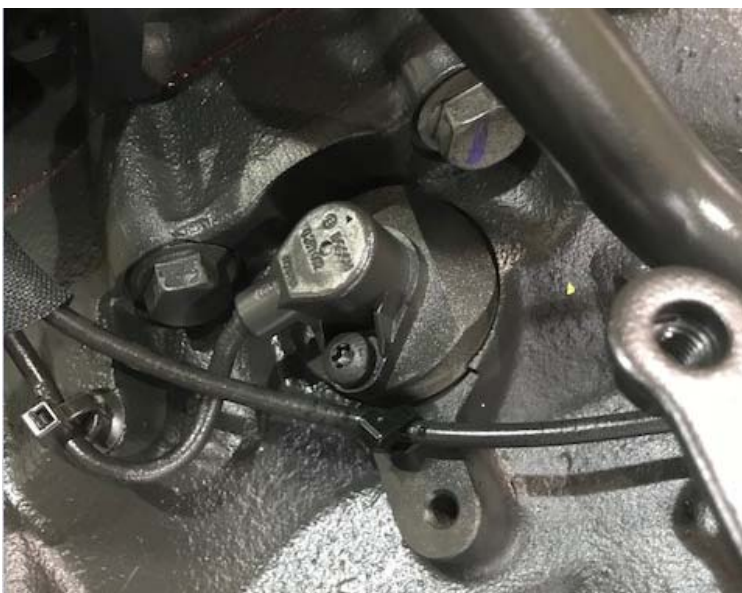
1. Remove the camshaft position sensor.
2. Use a borescope through the cam position sensor hole to determine the engine gear configuration.

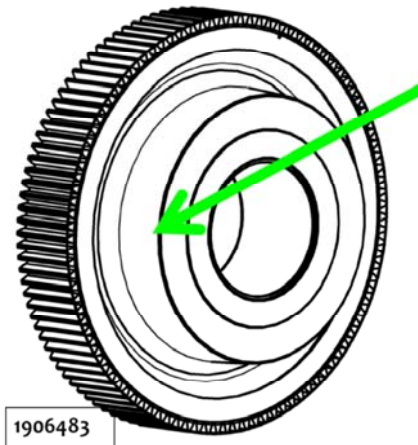
- During inspection if the single gear configuration (as shown below) is found with no smaller second gear, no further action is required. Reinstall the cam position sensor.

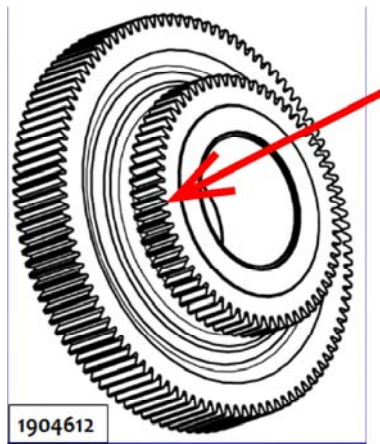
- During inspection if the dual gear configuration (as shown below) is found, replacement is required. In Engine Rapido, search for, and select, **Replace PTO Gear**. The job number is P 1401 378618 001 000. If the chassis number you are working on is not available in Engine Rapido, use the instructions for chassis no. JJ182284
