SERVICE BULLETIN

N° **189-177**

**REV. :** A - February 28, 2018

**ATA 55 - TAIL PLANE INSTALLATION UPGRADE**

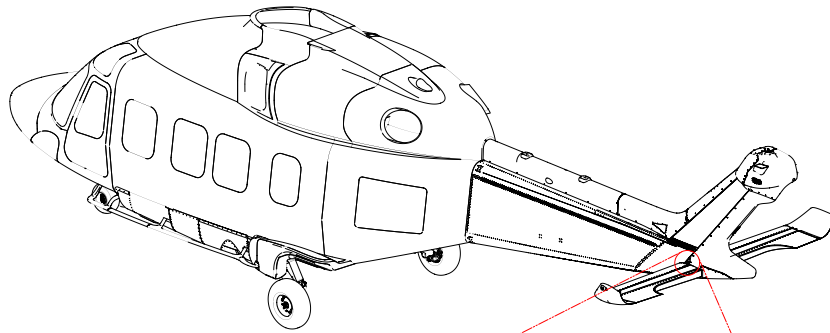
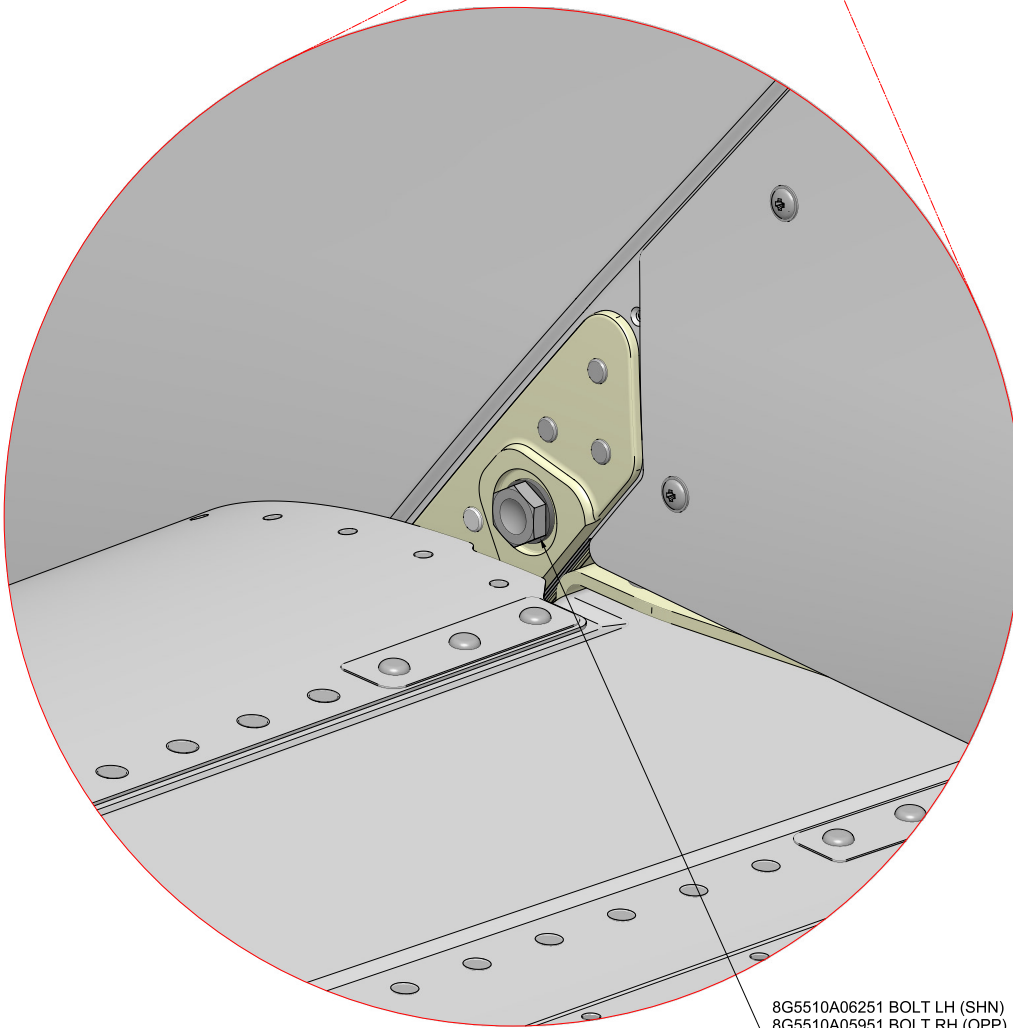
**Figure 12**

This SB has been issued after the report of two in service failures of the FWD LHS tail plane installation bolt. This SB provides all necessary instructions on how to inspect the forward bolt of the tail plane and to perform the tail plane installation retromod P/N 8G5510P00511 which provides the corrective action required to prevent the experienced failures which, if not corrected, could potentially lead to reduced stability in forward flight.

**DETAIL A**  
PERFORM VISUAL INSPECTION OF BOLT  
LH SIDE SHOWN  
RH SIDE OPPOSITE

1. With reference to Figure 12, perform a visual inspection of the tail plane installation. Make sure that the forward attachment bolts P/N 8G5510A06251 and P/N 8G5510A05951 are correctly installed and not broken.
2. If a bolt is found damaged, apply tail plane installation retromodification P/N 8G5510P00511 in accordance with Part II of this SB and advise Leonardo Product Support Engineering at the following address:  
[pse\\_aw189.mbx@leonardocompany.com](mailto:pse_aw189.mbx@leonardocompany.com).
3. Record for compliance with Part I of this Service Bulletin.
