**POST-REMEDIATION ENGINEERING  
REPORT**

**Lyndonville West Avenue Site  
Lyndonville, New York**

**October 2005    Project No. 507619  
18984401**

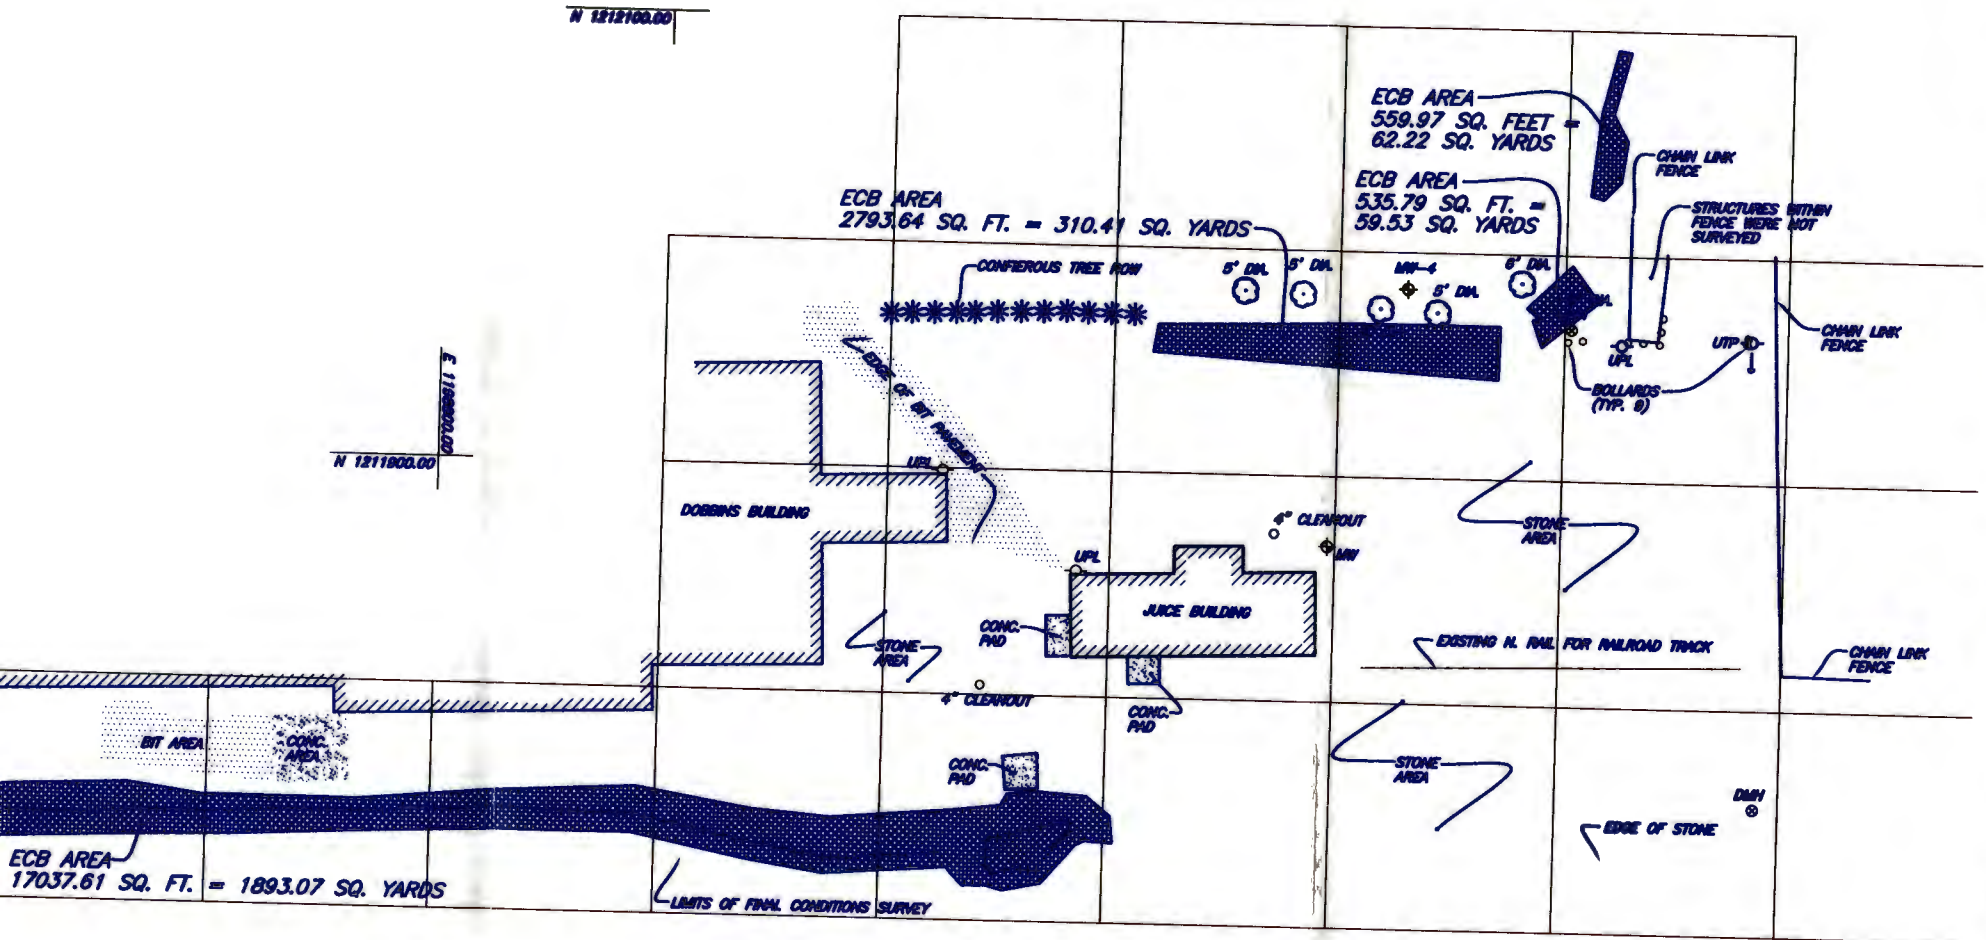
CLIENT:	<b>DuPont</b>	TITLE:	<b>Erosion Control Blanket</b>
PROJECT:	Post-Remediation Engineering Report The Lyndonville West Avenue Site, Lyndonville, NY		
DATE:

Erosion and sediment control measures were installed and maintained throughout the project. Measures included the installation of erosion control blank and revegetation. Figure 8 shows areas where the erosion control blanket was installed. Figure 9 shows areas that were hydroseeded. The site was inspected one month following field activities by URSD staff. It was noted that grass was well established in the hydroseeded areas.
