Osborne Tire Reef Benthic Survey Report

Florida Department of Environmental Protection

25 June 2019

DOCUMENT NO. CSA-OLSEN-FL-19-81070-3424-04-REP-01-FIN-REV01

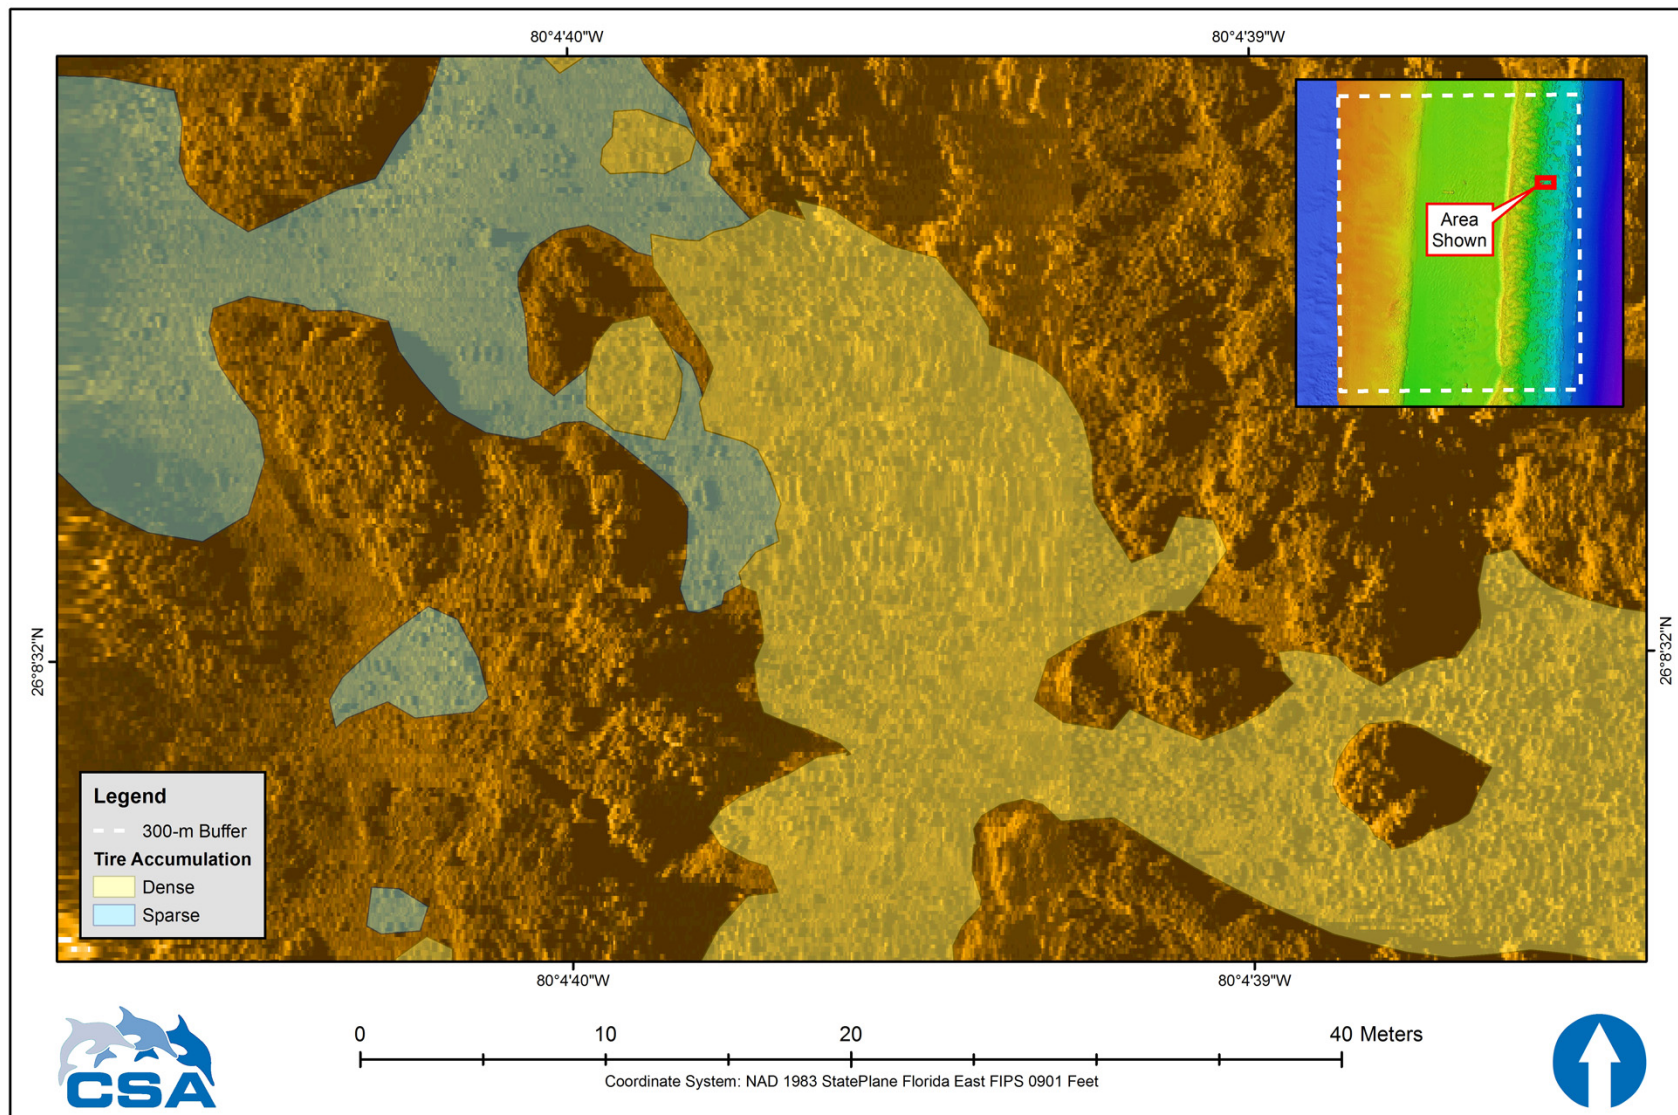
Figure 3. Side scan-sonar mosaic from outside third reef showing example of tire accumulation classification. Background Source: Side-scan sonar mosaic. Inset source: NOAA NOS Hydrographic Survey H12117, Year: 2008.

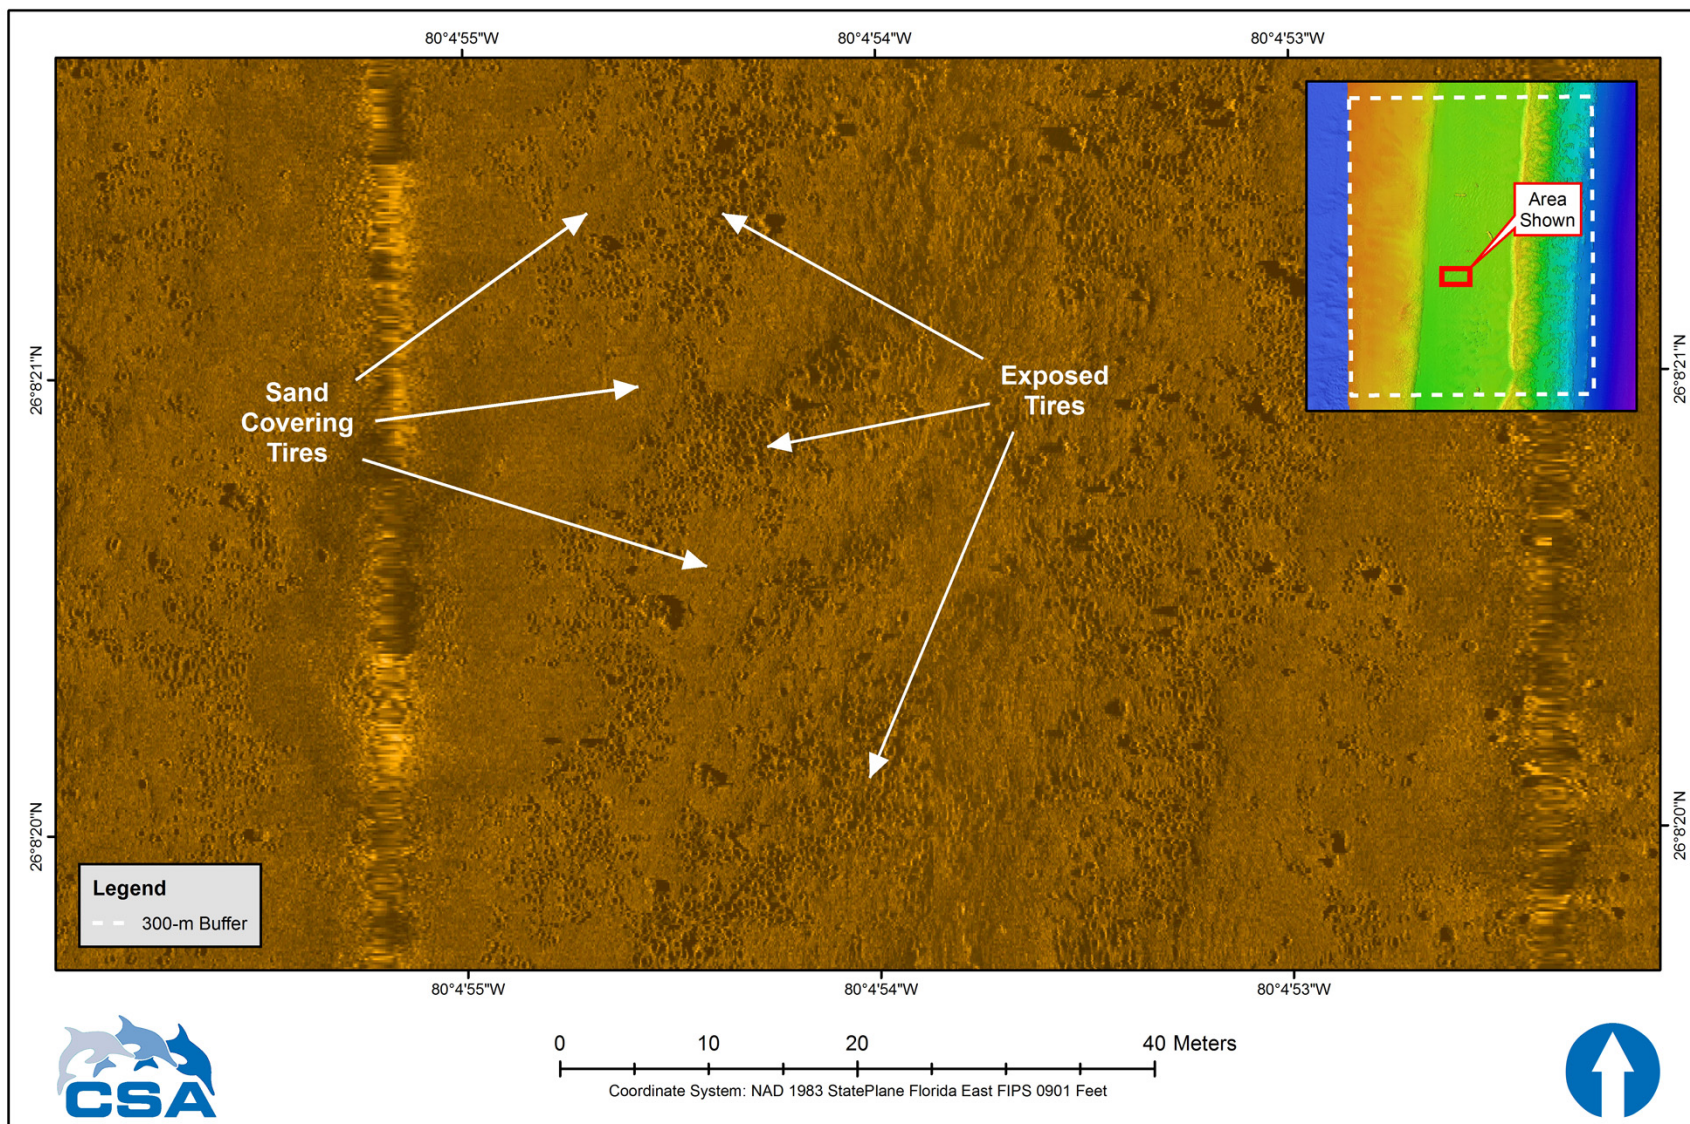
Counts of tires made within 5 m × 5 m grids at each of the 11 quadrat sites ranged from 0 up to 88 tires per 25 m² grid (3.5 tires m⁻²) with five of the sites having more than 1 tire m⁻² (**Table 2**). It became evident during the diver survey that many of the tires located within the OTR site were nearly or completely buried, and as such would have minimal to no side-scan sonar return, rendering them invisible in the side-scan sonar plots. This burial was observed during the review of diver video collected at several of the sites where large scale sand waves up to 0.5 m height were evident, half covering bundles of tires and nearly totally covering loose tires. This is also evidenced in **Photos C-19 to C-23** and can be detected by zooming in on the side scan sonar plots from areas just to the north of Site D21 (**Figure 8**) and to the south of Site D12 where alternating bands of sand waves and exposed tires can be observed.

Figure 8. Bands of wide sand wave features with exposed tires in troughs north of Site D21. Background source: Side-scan sonar mosaic. Inset source: NOAA NOS Hydrographic Survey H12117, Year: 2008.

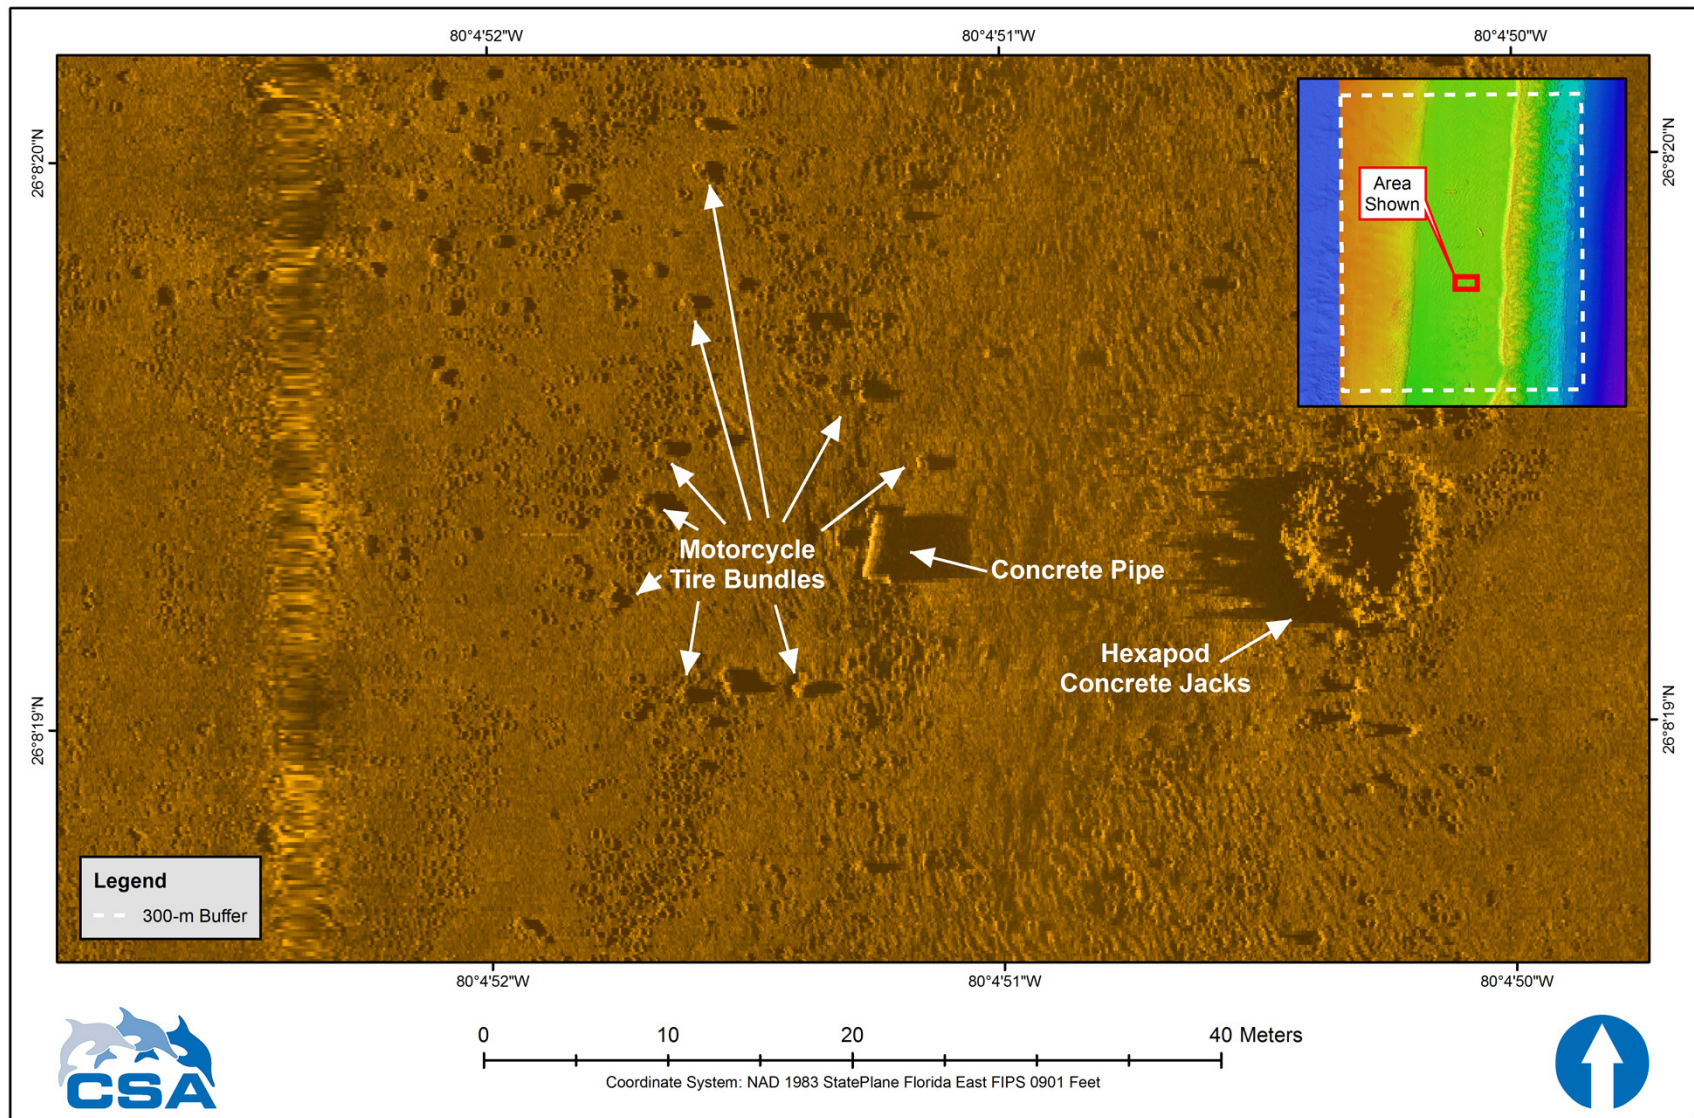
While the Scope of Work referenced “assemblages of tires stacked vertically, cemented into a concrete anchor,” dive teams did not observe features precisely fitting this description. However, intact bundles of 6 to 10 motorcycle (or small width) tires containing what appeared to be cement (**Photos C-3 and C-24**) were observed, primarily in an area to the northwest of the circle of hexagonal concrete jacks (Site D20); these may be the referenced structures but they were not cemented into a visibly apparent anchor. These exhibited a relatively distinct side scan sonar return (**Figure 9**).

Figure 9. Intact bundles of motorcycle tires appearing to be filled with cement, to the west and northwest of the hexagonal concrete jacks at Site D20. Background source: Side-scan sonar mosaic. Inset source: NOAA NOS Hydrographic Survey H12117, Year: 2008.

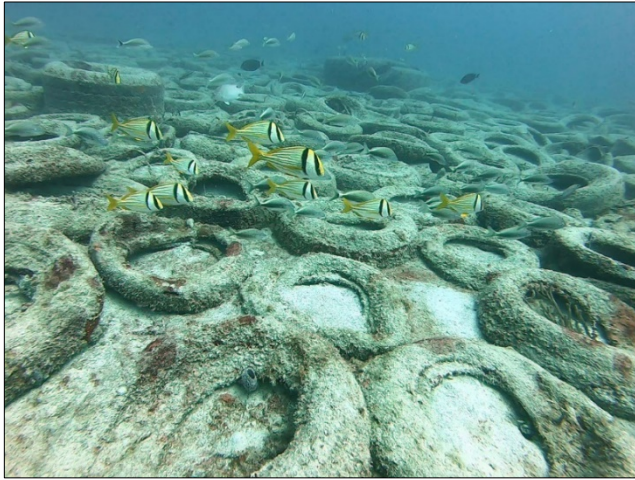
Photo C-1. Area of dense tire accumulation at Site D2.

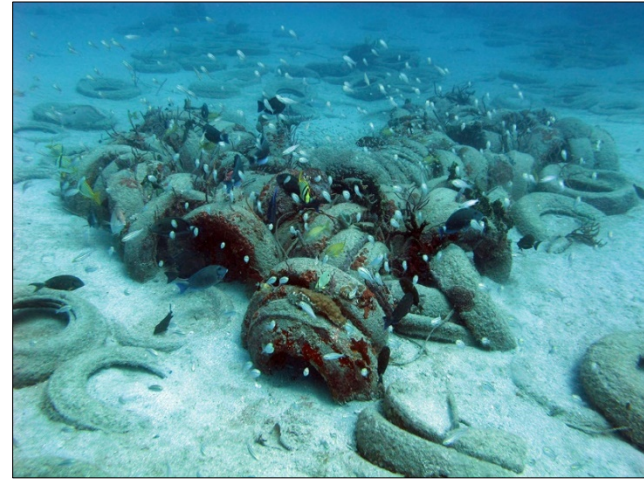
Photo C-2. Intact bundles of tires with attached stony corals and octocorals at Site D21.

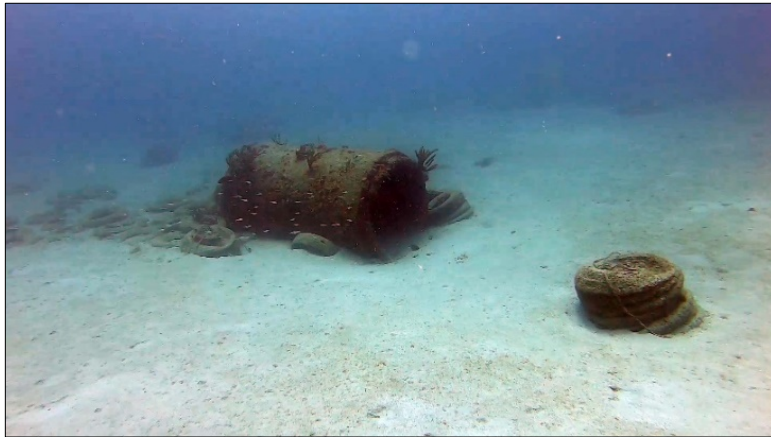
Photo C-3. Bundle of motorcycle tires near large section of concrete pipe west of D20.

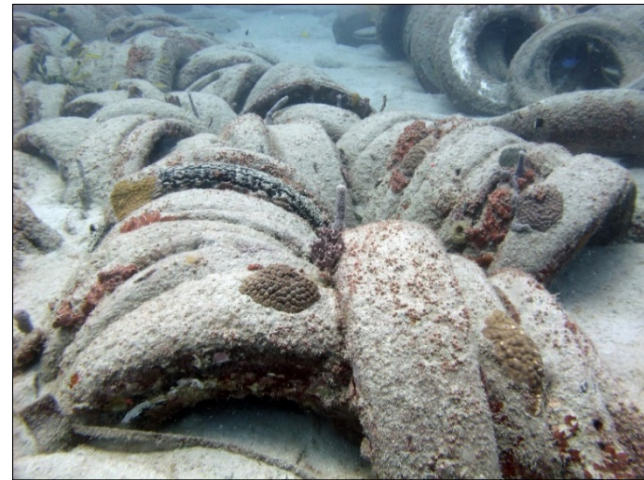
Photo C-4. Partially intact bundles of tires with octocorals and stony corals (*Montastrea cavernosa* and *Porites astreoides*) at Site D 16.

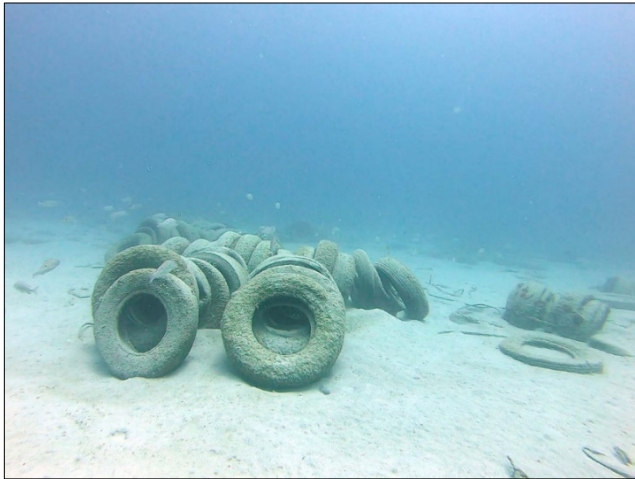
Photo C-5. Tires gathered for removal by commercial divers near site D16.

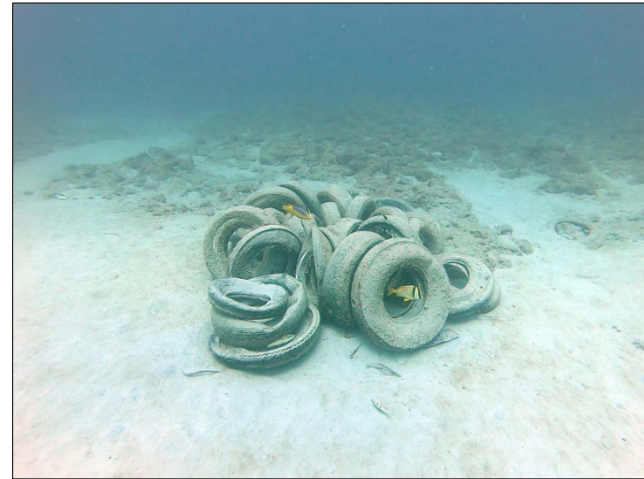
Photo C-6. Recently stacked tires east of second reef and south of Site D5.

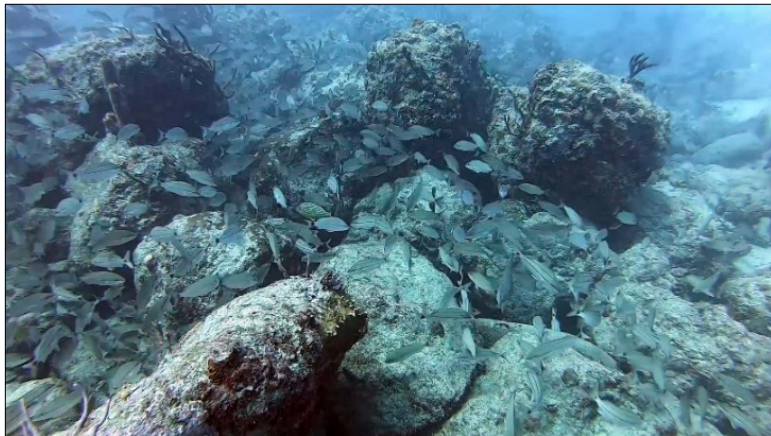
Photo C-7. Boulder reef at Site D9.

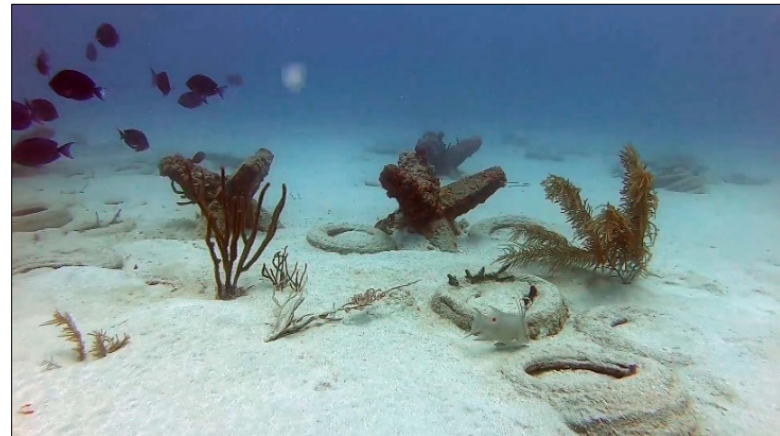
Photo C-8. Hexagonal concrete jacks near Site D20.

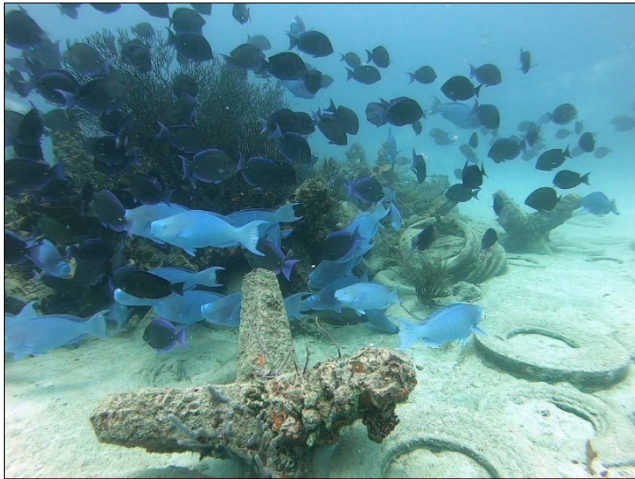
Photo C-9. Edge of large ring of hexagonal concrete jacks at Site D20.

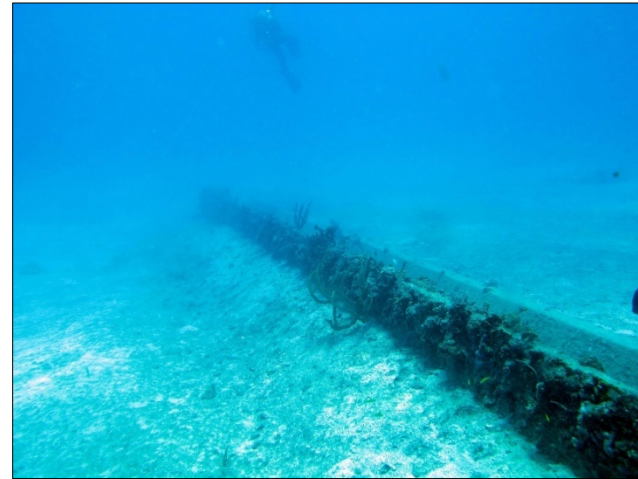
Photo C-10. Concrete girder on seafloor near south margin of 300-m buffer.

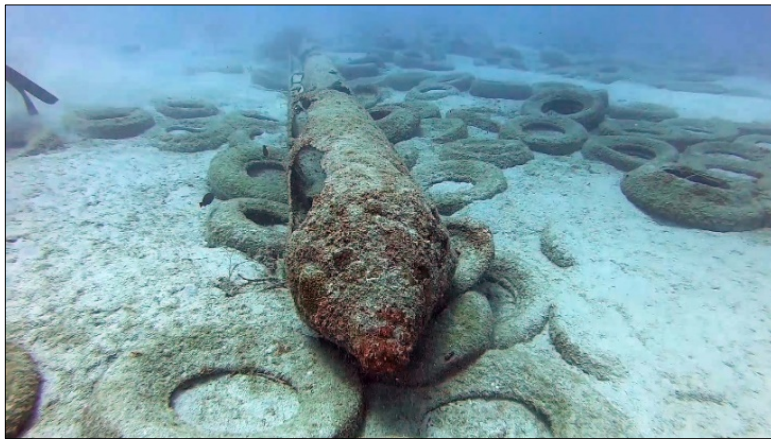
Photo C-11. Corroded barge spud in area of tires at Site D13.

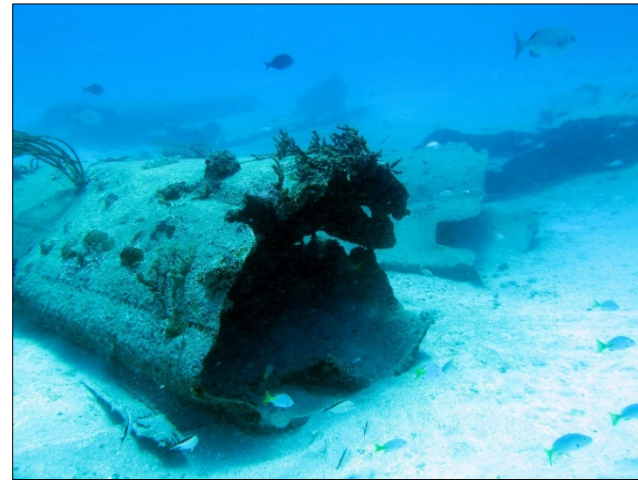
Photo C-12. Large flattened metal tubing/pipe south of Site D25.

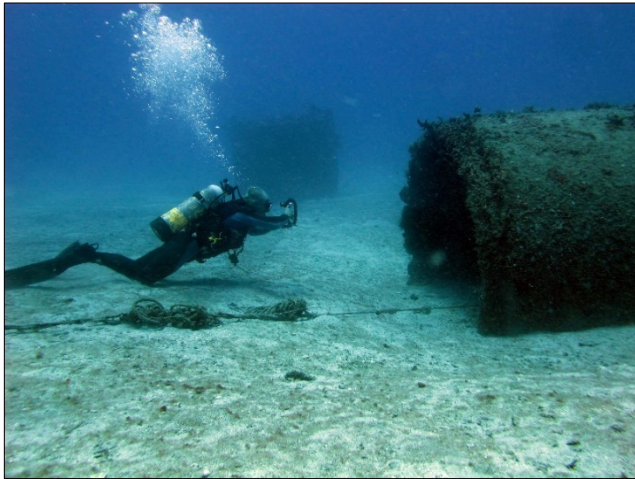
Photo C-13. Large diameter concrete pipe at Site D25.

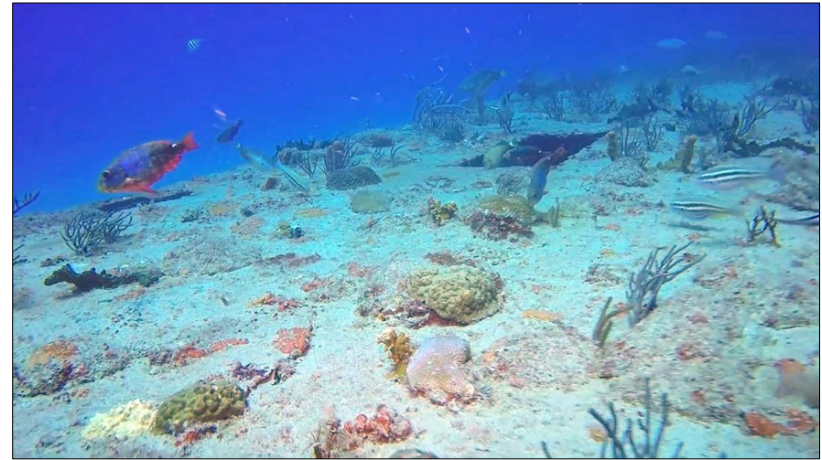
Photo C-14. Deck of barge immediately north of Site D12.

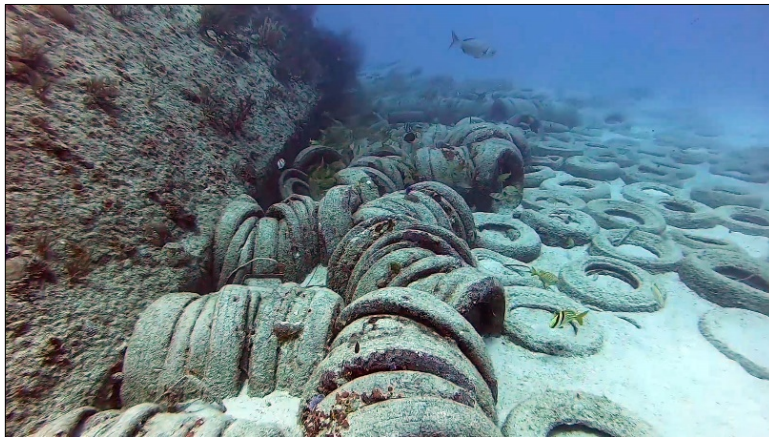
Photo C-15. Bundles of tires south of “upside down” barge near center of Osborne Tire Reef site.

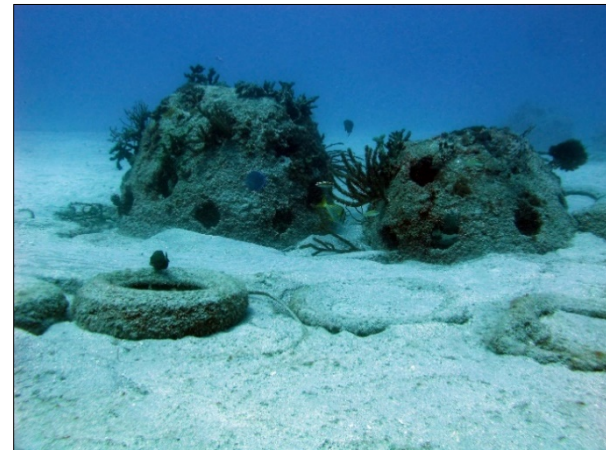
Photo C-16. Reef balls with attached octocorals, sponges, and stony corals at Site D6.

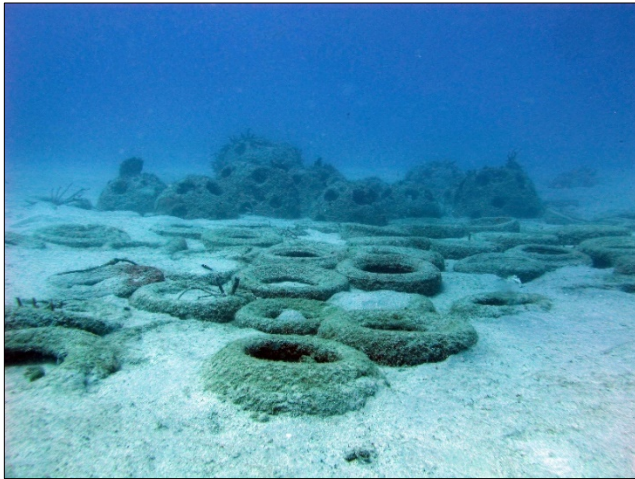
Photo C-17. Grouping of reef balls near loose tires at Site D7.

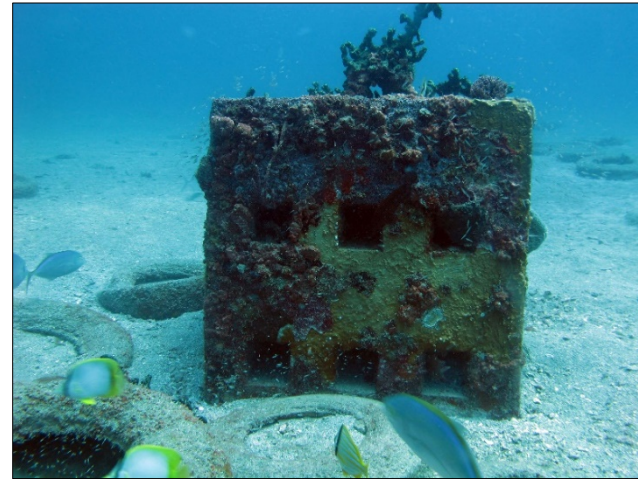
Photo C-18. NOVA reef module in southwest portion of project area.

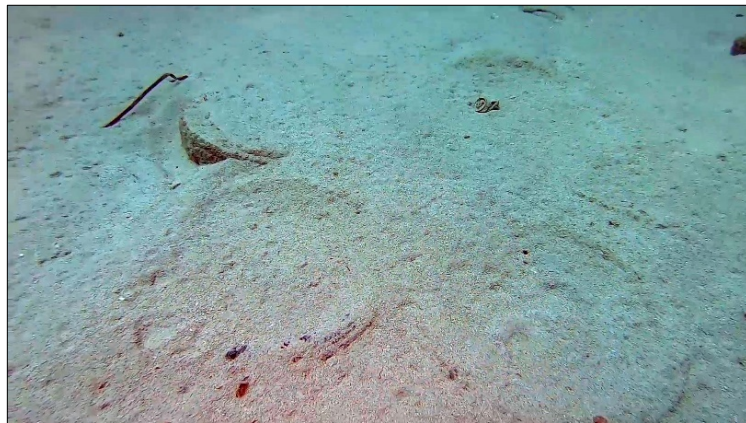
Photo C-19. Outlines of buried tires at Site D17.

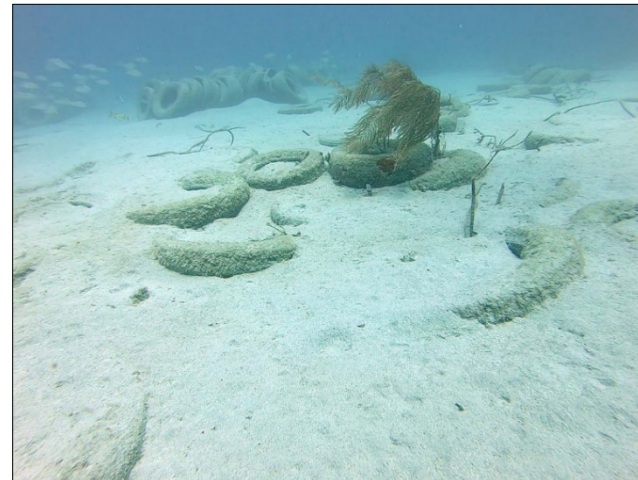
Photo C-20. Partially buried tires and stacks of tires being removed at Site D16.

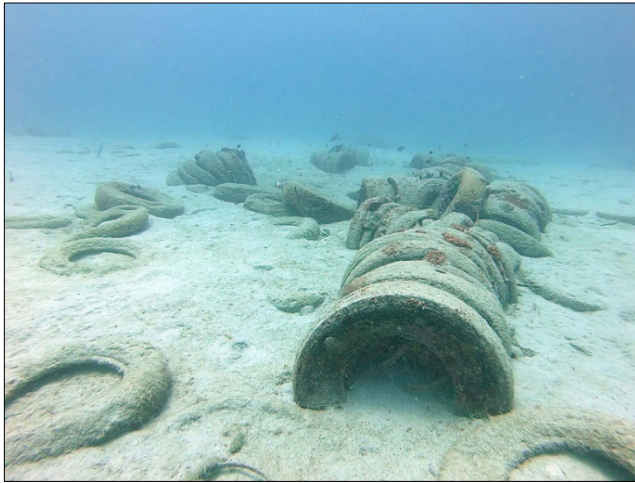
Photo C-21. Partially buried intact bundles of tires south of Site D16.

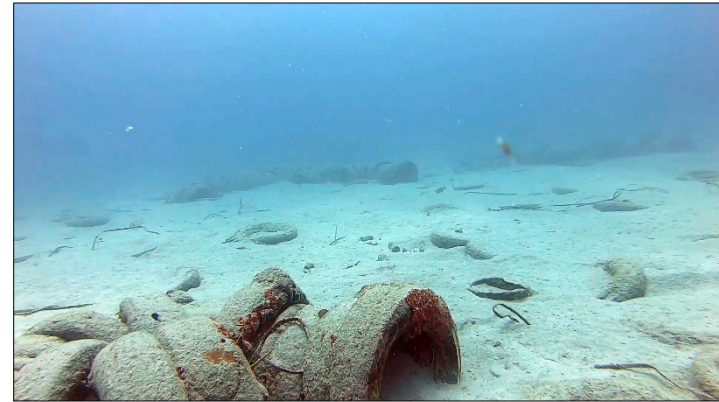
Photo C-22. Area of buried tires south of Site D16.

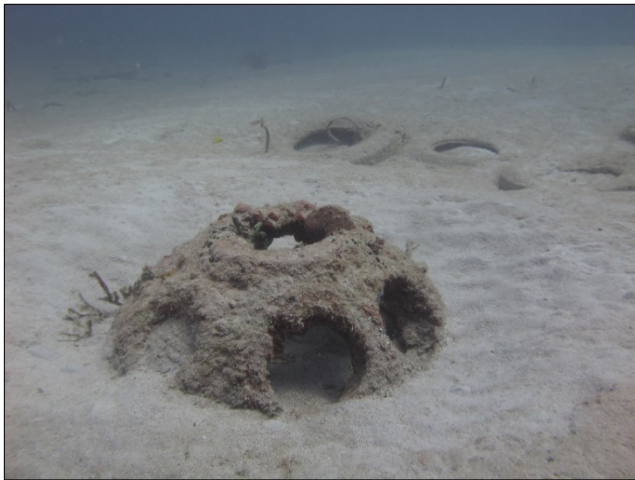
Photo C-23. Buried tires and reef ball south of Site D26.

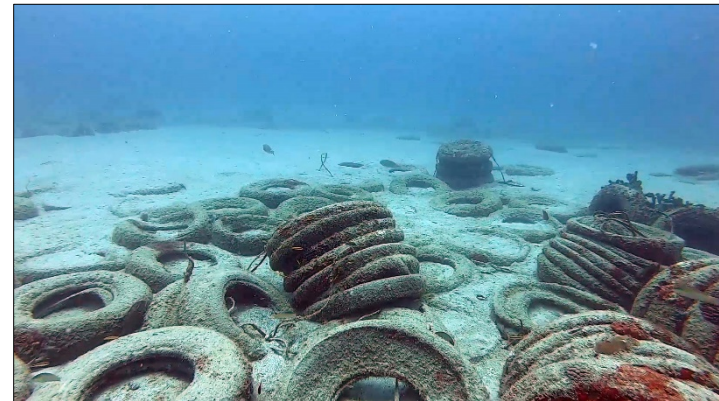
Photo C-24. Short bundles of motorcycle tires among other loose tires northwest of Site D20.

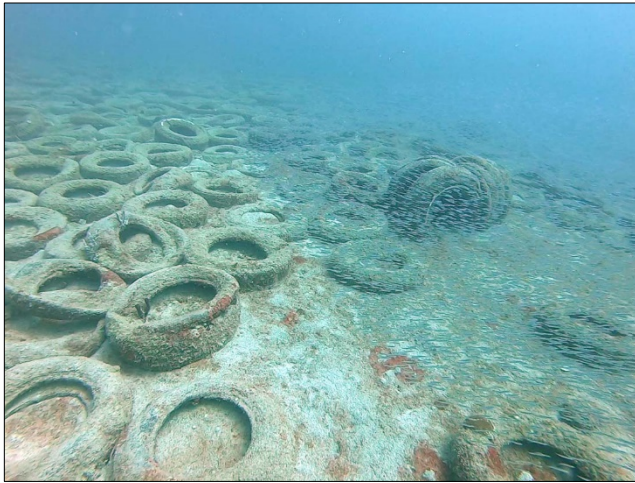
Photo C-25. Large concentration of loose tires near Site D2, north of Osborne Tire Reef northern boundary.

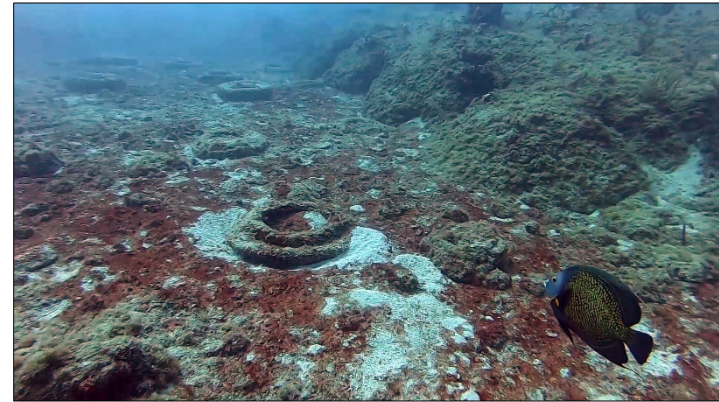
Photo C-26. Scattered tires in sand channel across third reef along Transect T1.

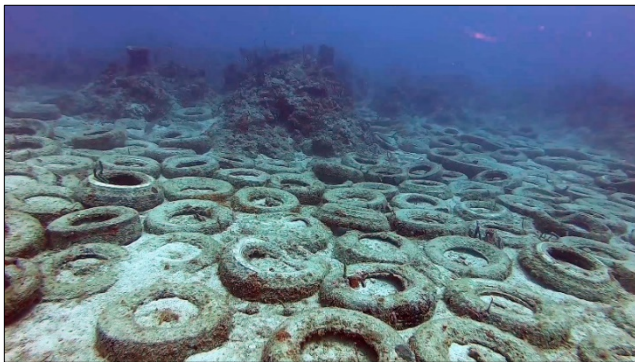
Photo C-27. Tires south of Site D15 in sand channel east of third reef.

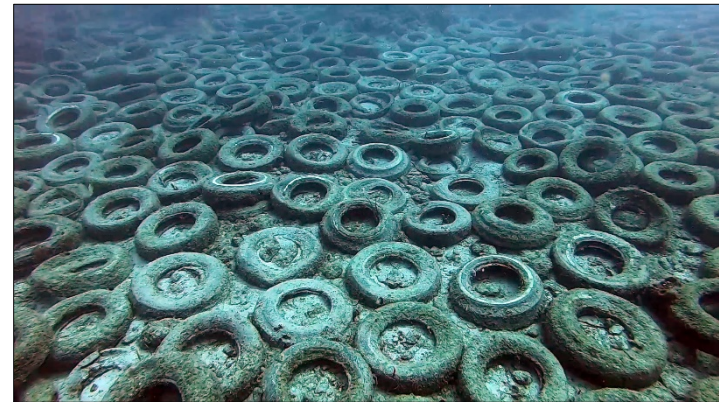
Photo C-28. Loose tires covering bottom of sand flat east of third reef on Transect T2.

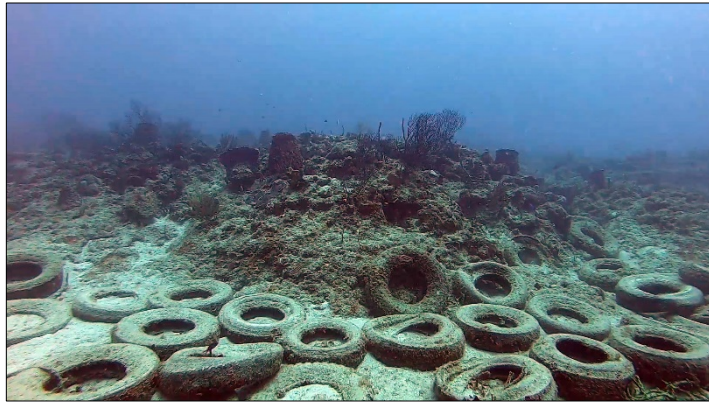
Photo C-29. Tires lying against third reef edge near Site D15.

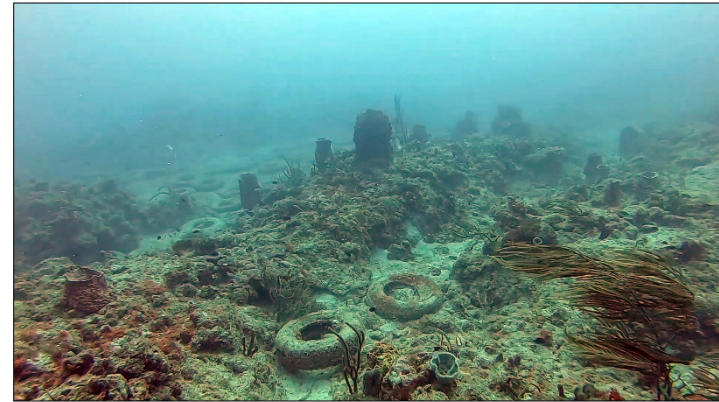
Photo C-30. Tires in elevated sand-filled depression on reef on Transect T2.

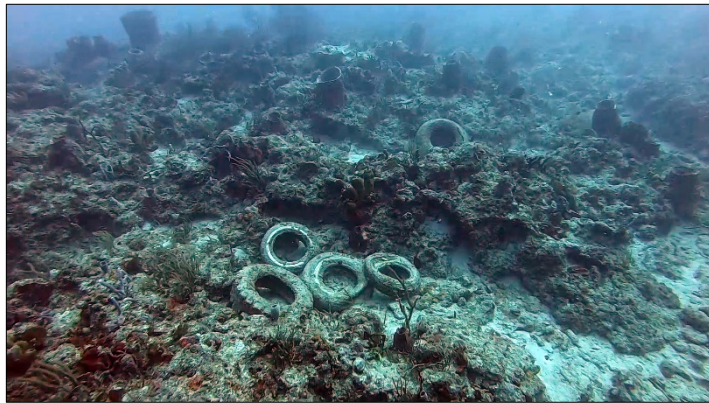
Photo C-31. Tires in cut across reef along Transect T2.
