Illinois Commerce Commission
Assessment of AmerenCIPS'
Reliability Report and Reliability Performance
for Calendar Year 2004

Pursuant to 83 Illinois Administrative Code 411.140

November 14, 2005

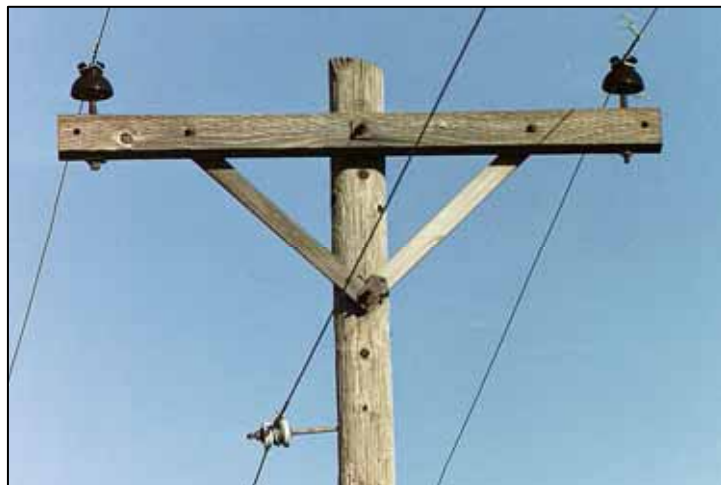
Figure 1 (Photo 05B1)
Spool bolt coming out of pole,
Circuit X81555, north of Tuscola

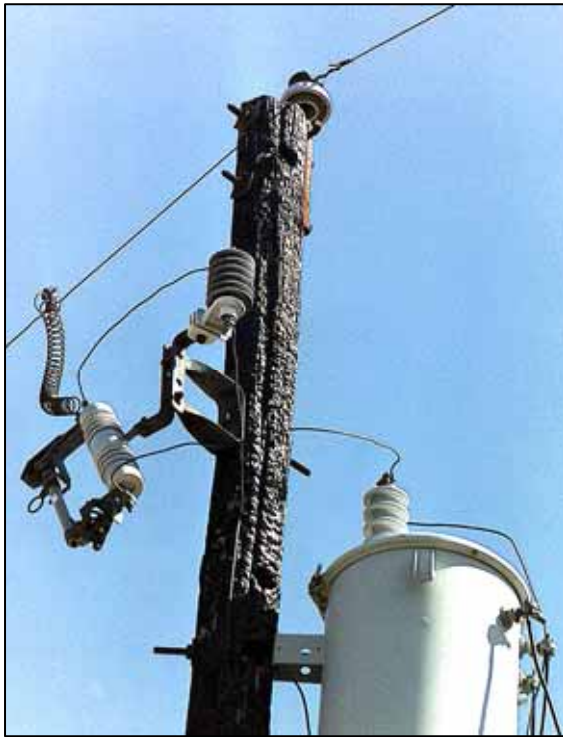
Figure 2 (Photo 05B3)
Burned pole top (lightning damaged?),
Circuit U39541, Main & Maple Sts., Timewell

| <i>Map No.</i> | <i>Item Description</i> | <i>Photo(s)</i> | <i>Location</i> |
|---|---|---|--|
| 19c | Burned pole top (lightning damaged ?) | B2, B3, B4 | At Sta. 11538 at the corner of Main St. & Maple St. (labeled Road A on map), Timewell |

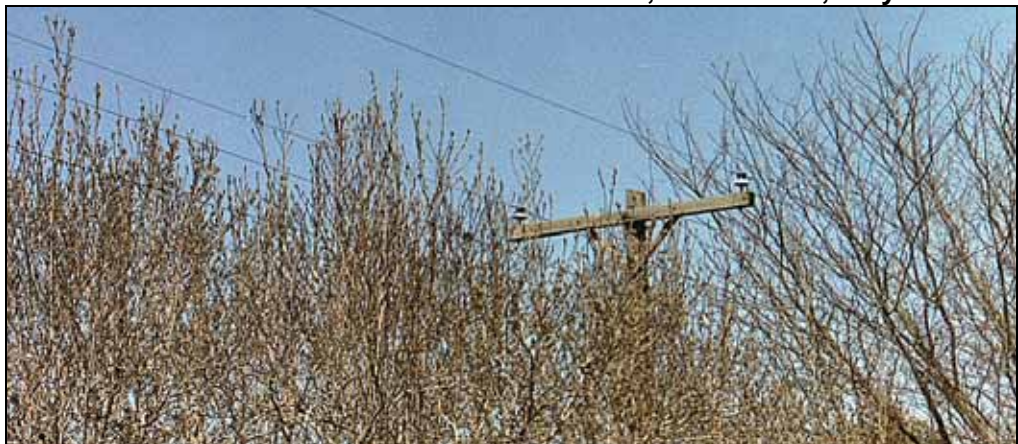
Figure 3 (Photo 05B6)
Trees into primary,
Circuit U39541, Madison St., Clayton

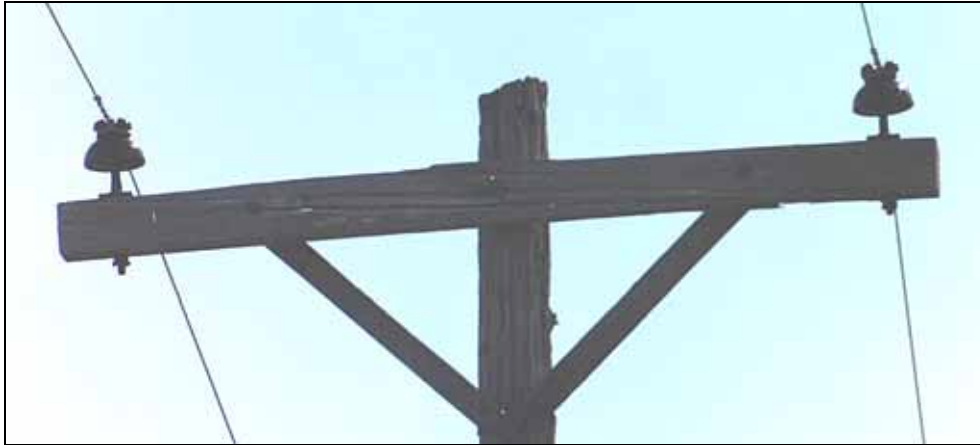
Figure 4 (Photo 05B10)
Split & deteriorated crossarm and badly shell rotted pole,
Circuit U39541, southeast of Golden

| Summary of Distribution Circuit Field Inspection by ICC Staff | | | |
|---|---|---|---|
| 13 | Split & deteriorated crossarm and badly shell rotted pole | B10, B11 | South of CR 2300 in tap to Sta. 6127 on road not labeled on map, about halfway to Sta. 6127 |

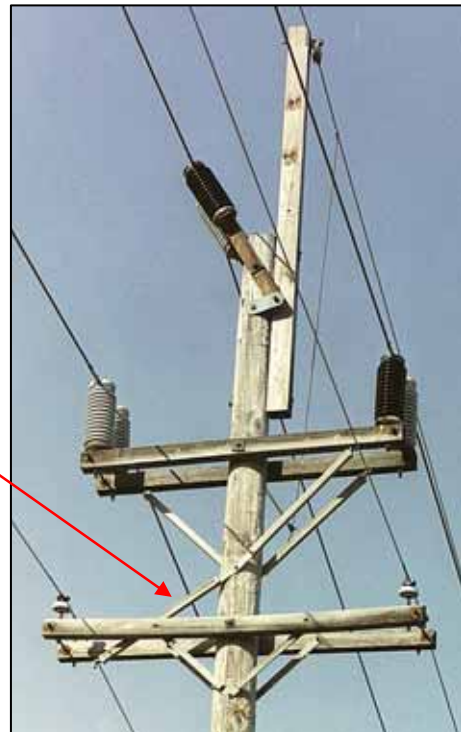
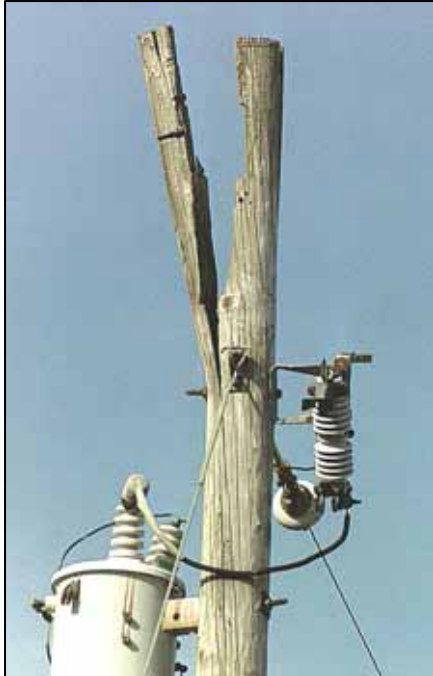
Figure 5 (Photo 05B12)
69 kV brace disconnected & hanging down
(& close to 12 kV phase conductor),
Circuit V79594, east of Barrow

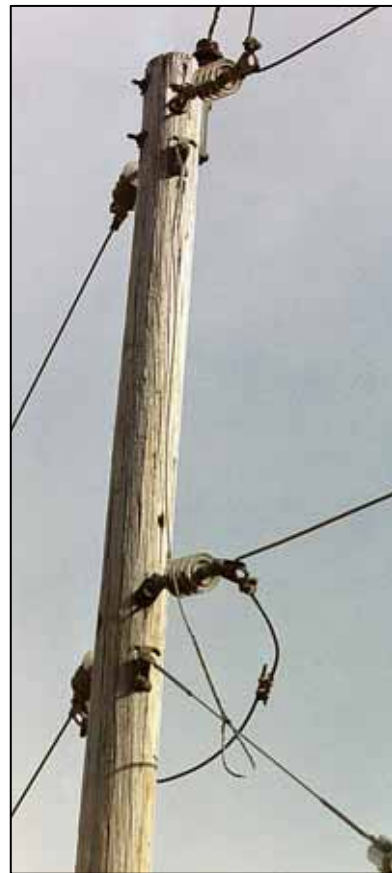
Figure 6 (Photo 05B15)
Badly split pole top,
Circuit V79594, northwest of Barrow

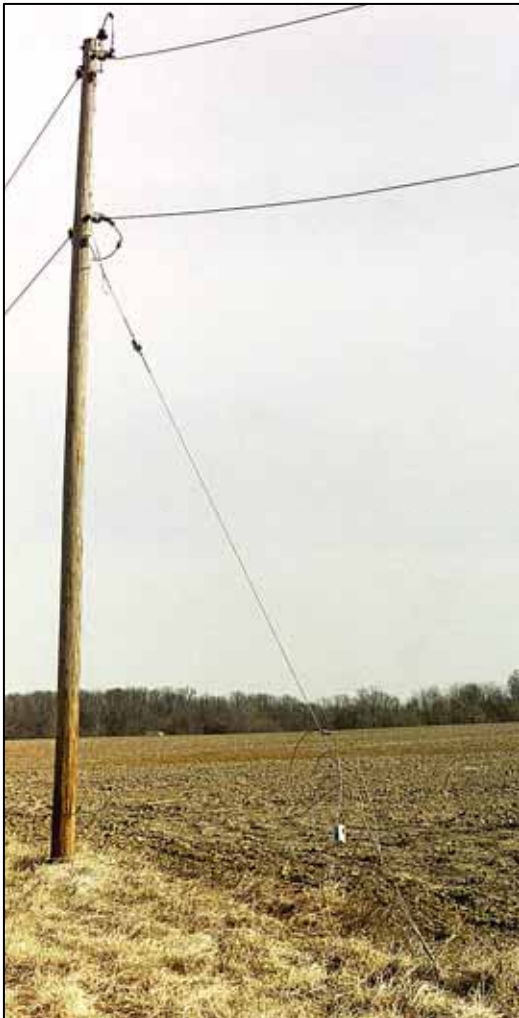
Figures 7 & 8 (Photos 05B19 & 05B18)
Broken primary downguy
(broken guy grip--possible lightning damage),
Circuit V79594, northwest of Barrow

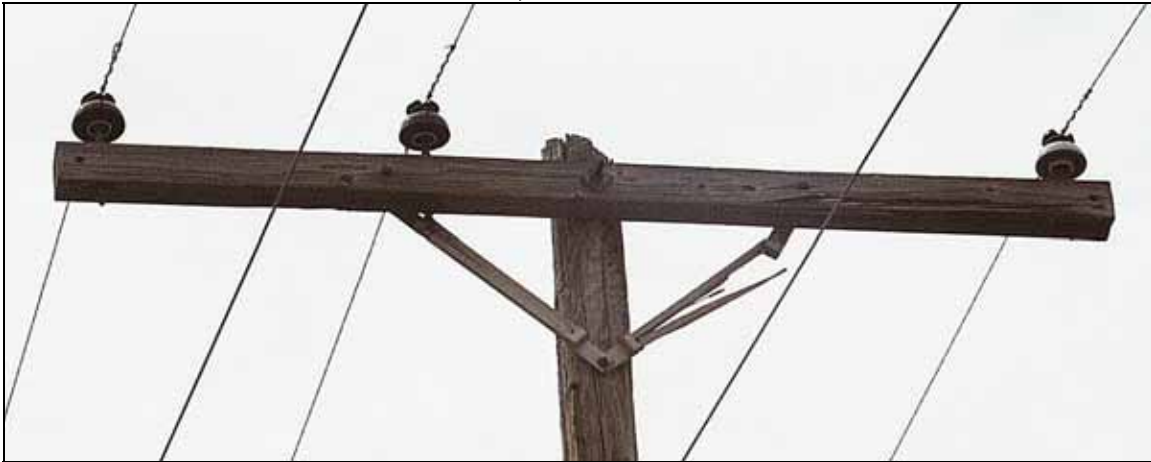
Figure 10 (Photo 05D5)
Split crossarm,
Cir. X96543, S. of Lawrenceville

Figure 11 (Photo 05D6)
Split wood brace (lightning damage),
Circuit X96543, south of Lawrenceville

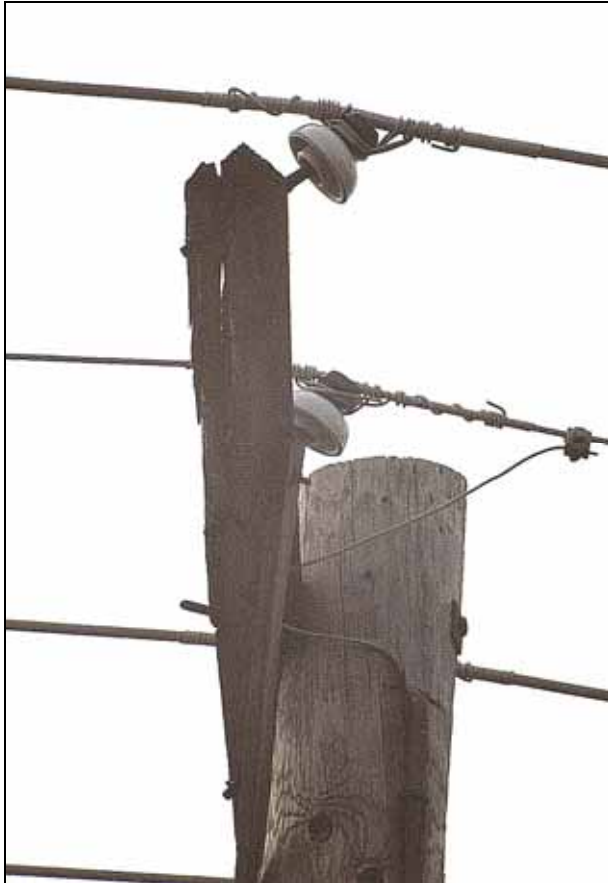
Figure 12 (Photo 05D8)
Badly split (lightning damaged) crossarm
& crossarm badly twisted on pole,
Cir. X96543, On Rt. 1, west of St. Francisville

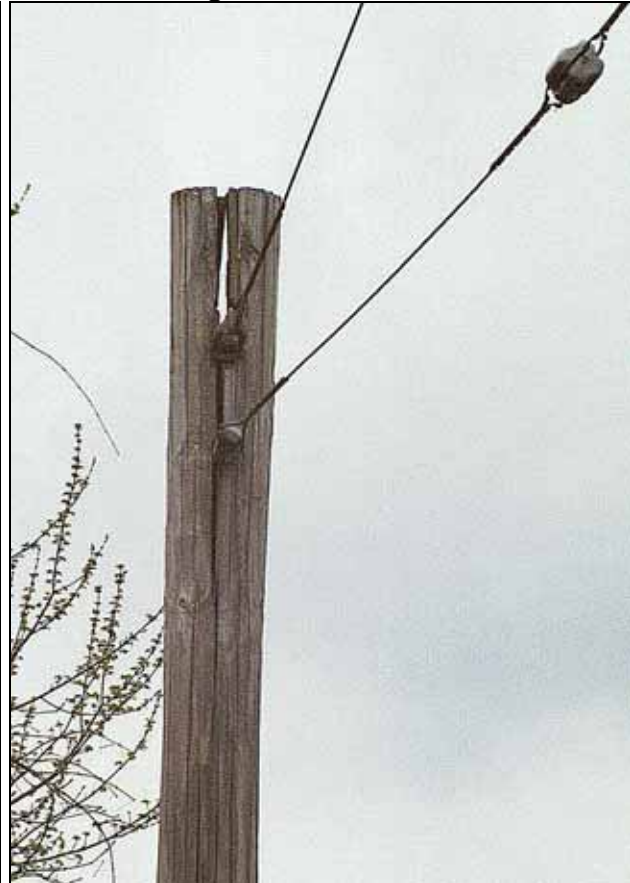
Figure 13 (Photo 05D18)
Guy stub pole badly split at top,
Circuit X96543,
9th & Meagher Sts., St. Francisville

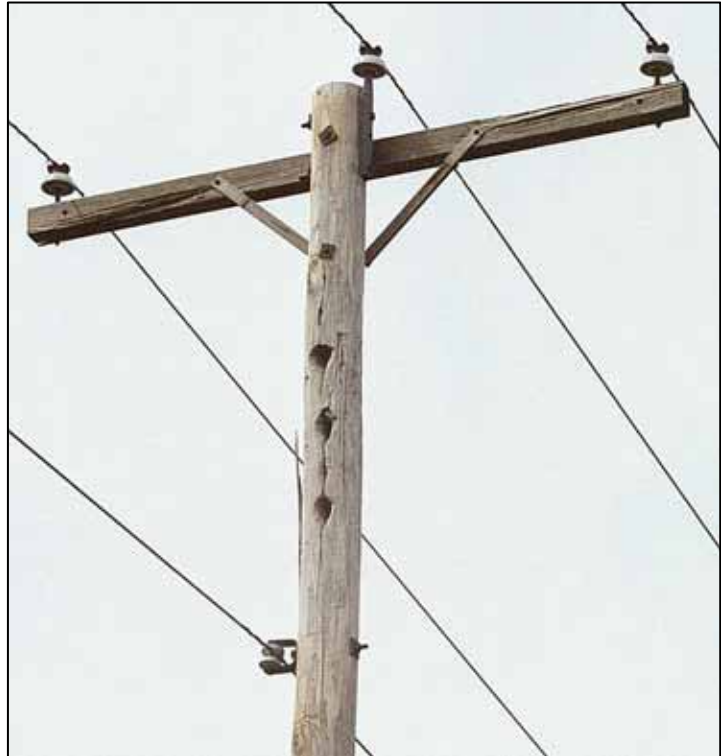
Figure 14 (Photo 05D11)
Lightning damaged crossarm &
3 large woodpecker holes in pole,
Cir. X96543, west of St. Francisville

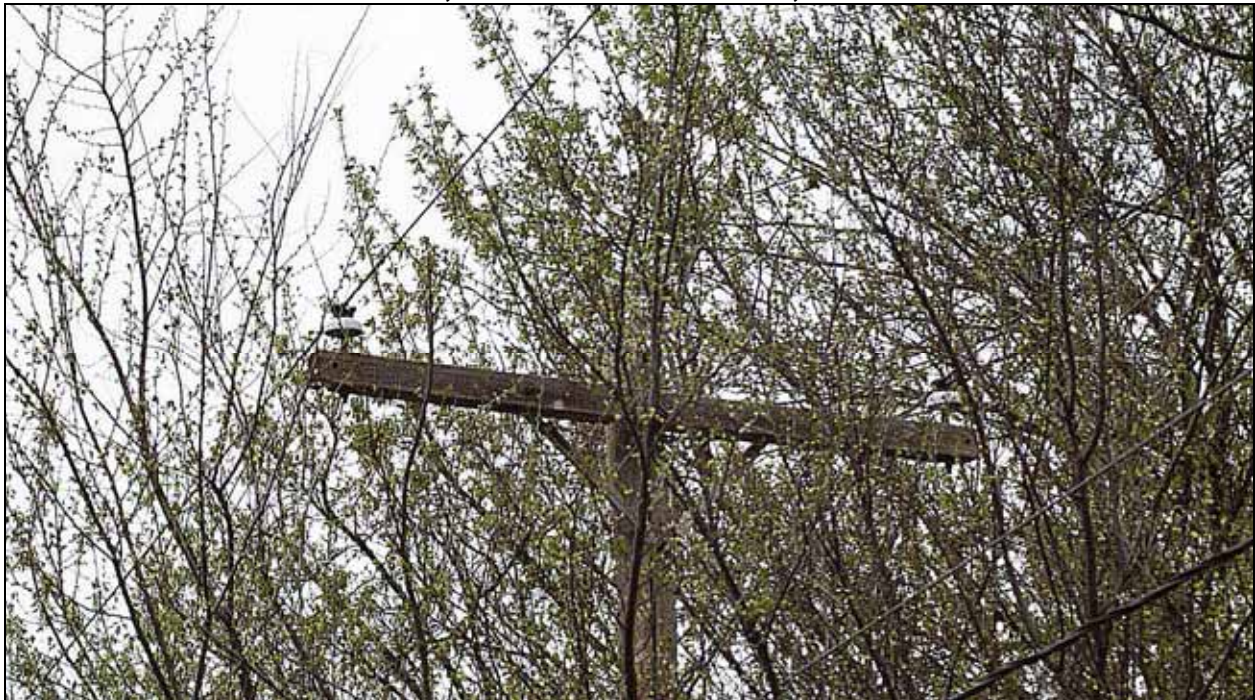
Figure 15 (Photo 05D15)
Trees growing into primary,
Circuit X96543, 9th St. north of Harold St., St. Francisville

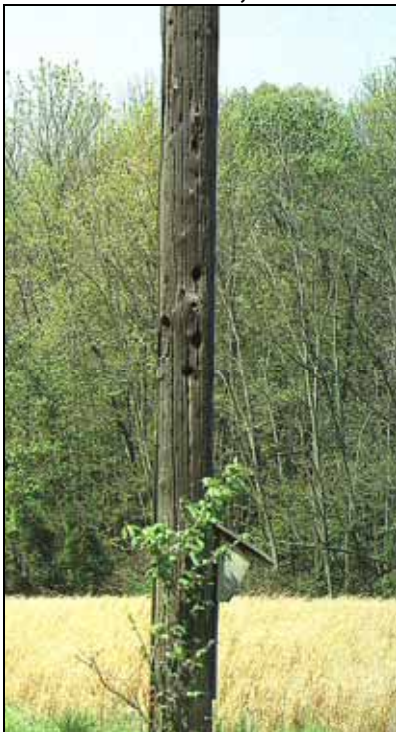
Figure 16 (Photo 05F9)

**Shell rotted pole w/4 woodpecker holes,
Circuit S47576, Herrin**

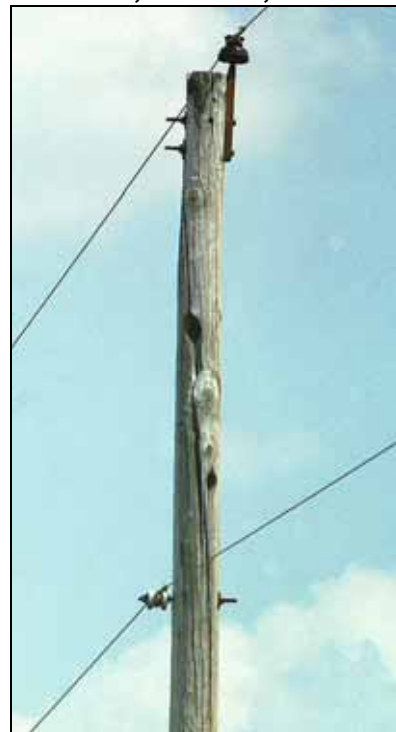
Figure 17 (Photo 05F13)

**Split pole top & 2 woodpecker holes in pole,
Circuit S47576, Ezra Rd., Freeman Spur**

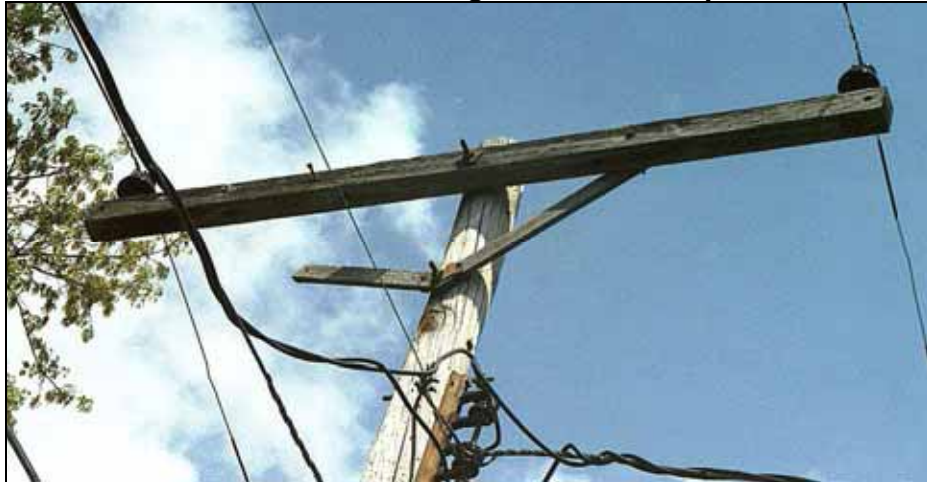
Figure 18 (Photo 05F14)
Wood brace disconnected from crossarm,
Circuit S47576, Orange St., Freeman Spur

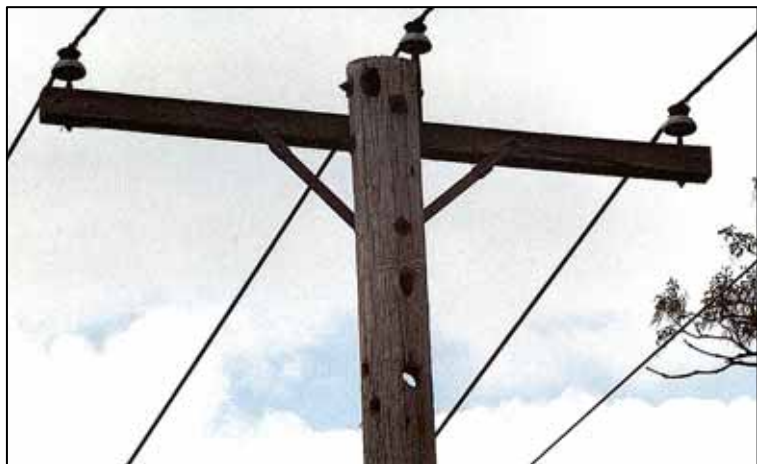
Figure 19 (Photo 05I16)
Woodpecker hole through pole & other holes in pole,
Circuit V23530, east of Detroit

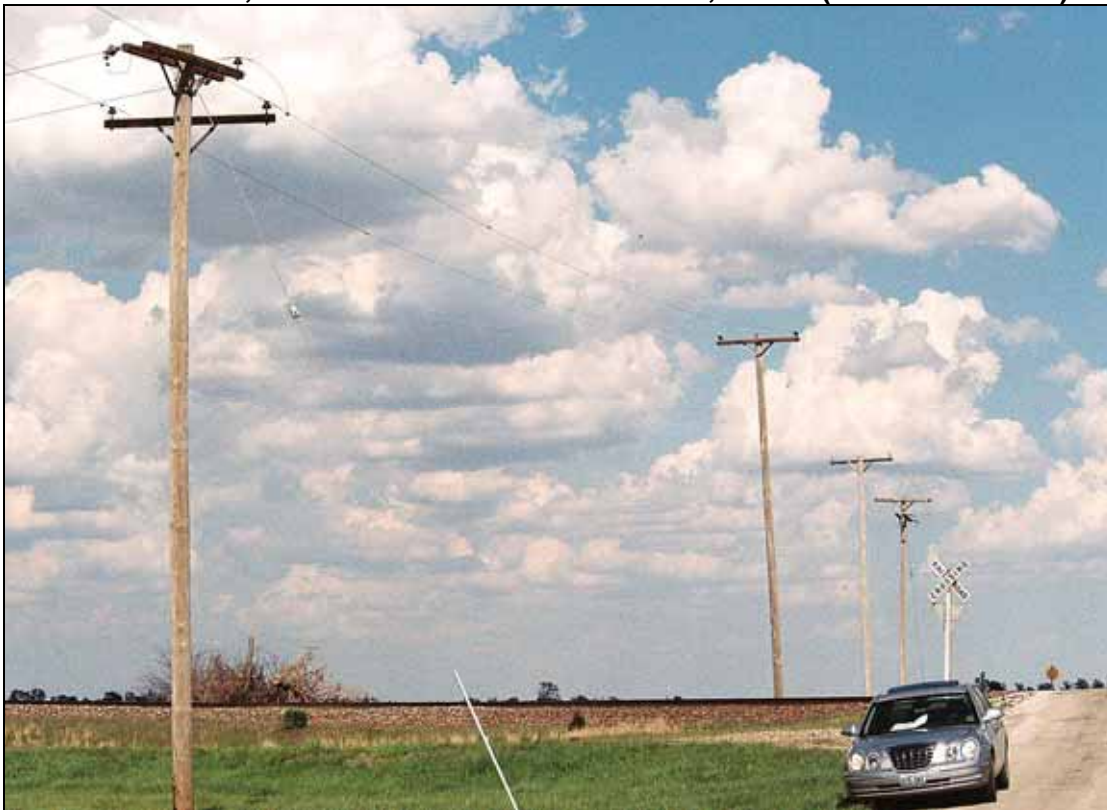
Figure 20 (Photo 05K11)

**Single wood crossarm supporting a 3-phase crossing of a railroad (double arms required),
(NESC structural strength violation)**

Circuit Y60593, Griffith Street west of Main Street, Gerald (south of Penfield)

(Double crossarms have been required for all railroad crossings in Illinois where wooden crossarms and pin-type insulators are used since General Order 10 was adopted on April 2, 1914)

Note: AmerenCIPS reported that it replaced the single crossarm with double crossarms at this location as required by the code on July 29, 2005. This location is now in compliance with the requirements of the NESC.

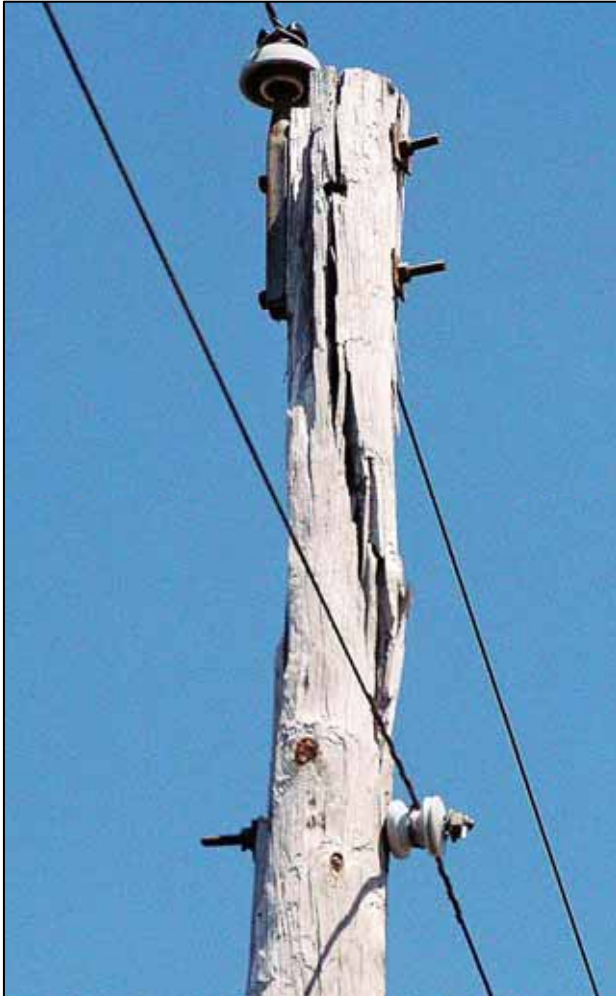
Figure 21 (Photo 05K8)
Lightning damaged pole top,
Circuit Y60593, Road 2800N, east of Rantoul

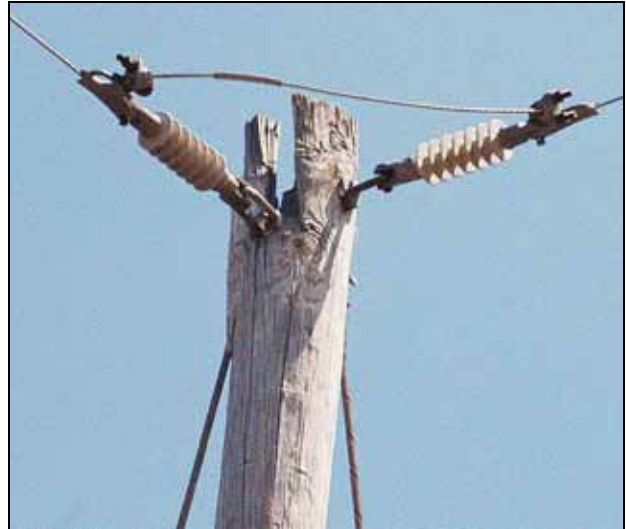
Figure 22 (Photo 05K7)
Badly split pole top,
Circuit Y60593, east of Rantoul

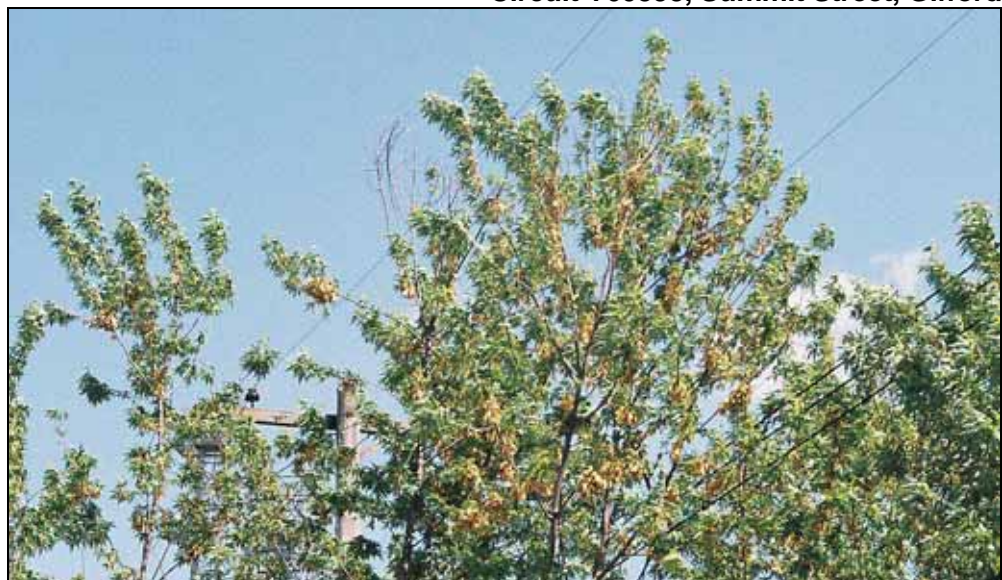
Figure 23 (Photo 05K9)
Soft maple tree into primary,
Circuit Y60593, Summit Street, Gifford

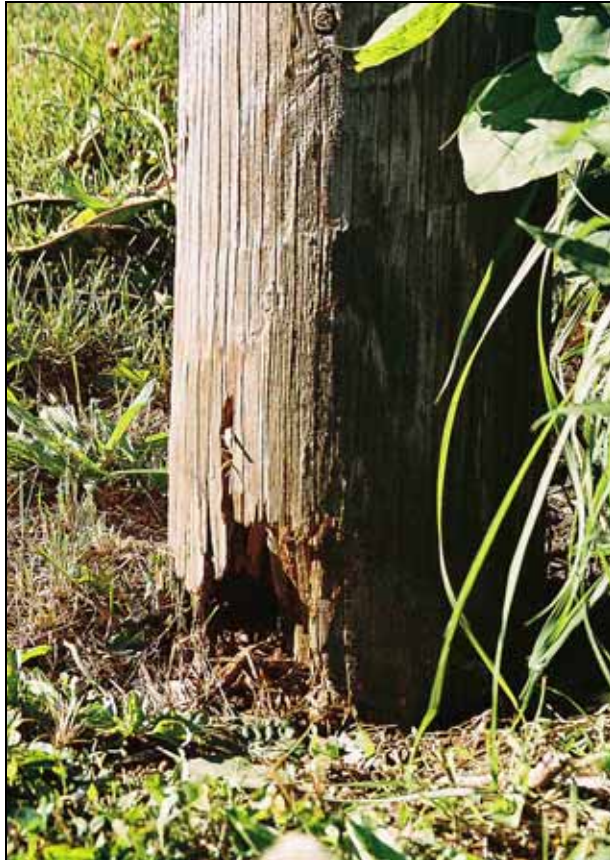
Figure 24 (Photo 05P1)
**Pole damaged at ground line,
Circuit U04538, Main St. east of Jackson St.,
Pleasant Plains**

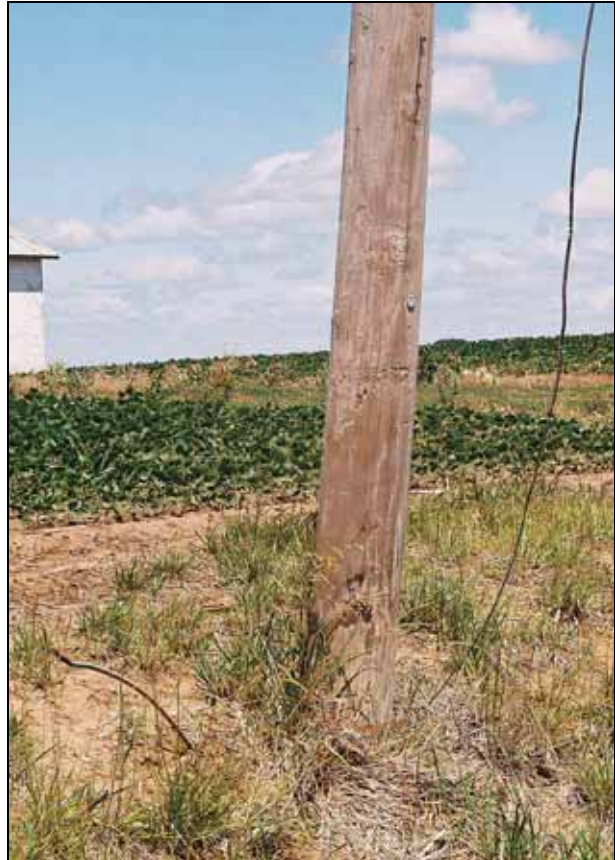
Figure 25 (Photo 05P5)
**Broken ground wire & ground rod
partially pulled out of ground,
Cir. U04538, CH 9C, south of Pleasant Plains**

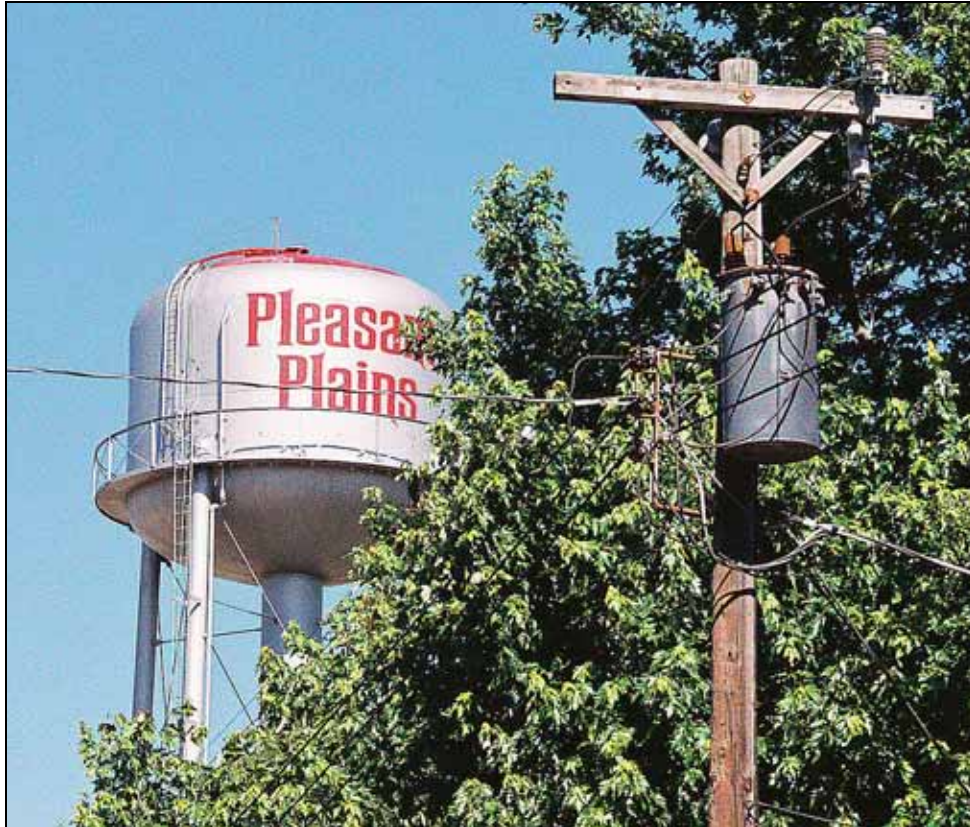
Figure 26 (Photo 05P3)
Primary burning a soft maple tree,
Circuit U04538, 4th Street east of Lincoln Street, Pleasant Plains

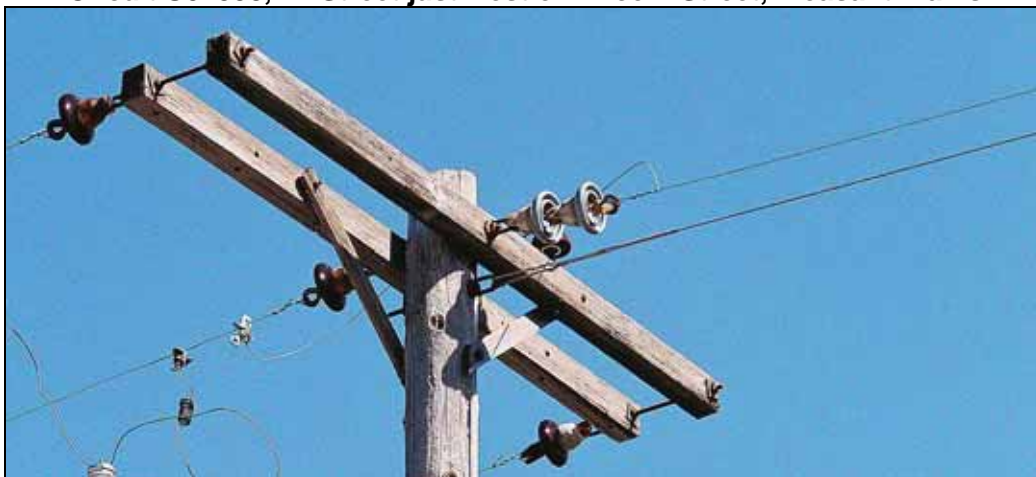
Figure 27 (Photo 05P4)
Overhead guy wire deadended 6" to 9" below 7.2 kV primary conductor on same pole,
(NESC clearance violation--12" minimum clearance required)
Circuit U04538, 4th Street just west of Lincoln Street, Pleasant Plains

Note: AmerenCIPS reported that it lowered the overhead guy wire on this pole on July 22, 2005, resulting in a vertical clearance of 18" to the primary conductor. This location is now in compliance with the NESC clearance requirements.
