National Transportation Safety Board

Aircraft Accident Investigative Update

On January 26, 2020, at 0945 Pacific standard time (PST), a Sikorsky SK76B helicopter, N72EX, collided with hilly terrain near the city of Calabasas, California. The pilot and eight passengers were fatally injured, and the helicopter was destroyed by impact forces and fire. The helicopter was operated by Island Express Helicopters Inc. under Title 14 Code of Federal Regulations (CFR) Part 135 as an on-demand passenger visual flight rules (VFR) flight from John Wayne-Orange County Airport, (KSNA), Santa Ana, California, to Camarillo Airport, (KCMA), Camarillo, California.

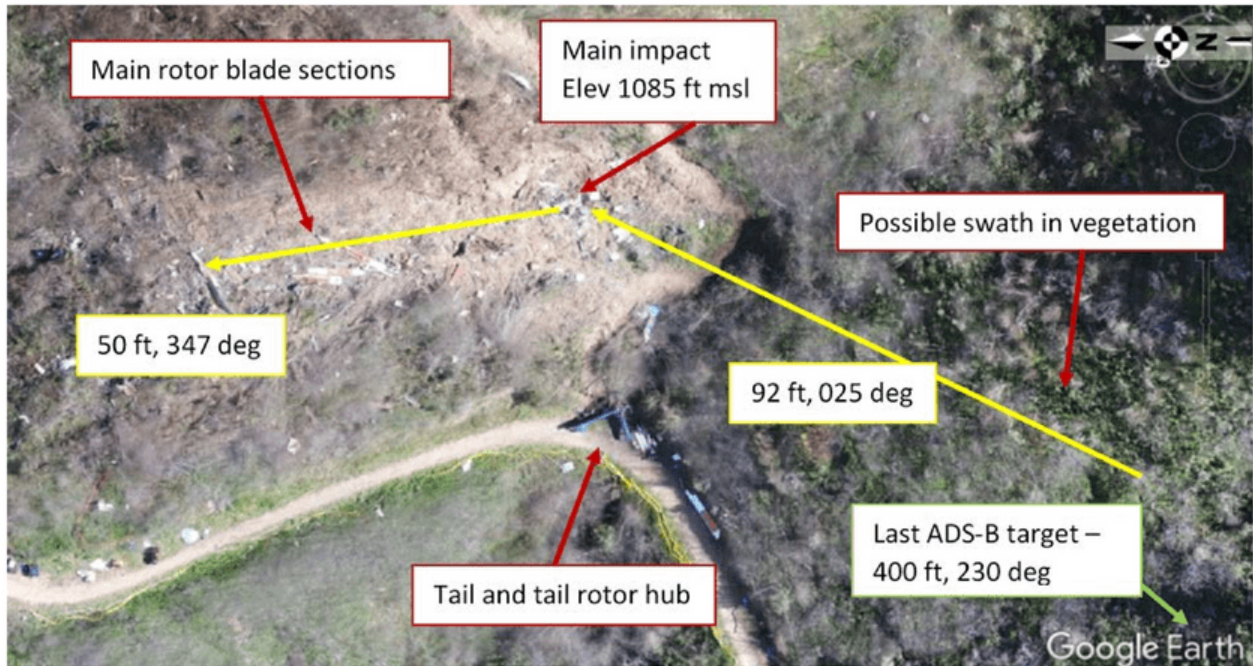
The wreckage was located in the foothills of the Santa Monica mountains, in a mountain bike park. The impact site was on an approximate 34° slope. The impact crater was 24 feet-by-15 feet in diameter and 2 feet deep.

Figure 1a. Google Earth map of wreckage area – southern (directions reference true north)

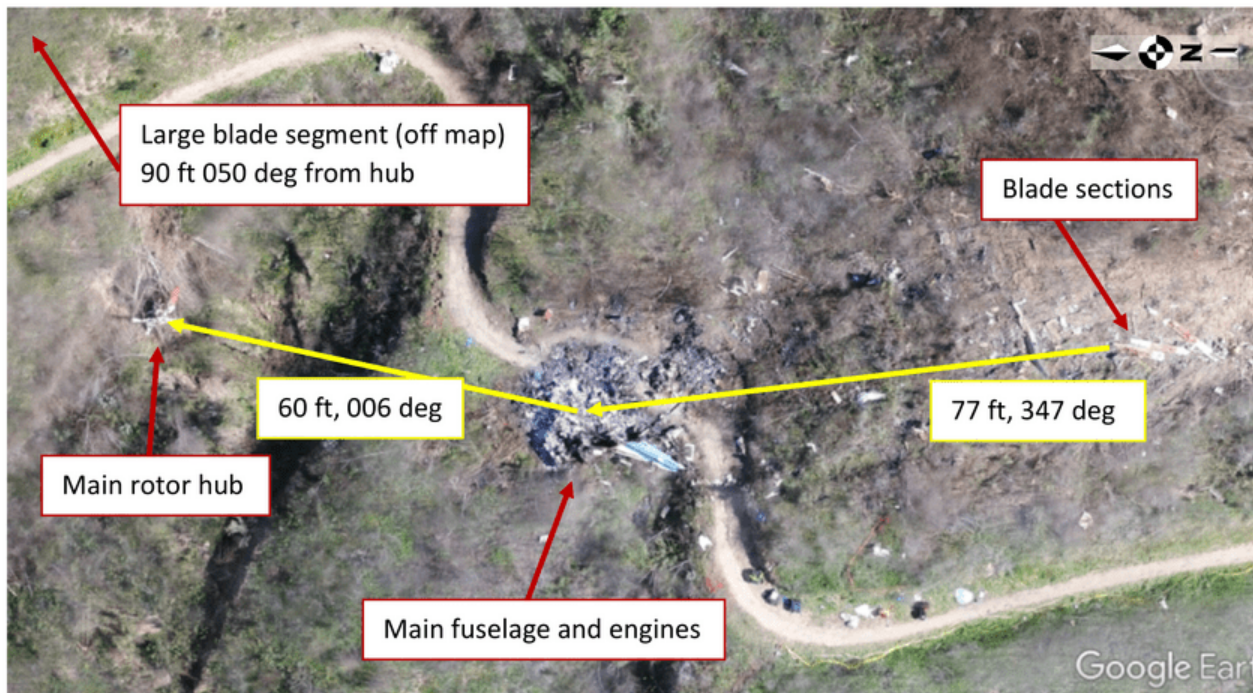
Figure 1b. Google Earth map of wreckage area – northern

All significant components of the helicopter were located within the wreckage area. Examination of the main and tail rotor assemblies found damage consistent with powered rotation at the time of impact. The initial point of impact consisted of highly fragmented cabin and cockpit debris. The vertical pylon and horizontal stabilizer were located about 40 feet below (downhill from) the

The main wreckage was about 127 feet from the impact crater along a 347° true bearing (335° magnetic) and consisted of the empennage/tailboom, both engines, avionics boxes, and portions of the cockpit instrument panel. The entire fuselage/cabin and both engines were subjected to a postcrash fire. The cockpit was highly fragmented. The instrument panel was destroyed and most instruments were displaced from their panel mounts. Flight controls were fragmented and fire damaged.

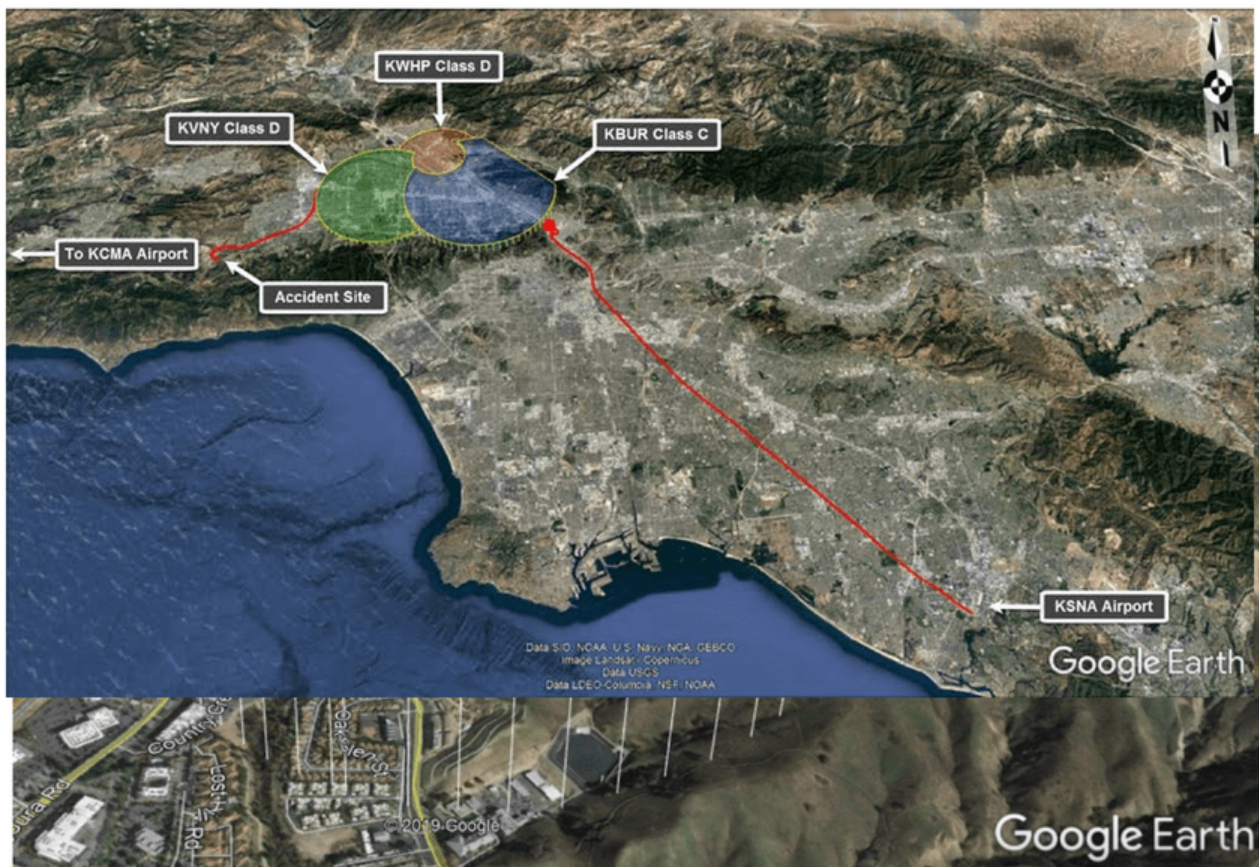
Radar/ADS-B data indicate the aircraft was climbing along a course aligned with Highway 101 just east of the Las Virgenes exit. Between Las Virgenes and Lost Hills Road, the aircraft reached 2,300 feet msl (approximately 1,500 feet above the highway, which lies below the surrounding terrain) and began a left turn. Eight seconds later, the aircraft began descending and the left turn continued. The descent rate increased to over 4,000 feet per minute (fpm), ground speed reached 160 knots. The last ADS-B target was received at 1,200 feet msl approximately 400 feet southwest of the accident site.

Figure 2. Overall Radar/ADS-B track of N72EX

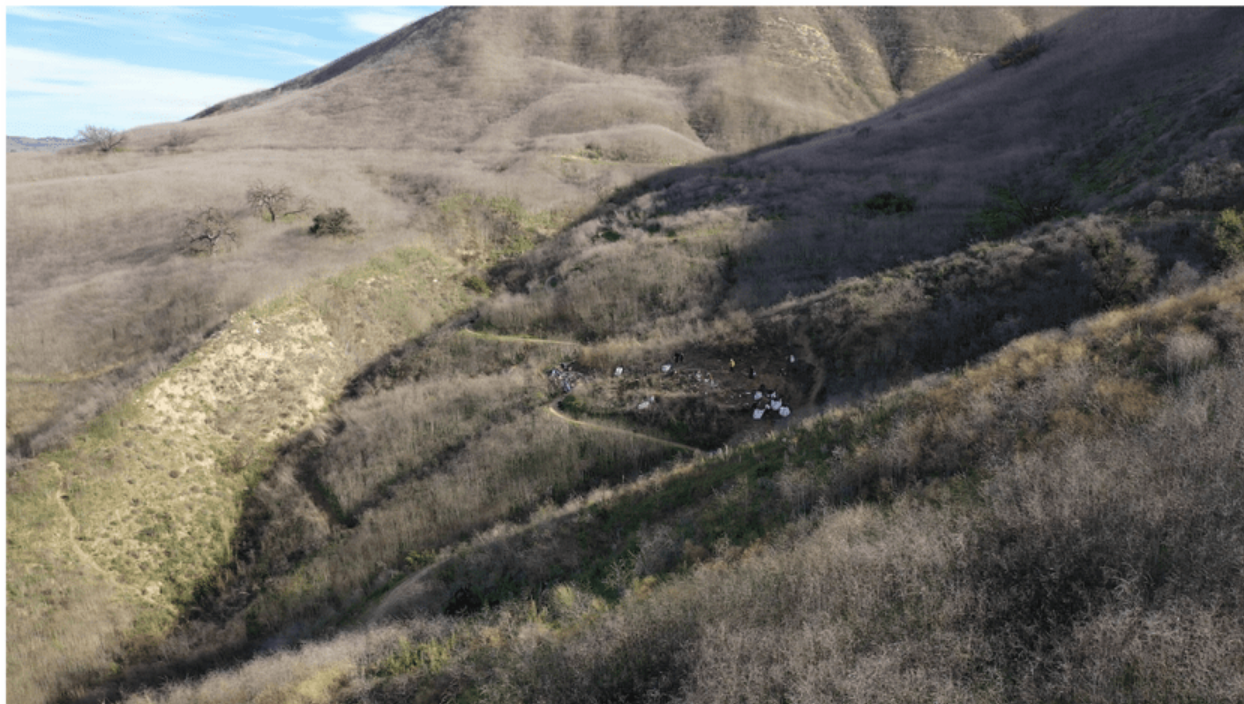
Figure 3C. Still image from drone video duplicating the flightpath of N72EX at position/altitude of last ADS-B target

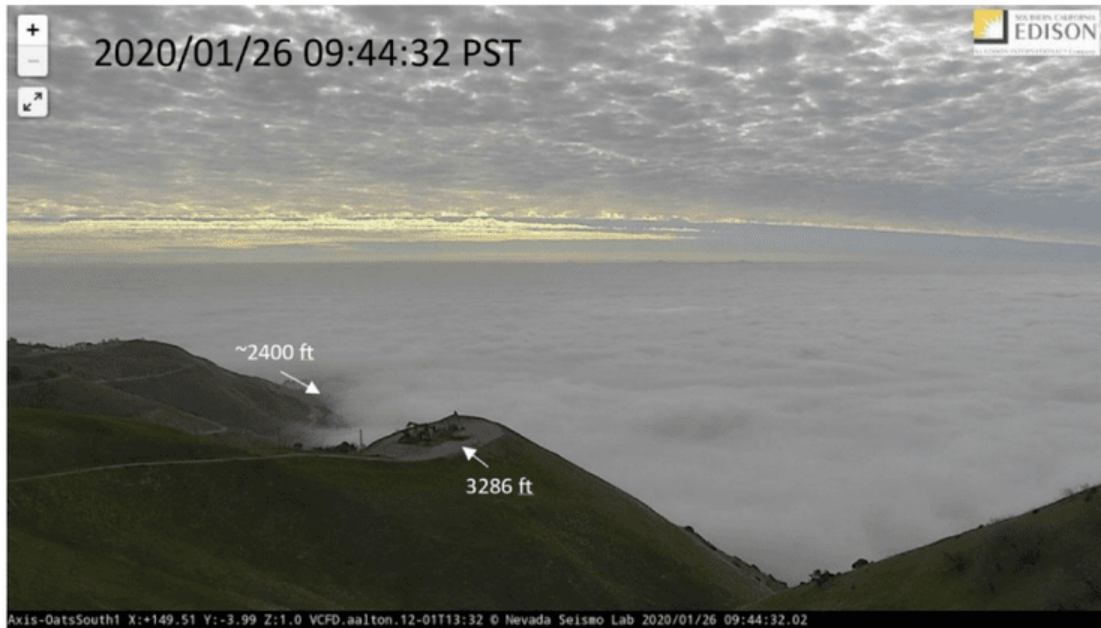
An ALERTWildfire camera image (figure 4) taken at 0944 PST looking southeast toward the city of Van Nuys, as publicized on the National Weather Service (NWS) Los Angeles Twitter account, depicted the top of the cloud layer to the east of the accident site. The NWS analyzed the top of the cloud layer to be about 2,400 feet above mean sea level near the terrain in the foreground of the image.

Figure 4. Camera image from 0944 PST

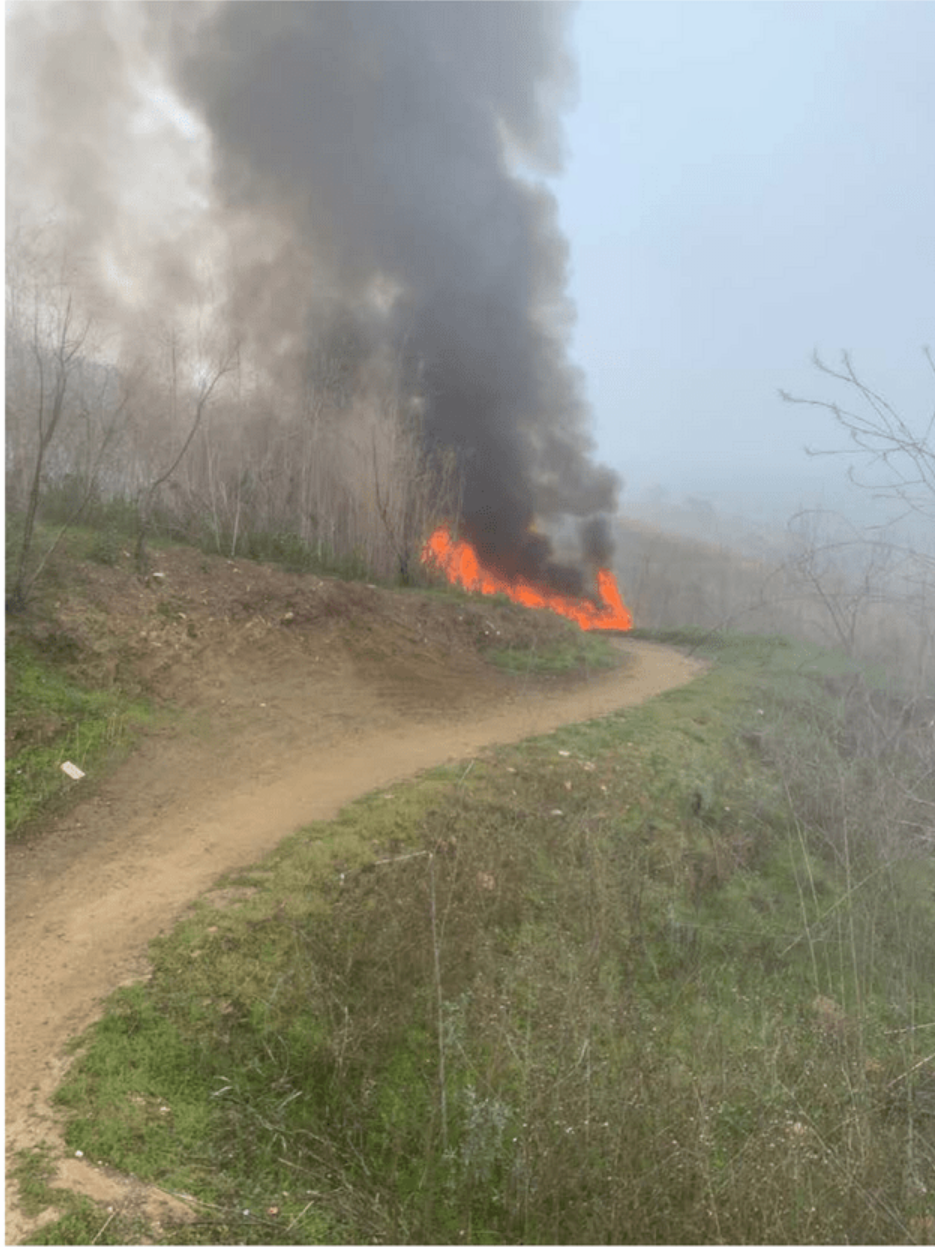
Videos and photos taken by the public in the area of the accident also depict fog and low clouds obscuring the hilltops. Figure 5a was taken by a witness on the mountain bike trail about 0950. The witness stated that the area was surrounded by mist. He said he began to hear the sound of a helicopter, which he described as appropriate for a helicopter flying while in a powered condition. He perceived the sound getting louder and saw a blue and white helicopter emerge from the clouds passing from left to right directly to his left. He judged it to be moving fast, travelling on a forward and descending trajectory. It started to roll to the left such that he caught a glimpse of its belly. He observed it for 1 to 2 seconds, before it impacted terrain about 50 feet below his position.

Figure 5a. Witness photo of accident site and weather conditions.

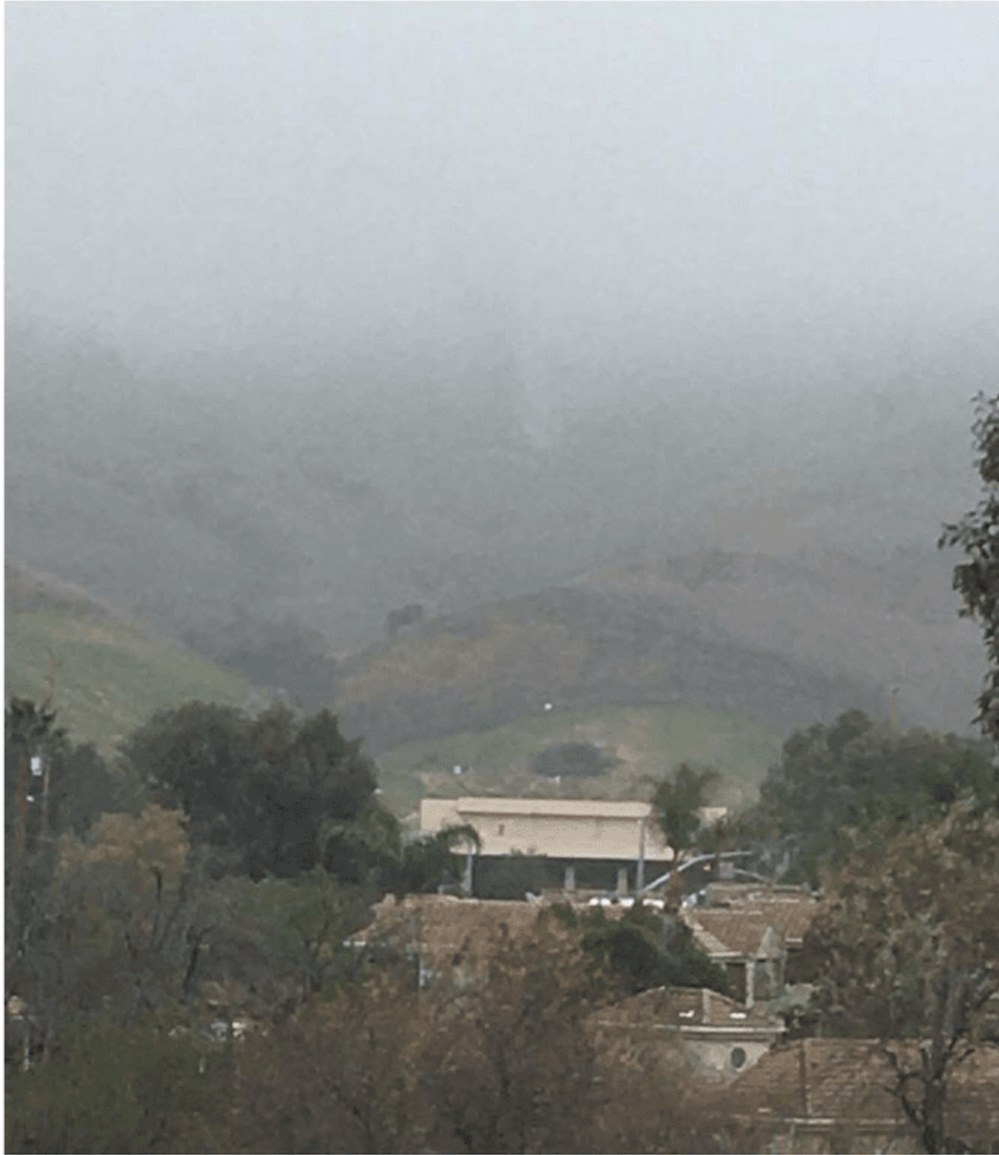
Figure 5b was taken by a nearby resident about 5 minutes after the accident from a location about 4,000 feet west of the site at an elevation of 750 feet msl.

Figure 5b. Resident photograph.

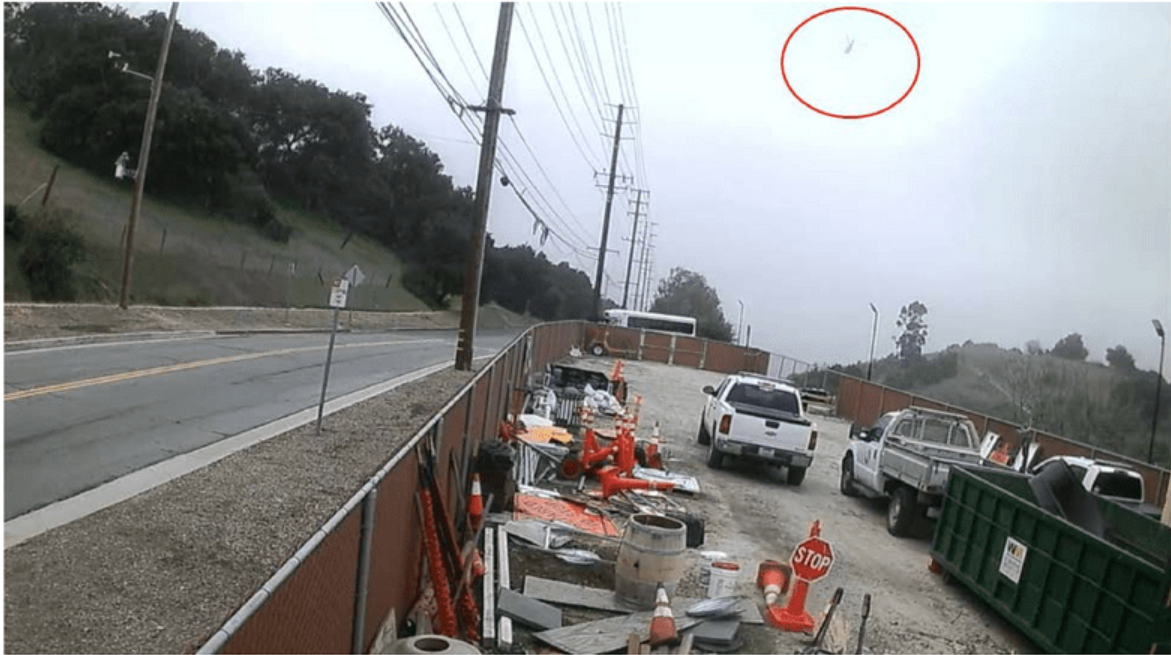
Figure 6 is a still frame from a security video obtained from a road maintenance yard adjacent to Moreau Road and Highway 101 depicting the helicopter proceeding westward along the highway and disappearing into the clouds.

Figure 6. Still frame from security video showing N72EX flying into clouds (circled in red)
