STATE OF VERMONT  
AGENCY OF TRANSPORTATION

**Scoping Report**

FOR  
**Ludlow BF 013-3(16)**

**VT Route 100, BRIDGE 102 OVER UNNAMED BROOK**

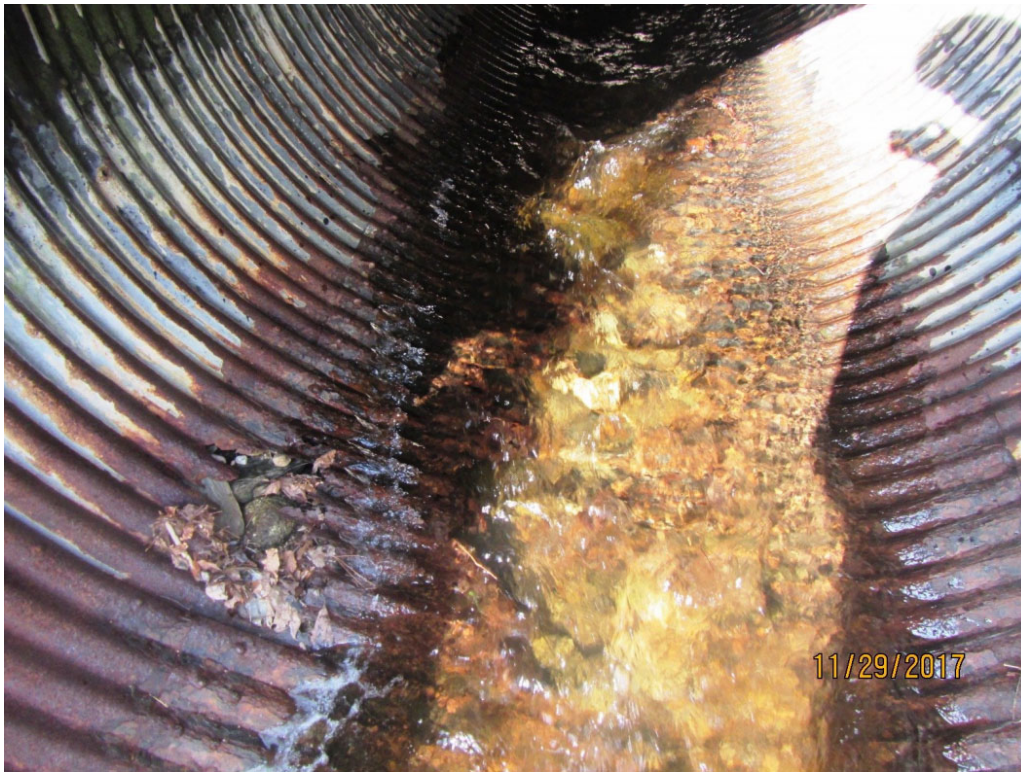
1. Bridge 102 is in poor condition. The last 15-feet of the pipe has heavy section loss along the invert from corrosion with numerous large holes through the invert.
2. The culvert clearspan does not meet the minimum bankfull width requirements.
3. There is a utility pole located behind the guardrail within the clearzone limits
4. VT Route 100 through the project area does not meet the minimum standards for width.

Picture 5: Culvert Barrel Condition

12/06/2019 - Pipe is in poor condition due to heavy corrosion of the last ~ 25' of the invert. Pipe is not significantly long nor buried deep and full replacement is now the practical option; rather than repair. ~ MJ/MK

12/05/2018 - Pipe is in poor condition due to heavy corrosion of the last 15' of the invert. Concrete invert repair needed soon, to compensate, before deformation occurs. ~ MJ/MK

We recommend **Alternative 2a**; a new precast concrete box with traffic maintained on an offsite detour during construction.

The new culvert will be a 14-foot x 8.5-foot precast concrete box culvert, in order to meet the VTrans Hydraulic Section's recommendation. The new precast box will have bed retention sills placed along the bottom of the box, to allow for a natural channel bottom to form, accommodating aquatic organism passage. Sills should be 12-inches high at the edges of the box and 6 inches high in the center, creating a V-shape across the full width of the box. Sills should be spaced no more than 8 feet apart throughout the structure with one sill placed at both the inlet and the outlet. Since the precast culvert will have a closed bottom, it will be protected from scour. In order to satisfy the AOP needs, the culvert invert should be buried 36 inches and E-Stone Type III should be placed along the length of the channel bottom through the culvert, resulting in a 5.5-foot-high waterway opening. The new culvert should have headwalls that extend four feet below the channel bottom at the inlet and the outlet to prevent undermining.

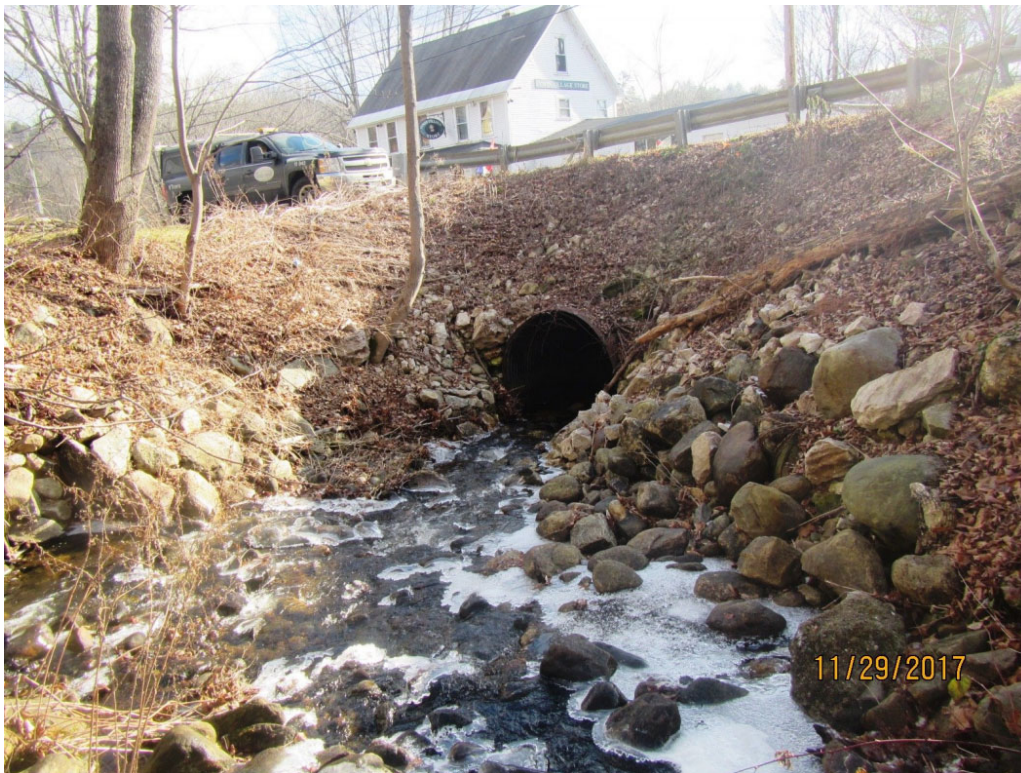
Picture 6: Culvert Inlet

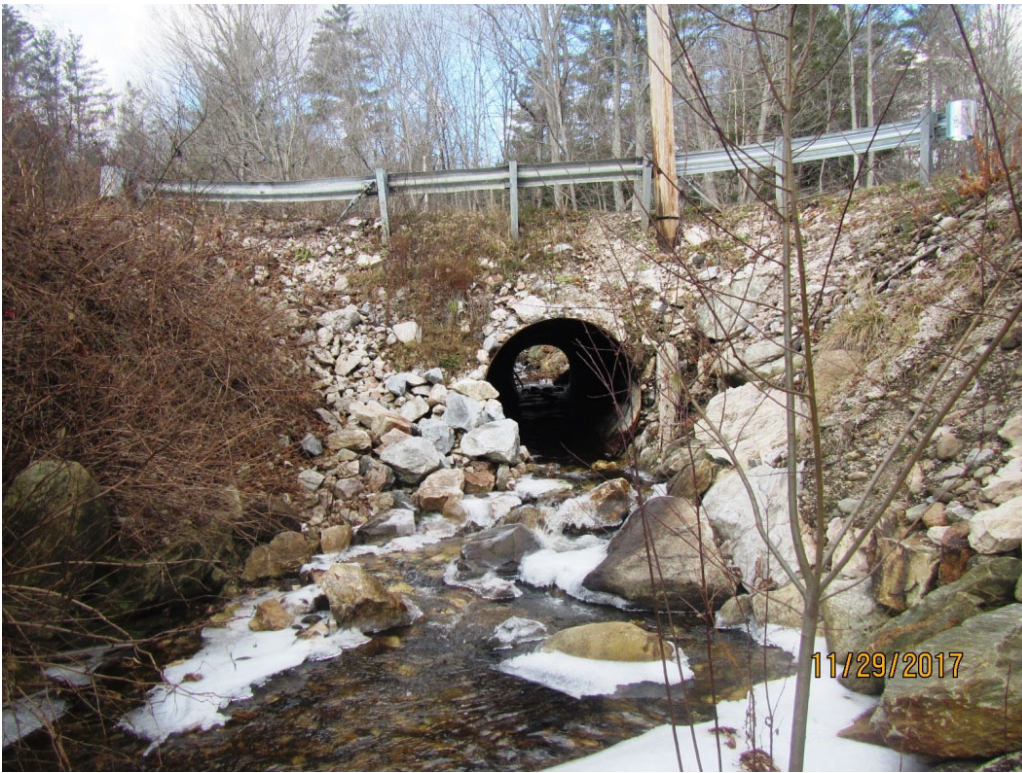
Picture 7: Culvert Outlet

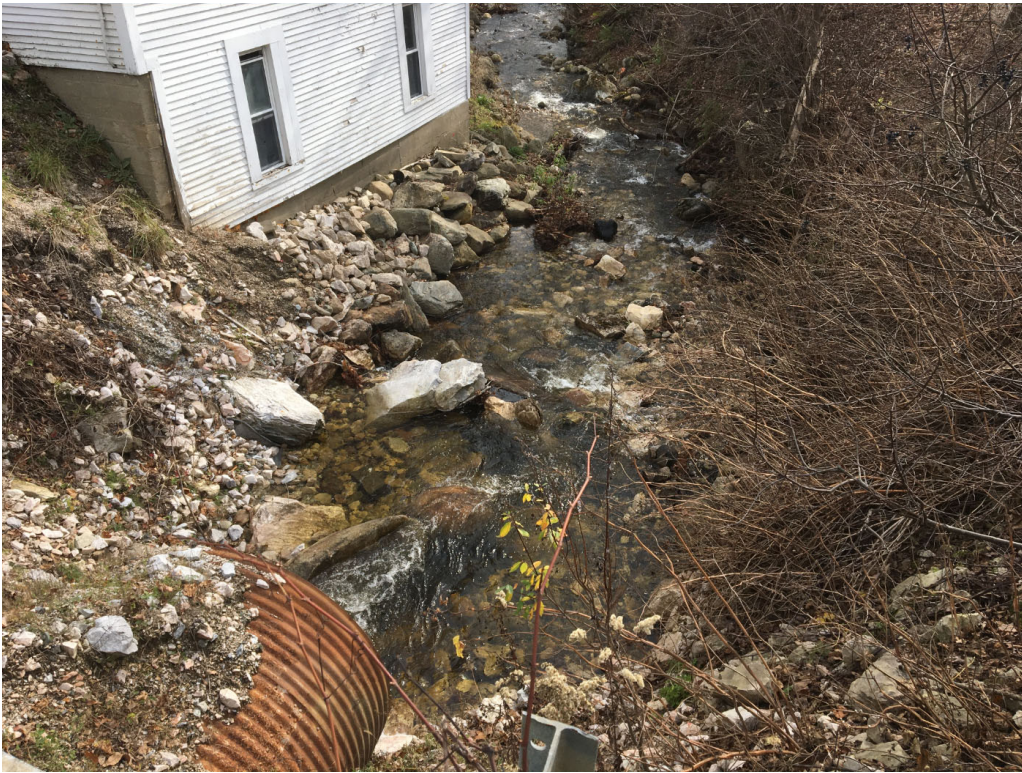
Picture 8: Foundation on downstream side

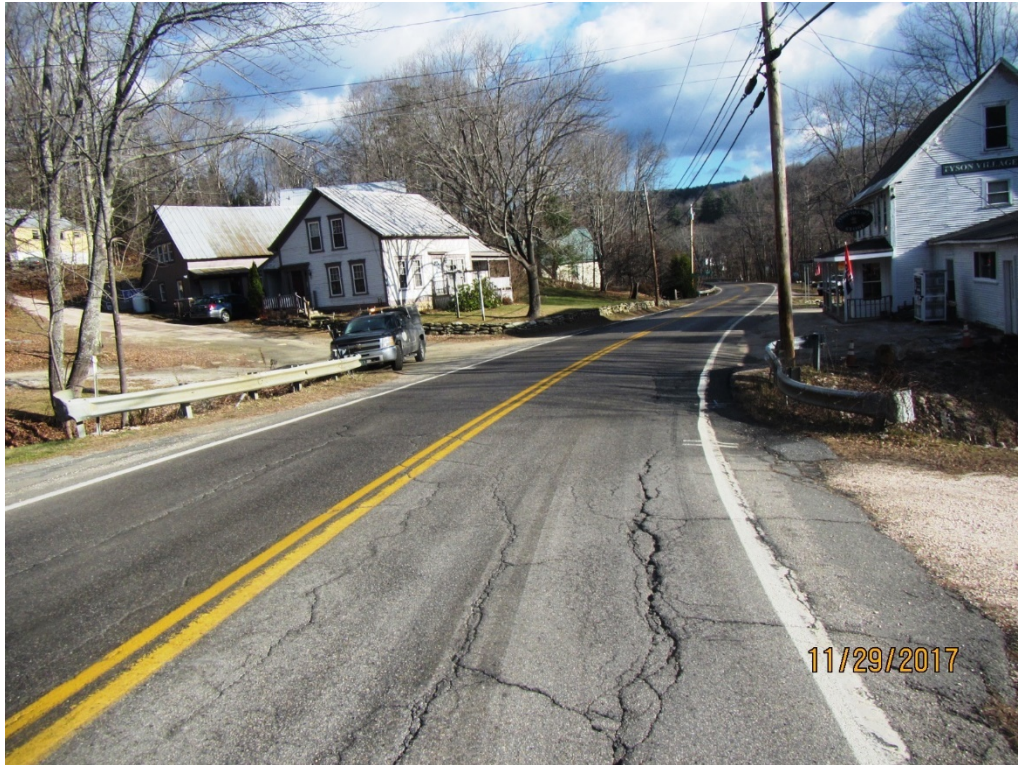
**Figure 3.1:** *Overhead utilities above culvert crossing VT RT 100. [Inspection photo dated 2017]*

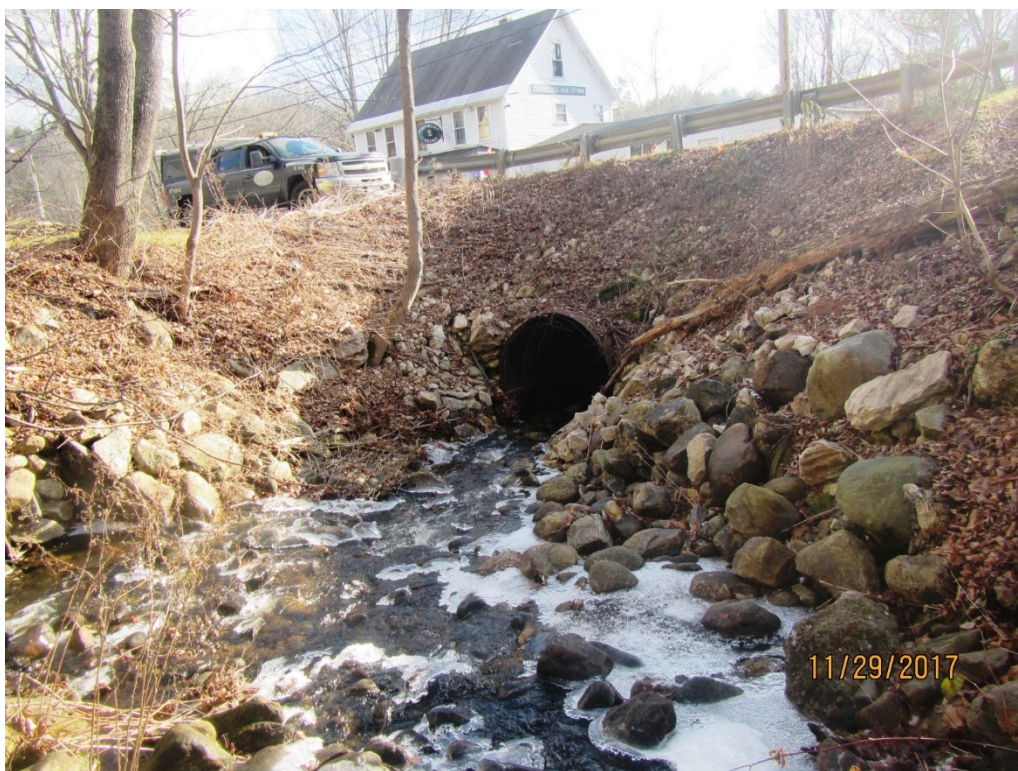
The Preliminary Geotechnical Report indicates that no bedrock has been observed at the project site. While there are large boulders at both the inlet and outlet, these were likely placed for slope stabilization. Borings should be taken early on in design to verify the in-situ conditions.

**Figure 3.2:** *Large stones at the inlet of the culvert. [Inspection photo dated 2017]*

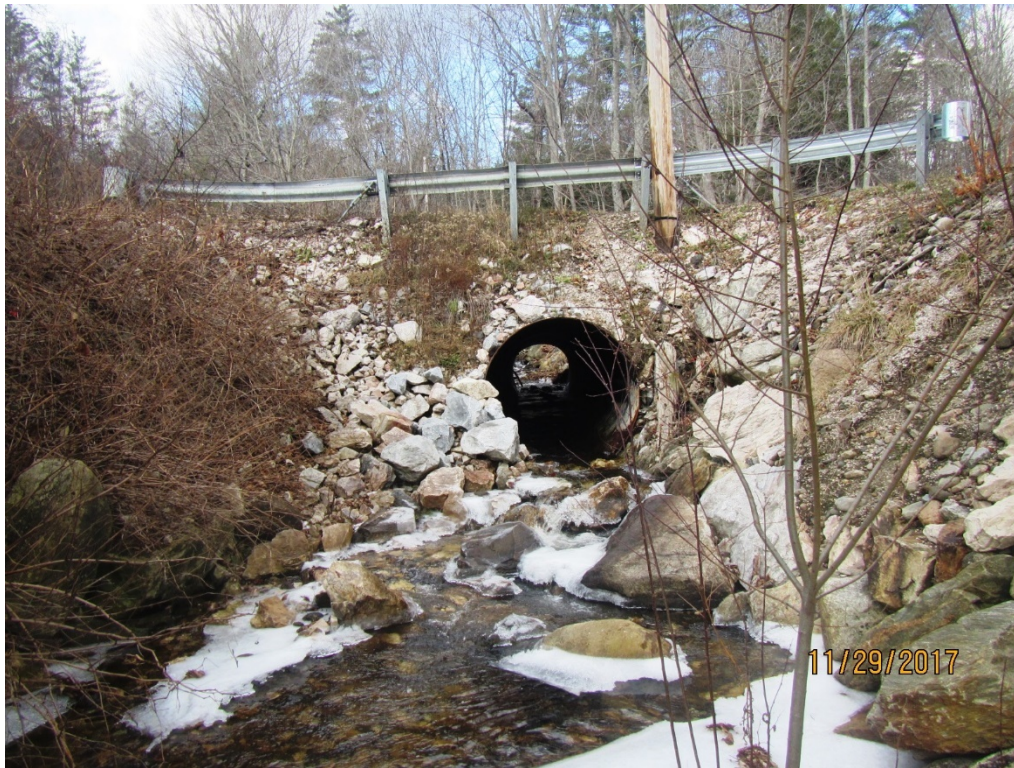
**Figure 3.3:** *Large stones observed at the outlet of the culvert. [Inspection photo dated 2017]*
