MILL PLINTHS GUNITING REPAIRS

PADDINGTON GOLD MINE, 30 KM
NORTH OF KALGOORLIE

MAINTENANCE - CONCRETE REPAIRS

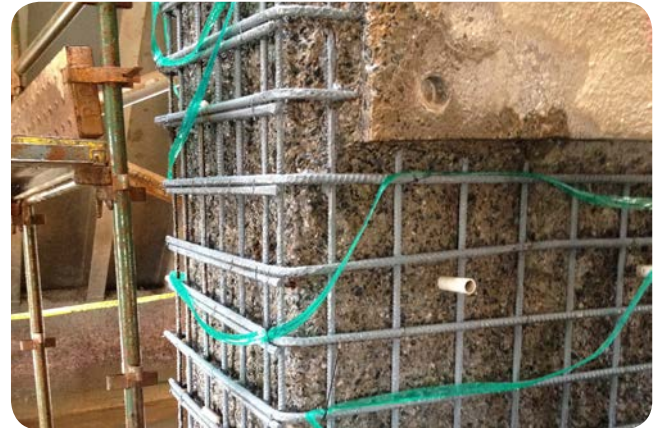
- ▶ Exposed reinforcement abrasive blasted and primed and hydration of existing concrete surface using soaker hose.
- ▶ Spray application of gunite by shotcrete hopper.
- ▶ Concrete surfaced to a smooth finish and cured.
