Problem:

- Thermal event originating in the headlamp/bucket area of vehicle

P4 Halogen Headlamp

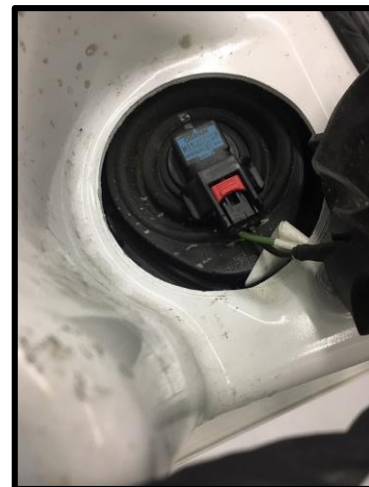
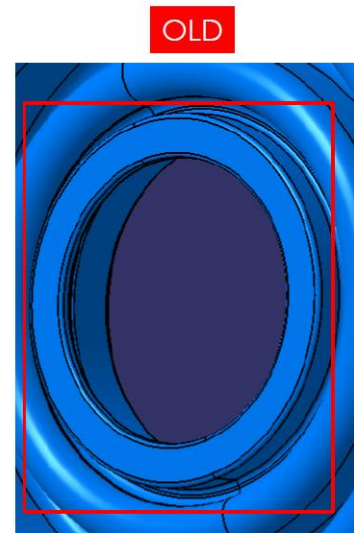
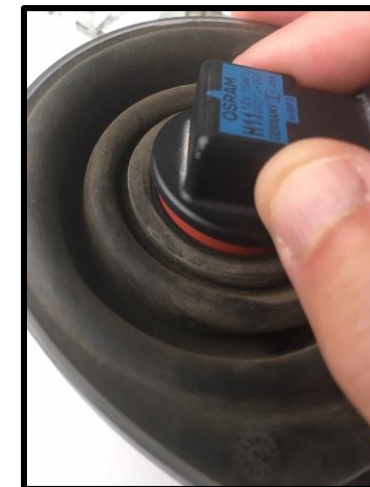
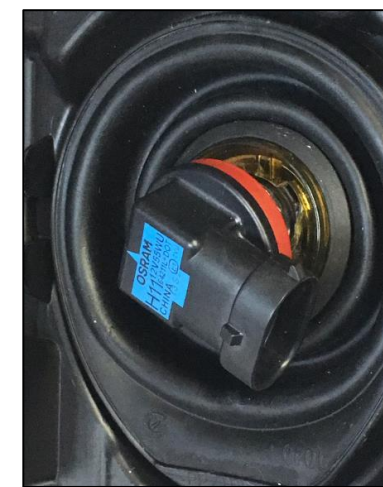
- Bulb installed incorrectly & may disengage from reflector/headlamp

- ✓ **Zero** reported issues with correctly installed bulbs (OEM or aftermarket)
 - ✓ DTNA driver manual calls for OEM Osram H11 replacement
- “Rib” - seals the bulb/socket

- All TMPs modifying headlamps (remove boot - installed grommet) as of 12/10/19
 - CLE started 12/5/19
- ZKW implementation of grommet with parts to DTNA C/O - 3/23/2020
- Warning label implemented
- Splash shield P59939+01 implemented 3/23/2020

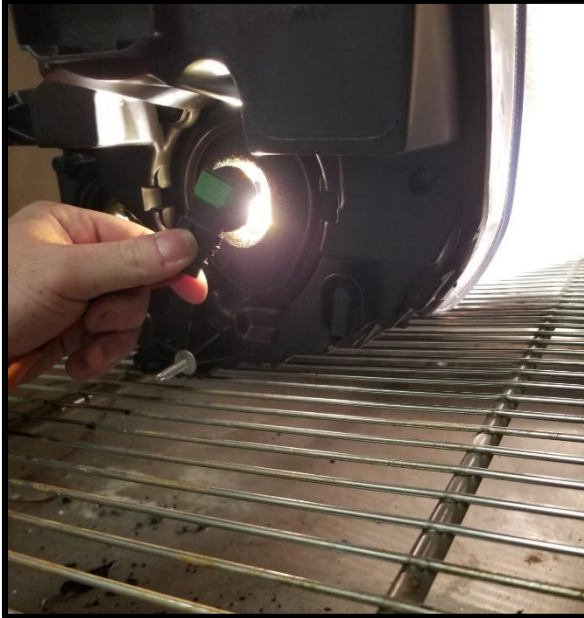
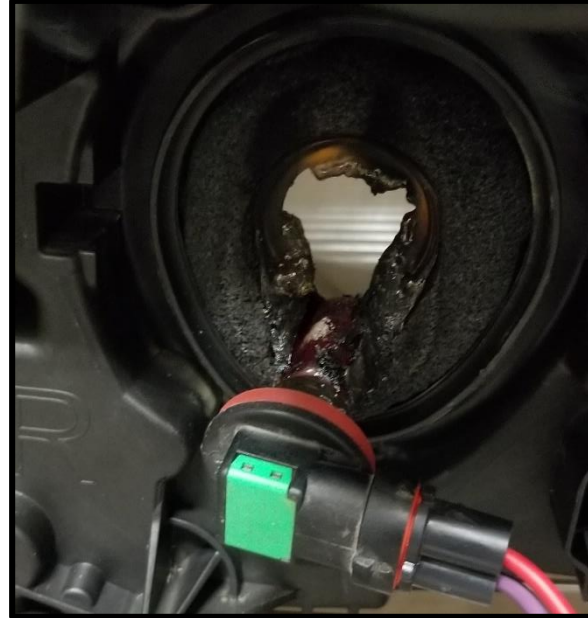
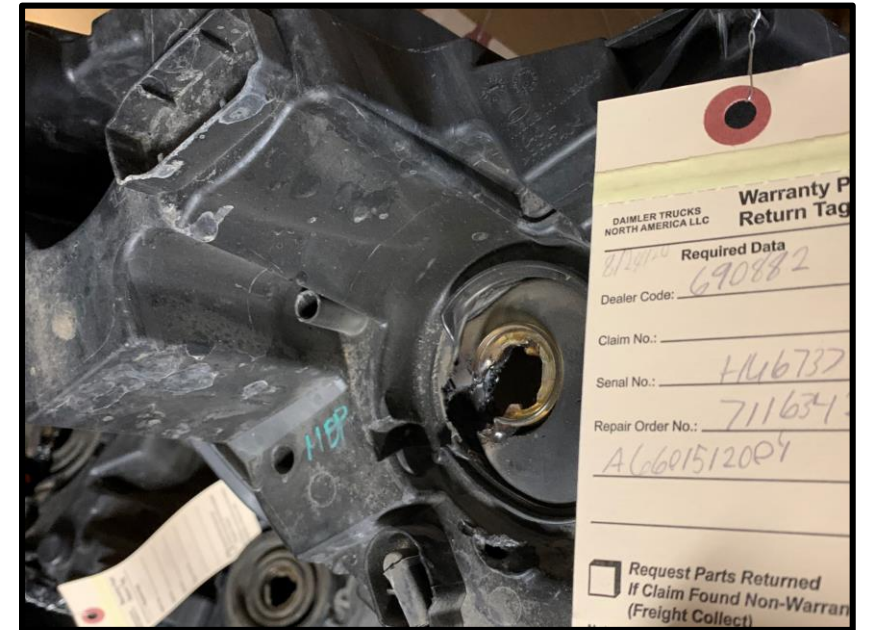
- Validation testing showing results of the foam boot with bulb purposely positioned to simulate **mis-installed** bulb
- The foam boot is doing its job to slow and stop the bulb from cutting into the lamp and surrounding parts of the truck.

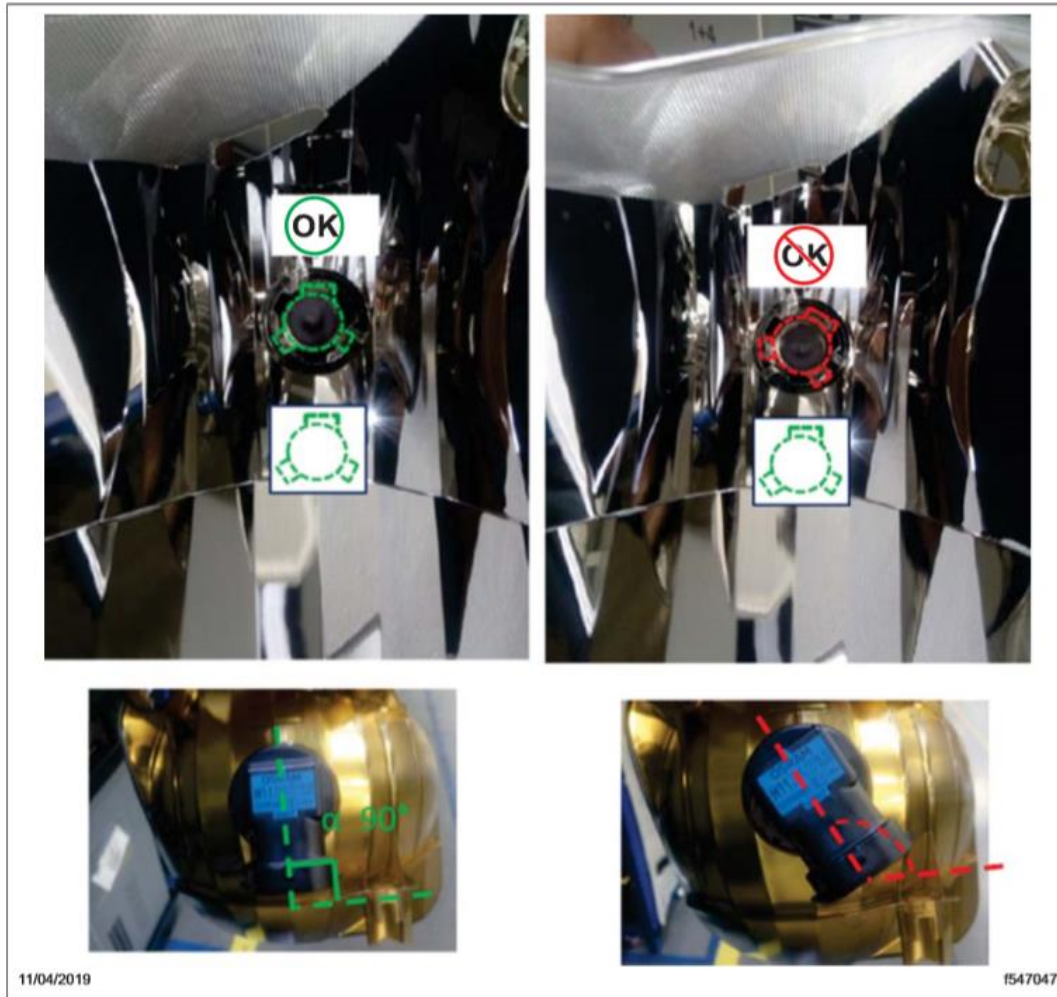
Fig. 11, View Through Headlamp Lens to Verify Bulbs are Fully Seated

- There are NO issues when bulbs are installed correctly
- Warnings, instructions, and system updates have been implemented to only help the operator
- Mis-installation IS detectable.
 - Inspection of bulb from the front (through lens)
 - Inspection of the bulb from the back
 - If mis-installed the light output on the road can be detected (dim, flickering)
