Subject: N212330480 - Service Update

Front Lift System Reservoir Cap Leak

Models: 2020-2021 Chevrolet Corvette

N212330480 Front Lift System Reservoir Cap Leak

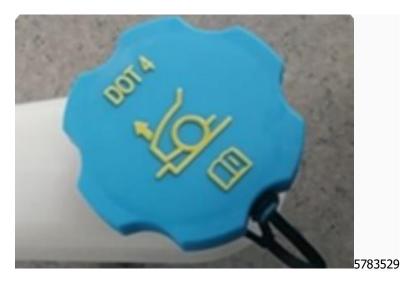
5700361

Note: Clean the filler cap and surrounding area before removing the cap.

3. Remove the incorrect reservoir cap. Discard the cap.

- Install the new service reservoir cap.
- Reinstall the front compartment rear access panel. Refer to Front Compartment Rear Access Cover Replacement in SI.
