# TECHNICAL TOPICS

### U0111-00 Lost Communication with Battery Energy Control Module "A"

### 19-22MY Range Rover, RR Sport

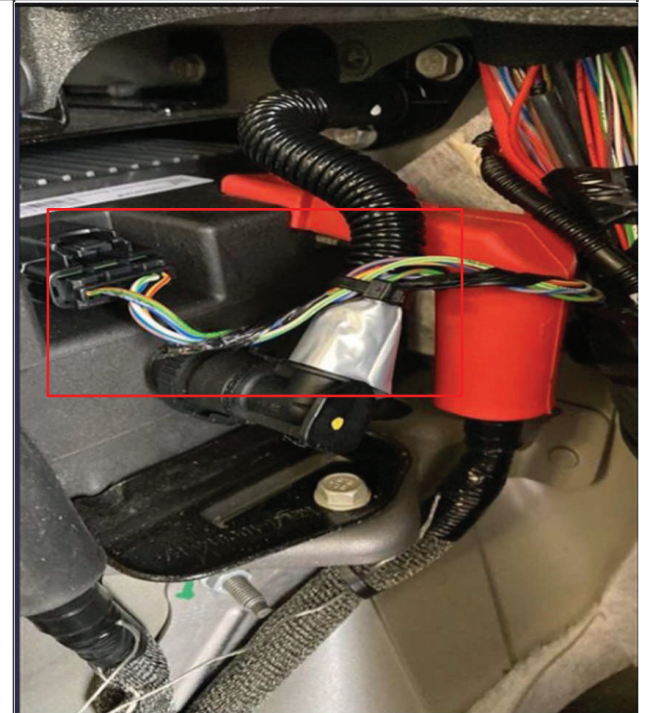
- DTC U0111-00 Lost Communication with Battery Energy Control Module "A" will come on
- Incorrect Battery Energy Control Module (BECM) harness routing causing tension on connector C4YB01D resulting in high resistance/open circuit.

- Remove the original clipping feature on the MHEV Battery harness and replace with a suitable cable tie (200mm x 4.8mm) making sure the harness is routed correctly and not tight putting the harness under stress as per the attachment and check for connector damage and repair if required.
