# Special Coverage Adjustment

## N192266180 Front Wiper Transmission Arm Linkage Failure

**Release Date:** September 2022

**Revision:** 01

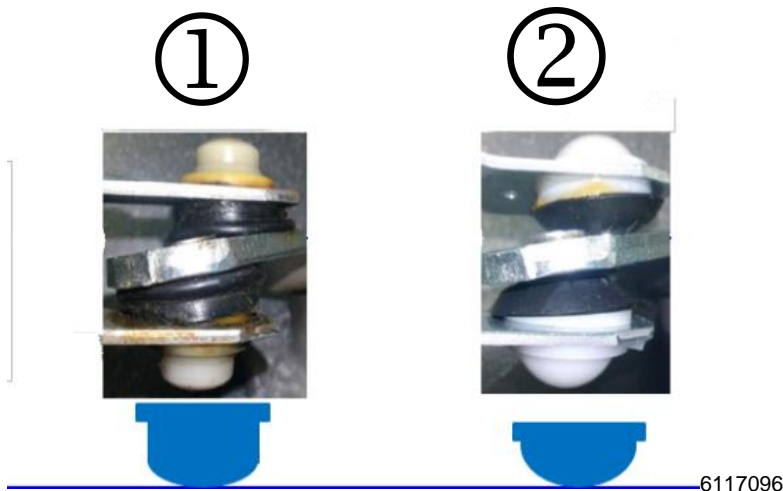
There are two types of nylon pivot cups.

- If the module has a “top hat” design (1), proceed with the link replacement procedure.
- If the module has a “dome shaped” design (2), Replace the module assembly.

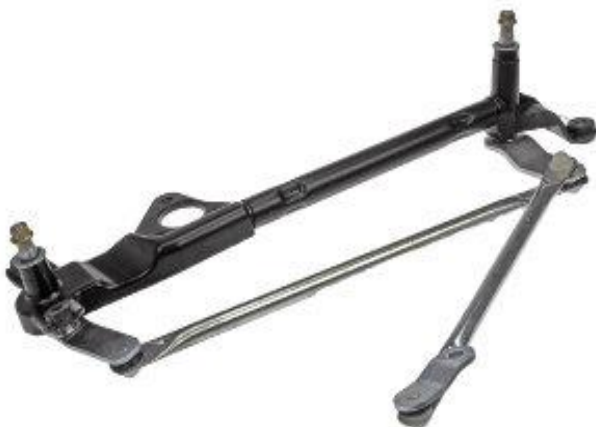
6055971

**Black painted aftermarket module frame**

- **NON-GM Wiper Module Assembly Example.** If the wiper module is determined to be a non-GM unit, replace the complete windshield wiper system module assembly. Refer to *Windshield Wiper System Module Replacement* in SI.

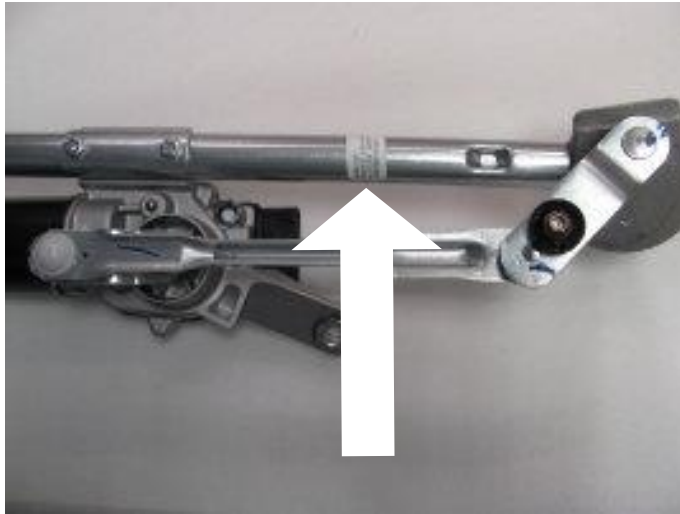
6055973

**GM OE parts will have a part number tag**

- **OE-GM Wiper Module Identification.** If the wiper module is determined to be a GM unit, proceed to step #2.

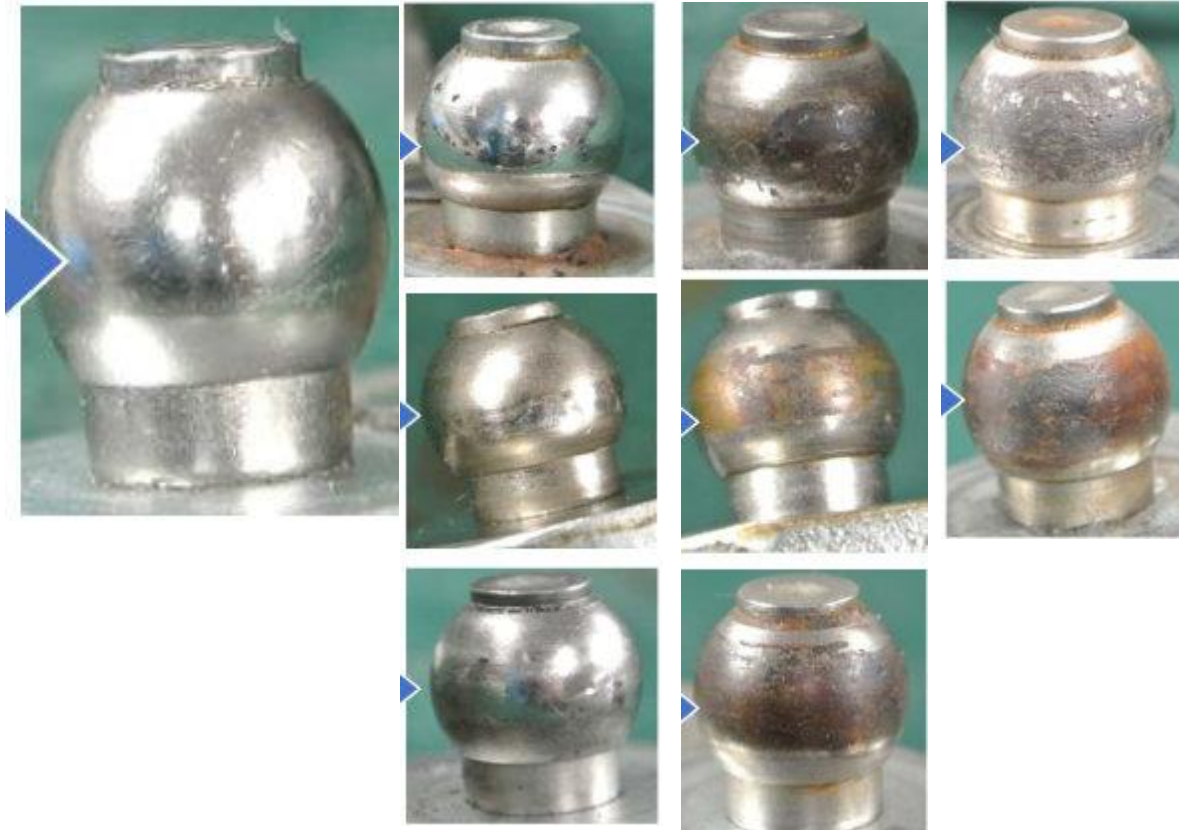
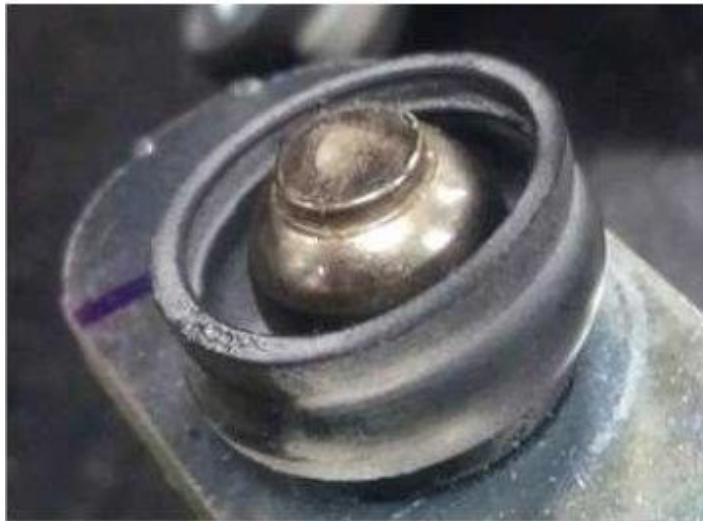
5. Using a suitable aerosol solvent and a small wire brush or abrasive pad, clean the old grease and debris from the ball joints. Wipe the ball joints clean with a suitable disposable towel.
6. With the ball joints cleaned, inspect the surface for severe damage (material missing).

**The below examples are acceptable levels pitting, flaking and rust residue.**

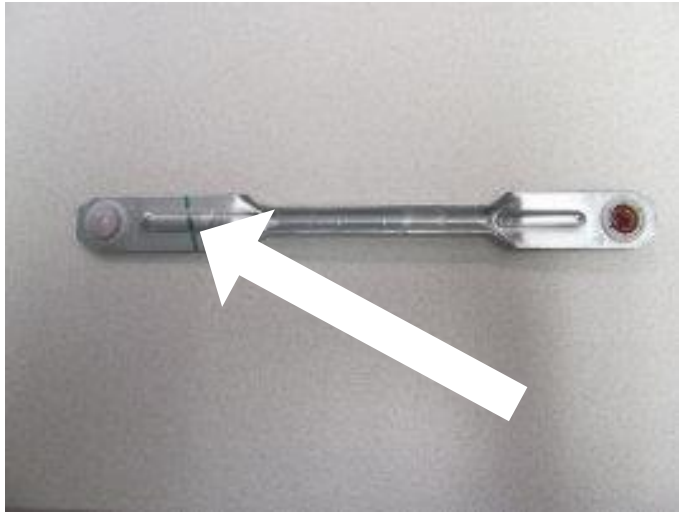
6116962

**IMPORTANT:** The short link rod has a long side and a short side. The long side is marked by a paint stripe. Ensure the long side is installed onto the motor pivot ball. Improper installation of this link will cause interference with the rotating assembly.
