STAR ONLINE PUBLICATION

Case Number: S228A000005 – Rev. A

Symptom/Vehicle Issue: Uconnect Box Error Message, With Active or Stored Cellular Antenna Open or Short Diagnostic Trouble Codes (DTCs)

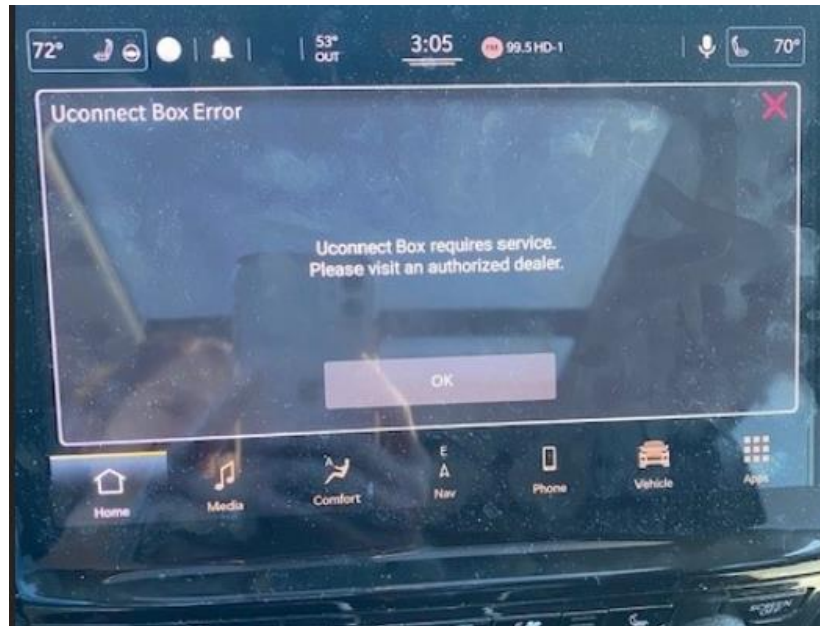
Figure 1: Error Message

Customer Complaint/Technician Observation: The customer may see “Uconnect Box Requires Service” message popup on the radio screen when vehicle starts. wiTECH shows one or more active or stored DTC(s):

Discussion: Every time the antenna open or short DTC(s) was set, the Uconnect box error popup will show on the screen. The message will stay on until next ignition off or customer closes the popup by pressing the cross button at top right corner of the screen.

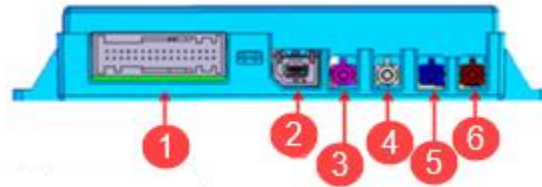
Figure 2: FAKRA Connector Location

TBM Connector	Description	Connector Color	Harness #	Harness Color
1	Main connector			
2	USB / Ethernet		C6	
3	Cellular antenna (CELL 1)	Purple	C2	Claret violet
4	LTE 2 antenna (CELL 2)	Pink / Magenta	C5	Heather violet
5	GNSS IN / Antenna signal	Blue	C3	Blue
6	GNSS OUT / Radio antenna	Brown	C4	Nut Brown

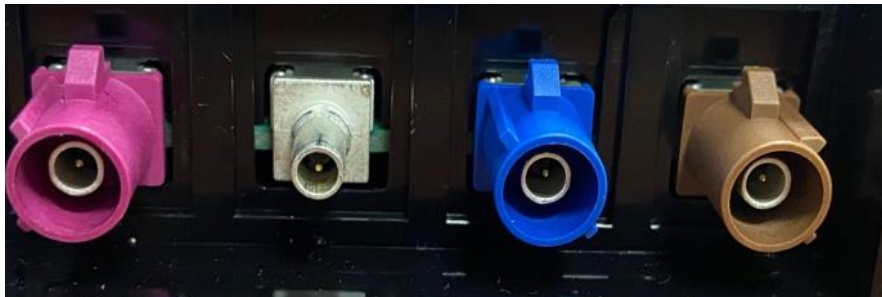
Figure 3: Example of Damaged/Missing Connector Housing

- Check to make sure the Telematics Box Module (TBM) software and Radio software are up to date.
- Determine the location of Cell 1 (Roof antenna) or Cell 2 (IP antenna).
- Prior to replacing any antennas, unplug all harness connections on TBM, antenna, and all inline connections. Use caution when handling connectors to not cause damage.
- Check harness continuity and look for any cable pinch or damage.
- Check for proper installation, connector damage, proper coax cable lengths (no tension, center stack approximately 3 in away from IP), bent terminals or a terminal pushed out.
- Plug all vehicle connections back in and perform ECU reset and erase DTCs.
