# TECHNICAL SERVICE BULLETIN

EL22-015
 NTB23-024
 March 14, 2023

# VEHICLE WILL NOT START AND DTCS P31E7 AND P0AA6 STORED IN EV/HEV CONTROL MODULE

**APPLIED VEHICLES:** 2019-2022 LEAF (ZE1)

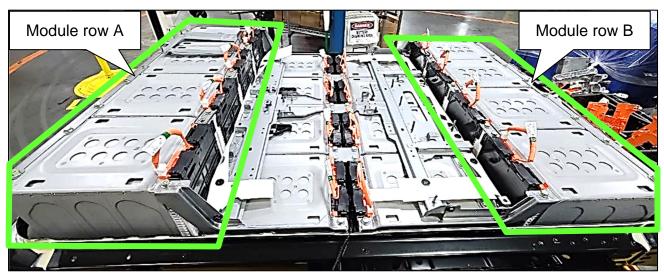
Figure 1

- 1. Perform ESM diagnosis for DTCs to determine which Li-Ion battery module has caused the DTC.
  - The affected module will only be in module row A or B (Figure 1).
