TECHNICAL SERVICE BULLETIN

Classification: DA22-001B	Reference: NTB22-038B	Date: June 20, 2023
------------------------------	--------------------------	------------------------

RAB WARNING LIGHT ON IN INSTRUMENT PANEL AND/OR DTC B2724-23 STORED

APPLIED VEHICLES: 2019-2021 Altima (L34)
2019-2022 Murano (Z52)
2019-2021 Rogue Sport (J11)
2019-2021 Versa (N18)

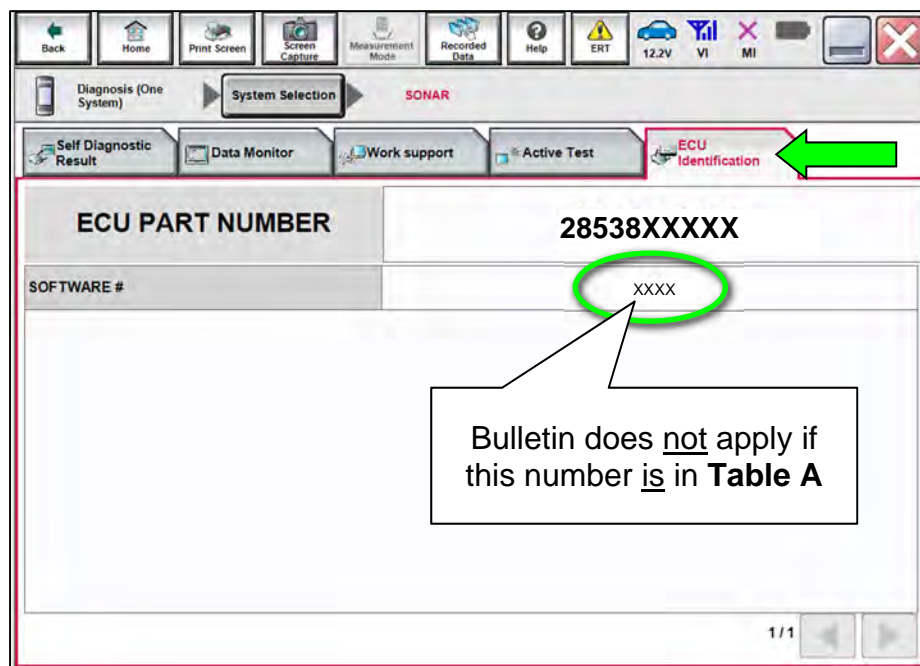
Figure 4

16. Confirm the current **SOFTWARE #** (Figure 4). See **Table A** (below) for model specific **SOFTWARE #**.
 - If the **SOFTWARE #** is in **Table A**, this bulletin does not apply. See the Electronic Service Manual (ESM) for further diagnostic information.

- If the **SOFTWARE #** is not in **Table A**, proceed to step 17.

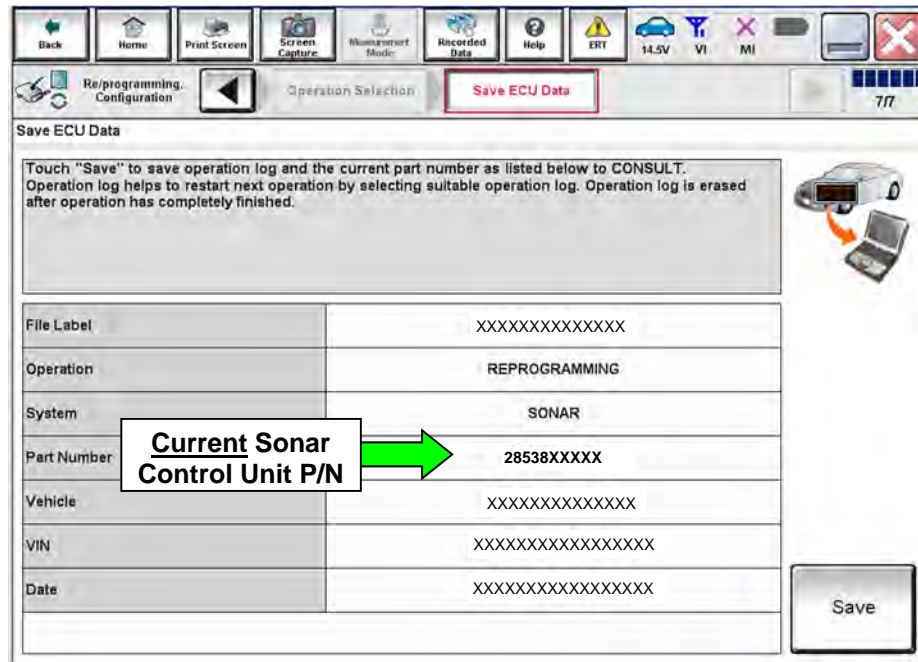
Figure 13

28. When you get to the screen shown in Figure 13, confirm that a reprogram is available as follows.

a. Find the Sonar Control Unit **Part Number** and write it on the repair order.

b. Compare the part number you wrote down to the part numbers in **Table B**.

- If there is a match, continue with the reprogramming procedure.
- If there is not a match in **Table B**, this bulletin does not apply. See the ESM for further diagnostic information.

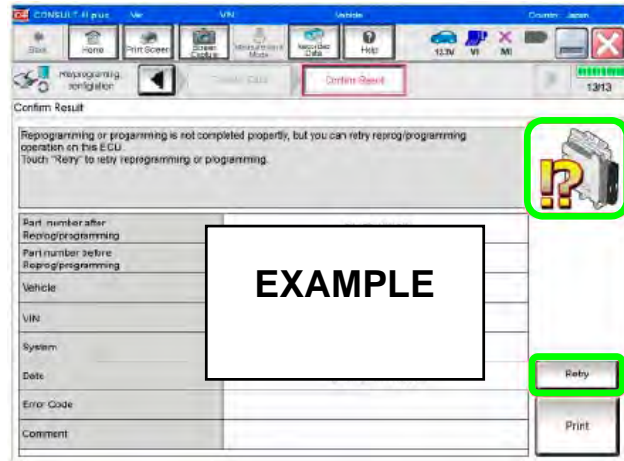
Figure 21

If reprogramming does not complete and the “!?” icon displays, as shown in Figure 21:

- Check battery voltage (12.0 - 15.5 V).
- Ignition is ON, engine OFF.
- External Bluetooth® devices are OFF.
- **All electrical loads are OFF.**
- **Select retry and follow the on screen instructions.**
- **“Retry” may not go through on first attempt and can be selected more than once.**

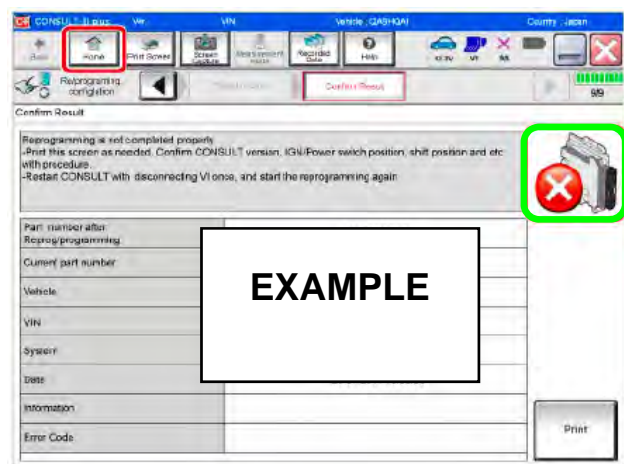
Figure 22

If reprogramming does not complete and the “X” icon displays, as shown in Figure 22:

- Check battery voltage (12.0 - 15.5 V).
- CONSULT A/C adapter is plugged in.
- Ignition is ON, engine OFF.
- Transmission is in Park.
- All CONSULT VI cables are securely connected.
- All C-III plus updates are installed.
- **Select Home, and restart the reprogram procedure from the beginning.**

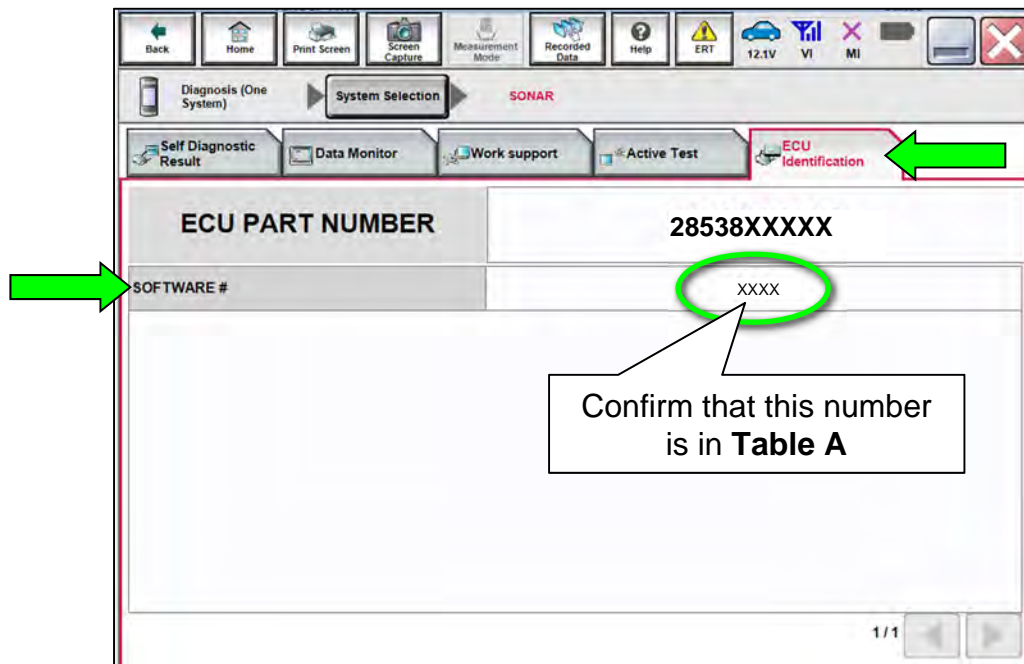
Figure 35

61. Confirm the **SOFTWARE #** (Figure 35).

- If the **SOFTWARE #** is in **Table A** on page 5, proceed to step 62.
- If the **SOFTWARE #** is not **Table A** on page 5, reprogramming did not successfully complete. Go back to step 18 on page 6 and perform the procedure again.

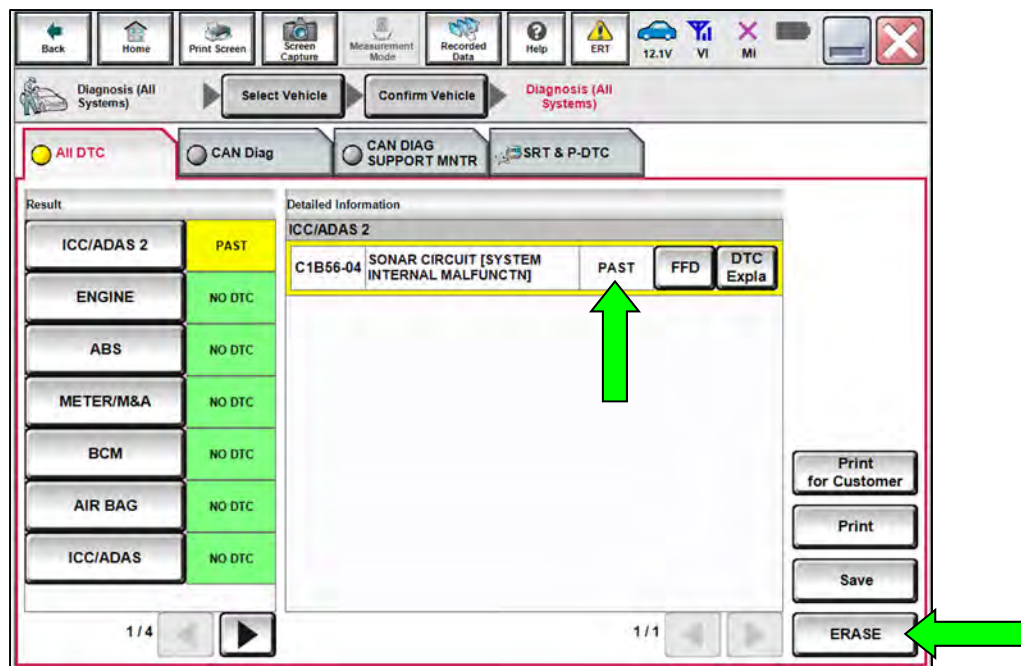
Figure 38

68. Confirm DTC C1B56-04 is displayed as **PAST** (not **CRNT**) (Figure 38).

69. Select **ERASE**.
