Technical Service Bulletin (TSB)
Sunglass Holder Won't Stay Closed

| REFERENCE: | TSB: 23-039-23 REV. A GROUP 23 - Body | Date: | July 14, 2023 | REVISION: | 23-039-23 |
| VEHICLES AFFECTED: | 2022 (WS) Grand Wagoneer/Wagoneer This bulletin applies to vehicles built on or before September 26, 2022 (MDH 0926XX) equipped with a Mini Overhead Console (Sales Code CUD). | MARKET APPLICABILITY: | | | |

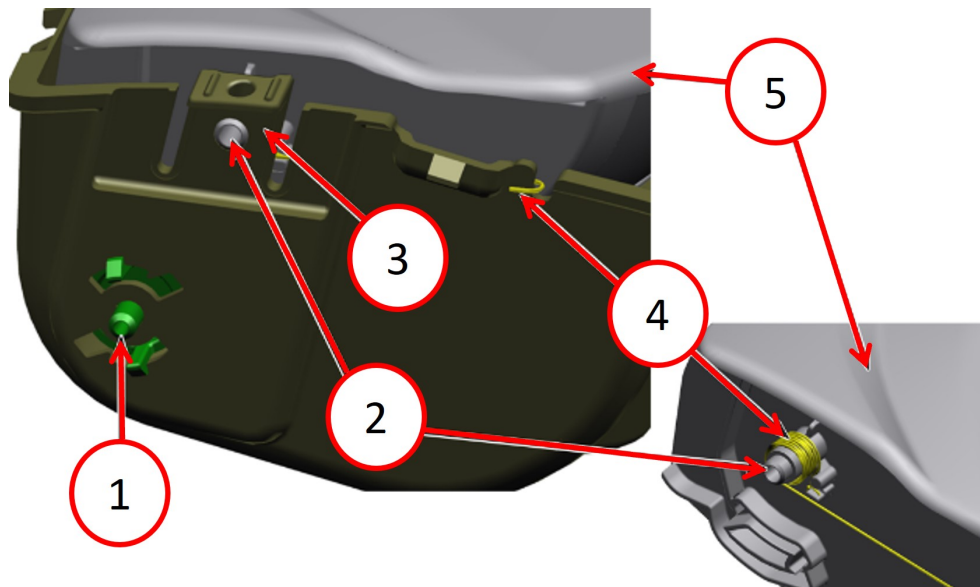
Fig. 2
Sunglass Storage Bin Assembly

| CAUSE: | Track length was designed too long. | | | | |

3. Disengage the sunglass storage bin spring from the backplate (Fig. 2) .

4. Disengage the sunglass storage bin pivot pins and remove the sunglass bin from the backplate (Fig. 2) . **Discard the sunglass storage bin.**
5. Using Mopar lubricant P/N 04773427AB, grease the backplate latch hole, inside of spring and guide rail on the **new sunglass storage bin** (Fig. 3) .

6. Install the new sunglass storage bin by engaging the sunglass storage bin pivot pins into the backplate (Fig. 2) .
7. Install the sunglass storage bin spring on the backplate (Fig. 2) .
8. Install the main bezel on the backplate (Fig. 1) .
