Technical product information

Topic	Engine intermittently fails to start/Kombi pop up 'Engine start system: fault'
Market area	Australia E04 Bentley rest Asia and Australia (6E04),China 723 Volkswagen (Anhui) Automotive CO (6723),China 796 VW Import Comp. Ltd (Vico), Beijing (6796),Germany E02 Bentley rest Europe (6E02),Japan E03 Bentley Japan (6E03),Korea, (South) E08 Bentley South Korea (6E08),United Arab Emirates E06 Bentley Middle East and Africa (6E06),United Kingdom E01 Bentley UK (6E01),United States E05 Bentley USA and rest America (6E05)
Brand	Bentley
Transaction No.	2061362/4
Level	EH
Status	Released for publishing
Release date	28-Sep-2023

New Continental GT/GTC and Flying Spur

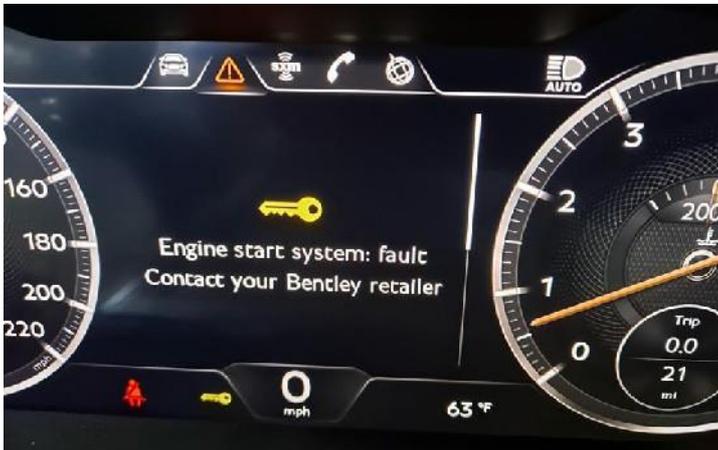
Engine starts but customer gets a pop up error on the Kombi

In the event the Kombi pop-up appears the following DTC will also be stored within address 46 -Convenience system central control unit
B143C29: Access/start authorization button, Range/Performance

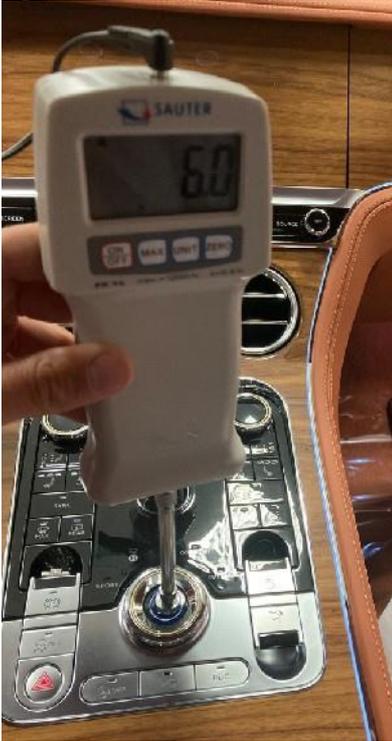
Figure 2

Note: Electrical tape not shown in image for clarity purposes only, please ensure tape is applied

3) Using the workshop tool WT10354 (Force gauge) and selected adaptor highlighted below (Figure 1), slowly press down on the Access/start authorization button centrally (Figure 2) and record the force (N) which each contact point 1 to 3 changes from 'Not operated' to 'operated'
