Interim Report of Commission of Inquiry  
into the Construction Works  
at and near the Hung Hom Station Extension  
under the Shatin to Central Link Project

(The Redacted Version)

February 2019

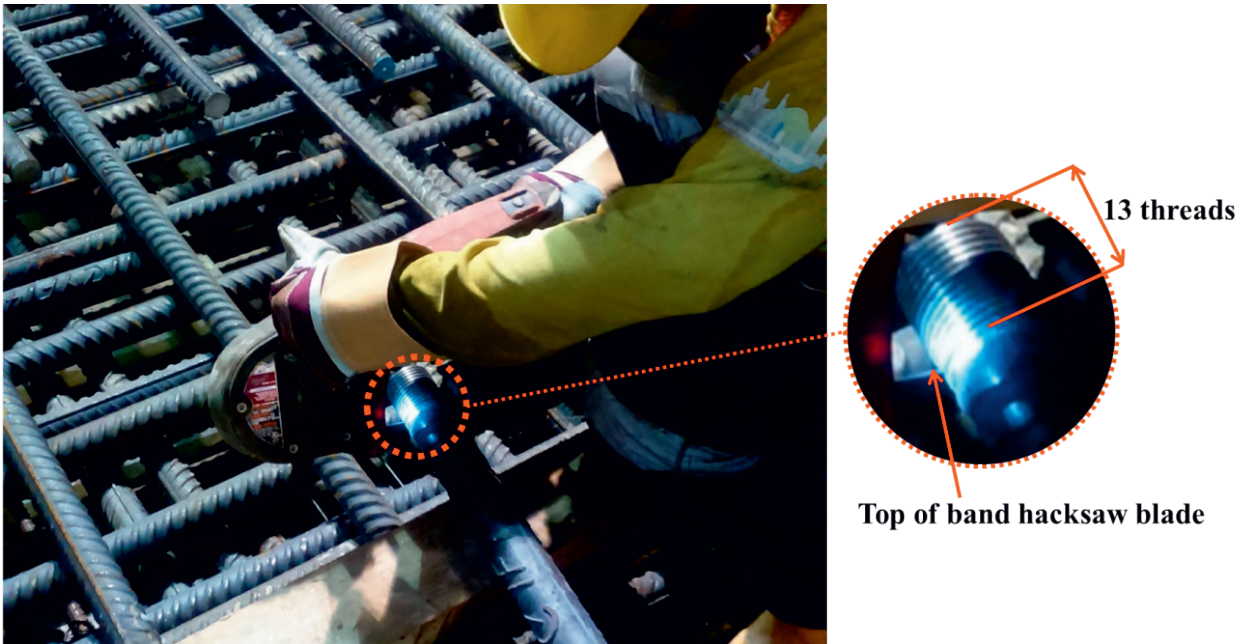
**Photograph 1**

69. During the course of the Commission hearings, there was evidence that it may have been an occasional practice, if for any reason Type A rebars were in short supply on site, to convert Type B rebars to Type A rebars by cutting away the ‘excess’ threads. While (understandably) this was not a practice recommended by BOSA, provided the shortened threads could be screwed into a coupler, the Commission is satisfied it would not have presented any safety risk.

<sup>14</sup> This photograph was one of three or four photographs taken one evening by Jason Poon showing the cutting of threads and almost immediately thereafter the installation of what may well be the same rebar into the diaphragm wall.

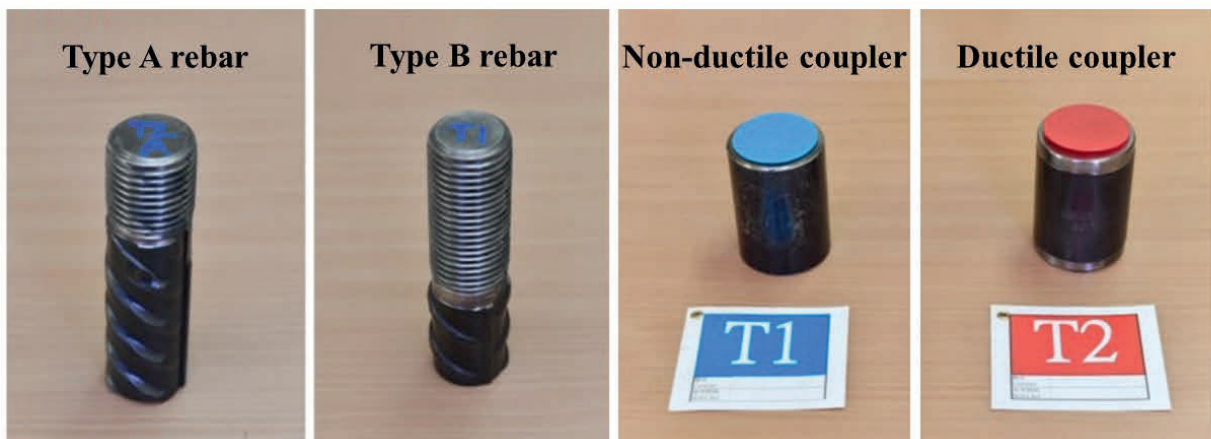
**Photograph 2**

71. BOSA also supplied two types of couplers, Type I and Type II, being non-ductile and ductile couplers respectively. The Commission heard evidence that, in order to avoid error, *only* ductile couplers – ‘Seisplisce’ couplers – were ordered by Leighton.

72. The following photographs show Type A and Type B rebars and Type I and Type II couplers. Type II couplers had red protective caps, whereas Type I couplers would have blue protective caps.

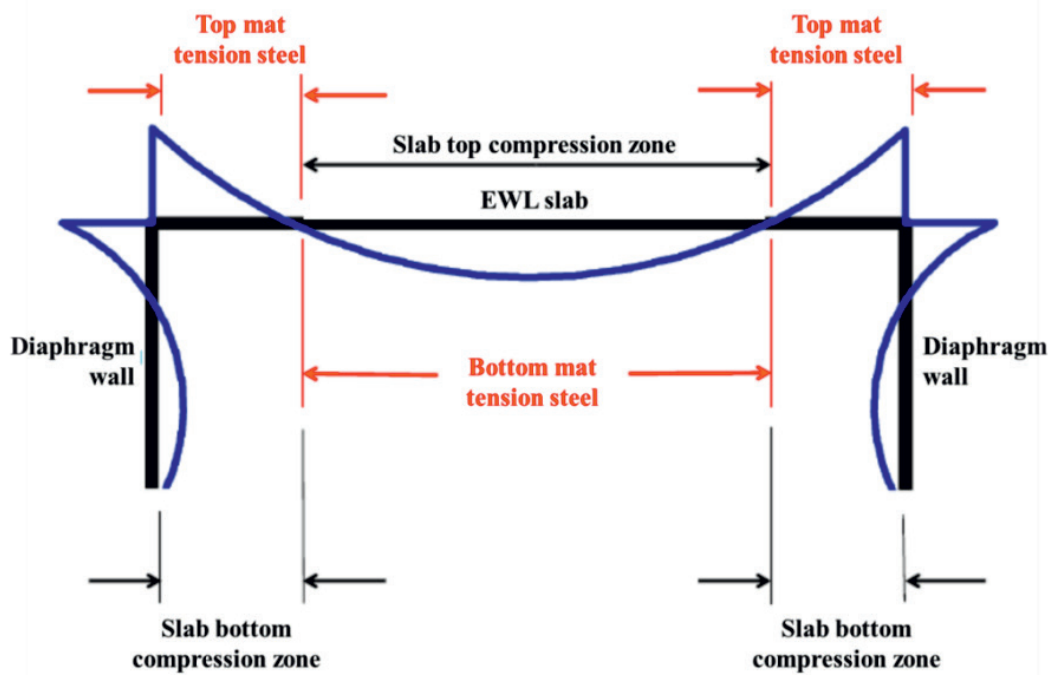
**Diagram 11**

340. The Commission was advised by the experts that, in order to comply with the Code, the amount of reinforcement steel in the bottom of the EWL platform slab needed to be at least equivalent to 50% of the reinforcement steel in the top of the slab.

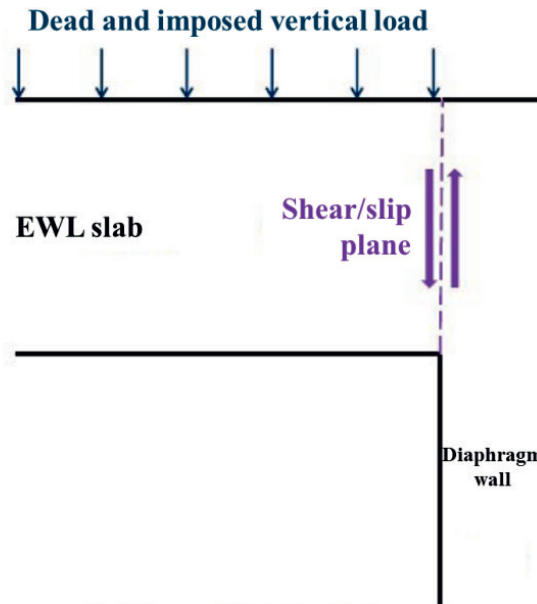
**Diagram 12**

Under vertical load interface becomes a shear/slip plane

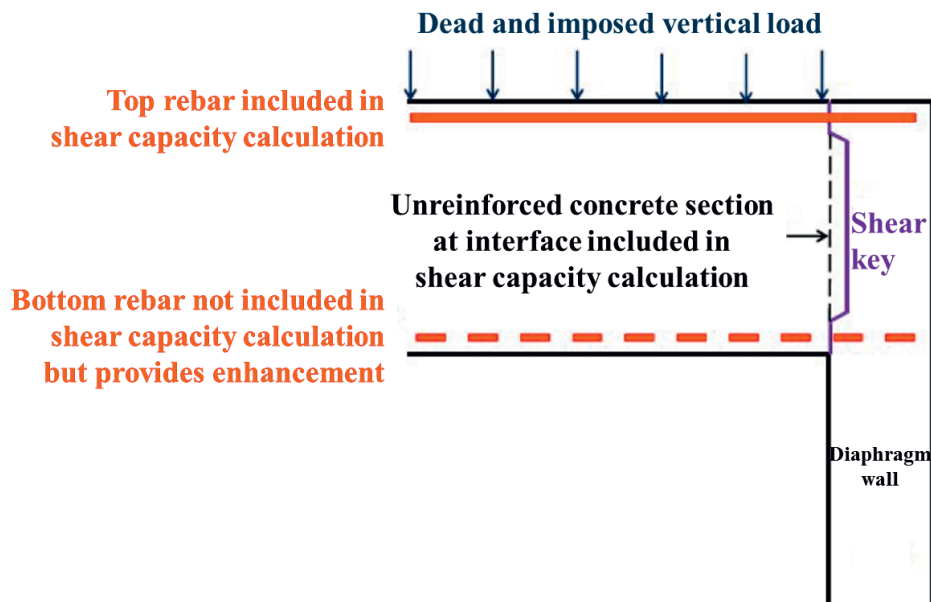
**Diagram 13**

Shear/slip resistance provided by top rebar and unreinforced concrete section

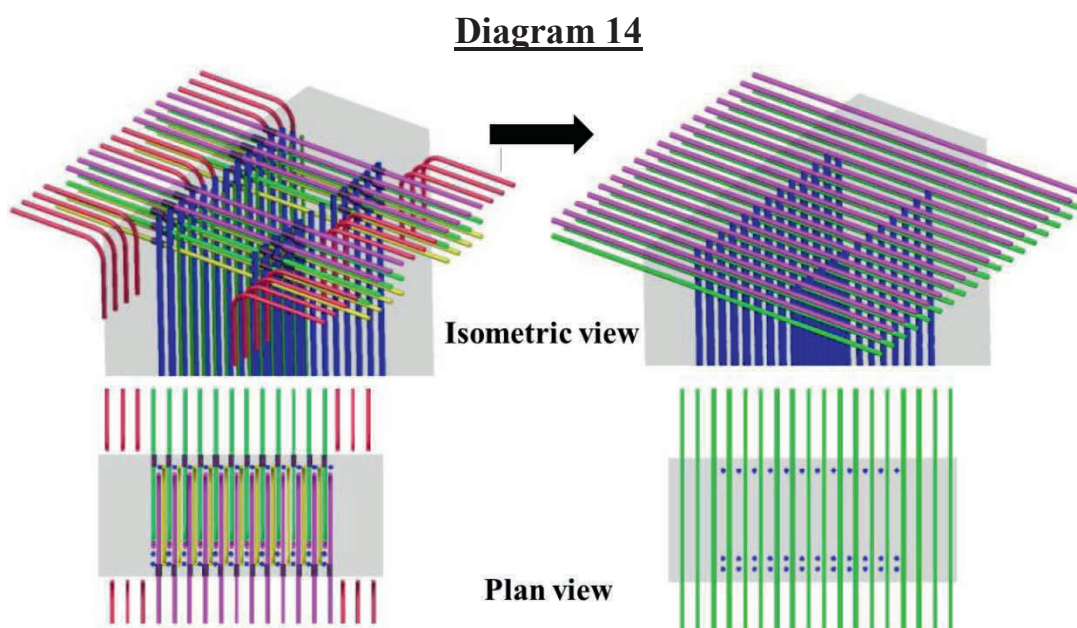
347. The experts also advised the Commission that a change from couplers to through bars would have no adverse structural implications. Indeed they advised that it would actually create a superior detail, as (1) it would remove a potential point of weaknesses (if any of the coupler assemblies should in any way be incorrectly connected), and (2) it would result in more reinforcement steel being provided across the top of the diaphragm wall connecting into the slabs either side.

348. Nick Southward explained to the Commission how the change resulted in additional reinforcement being provided. He illustrated this with a diagram which appears below
