**2017 ANNUAL SITE SUMMARY REPORT
DOMTAR TRANSCONA FORMER CREOSOTE SITE
WINNIPEG, MANITOBA**

KGS Group 17-0953-001
March 2018

RE: 2017 Annual Site Summary Report
Domtar Transcona Former Creosote Site
Winnipeg, Manitoba – Final Report

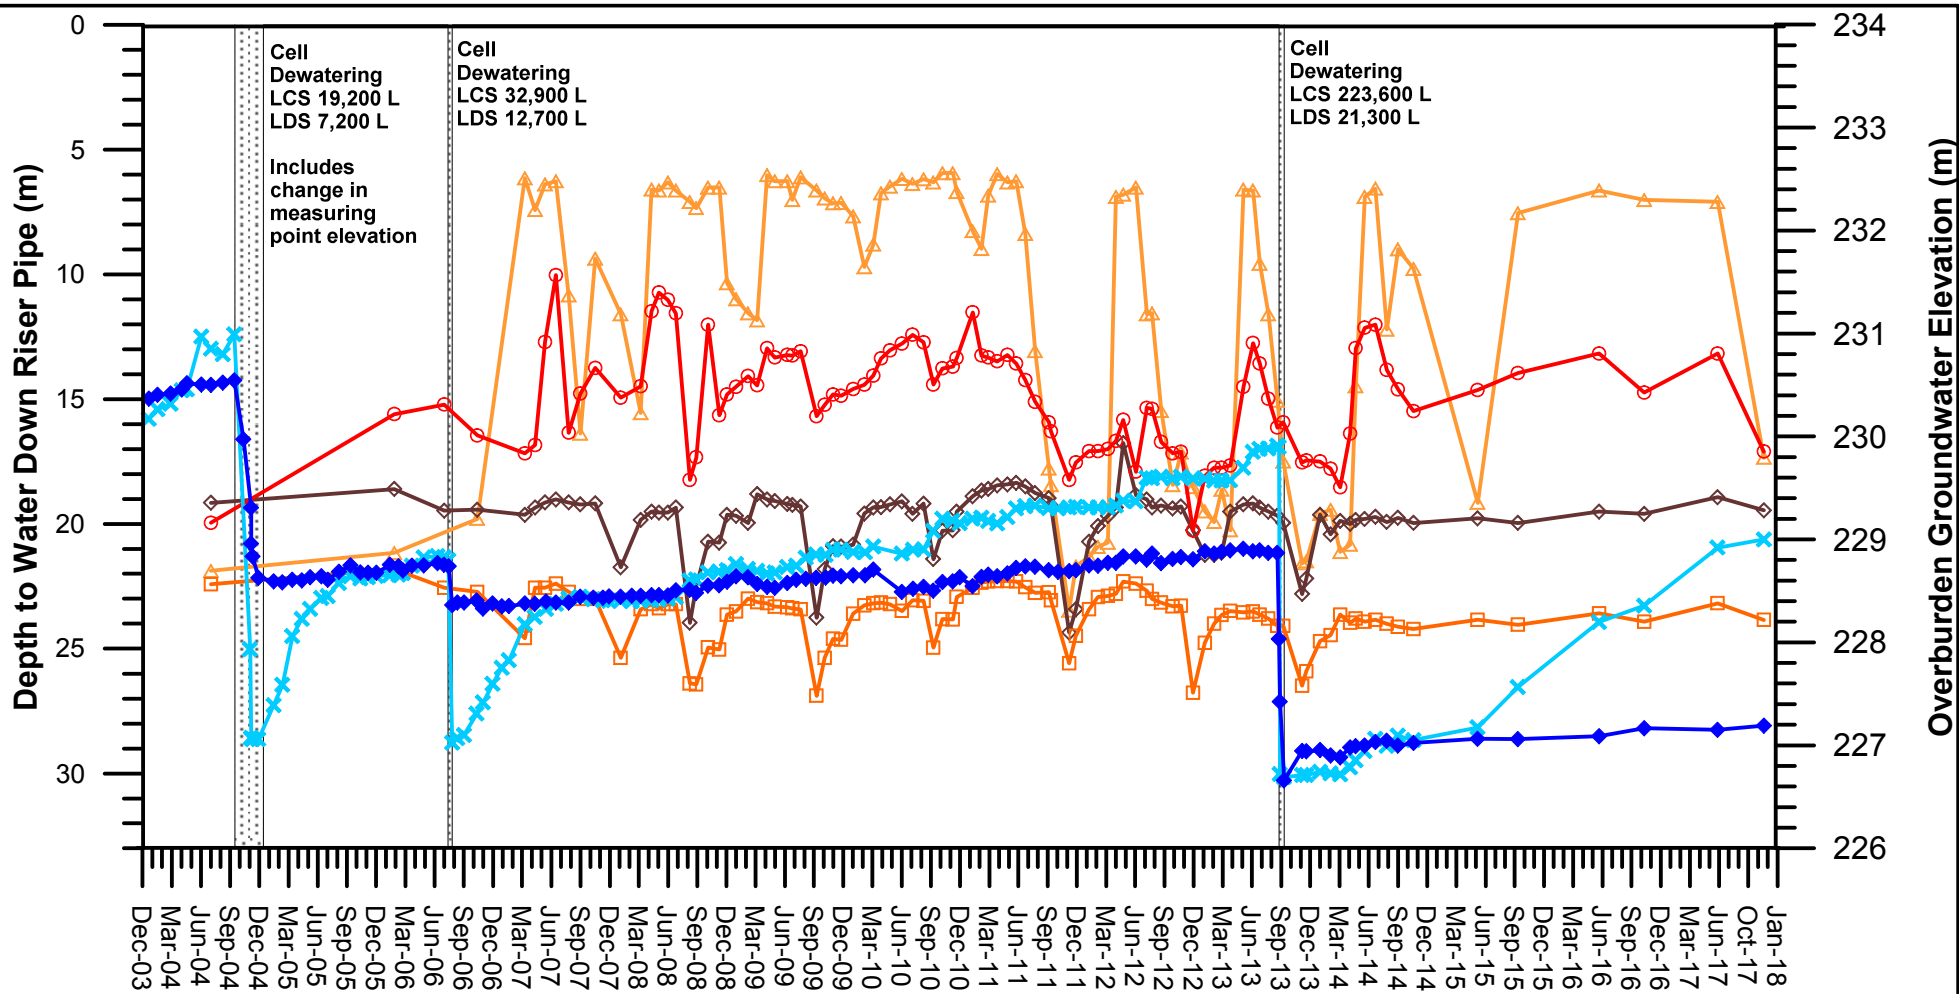
The KGS Group LCS and LDS inspection reports for 2017 are included in Appendix B. For each inspection, the measured distance down the sloped LCS and LDS riser pipes to water was recorded during each visit. Water levels were recorded as the depth to water, from the outer collar, down each LCS/LDS inclined slope pipe on both the north and south sides of the containment cell. The inclined pipes are designed at approximately a 1V:4H decline. The water levels as of November 15, 2017 in the LCS and LDS systems as (measured from the south side pipes) and within the surrounding overburden are displayed on Figure 3.

Since dewatering in 2013, the water level within the LCS has shown a very gradual increase through 2017. The water level within the LCS has increased at approximately 0.06 m/year since dewatering, consistent with the 0.1 m/year rate of increase observed historically. In contrast, the water level in the underlying LDS has shown a greater change. The water level within the LDS showed a distinct increase between September 2013 and November 2017 of 2.3 m vertically (average of 0.57 m/yr). Rapid rises have occurred in the LDS after dewatering in the

The increase in LDS water level observed, which is above the LCS level, demonstrates an inward hydraulic pressure on the cell, protecting against outward migration of leachate. Future monitoring in 2018 will confirm whether the increase observed in the LCS continues at this rate, or whether the water level stabilizes.

As of November 2017, the water levels within the LCS and LDS were generally below the surrounding overburden well water levels measured since 2013 (prior to the previous dewatering event), with the exception the LDS exceeding the level measured at overburden monitoring well 2003-Cell-2. As the LCS water level is still well below surrounding overall groundwater elevations, and the previous level observed in 2013 prior to dewatering of the LCS and LDS, no dewatering is recommended at this time.

No Cell Dewatering Program was conducted in 2017. The last dewatering program was conducted in late 2013. Future dewatering would be recommended if the water level within the LCS reaches a similar level to observed in 2013, prior to the last dewatering event. Currently the water level in the LCS is well below the 2013 and current surrounding overburden levels and thus no dewatering program is recommended at this time.

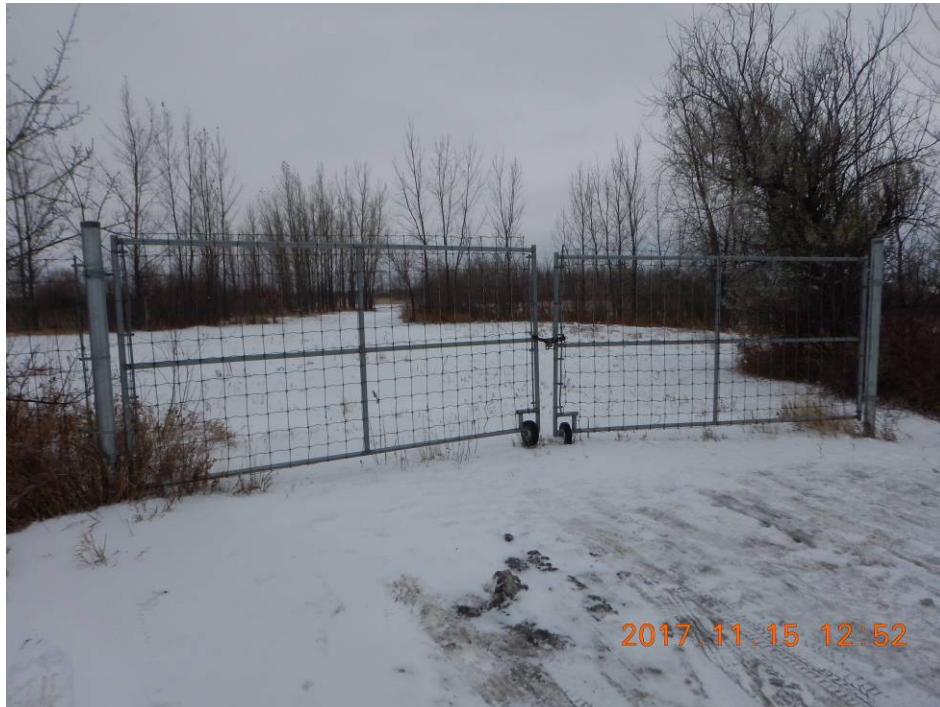
Photo 1 – Gunn Road Access Gate at Entrance to Bioreserve – Locked Upon Arrival

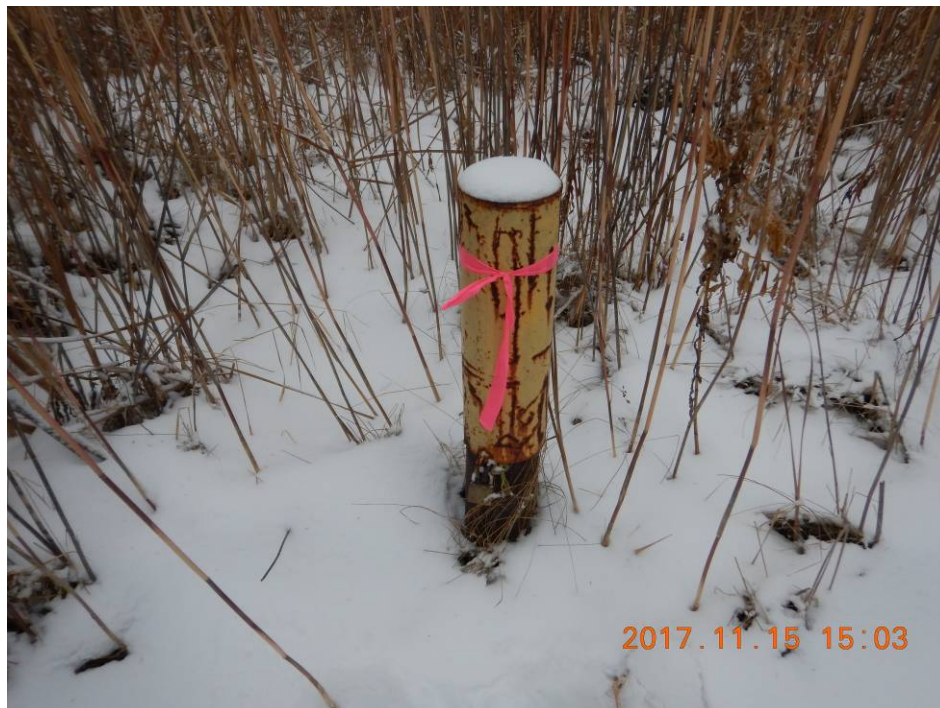
Photo 2 – Well MW1 – Casing Locked and Welded

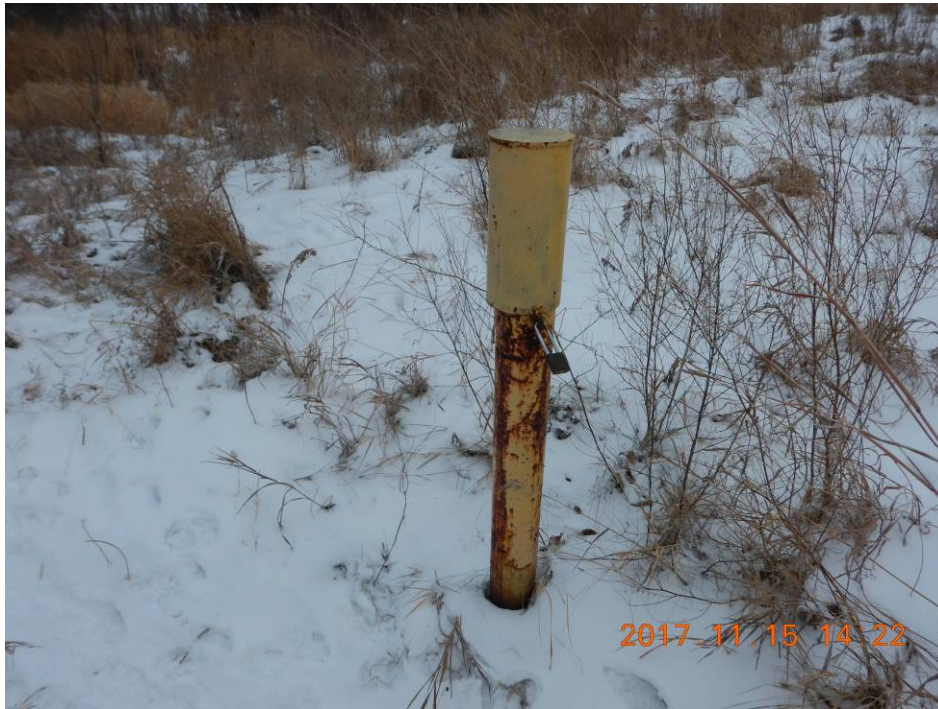
Photo 3 – Well MW2 – Casing Locked and Welded

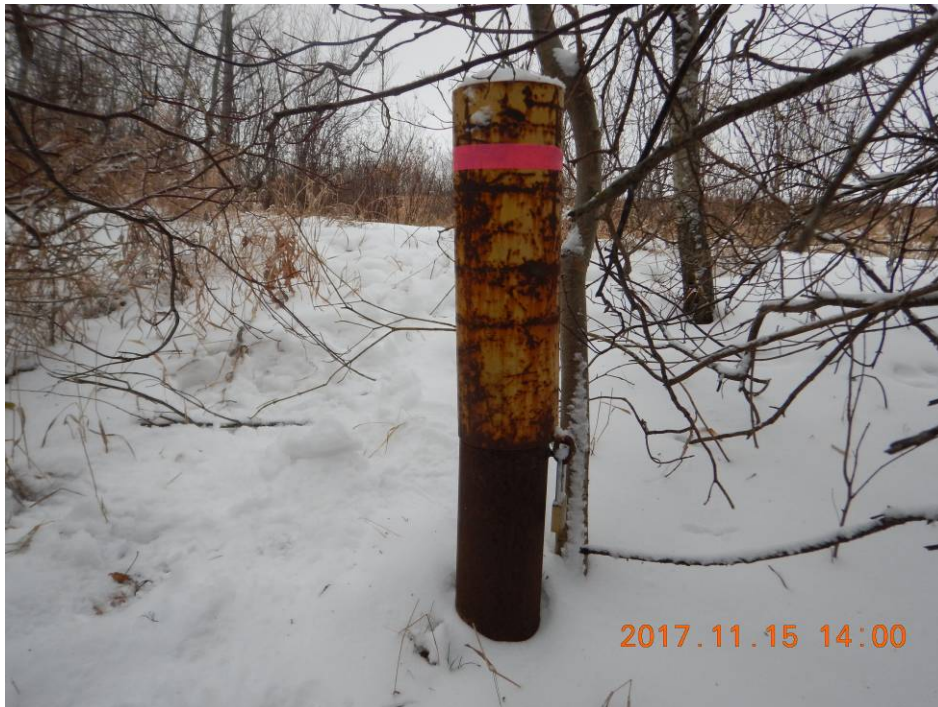
Photo 4 – Well MW3 – Casing Locked

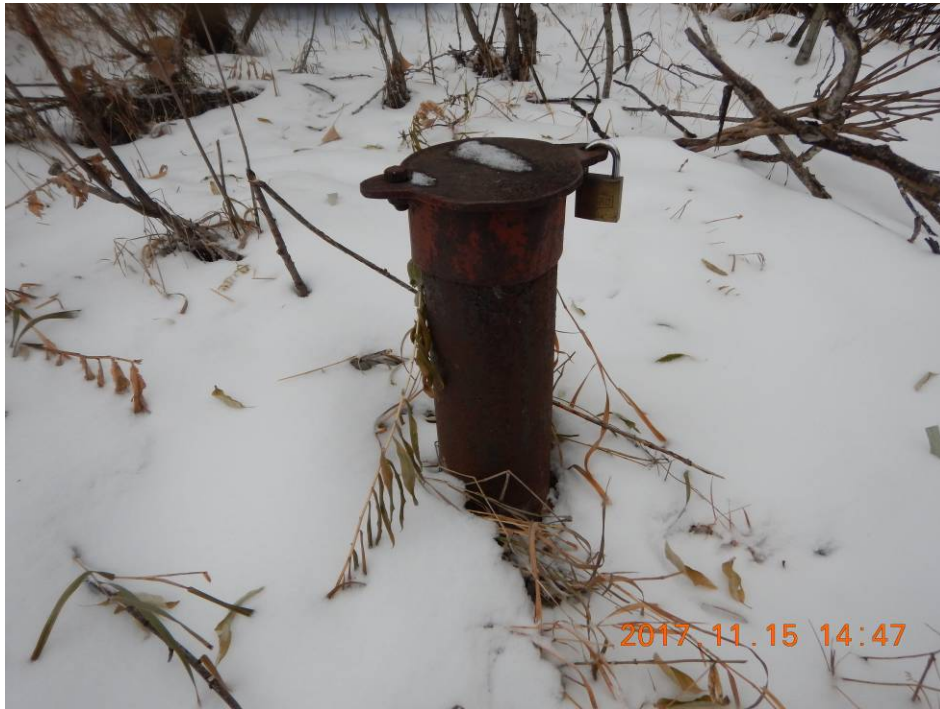
Photo 5 – Well MW4 – Casing Locked

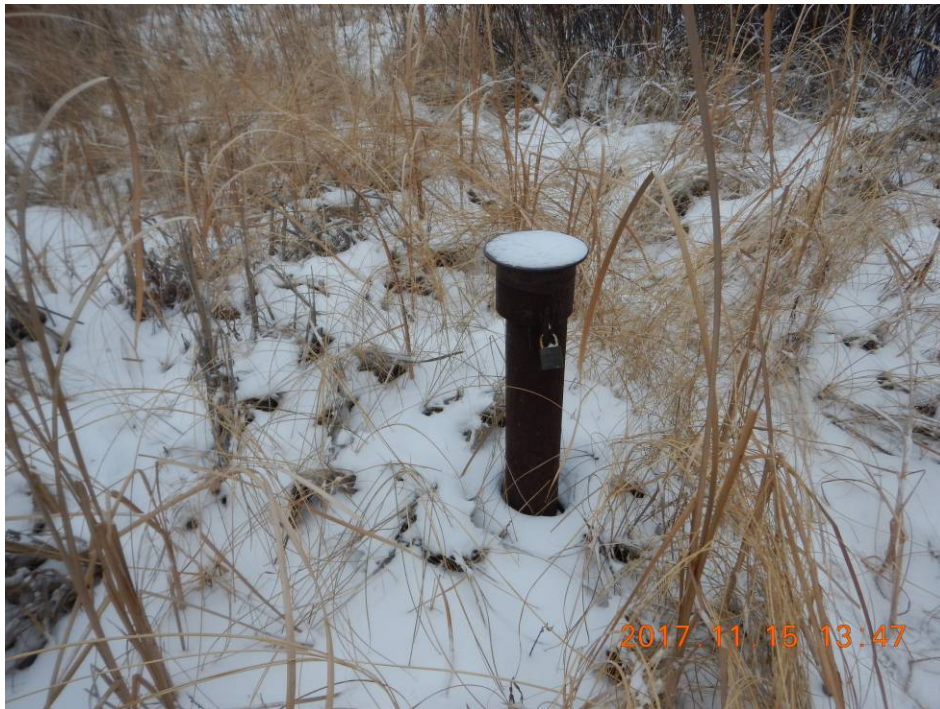
Photo 6 – Well MW6 – Casing Locked

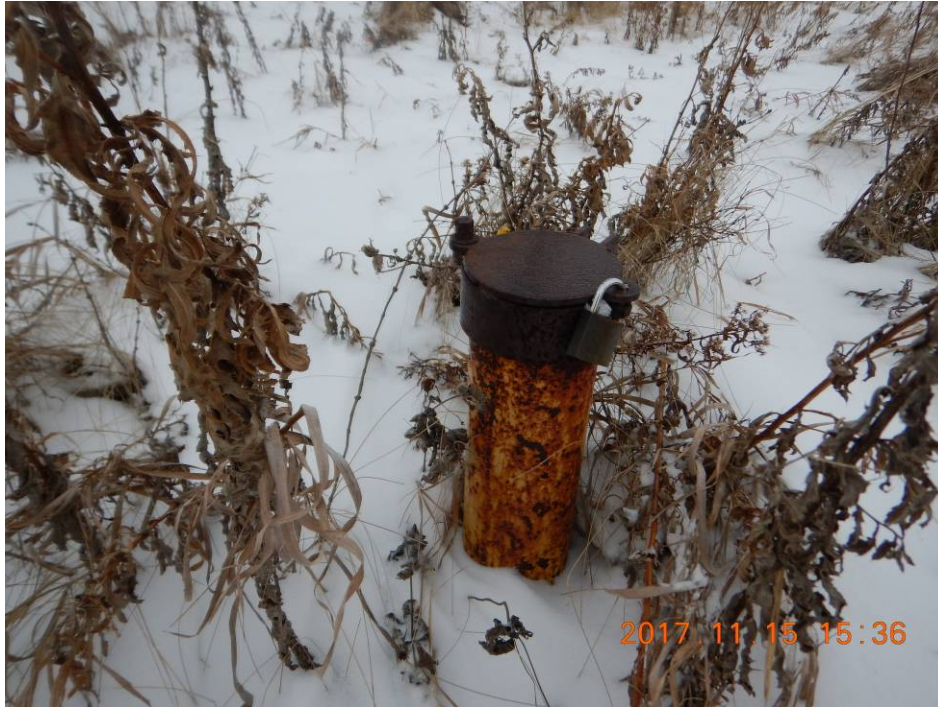
Photo 7 – Well MW7 – Casing Locked and Welded

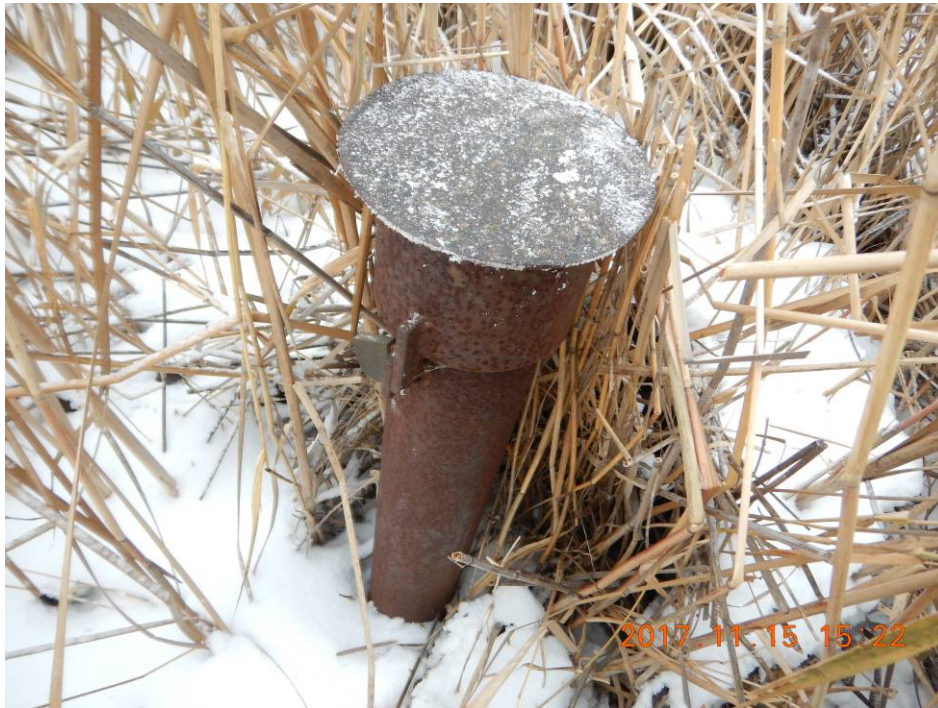
Photo 8 – Well MW8 – Casing Locked and Welded

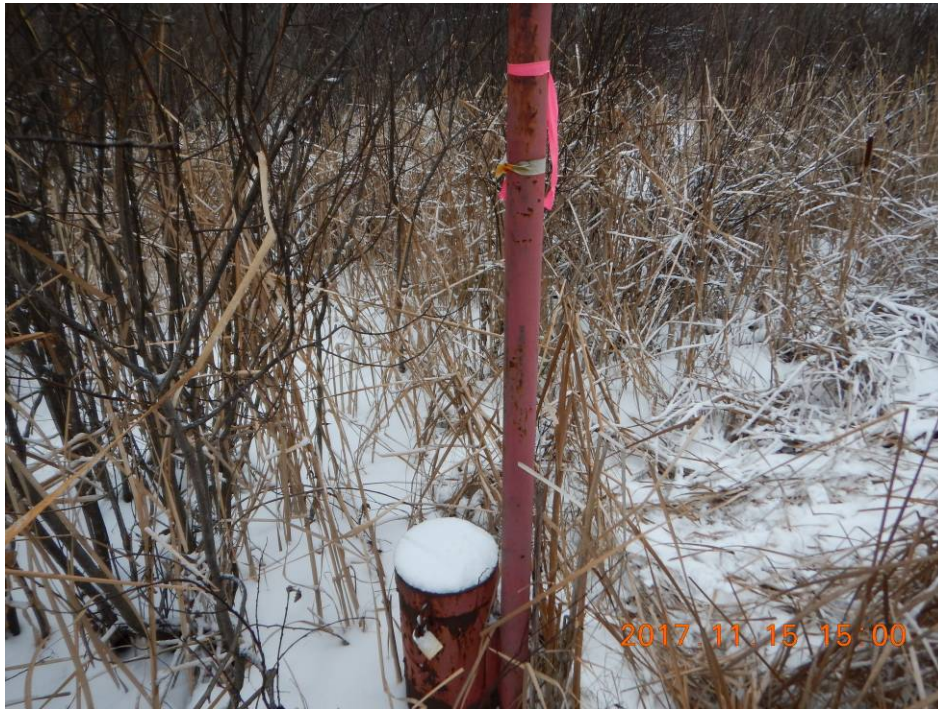
Photo 9 - Well MW9 – Casing Locked and Welded

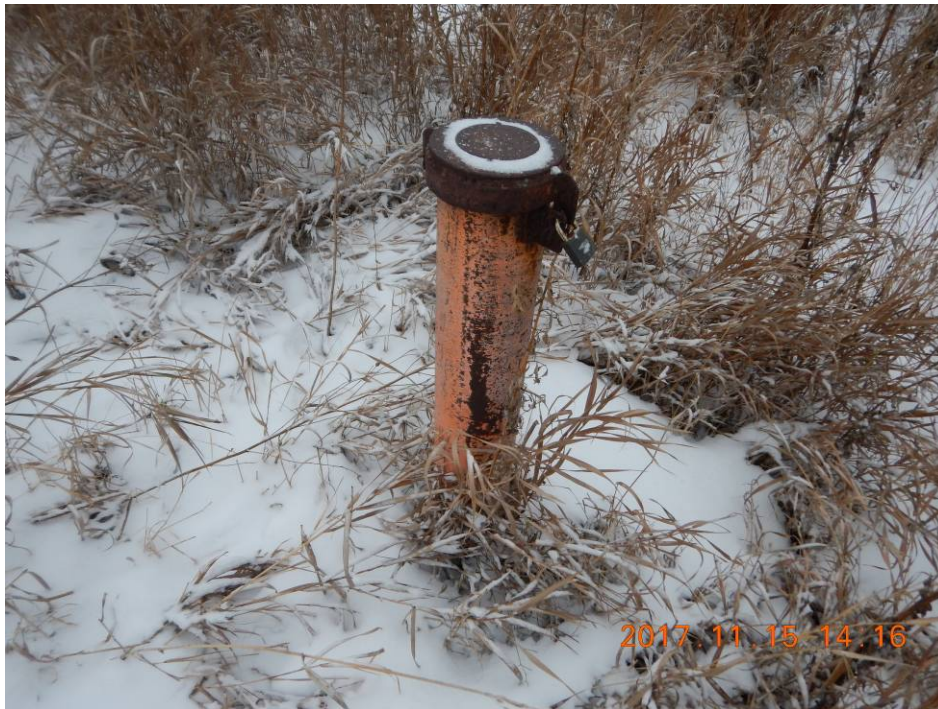
Photo 10 - Well MW10 – Casing Locked

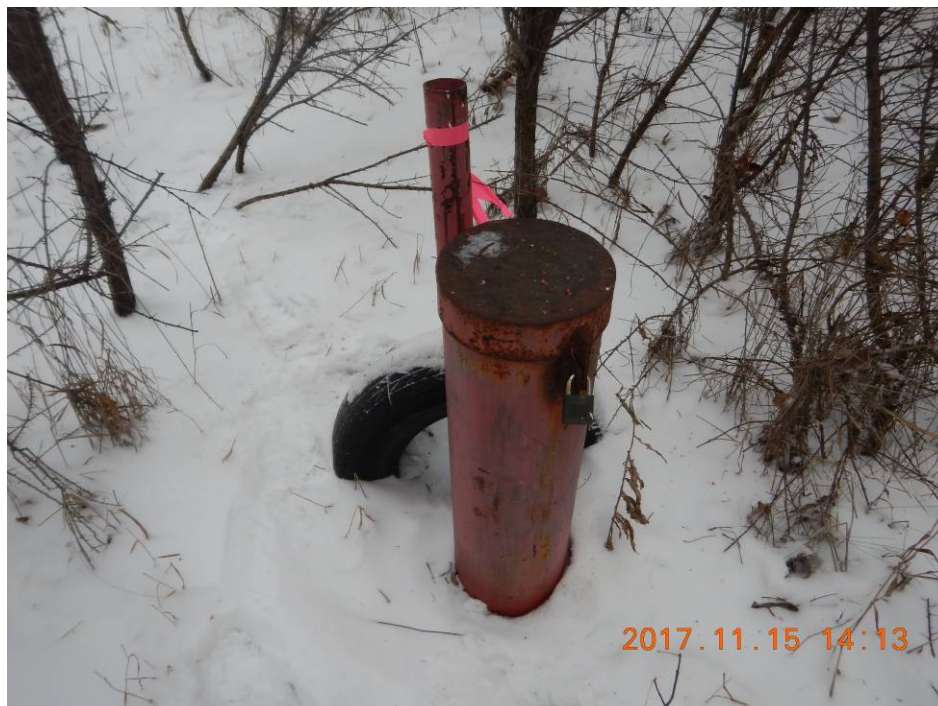
Photo 11 - Well MW11 – Casing Locked

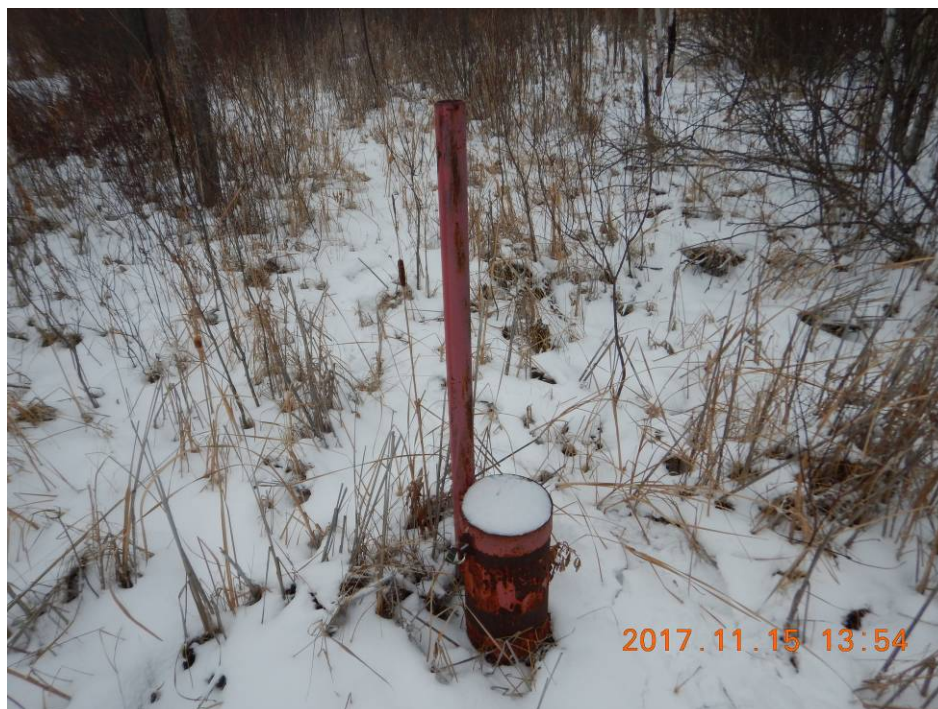
Photo 12 - Well MW12 – Casing Locked

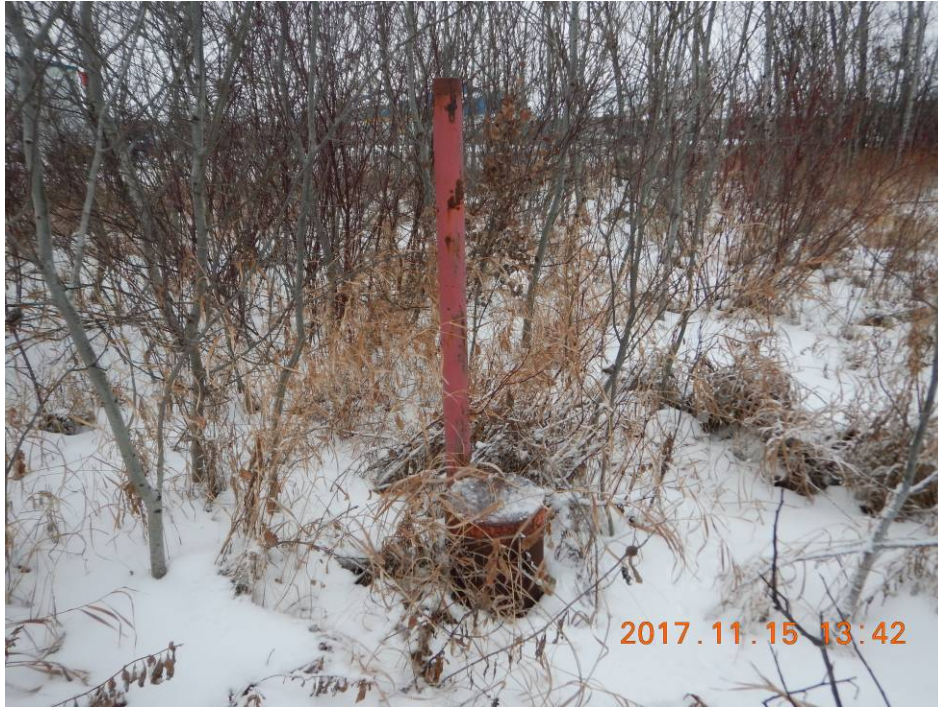
Photo 13 - Well MW13 – Casing Locked

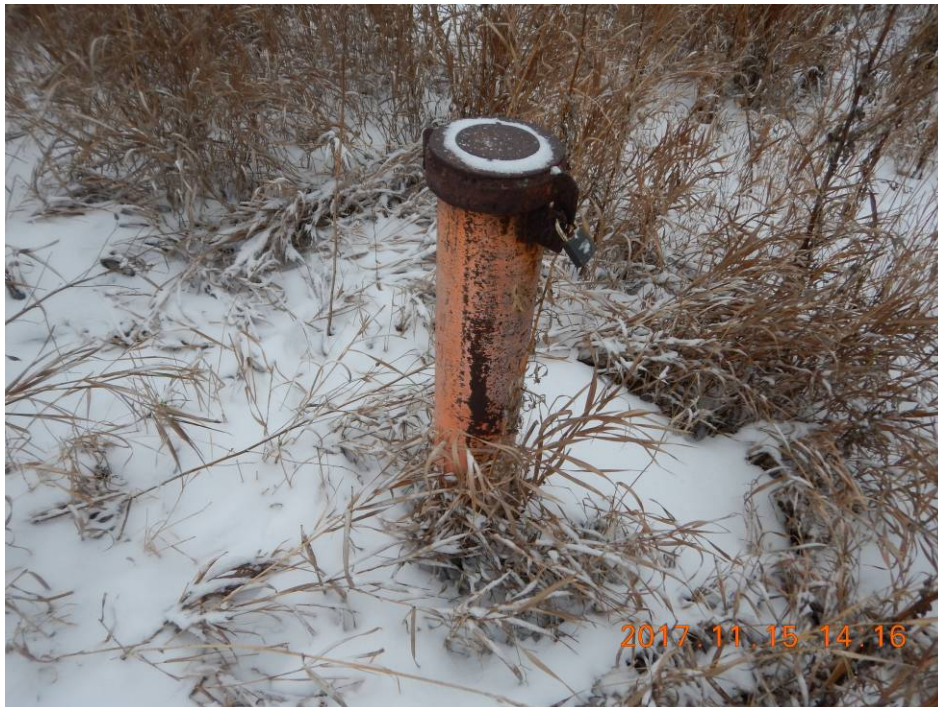
Photo 14 - Well MW14 – Casing Locked and Welded

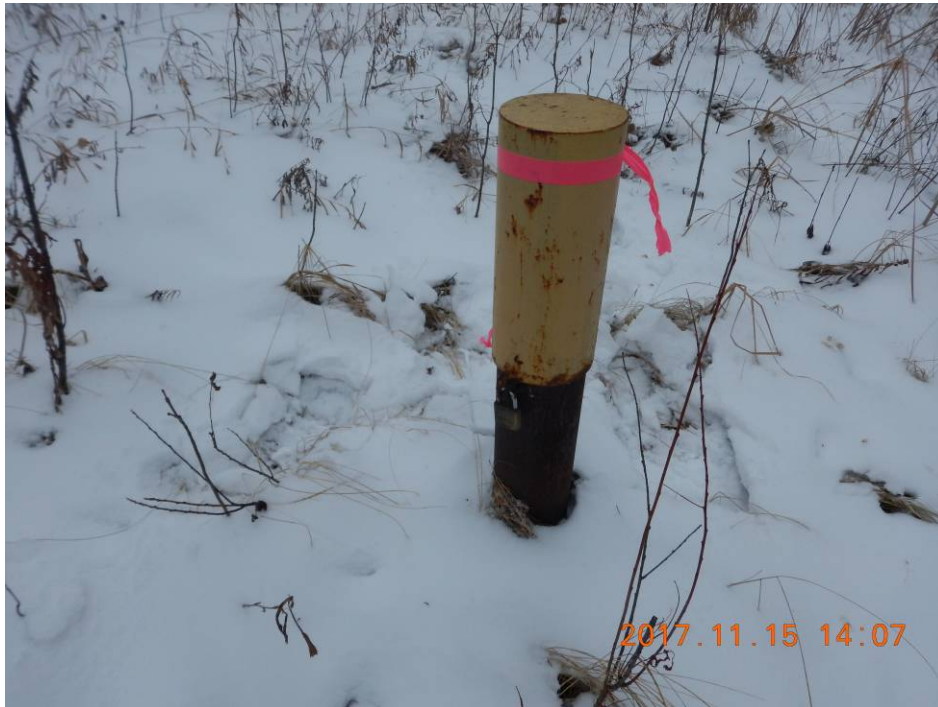
Photo 15 - Well 2000-B1 – Casing Locked

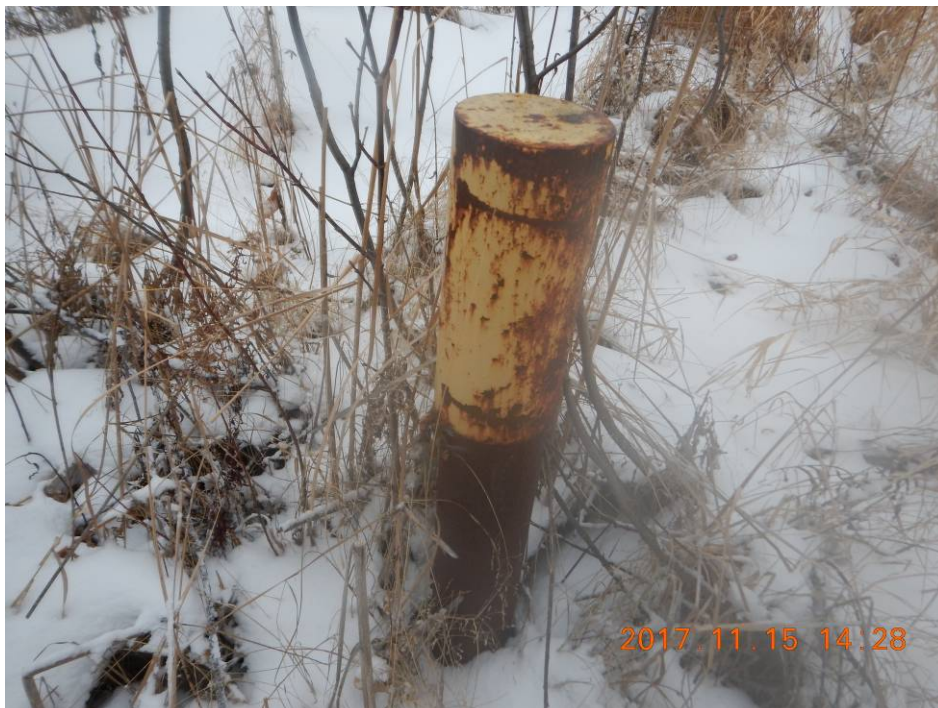
Photo 16 - Well 2000-B2 – Casing Locked

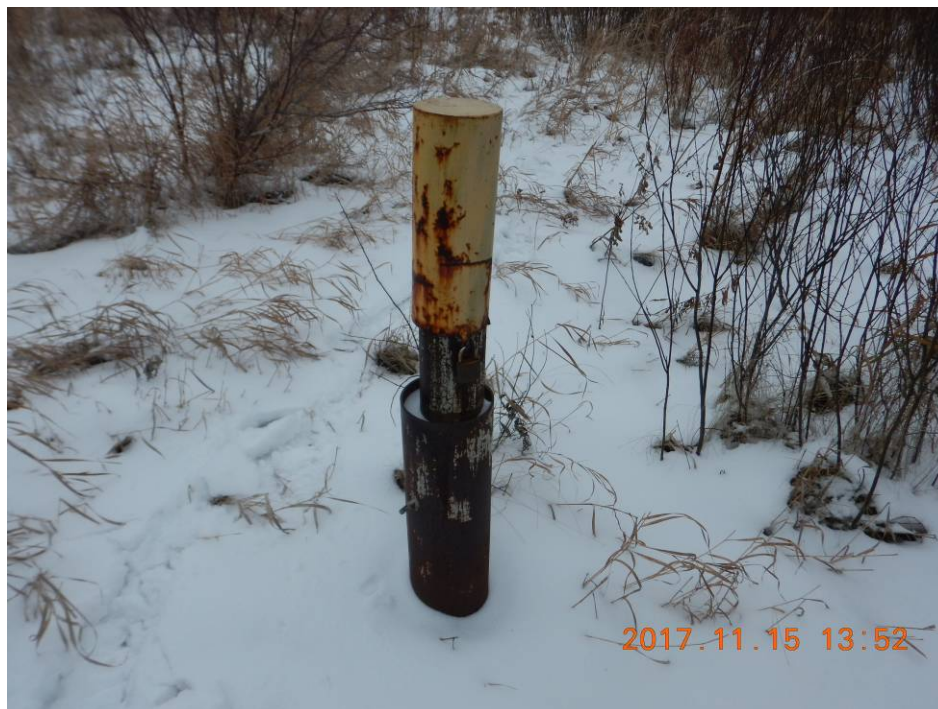
Photo 17 - Well 2000-B3 – Casing Locked and Welded

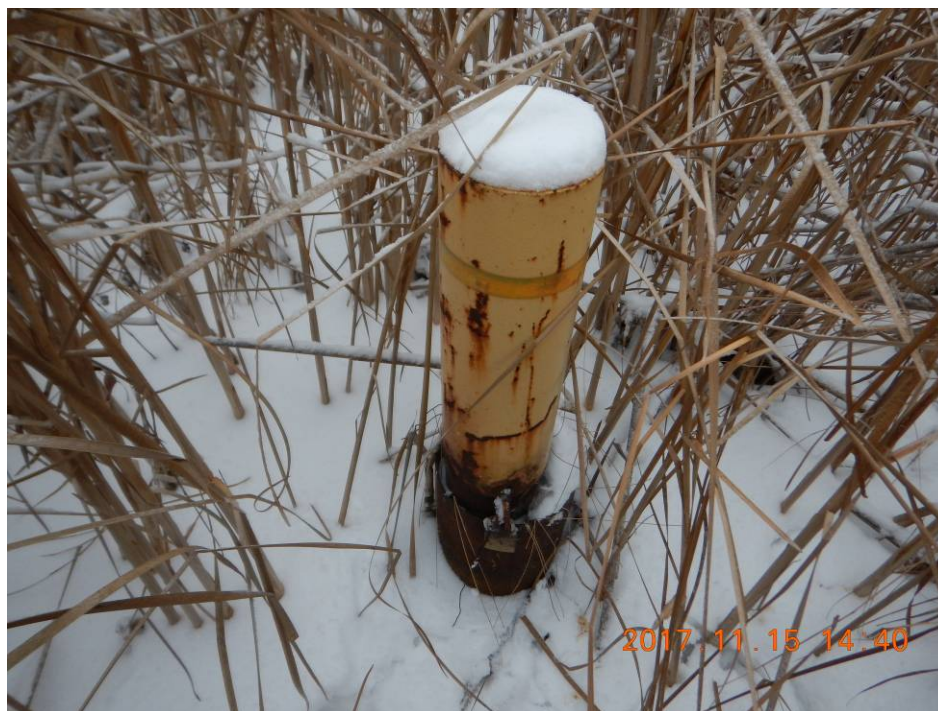
Photo 18 - Well 2000-B4 – Casing Locked and Welded

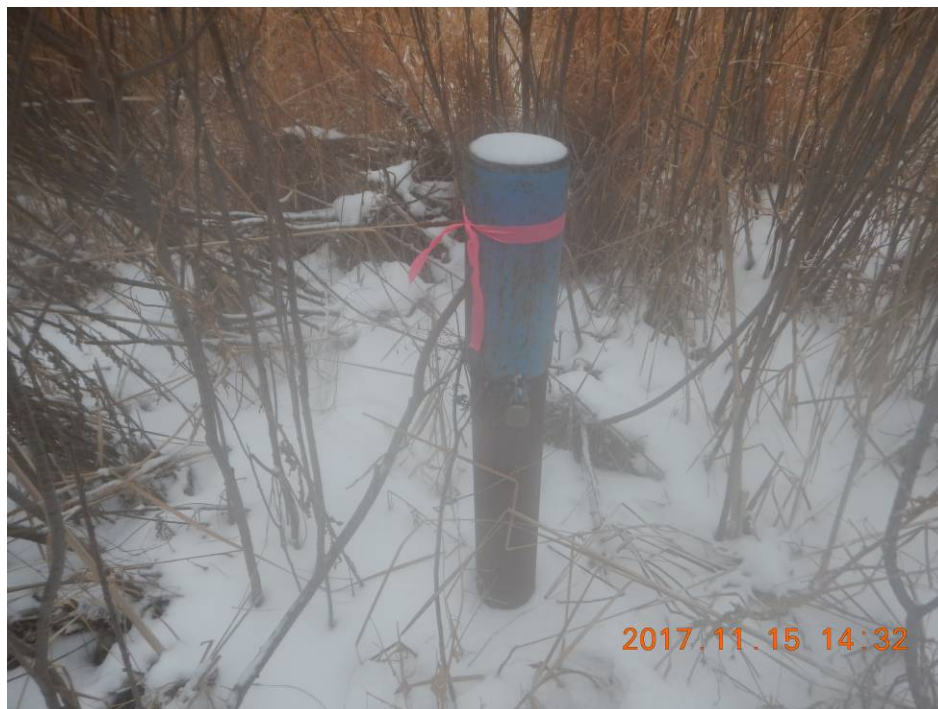
Photo 19 - Well 2002-B5 – Casing Locked and Welded

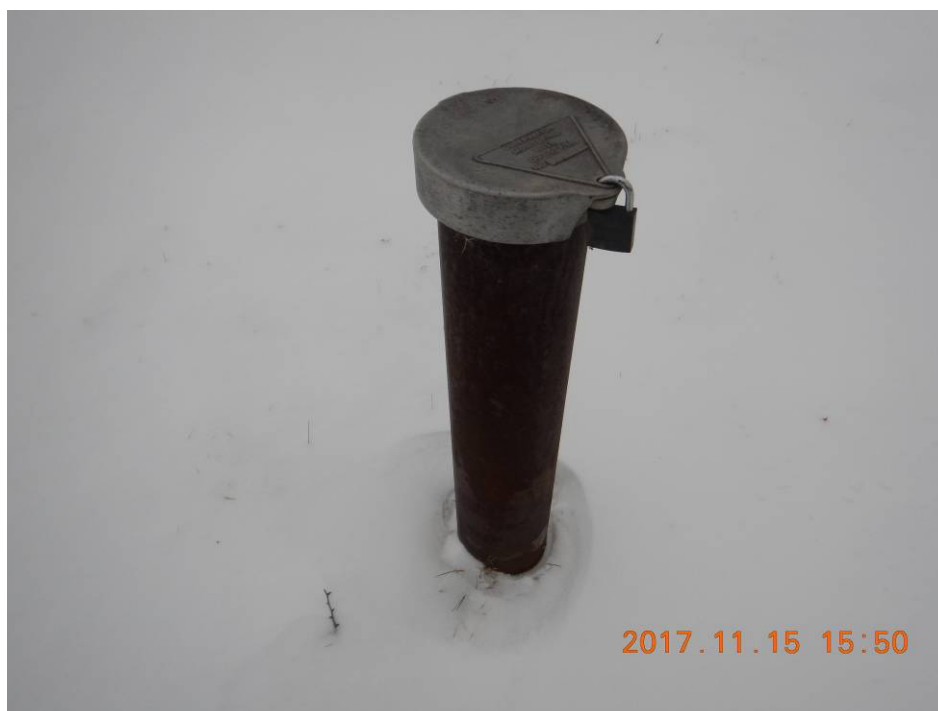
Photo 20 - Well 99-B1 – Casing Locked

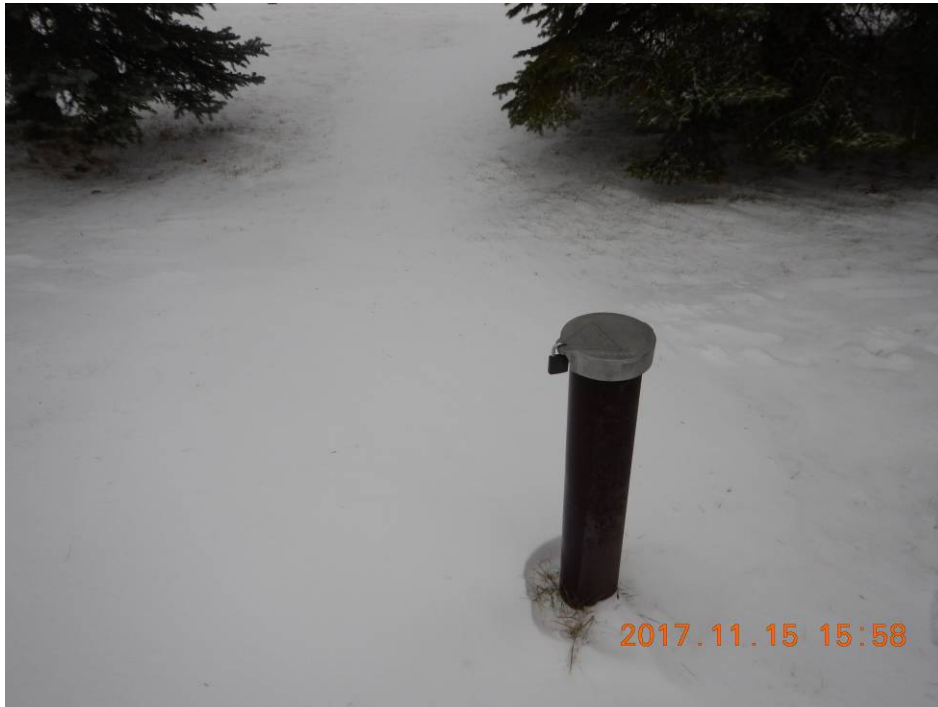
Photo 21 – Well 99-B2 – Casing Locked

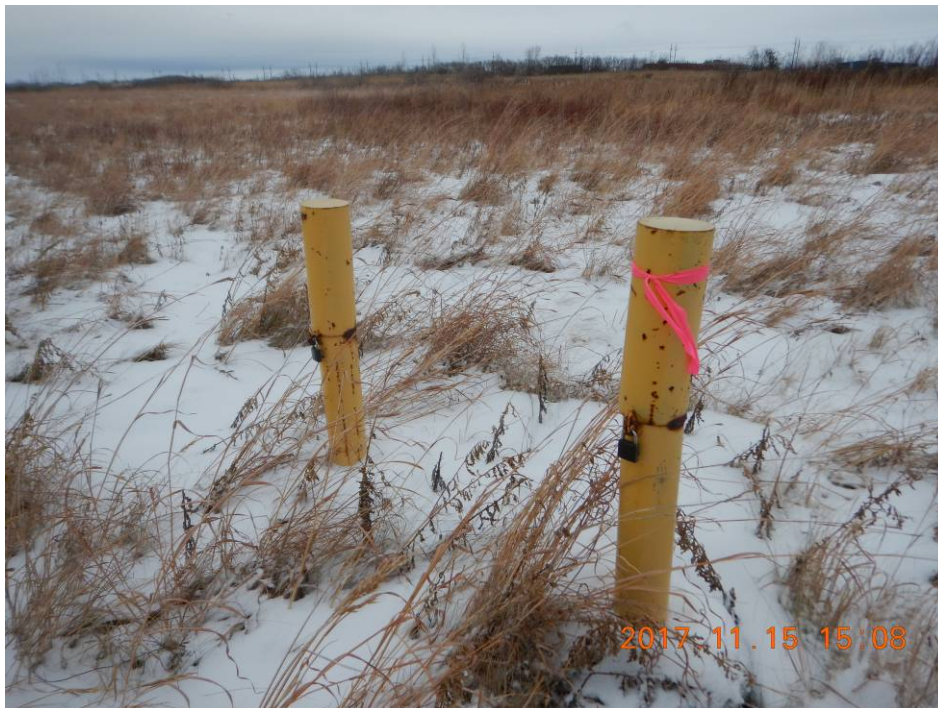
Photo 22 - Wells 99-1S and 99-1D – Casings Locked and Welded

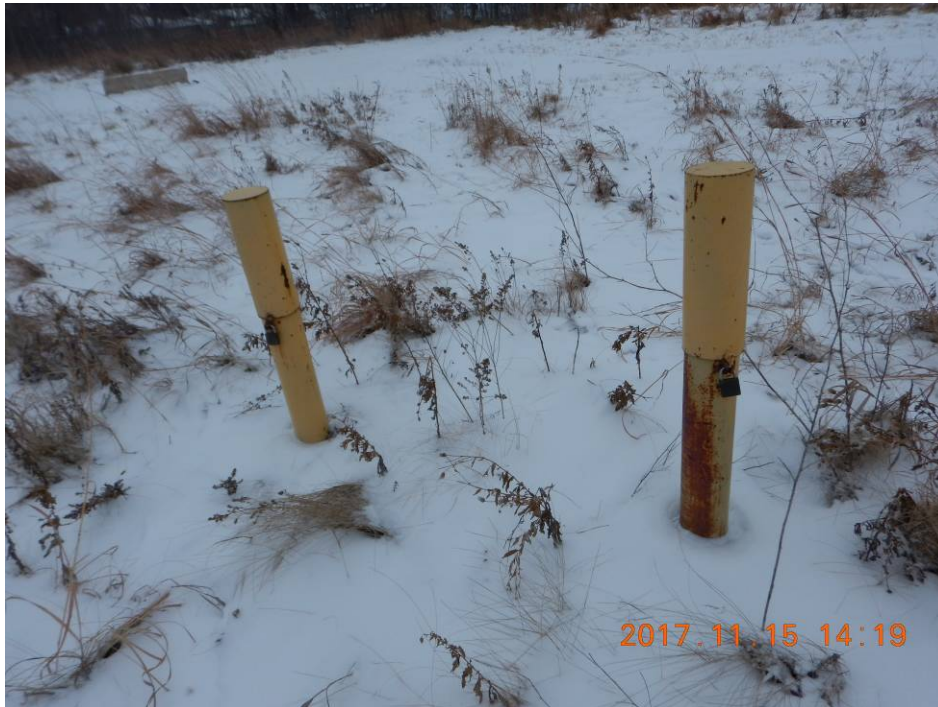
Photo 23 - Wells 99-2S and 99-2D – Casings Locked and Welded

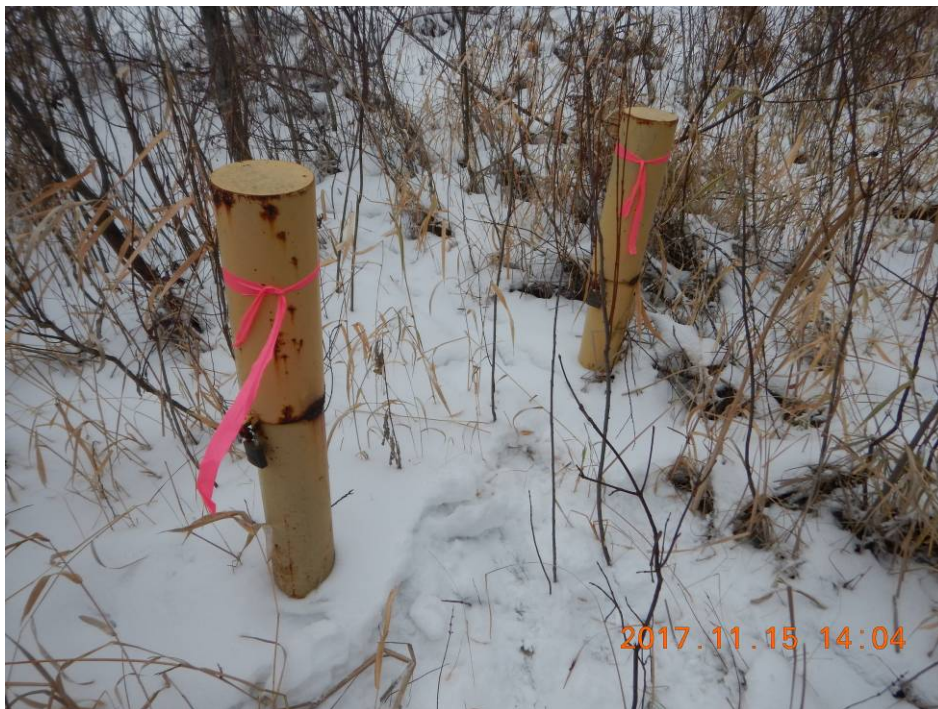
Photo 24 - Wells 99-3S and 99-3D – Casings Locked and Welded

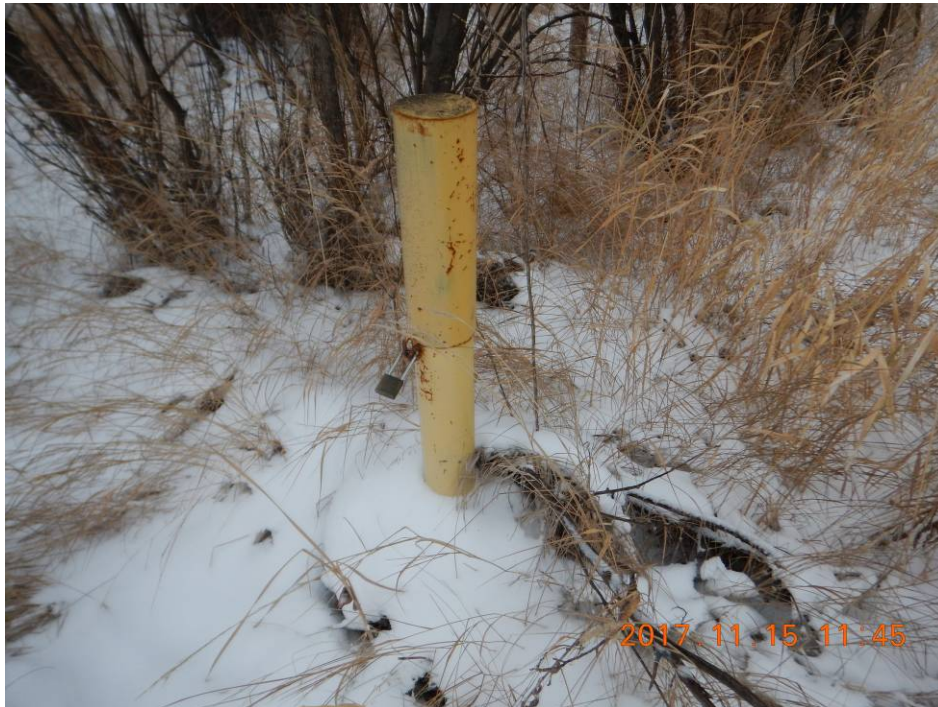
Photo 25 - Well 99-Cell-1 – Casing Locked

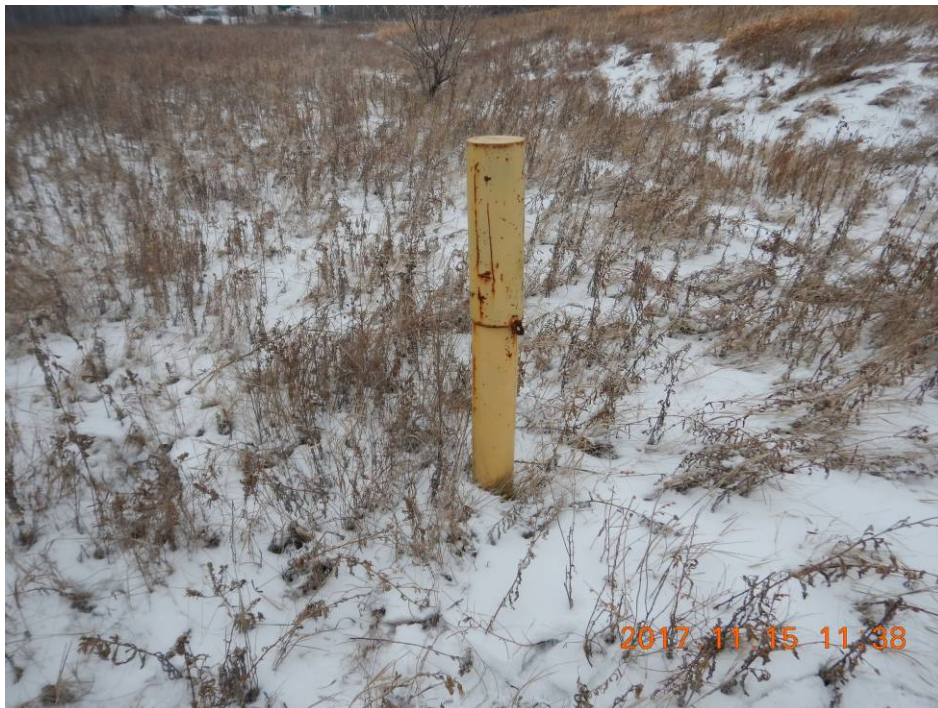
Photo 26 - Well 2003-Cell-2 – Casing Locked

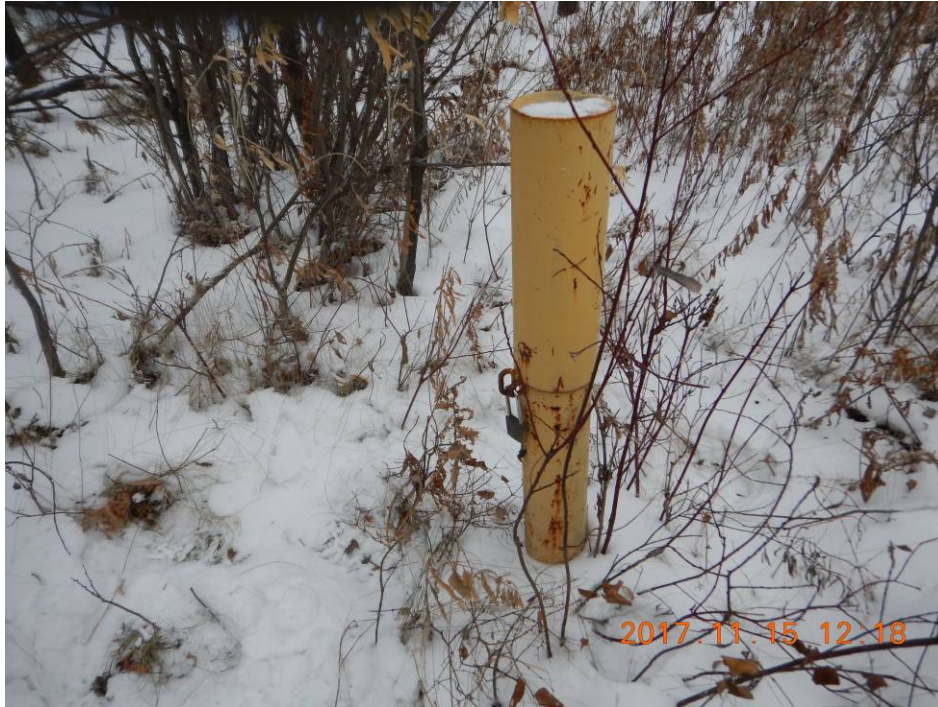
Photo 27 – Well 99-Cell-3 – Casing Locked

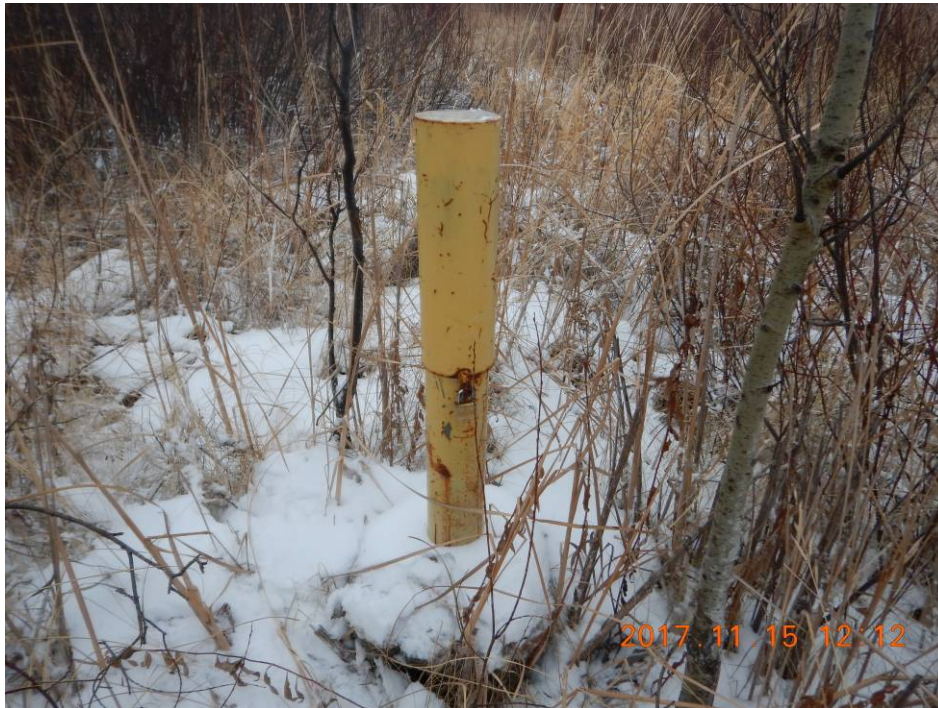
Photo 28 – Well 99-Cell-4 – Casing Locked

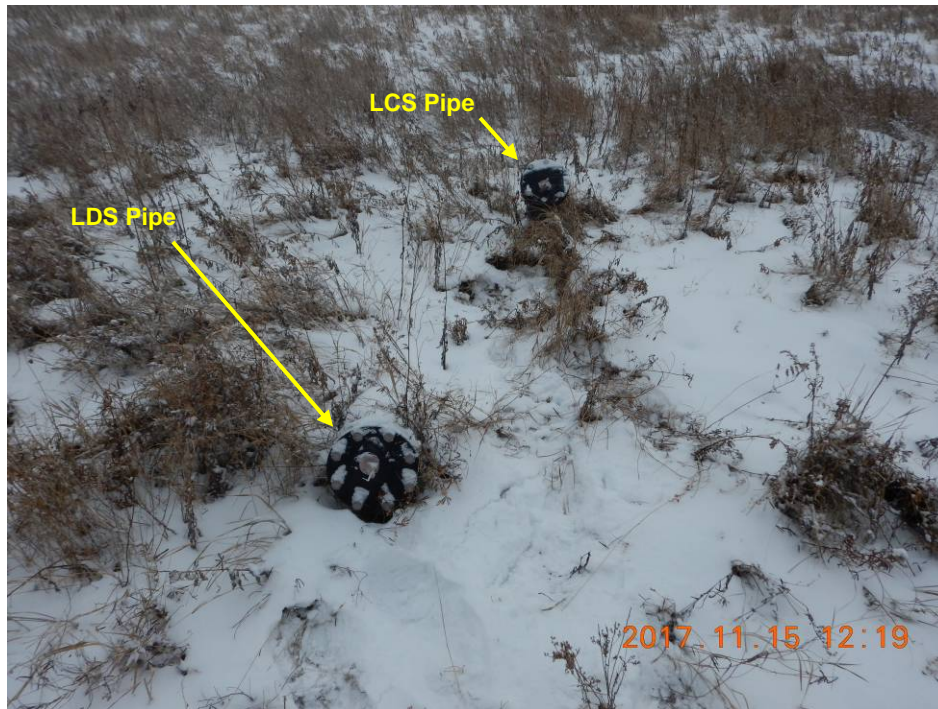
Photo 29 – Leachate Collection and Leakage Detection System (LCS and LDS) Access Pipes North Side – Locked and Secure

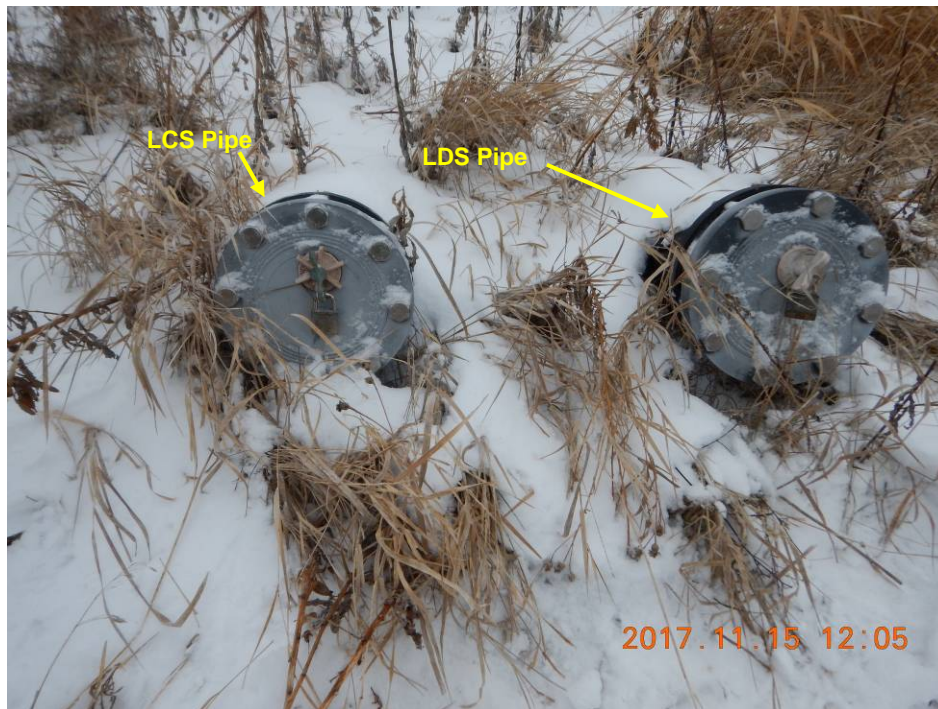
Photo 30 – Leachate Collection and Leakage Detection System (LCS and LDS) Access Pipes South Side – Locked and Secure
