**2017 ANNUAL SITE SUMMARY REPORT
DOMTAR TRANSCONA FORMER CREOSOTE SITE
WINNIPEG, MANITOBA**

KGS Group 17-0953-001
March 2018

RE: 2017 Annual Site Summary Report
Domtar Transcona Former Creosote Site
Winnipeg, Manitoba – Final Report

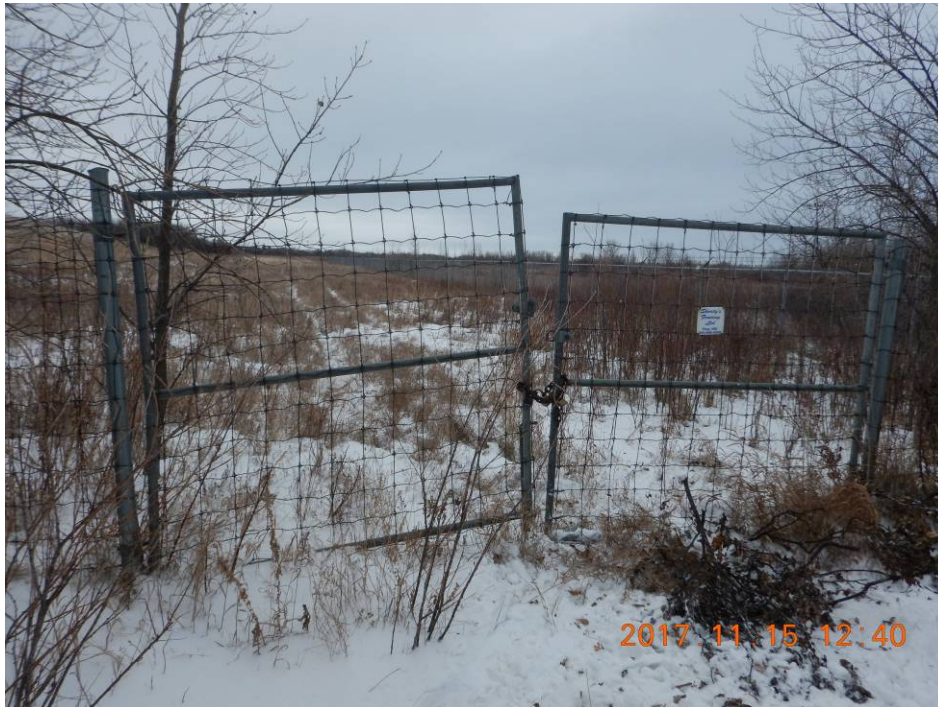
Photo 31 – Containment Cell Area Entrance Gate – Locked at Completion of Cell Inspection
