NEW JERSEY DEPARTMENT OF ENVIRONMENTAL PROTECTION AND ENERGY
DIVISION OF RESPONSIBLE PARTY SITE REMEDIATION
DISCHARGE RESPONSE ELEMENT

ADMINISTRATIVE COST RECOVERY
ENFORCEMENT REFERRAL

RE: ROLLINS TERMINAL INC. 9012241045 PKB
Case name Incident # PAC

ROLLINS TERMINAL, FOOT OF E. 2nd ST., BAYONNE Block 54D/52B, 52C4 0901
Location of Violation Block and Lot Cty/Mun Code

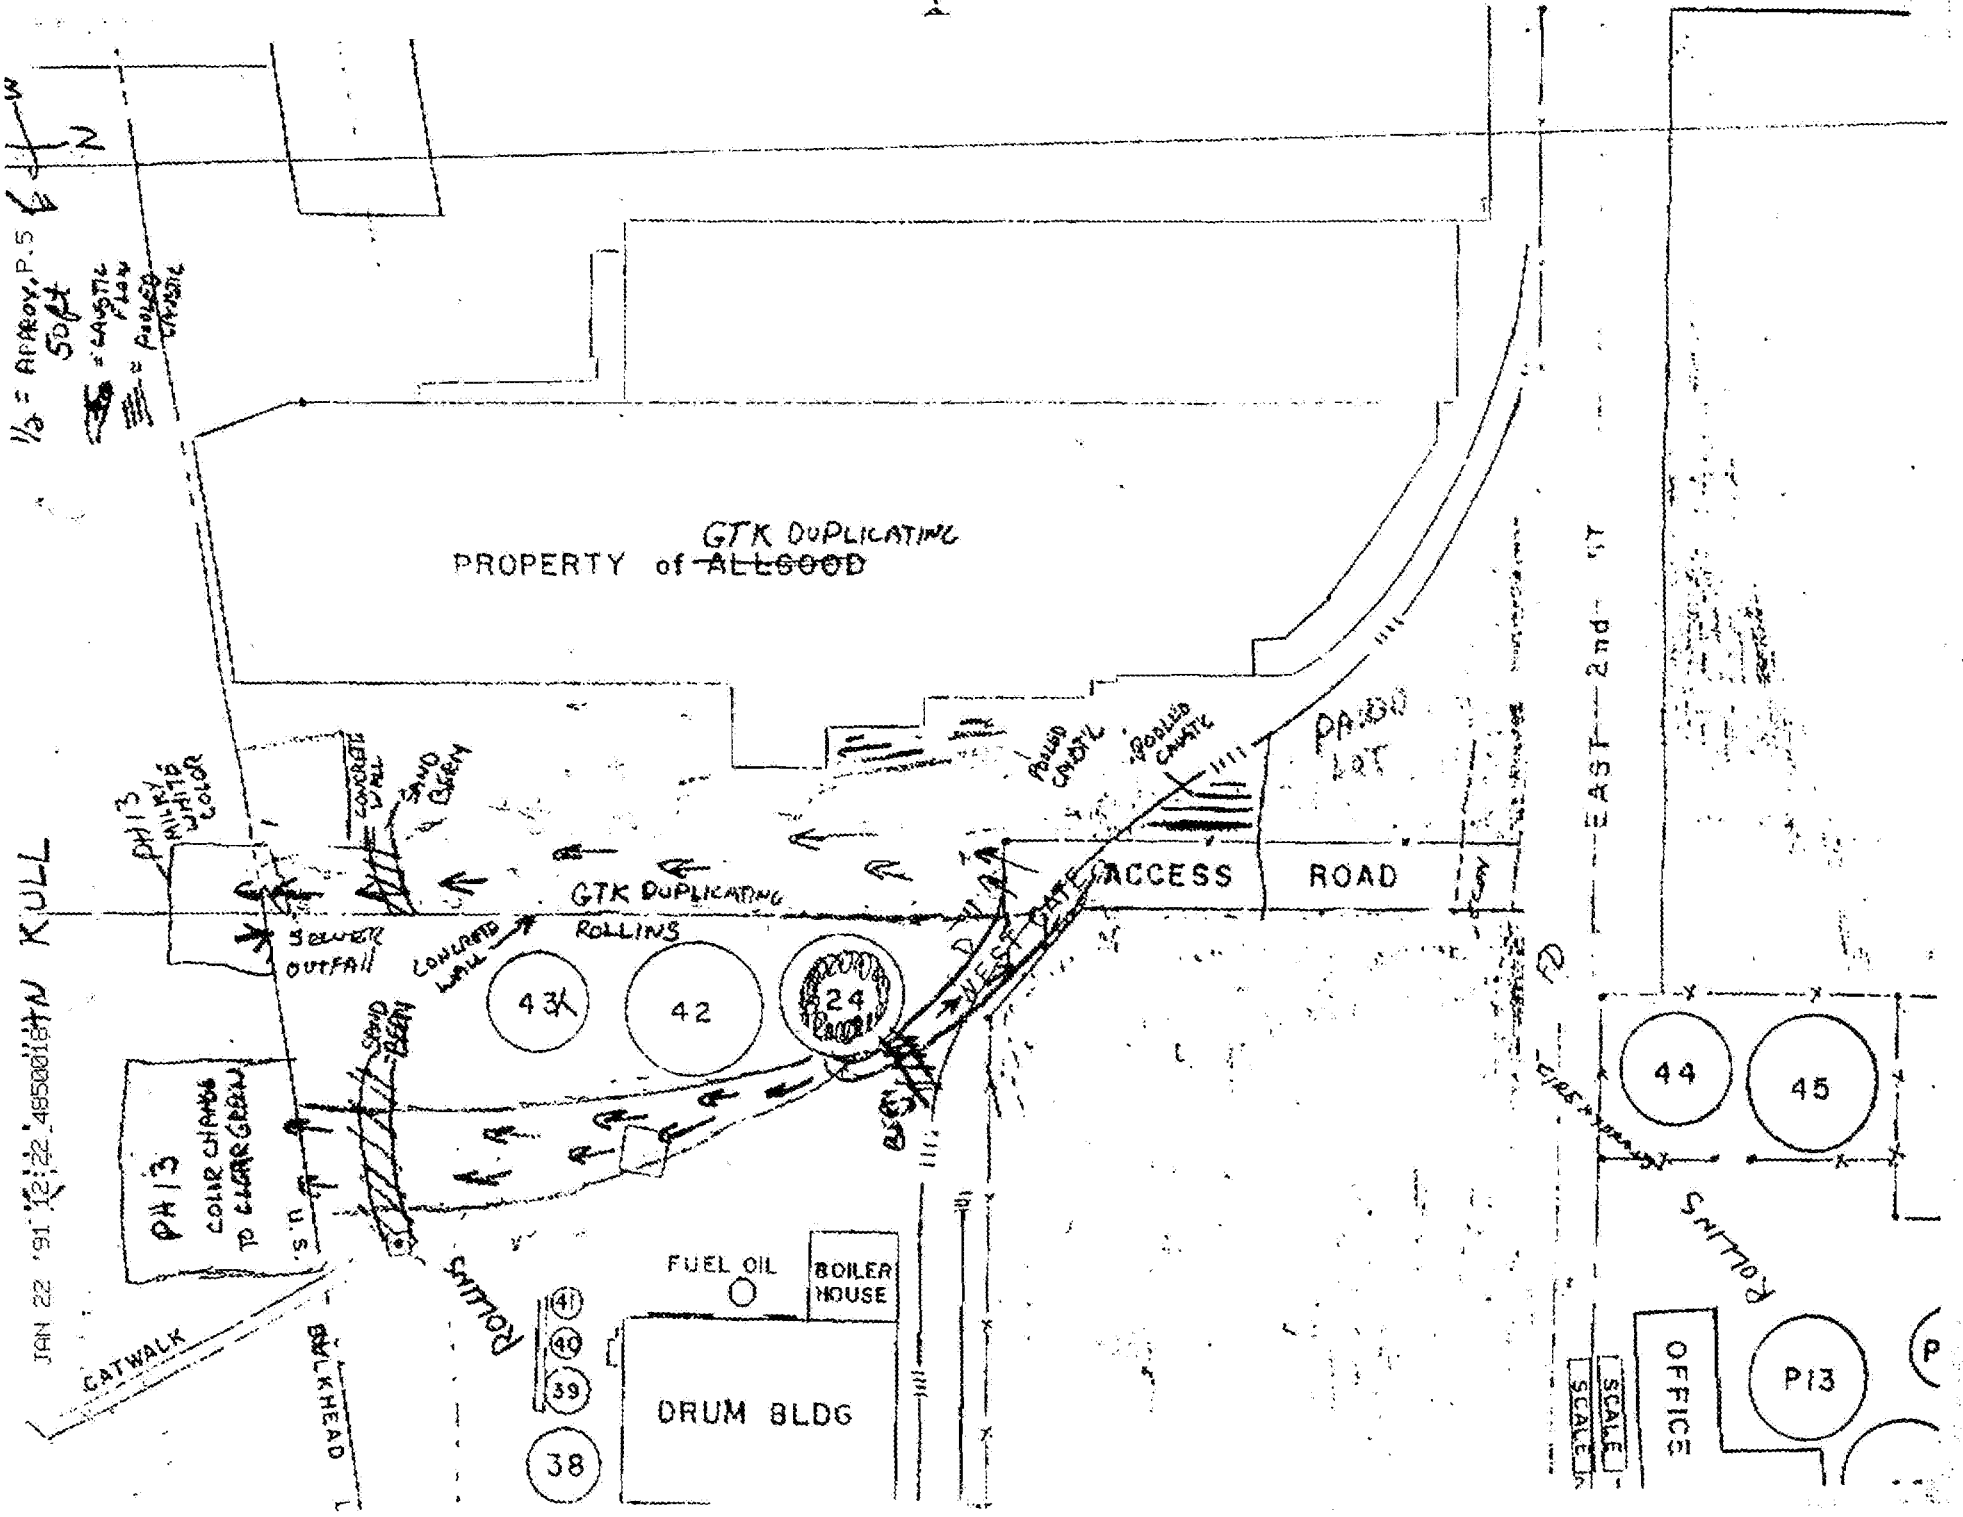
JAN 22 '91 12:22 48500147M KULL

A spill of 547,000 gallons of 50% caustic solution resulted from a rupture in the bottom welded seam of tank #24 at the Rollins facility. The tanks last internal visual inspection was reported to be in 1983. It is not known when the vessel was last 'sonically' tested.

Large quantities of material entered the Kill Van Kull resulting in significant PH change in areas adjacent to the Rollins bulkhead. No fish kill was noted at this time.

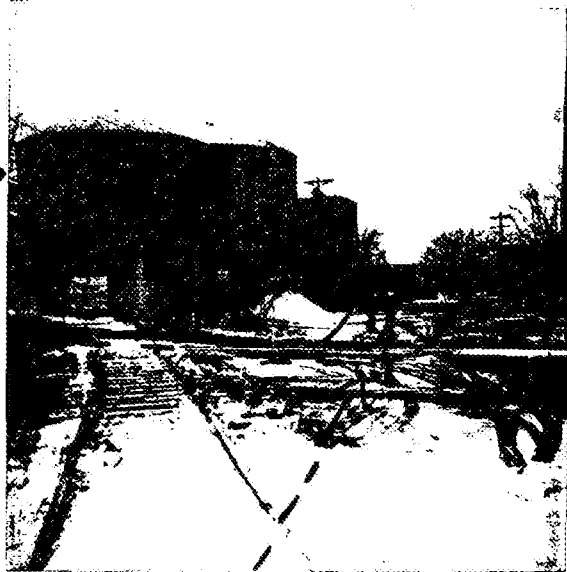
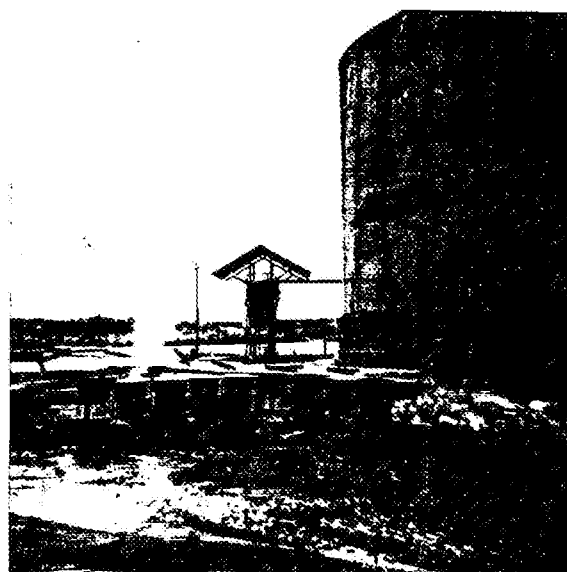
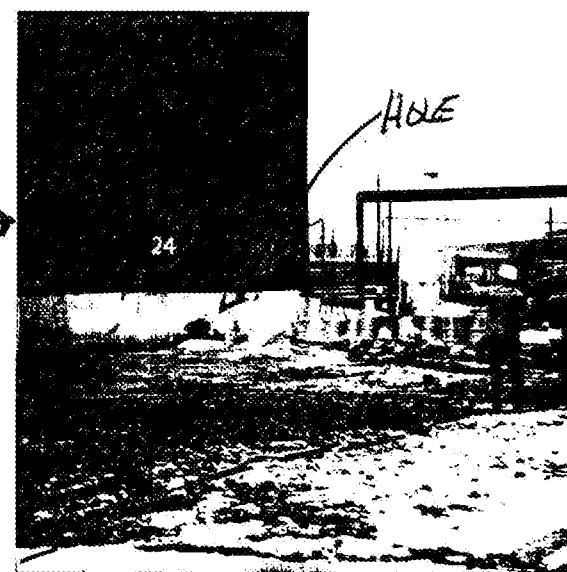
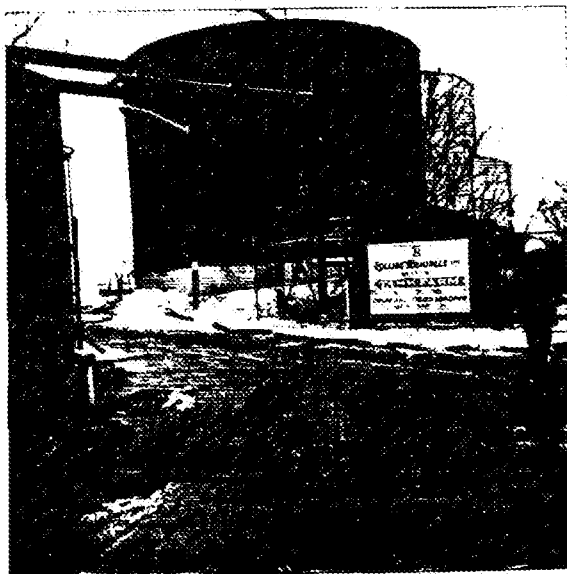
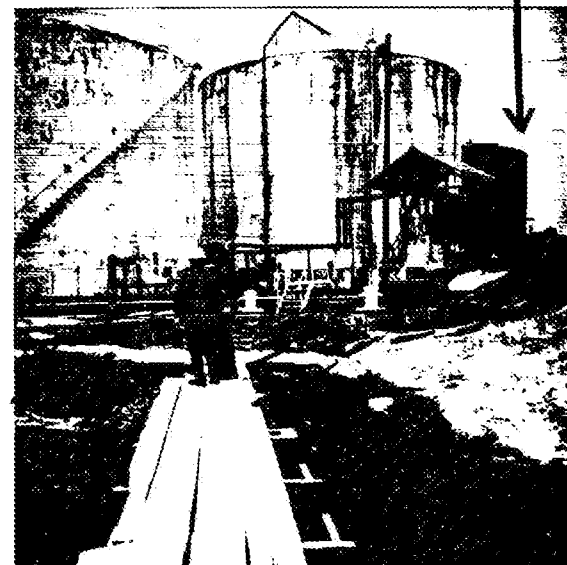
87-119
AFFECTED TANK
- SPILL AREA

There were two large black above ground storage tanks in a berm area, but one was identified as leaking. The liquid could be observed coming from underneath and leaching through the bottom seams of the tank. A check of the liquid revealed that it had the same ph as the river, and exiting the vessel at an alarming rate. There was a berm around the tank but, through visual inspection, the berm would not be sufficient in the event of total failure of the tank. The ground around the tank had the same ph as did the river and the liquid. The marine police officers secured the scene to have the owner of the property respond. Still checking around the tank area it was observed that the flow of liquid getting greater. It became obvious that the liquid was causing material failure of the tank. A drain in the middle of the dike area was filled with the liquid and made it's way into the river.
