Tennessee Valley Authority, Post Office Box 2000, Spring City, Tennessee 37381-2000

John A. Scalice  
Site Vice President, Watts Bar Nuclear Plant

WATTS BAR NUCLEAR PLANT (WBN) - RADIATION MONITORING SYSTEM  
ASSESSMENT, SUPPLEMENTAL INFORMATION

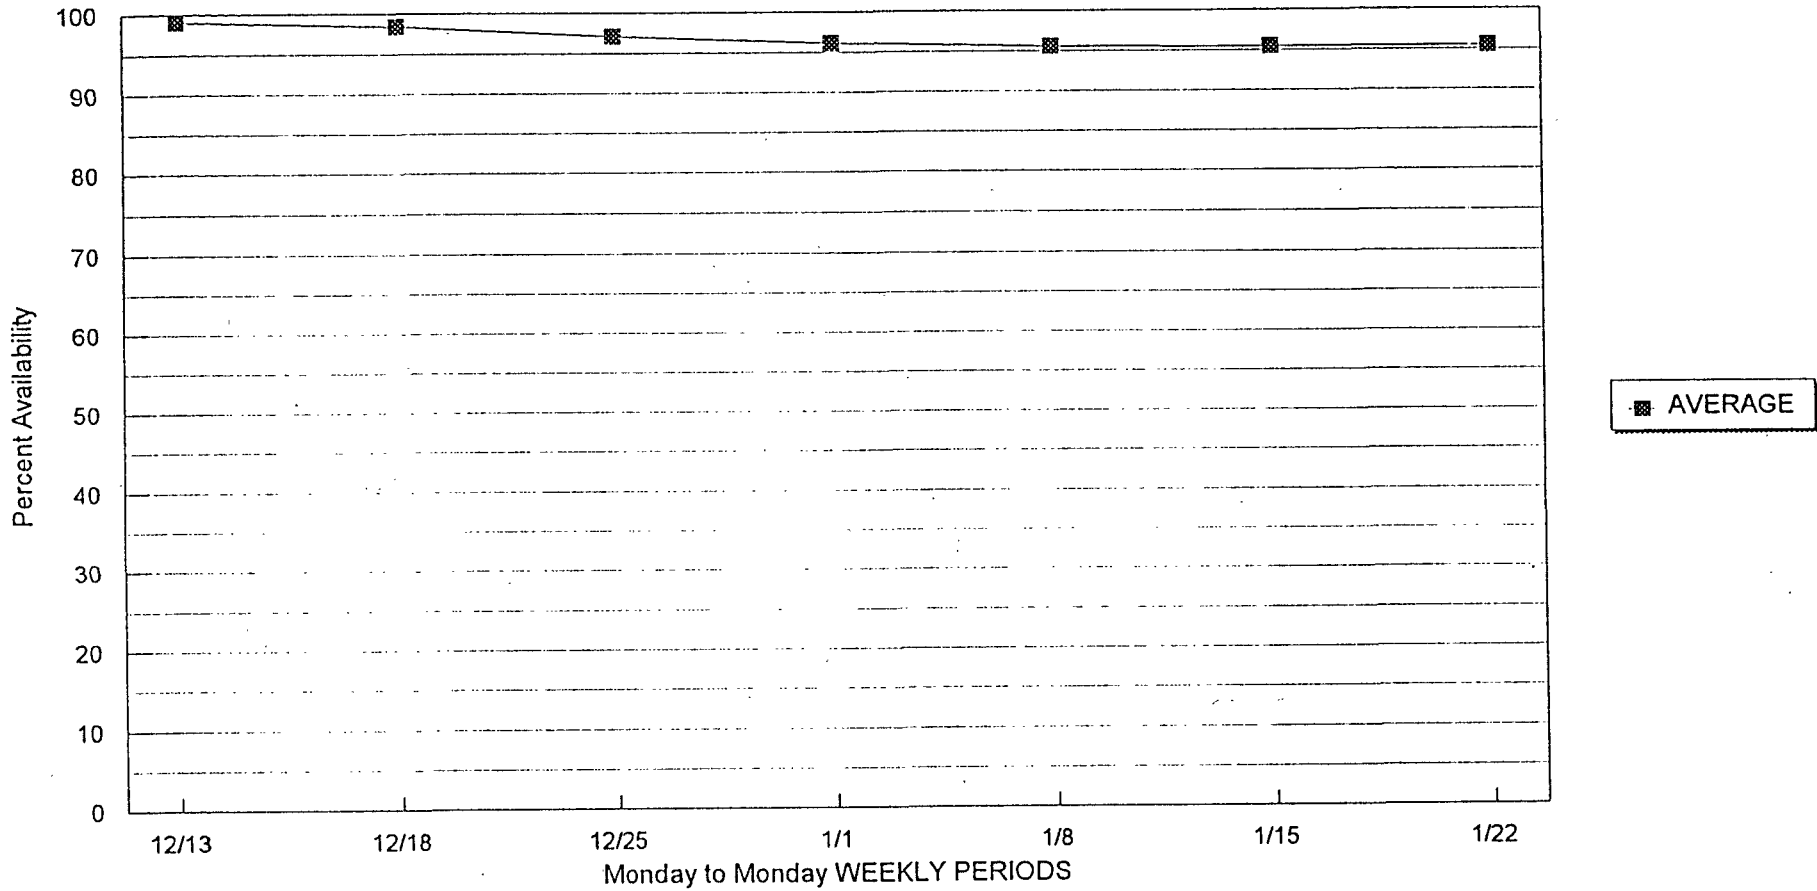
GRAPH 3  
ODCM MONITOR UNAVAILABILITY

Principal cause for downward trend is the unavailability of monitors 1-RE-90-119, 1-LPR-90-120, and 121 to correct electronic noise issues.

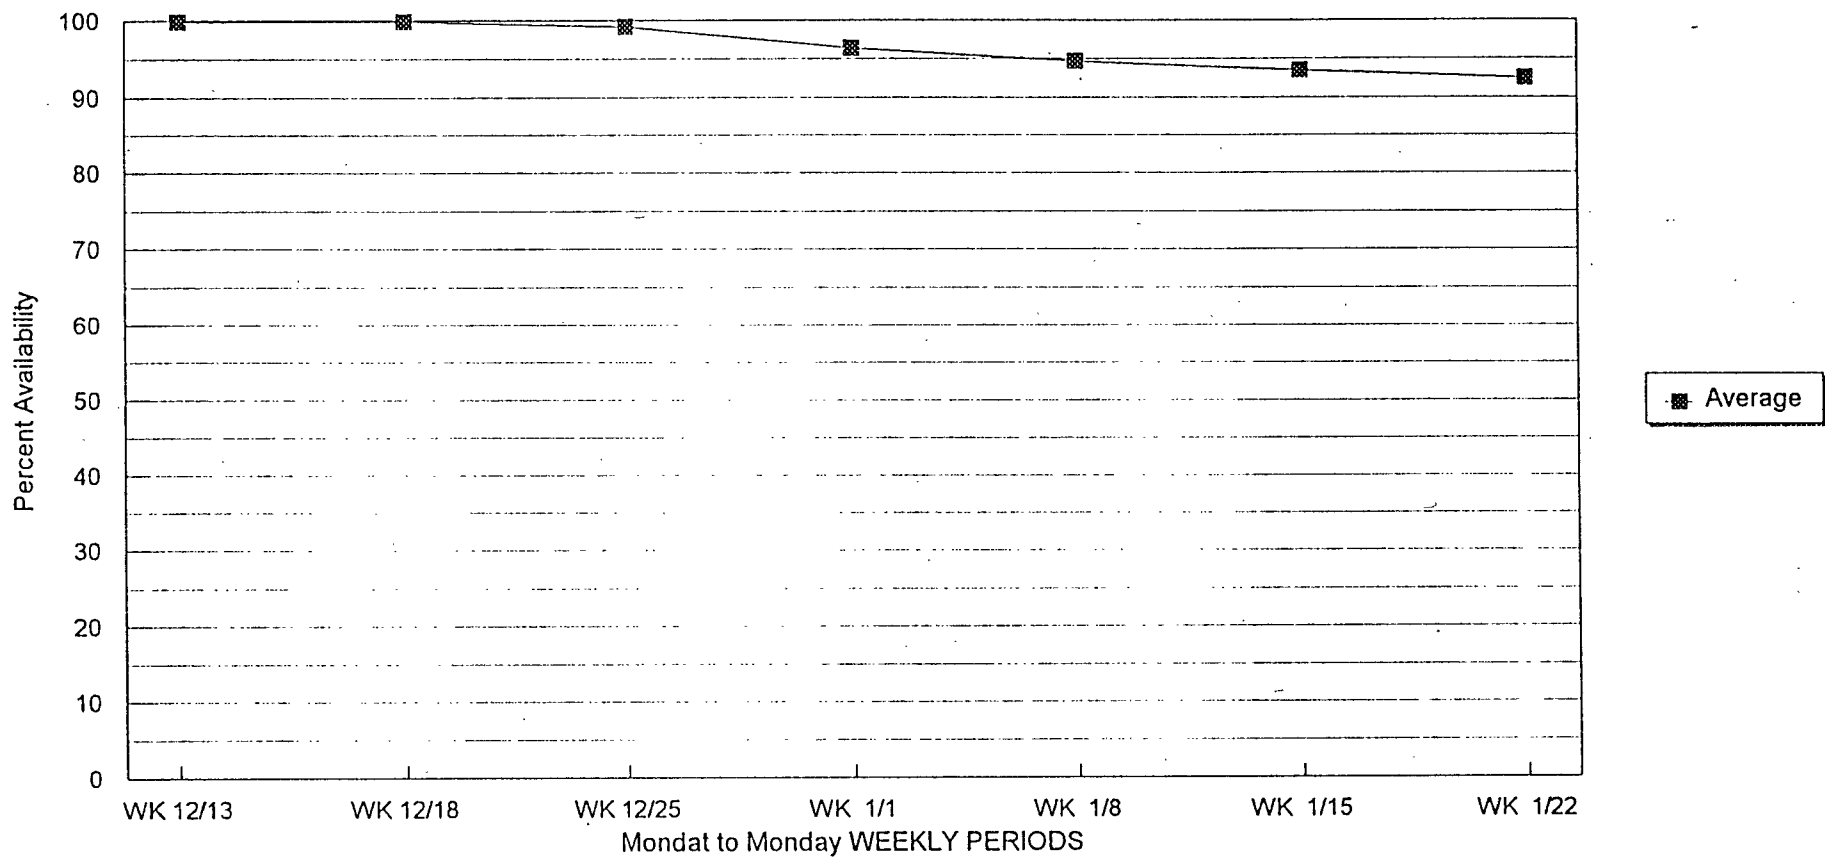
# ODCM Monitors

Principal cause for downward trend is the unavailability of monitors 1-RE-90-119, 1-LPR-90-120, and 121 to correct electronic noise issues.
