Salem Nuclear Generating Station, Unit No. 1 and Unit No. 2
Facility Operating License Nos. DPR-70 and DPR-75
NRC Docket Nos. 50-272 and 50-311

Subject: Response to NRC Request for Additional Information dated April 15, 2010, Related to Structures and Structures-Related Aging Management Programs for the Salem Nuclear Generating Station, Units 1 and 2 License Renewal Application

Enclosures: A. Responses to Request for Additional Information
B. Updates to LRA Appendix A and Appendix B
C. Updates to License Renewal Commitment List
D. MPR Associates Report MPR-2613, Revision 3

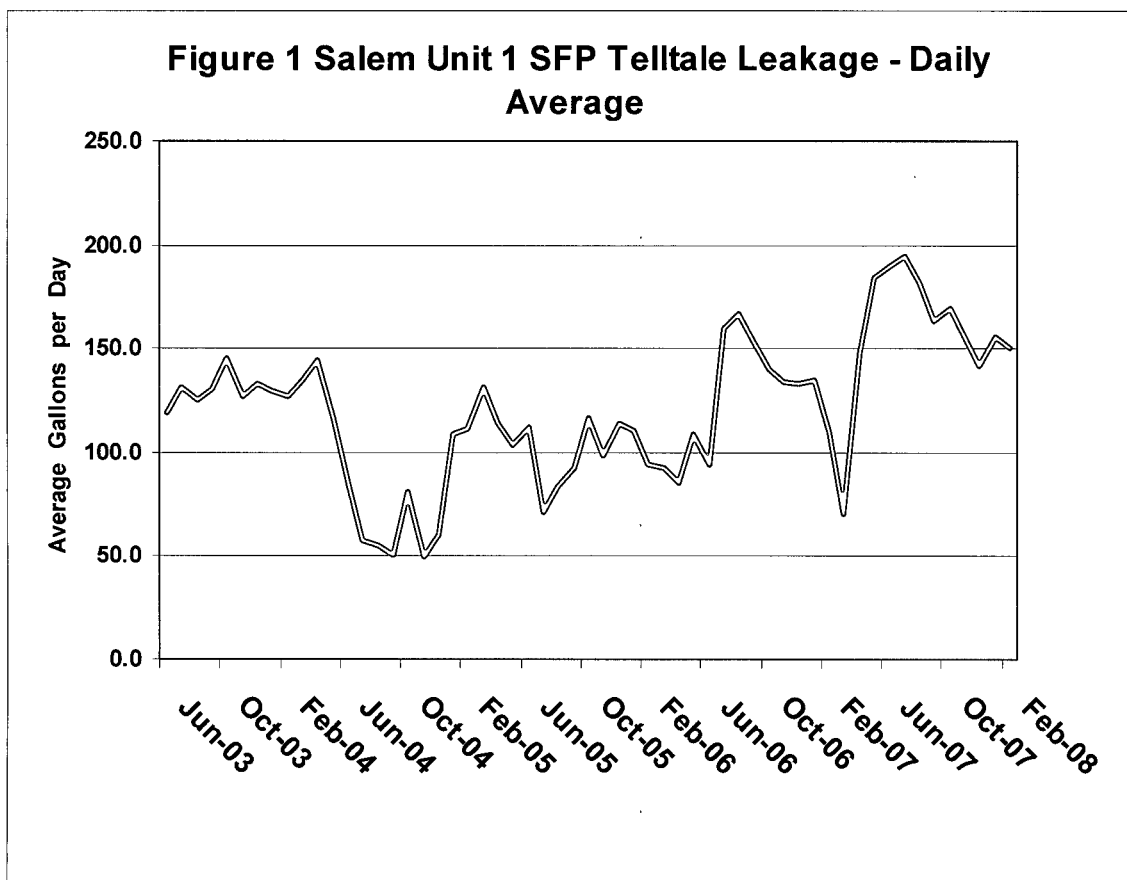
In 2003, Salem began monitoring and trending leakage through the telltales. The volume of leakage varies as indicated in Figure 1 below but on an average is approximately 100 gallons per day. This figure shows average daily leakage up to February, 2008. Based on sump pump run times, daily telltale leakage rates have remained approximately the same for 2008, 2009 and early 2010. The trends of leakage through the telltales are used as an indicator that corrective actions are required to maintain proper drainage through the leak chase system, thus, preventing buildup of borated water between concrete and the liner.

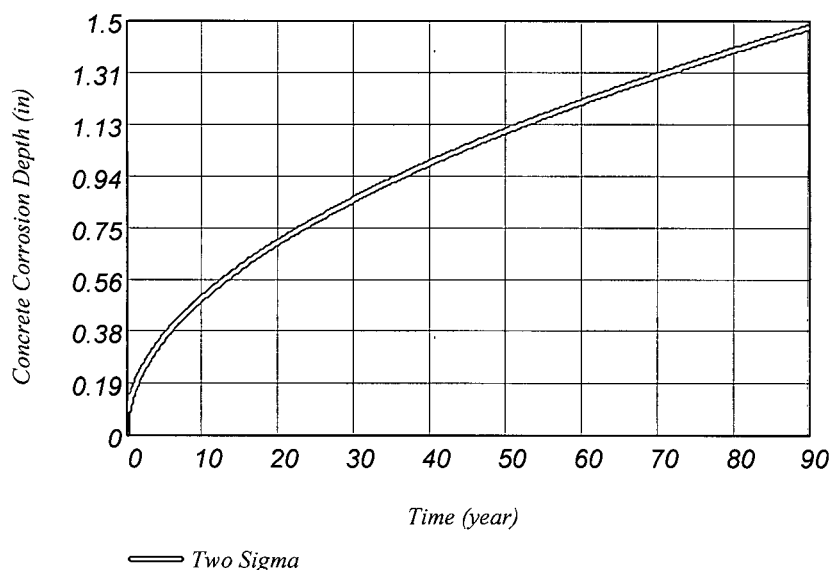
Figure 2 - Extrapolation of Degradation through End of Plant Life

Beginning in 2003 a series of borated water degradation tests were conducted on core samples taken from the Salem Auxiliary Building and new concrete specimens that were made to the original Salem specifications using aggregate from the original sources. Concrete test specimens were submerged in a borated water bath for varying periods up to 39 months. The borated water bath testing parameters (borated water concentration and temperature) were maintained to be representative of the SFP water. The tests were conducted in a manner which was conservative with respect to the actual conditions expected in the FHB. Test specimens were removed from the bath at periodic intervals and degradation of the exposed concrete surface was measured. Results show that degradation is diffusion-controlled, which is consistent with published studies of weak acid attack of concrete. A curve fit of degradation versus time was generated using the measured degradation from test specimens. The following figure 2 shows the curve fit.

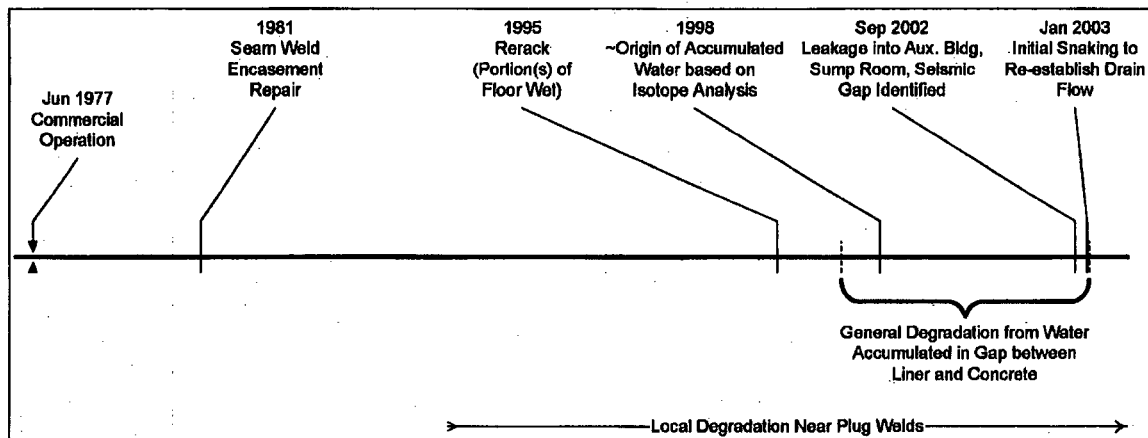
Figure 6-1. Leakage Timeline for Salem Unit 1

Blockage of the drains and accumulation of water in the gap between the pool and the walls occurred sometime between 1995 and 1998. In 1995 some of the channels and drains were open for flow. However, radioisotopic analysis indicates that by 1998 SFP leakage was accumulating in the gap rather than flowing out the telltales.

The 1995 re-rack project may have contributed to formation of telltale blockages. In general, the velocity of the leakage overflowing into the channels is low, too low to entrain sand and other particulate matter. However, leakage flow observed during the re-rack as water was forced into the channels likely was high enough to carry particulates into the channels.

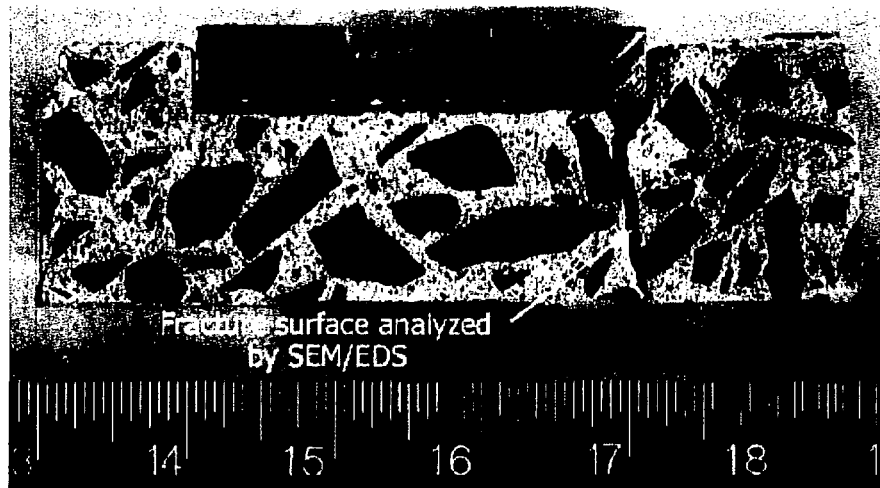
Figure 8-2. Core 122—Cross-Section View Showing Fracture along Crack

The three cores exhibited cracking as noted below.

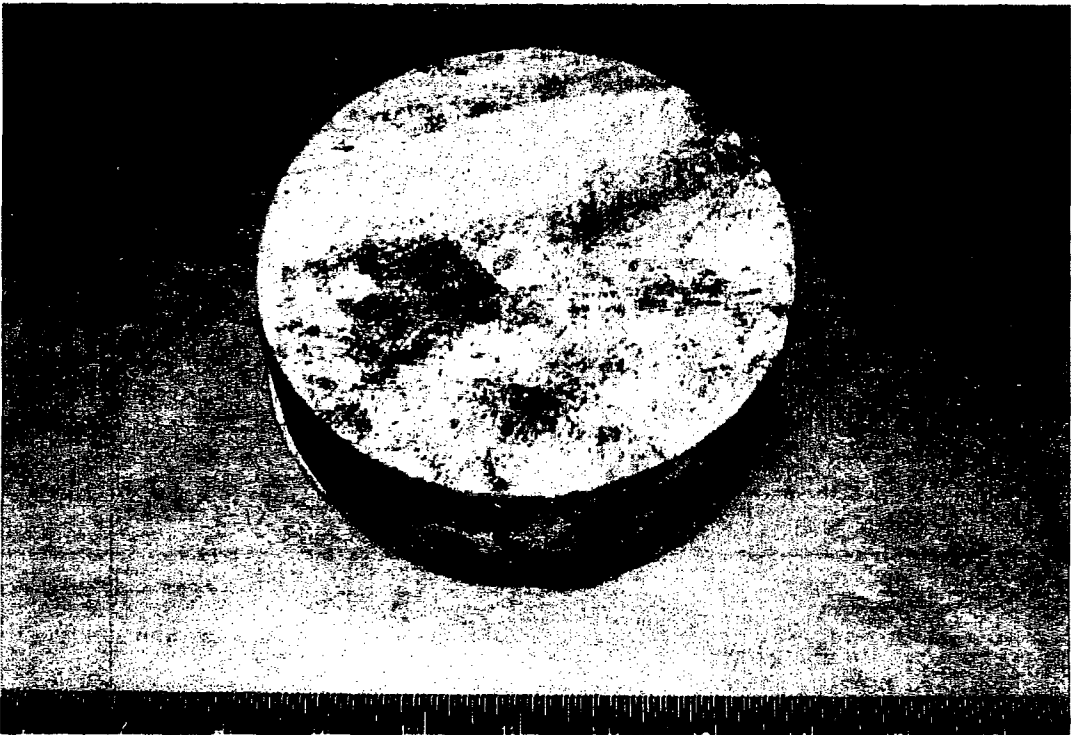
Figure 1. Photographs of Core 122. The upper photograph shows Section 1 (upper 2 in. of core). The stainless steel channel can be seen imbedded in the concrete. The lower photograph shows Section 2 (2 to 4 in. depth).

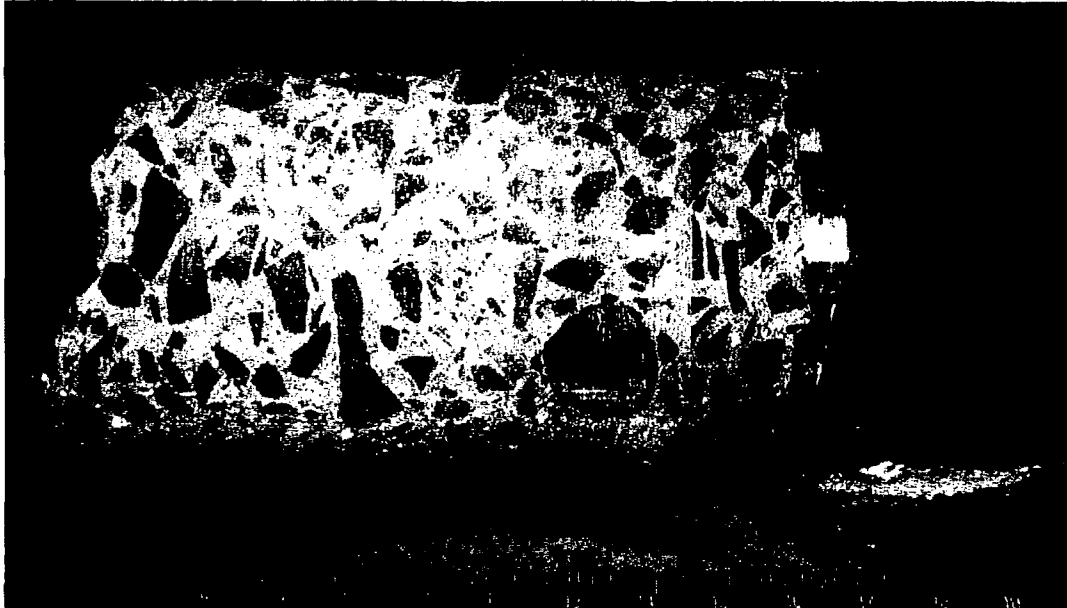
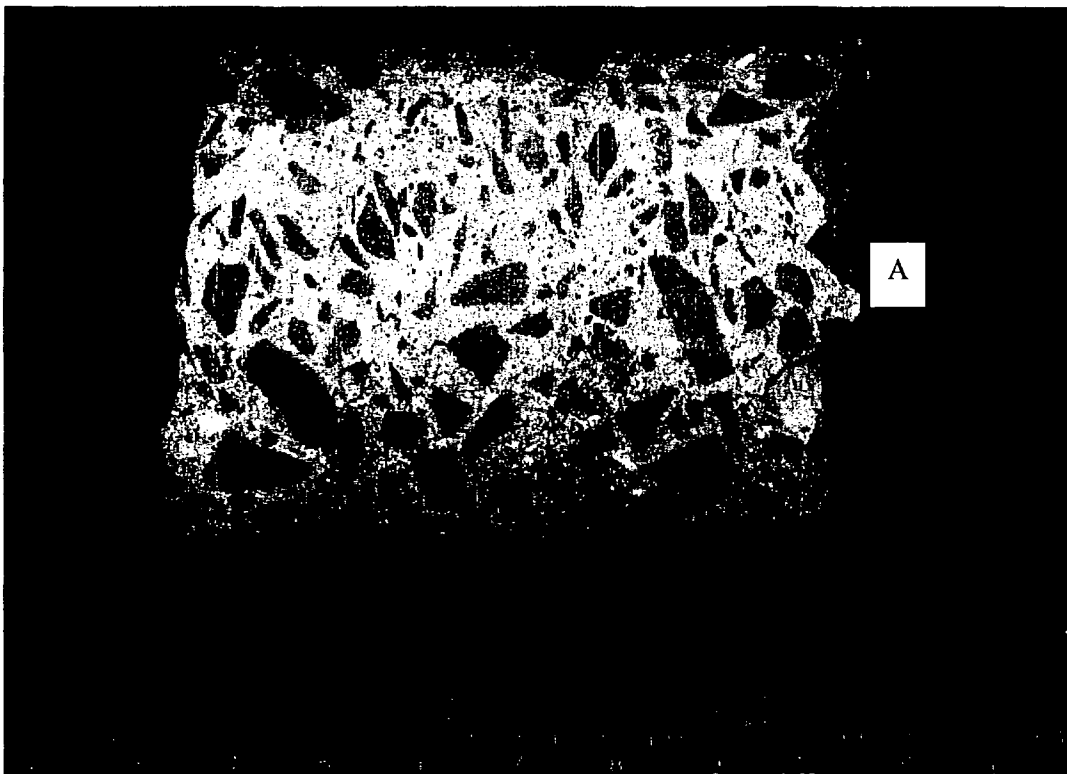
Figure 2. Photographs of Core 123. The upper photograph shows the top 10 in. of the core. The lower photograph shows the core from a depth of 10 to 18 in. These two pieces were originally connected at surface "A".

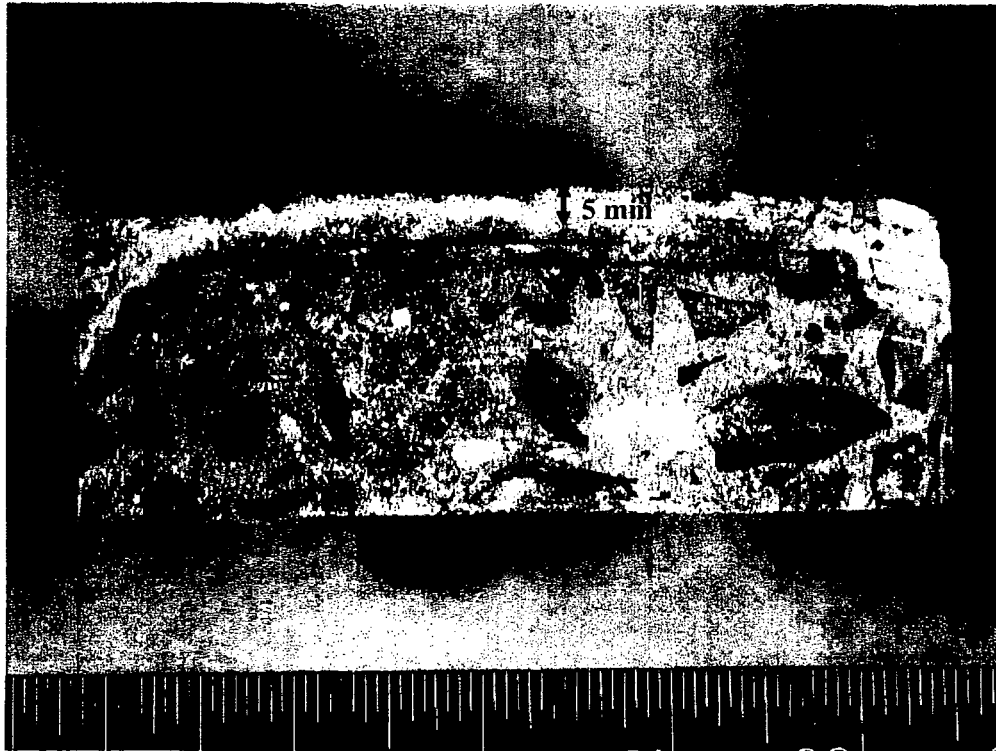
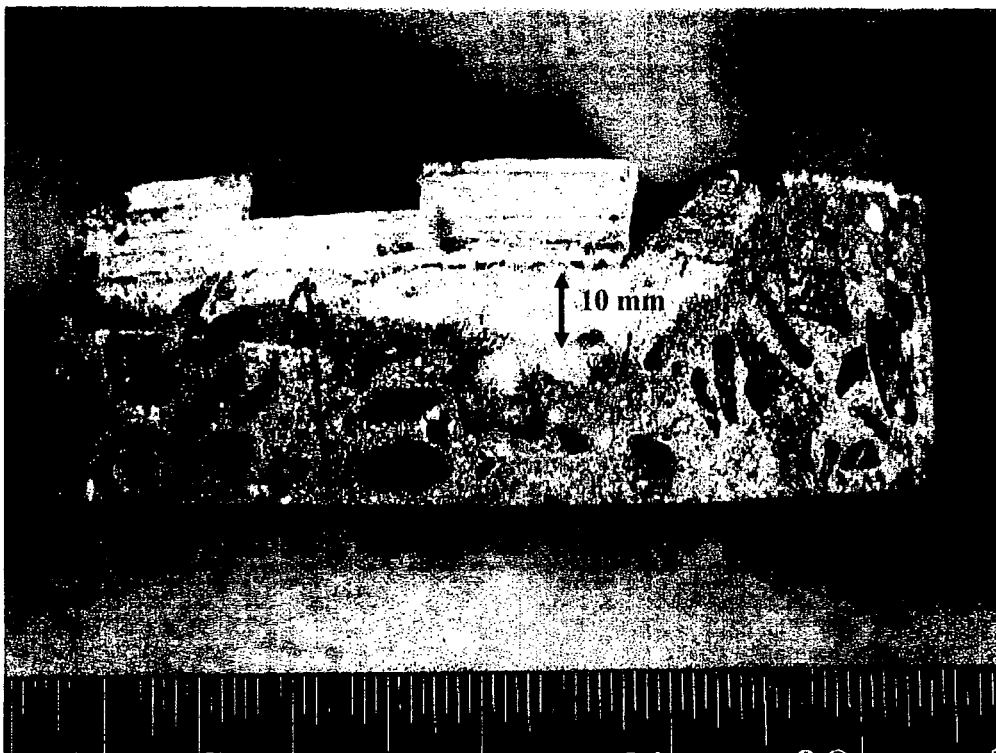
Figure 5. Exterior surfaces of Section 122-1. The light colored cement paste near the top surface of the core represents the degraded cement paste. It can be seen that the depth of the degraded cement paste in the vicinity of the channel is significantly greater than the depth of the degraded cement paste away from the channel.

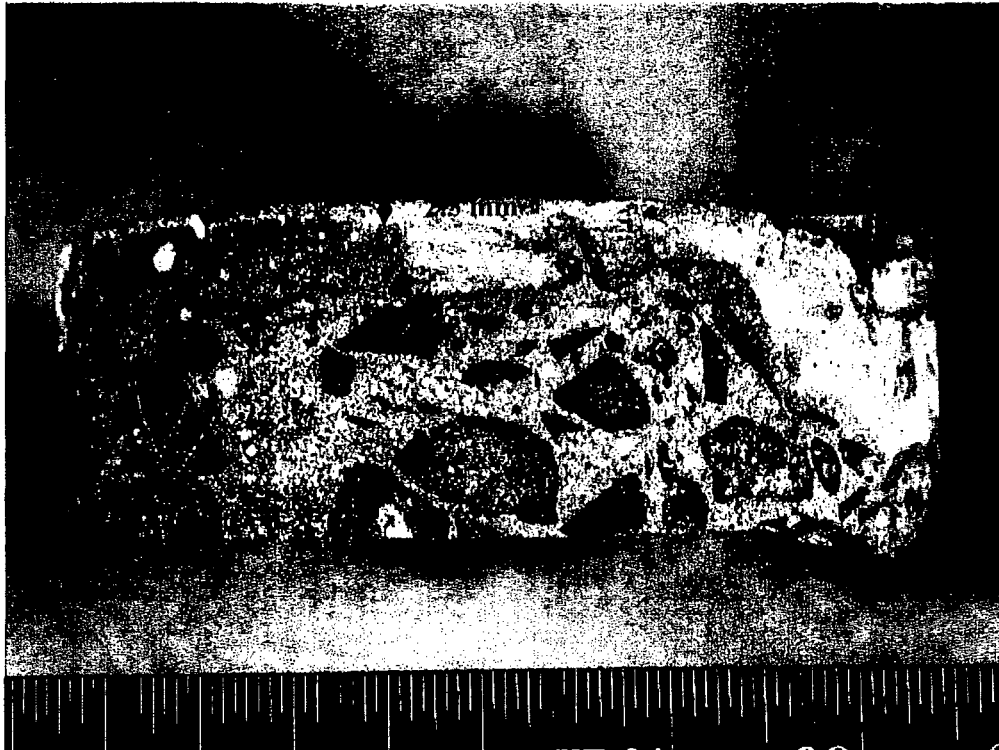
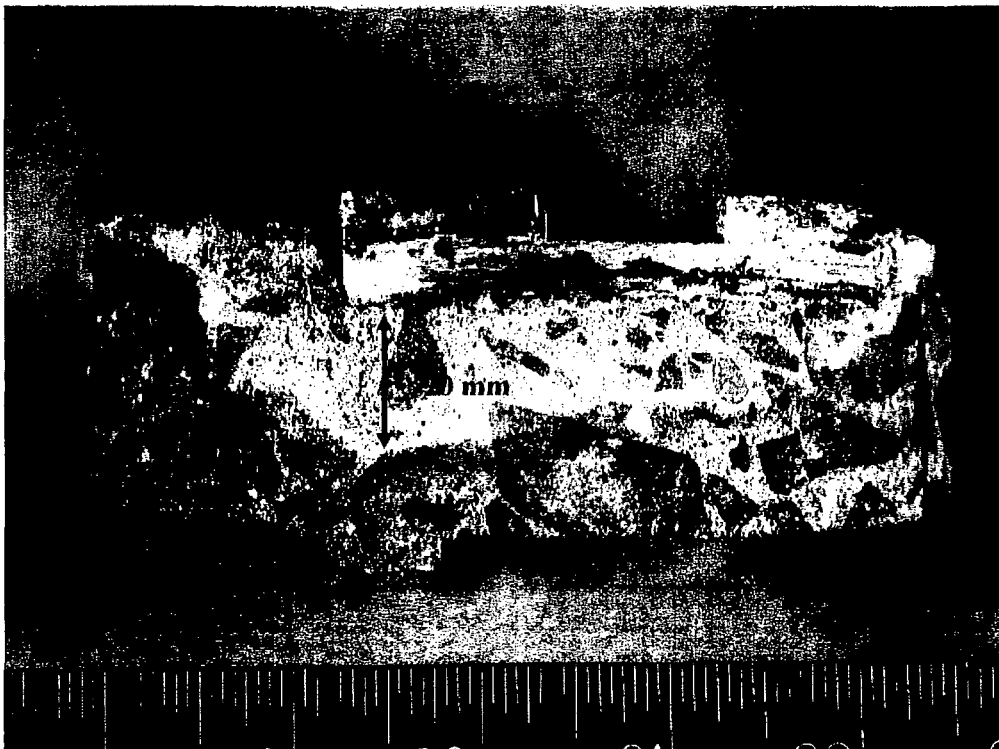
Figure 6. Exterior surfaces of Section 122-1. The light colored cement paste near the top surface of the core represents the degraded cement paste. It can be seen that the depth of the degraded cement paste in the vicinity of the channel is significantly greater than the depth of the degraded cement paste away from the channel.

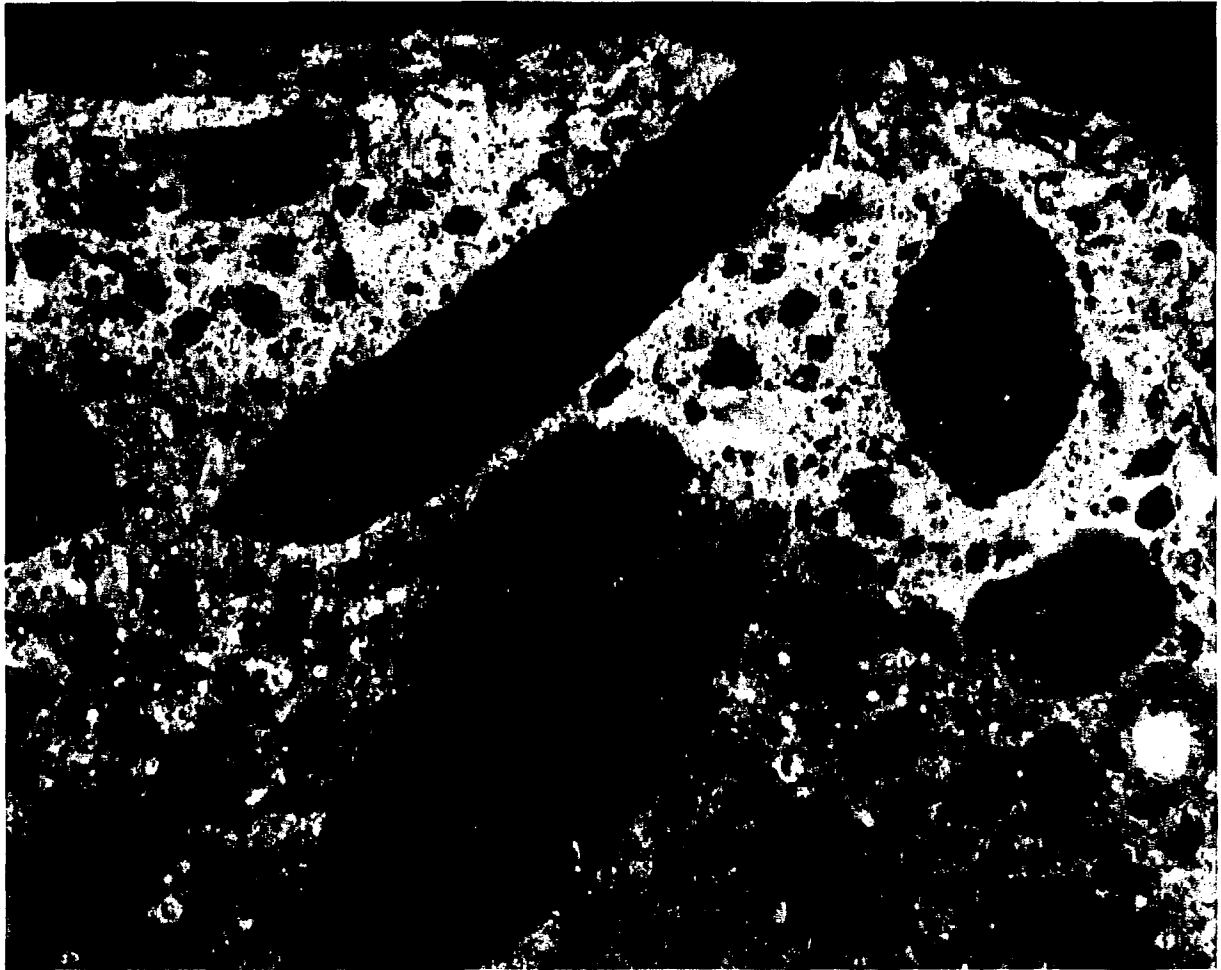
Figure 9. Cross-section view of Core 122, Section 1 taken under the microscope. The photograph shows small air voids filled with white secondary deposits. The air voids within the cement paste affected by the boric acid penetration does not contain the secondary deposits.

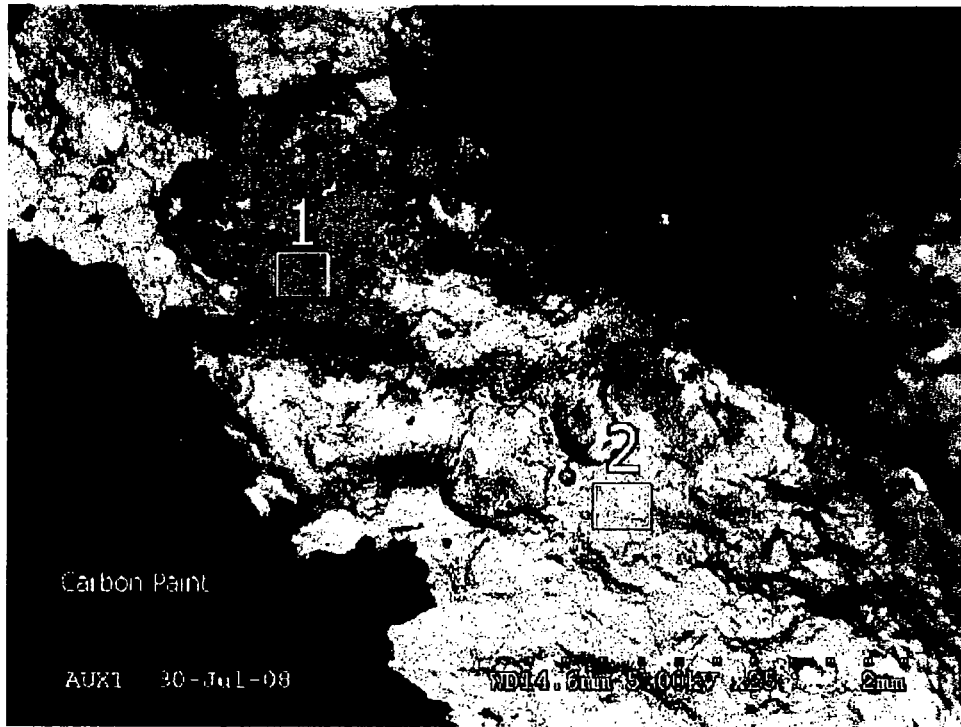
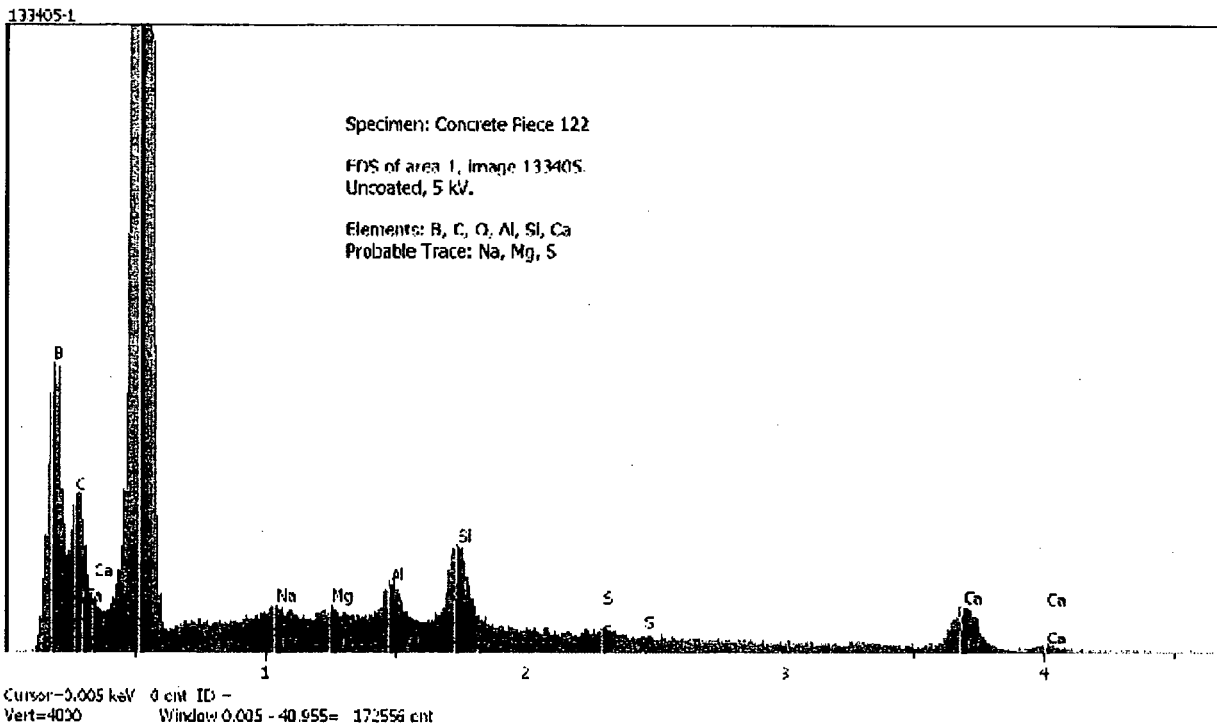
Figure 10. SEM Photograph and EDS analysis of secondary deposits on the fracture surface of Core 122 (see Figure 7). The EDS analyses of the secondary deposit material shows boron as a major element.

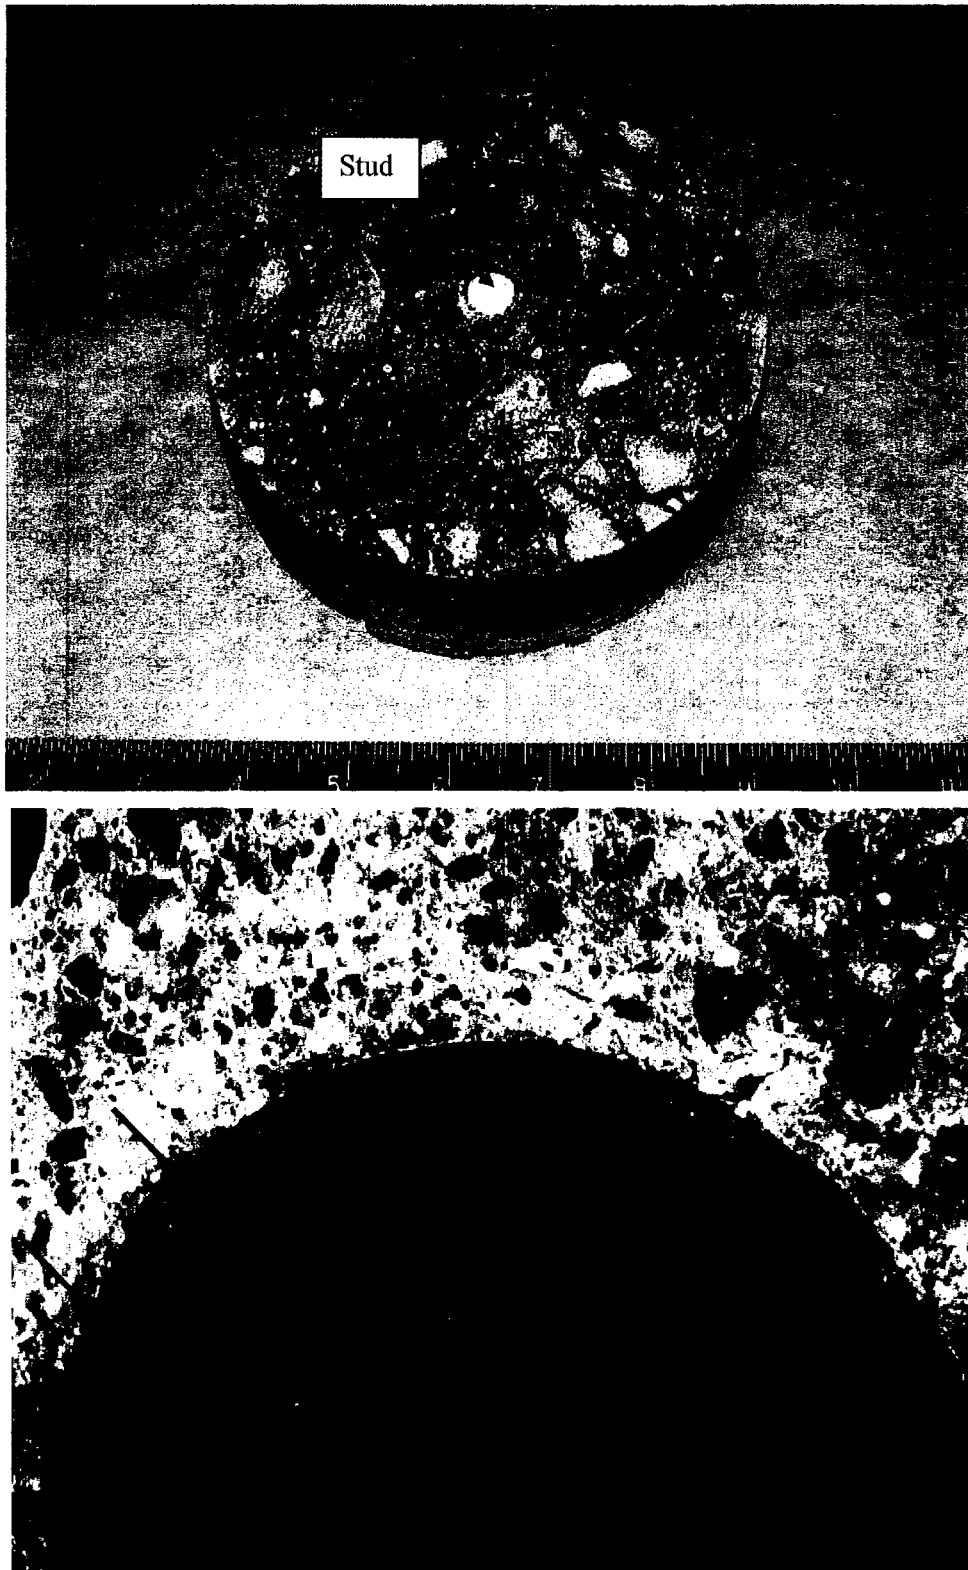
Figure 11. The upper photograph shows the bottom surface of Core 122, Section 1. The lower photograph was taken under the microscope and shows the stud/concrete interface. Note the separation between the concrete and the stud (black arrows) and the crack (blue arrows)

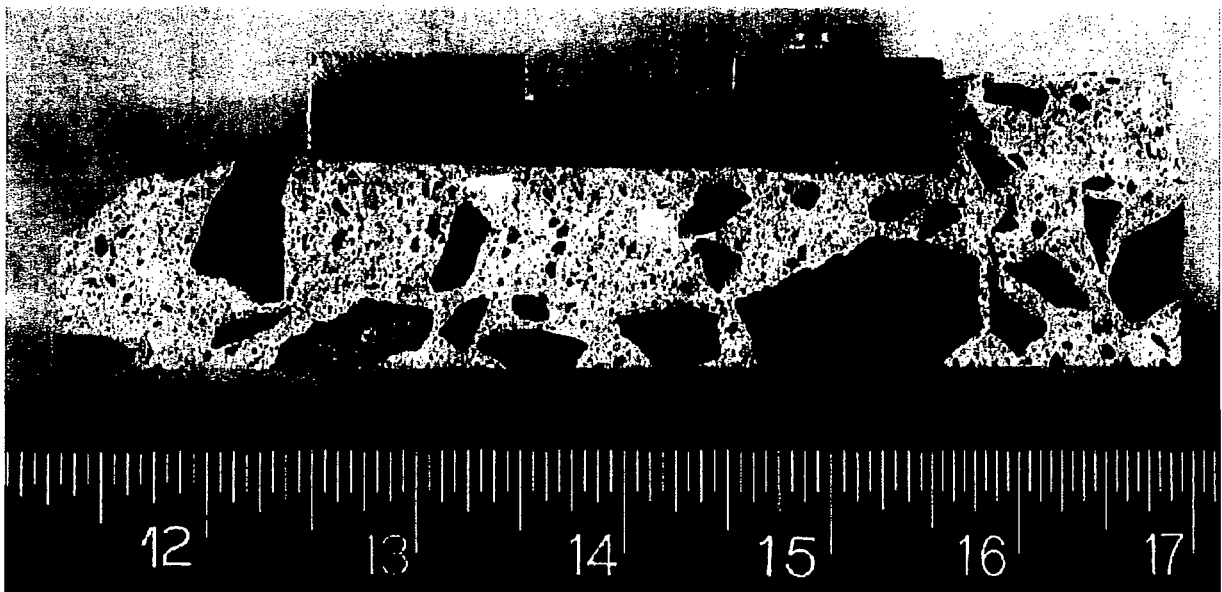
Figure 13. Cross-section view of Core 123, Section 1 (lapped surface). The upper left portion of the specimen was fractured during the removal of the stainless steel liner (see Figure 2).

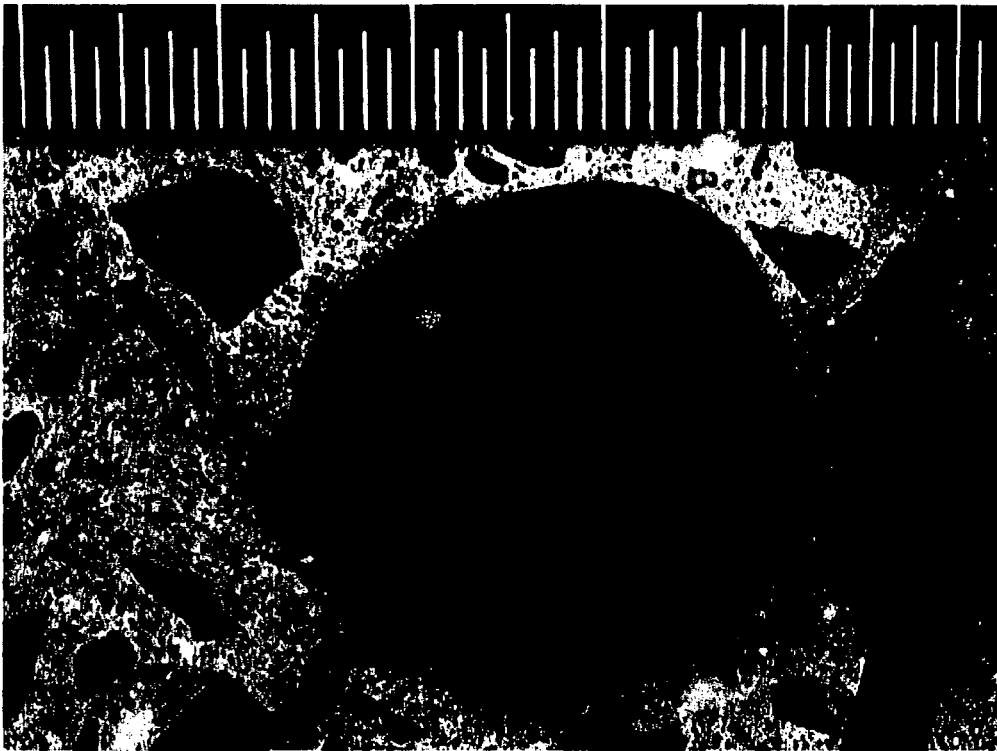
Figure 14. Cross-section views of Core 123, Section 2. The photographs show the cross-section of the No. 11 steel rebar. A gap can be seen at the lower rebar/concrete interface. This gap is due to settlement of the concrete prior to hardening. Cracking on either side of the rebar can also be seen.

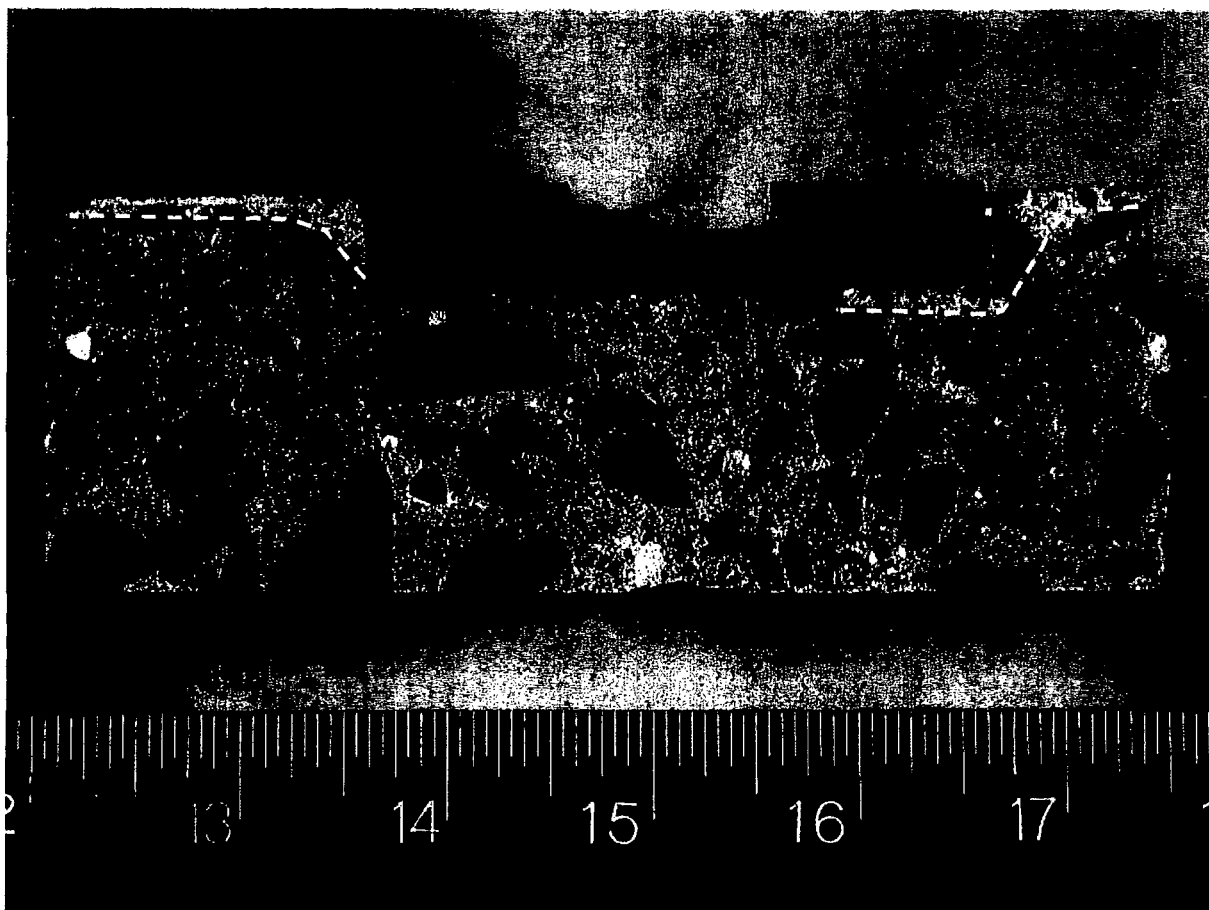
Figure 15. Cross-section view of Core 124, Section 1 (lapped surface). The dashed yellow line shows the area of the degraded cement paste. Two vertically oriented parallel cracks are shown by the arrows.

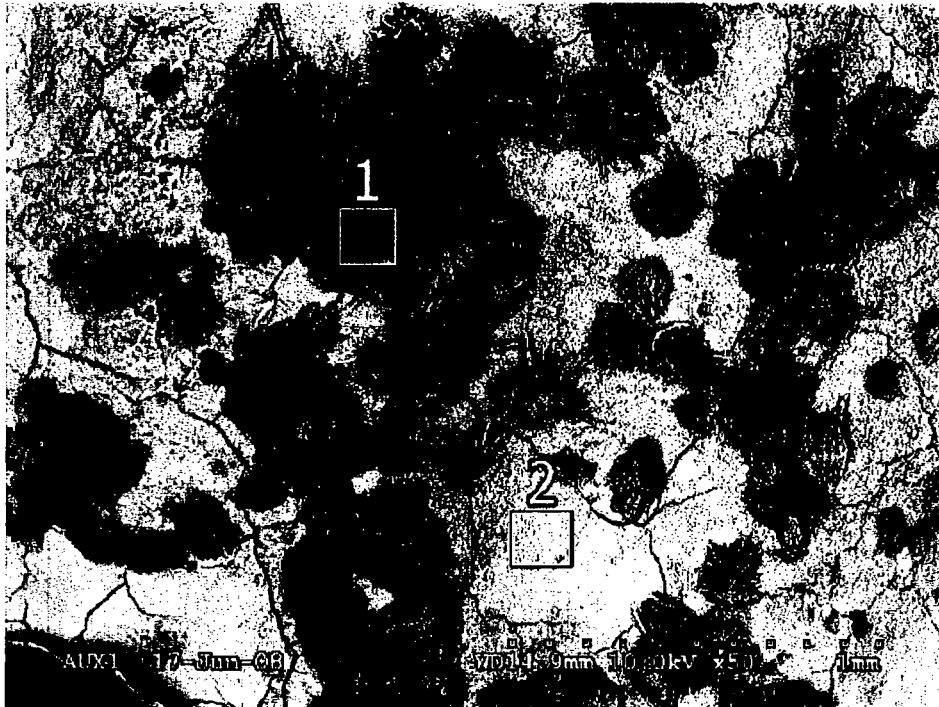
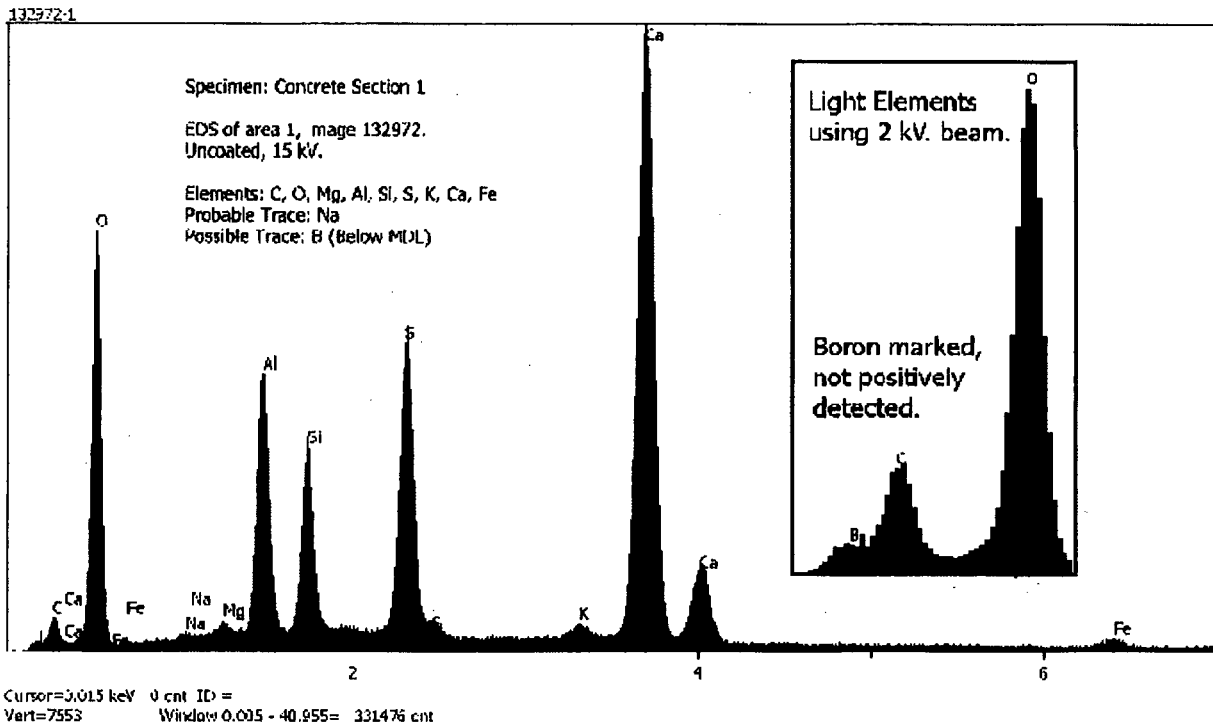
Figure 17. SEM Photograph and EDS analysis of fibrous secondary deposits present in an air void of Core 124. The photograph is the same area shown in Figure 16. The high sulfur and aluminum content indicates that the material is ettringite ($\text{Ca}_6\text{Al}_2(\text{SO}_4)_3(\text{OH})_{12} \cdot 26(\text{H}_2\text{O})$).

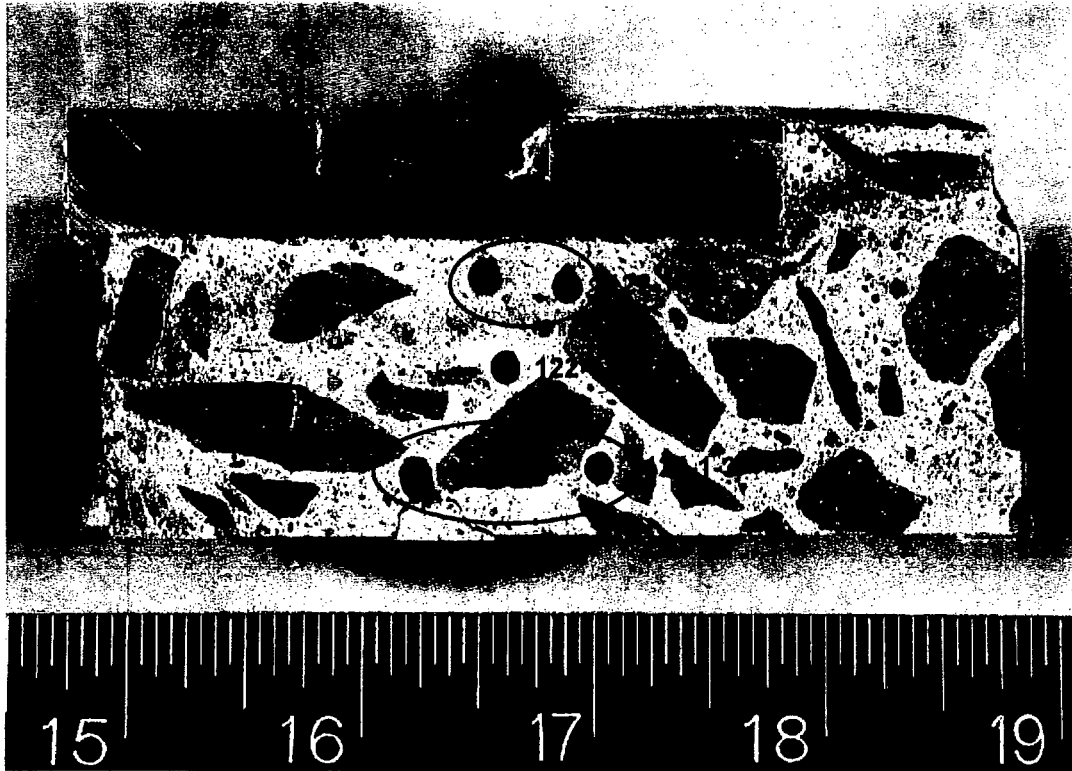
Core 122 - Boron Sample Locations

Sample ID	Distance below top surface of channel	Boron concentration, ppm
122-1-1	11/16"	4370
122-1-2	1-1/16"	593
122-1-3	1-9/16"	1410

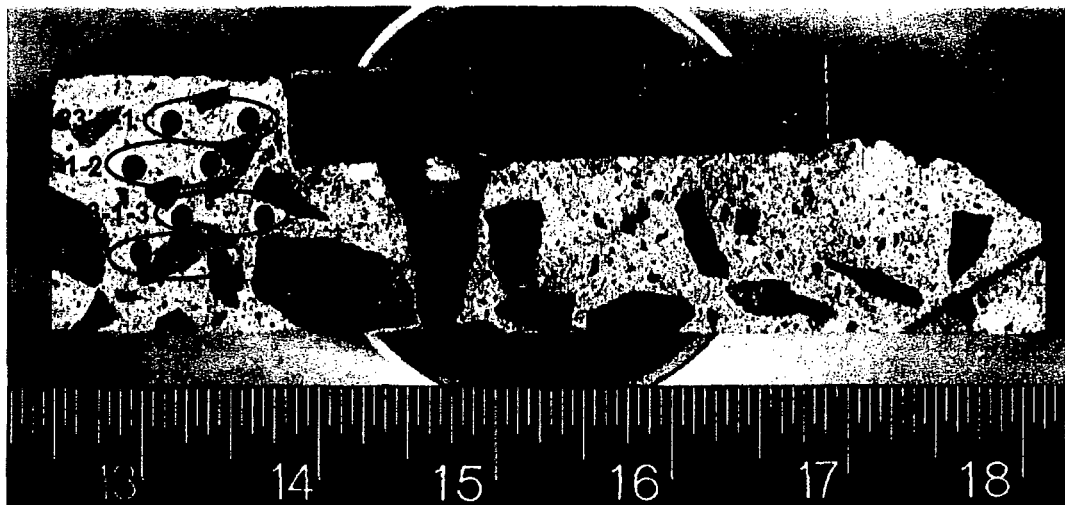
Core 123 - Boron Sample Locations

Sample ID	Distance below top surface of channel	Boron concentration, ppm
123-1-1	1/4"	806
123-1-2	1/2"	285
123-1-3	13/16"	387
123-1-4	1-1/16"	549
123-2-1	2-1/2"	64
123-baseline	~14"	36

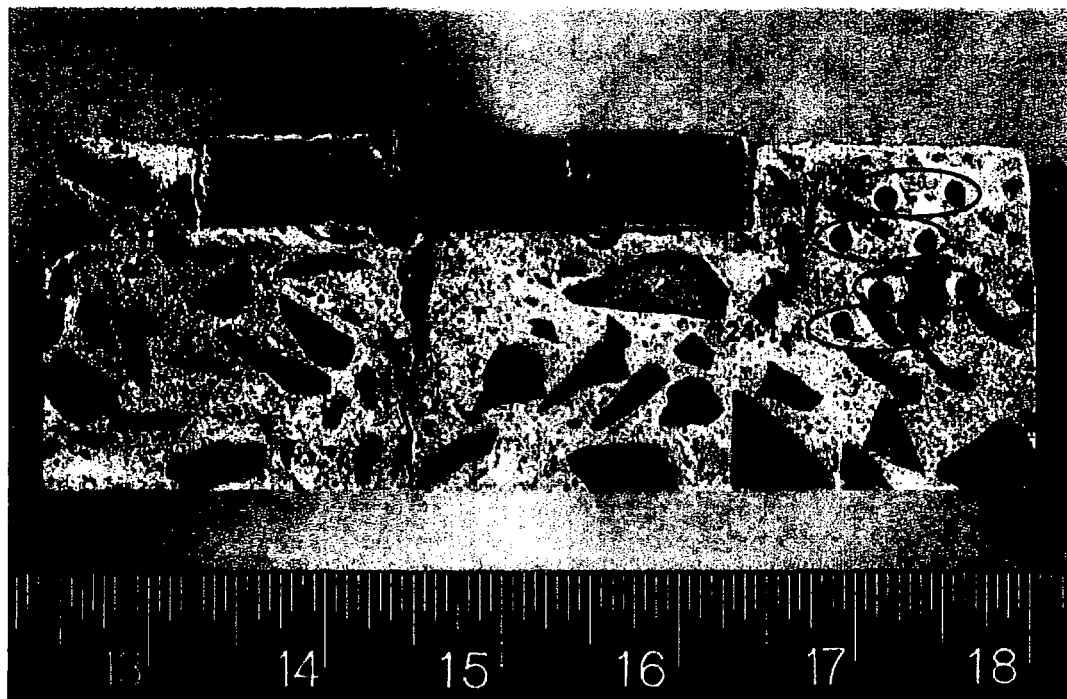
Core 124 - Boron Sample Locations

Sample ID	Distance below top surface of channel	Boron concentration, ppm
124-1-1	1/4"	3670
124-1-2	1/2"	1000
124-1-3	11/16"	109
124-1-4	1"	136
