NONCONFORMANCE - REPORT LOG & STATUS BOOK

1. PROJECT NO. 7220

MIDLAND PLANT UNIT #2  
 CONSUMERS POWER CO.  
 EG # 7220-M-115-KC

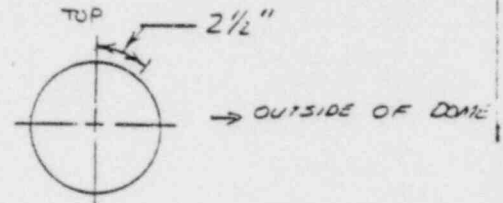
BASE MATERIAL REPAIR  
MAP  
FOR  
PIPE SPOOL 2-GCB-006-S613-7

16. Nonconforming Condition: The following defects were noted during inspection in the last 21 1/2" of 2 1/2" pipe spool 2-GCB-006-7.				24. Disposition Concurrence			
21 1/2" of 2 1/2" pipe spool 2-GCB-006-7.				REWORK	REJECT	REPAIR <input checked="" type="checkbox"/>	USE AS IS

DEFECT # 1

LOCATED:  $2\frac{1}{2}$ " FROM THE NOZZLE END.

22. <input type="checkbox"/> Field Engineering Disposition		<input checked="" type="checkbox"/> FIELD ENGINEERING RECOMMENDED DISPOSITION TO PROJECT ENGINEERING					
Repair surface defects in accordance with Project Specification 7220-M-204, Paragraph 5.2.1 and ASME Code, Paragraph NB-2500 and 2539.6. Repair procedure and weld map attached.							
<i>Joseph H. Medhurst</i> <i>C. Williams</i> 11-30-76

In accordance with Project Specification 7220-M-204, Paragraph 5.2.1 and ASME Code Paragraph NB-2500 and 2539.6, the following welding repair procedure is defined:

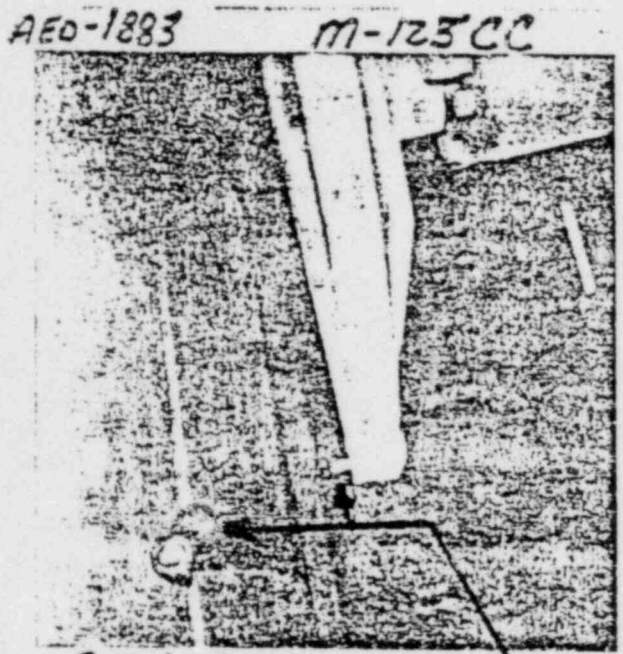
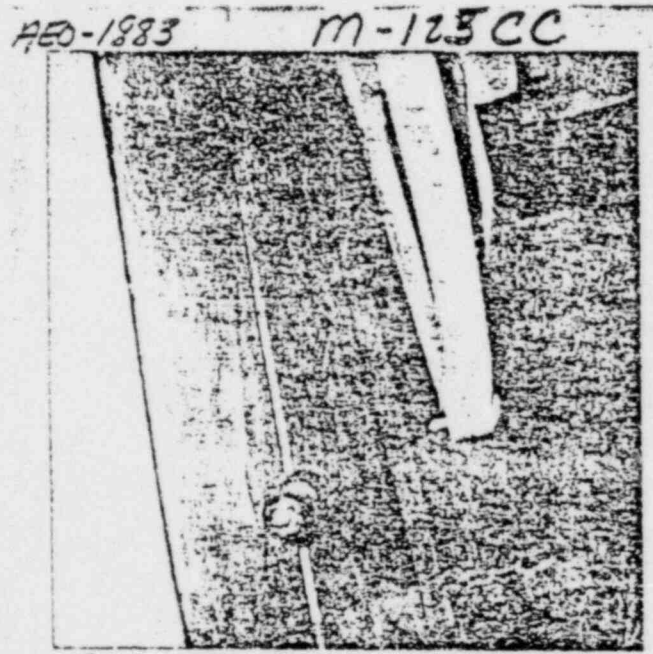
NCR 588

HANDLE BROKEN  
OFF MANUAL OPERATOR

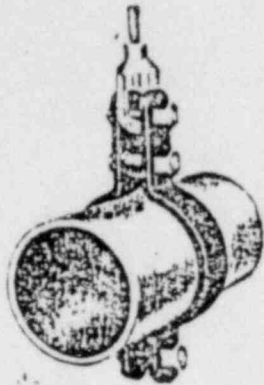
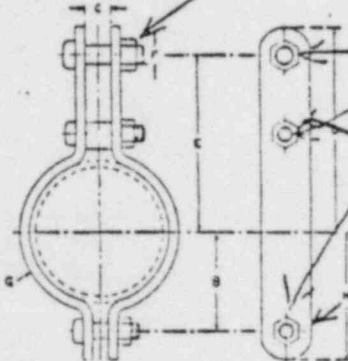
double bolt pipe clamp  
fig. 295

*F" BOLT DIAMETER  
NOT SPECIFIED  
AS TYPICAL  
3 PLACES*

*BOLT NUT  
MATERIALS  
NOT SPECIFIED*

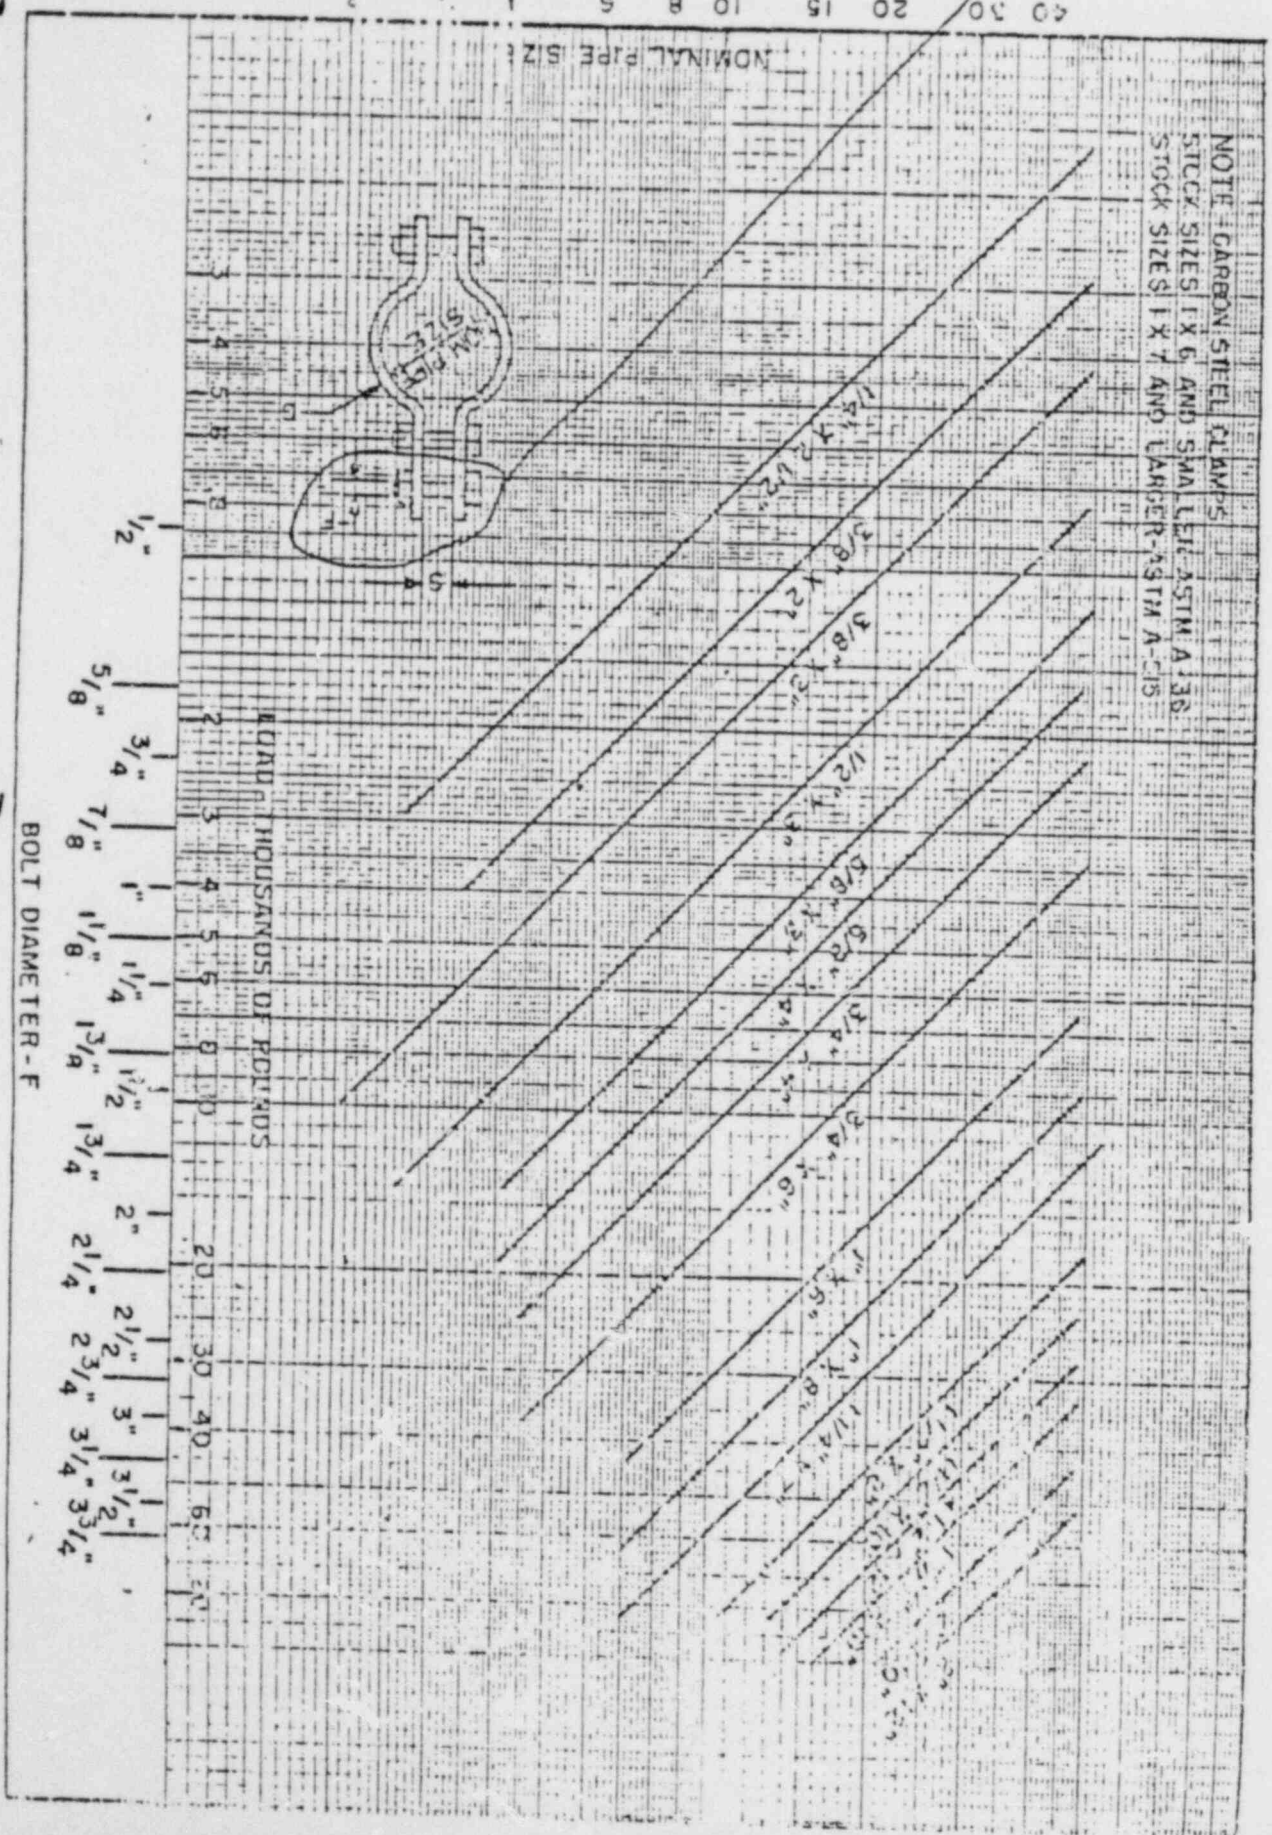
August, 1973  
 F" DIMENSION NOT SPECIFIED AS TYPICAL 3 PLACES  
 CHART-C

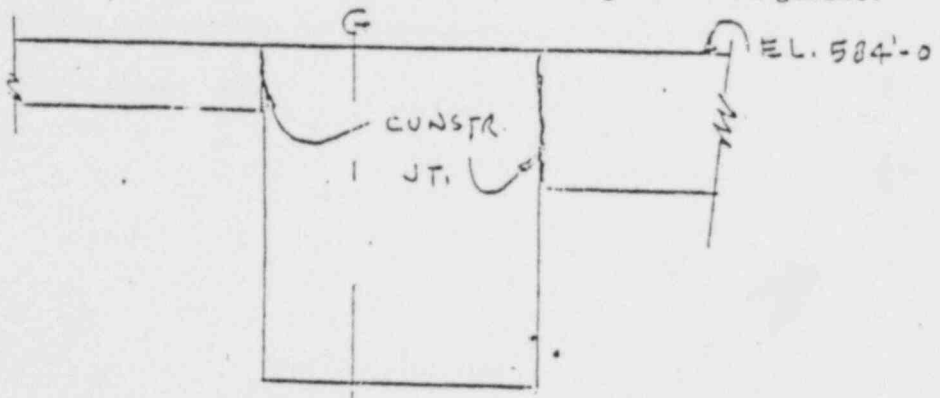
The above requests are made to reflect the as-built condition of the door header at G/6.6. The as-built condition conforms to the original project engineering design to pour the door header to elev. 584' without an intermediate horizontal construction joint.

Revise sections F and G of the referenced drawing to:

- a) Delete the additional 4-#8 horiz. bars and 6-#5 cap bars.
- b) Show the following as-built construction joint arrangement:

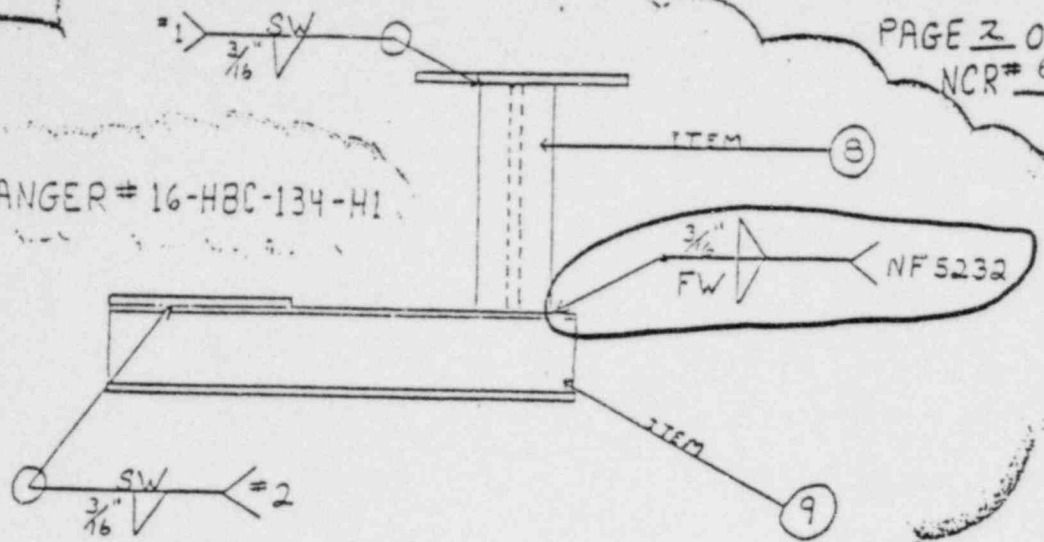
ASME HANGER # 16-HBC-134-H1

DETAIL: AS PER SECTION AA  
ITT GRINNELL DWG.# 2-617-6-1 Rev. 2  
DESIGN AS SHOWN

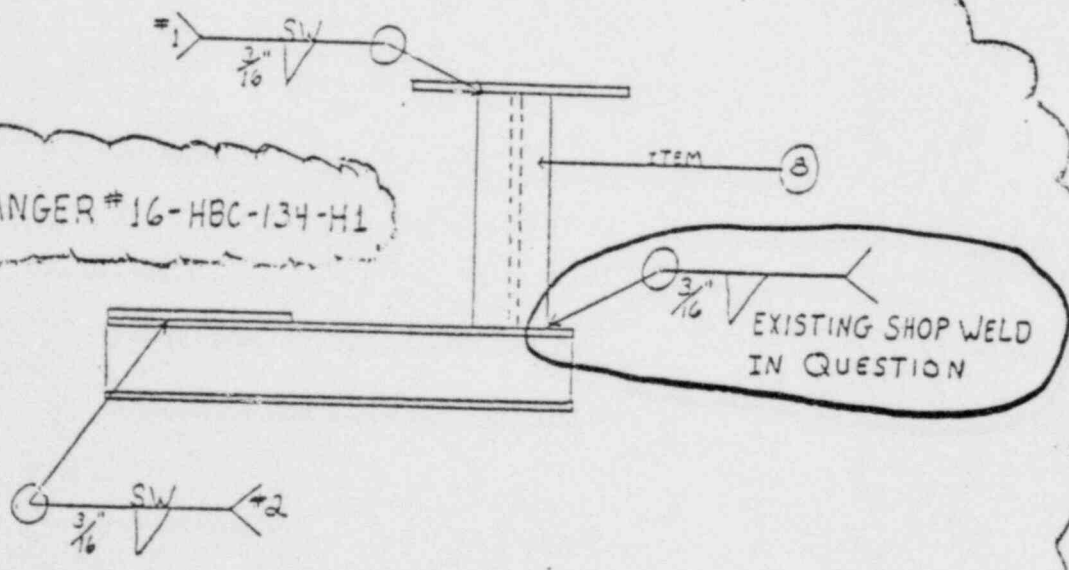
ASME HANGER # 16-HBC-134-H1

AS BUILT

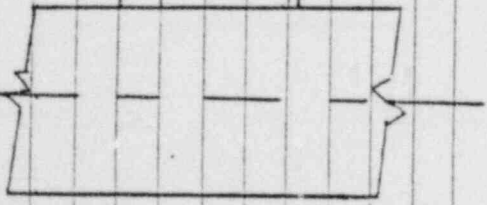
14 NCR NO. 433

14 OF 18 DOWELS HAVE FROM 1/4" TO 0" COVER

5.6 LINE WALL, WEST FACE (LOOKING EAST)

INCREASE THICKNESS OF SLAB AT BOTTOM BY 1"

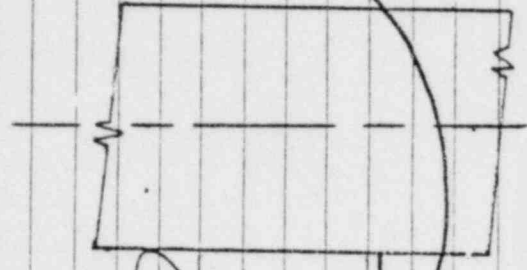
(D)

26 OF 31 DOWELS HAVE FROM 1/4" TO 0" COVER  
TOL. ER. 0.24'-0"

REPAIR AS PER FIELD'S RECOMMENDATION

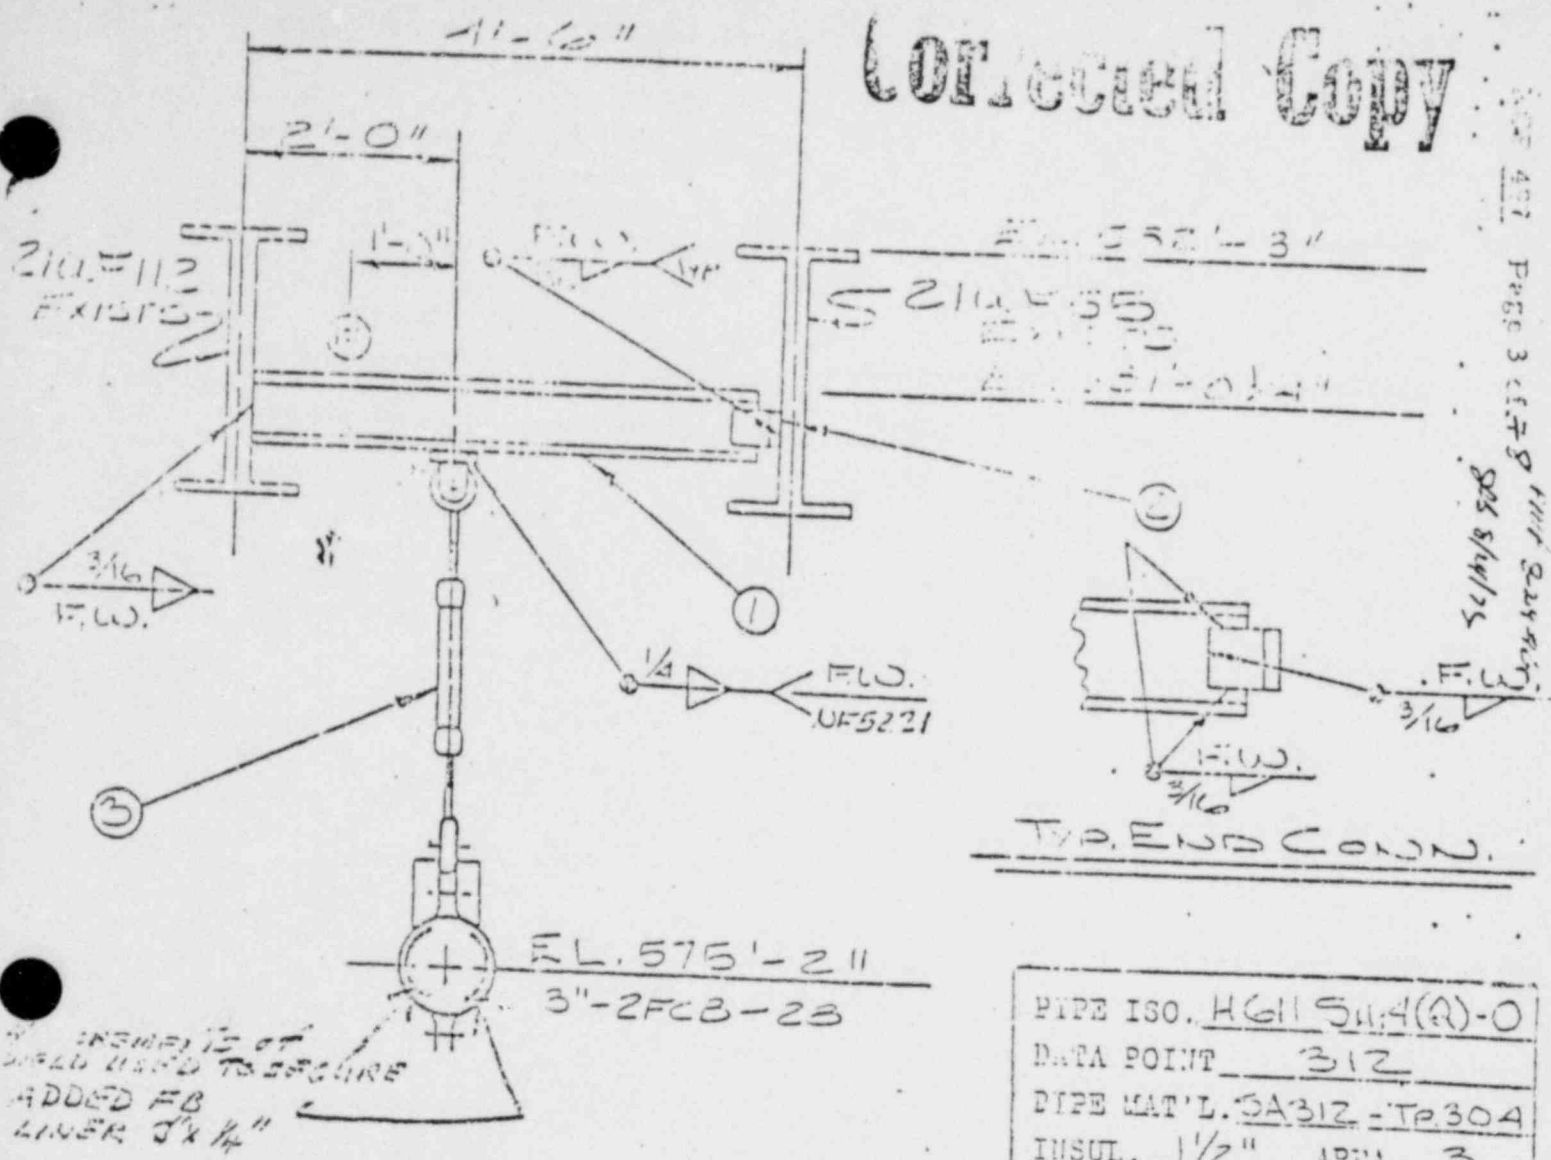
3"-2FCB-28-H6

INSURE IS OF  
WELD USED TO SECURE  
ADDED FB  
LINER 3/4"

DESIGN SK 2-11-4-34 REV 1  
 VENDOR DRAWING REVIEW APPROVAL  
 LEVEL 1  
 S. AMP 82476  
 CLAMPS USED ARE MODIFIED 3" DIA  
 FIG. 295 WITH FLAT BAR LINERS  
 SKETCH INDICATES 3" DIA FIG 295  
 FOR USE ON BILL OF MATERIALS  
 ITEM 3, FIG. 211. 1 SWAY STRUT

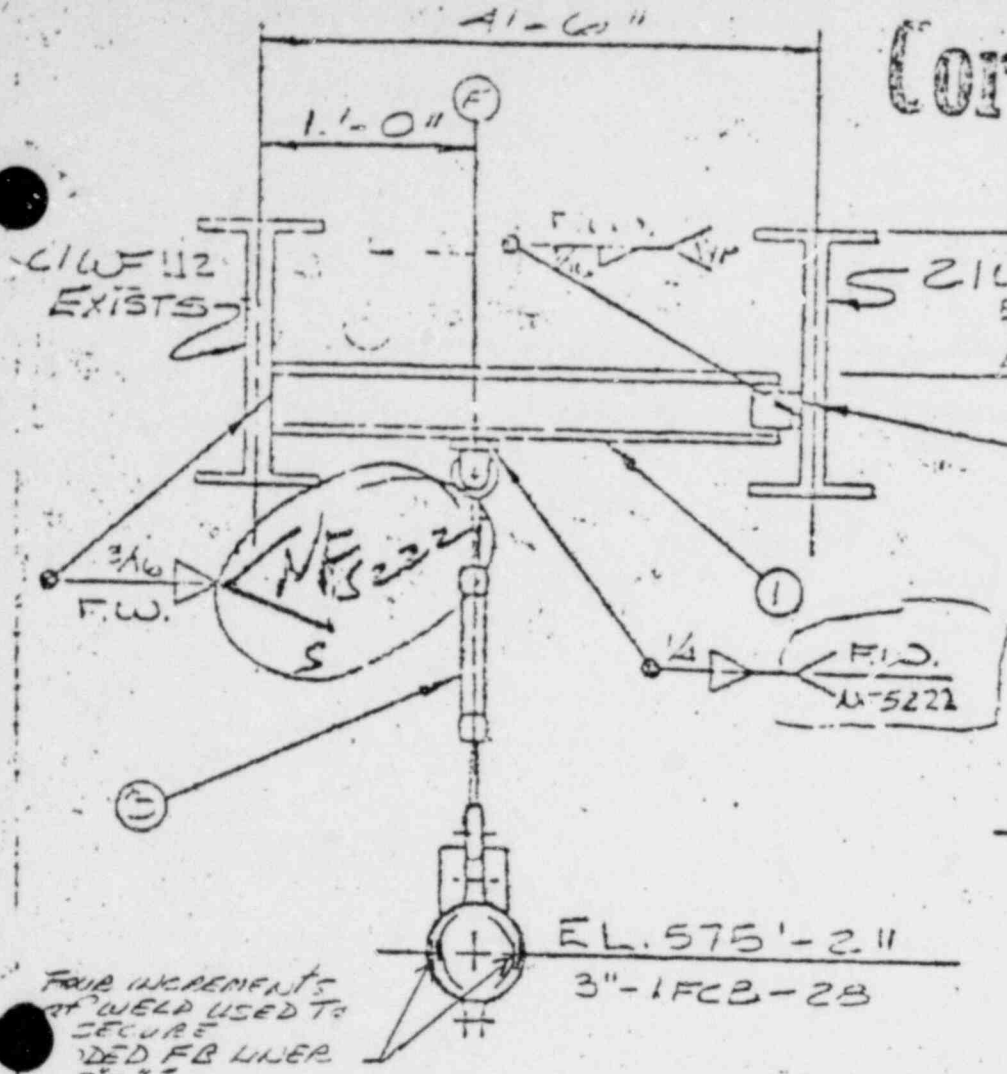
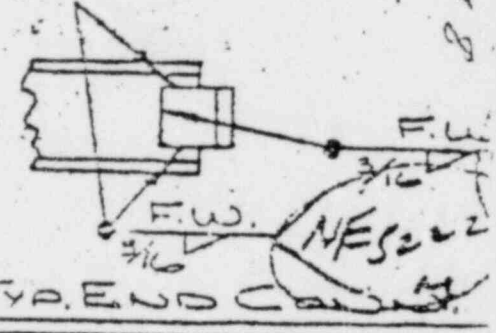
EL. 575'-2" 3"-1FCB-28

FOUR INCREMENTS OF WELD USED TO SECURE MODIFIED FB LINER 3"x4"

3-1FCB-28-H6  
 DESIGN SK 1-11-4-34 REV. 1  
 VENDOR DRAWING APPROVAL LEVEL 1  
 CLAMPS USED ARE MODIFIED 5" DIA. FIG 295 WITH FLAT BAR LINERS  
 SKETCH INDICATES 3" DIAMETER  
 FIG 295 FOR USE ON BILL OF MATERIALS ITEM 3 FIG 211 #1 SWAY STRUT

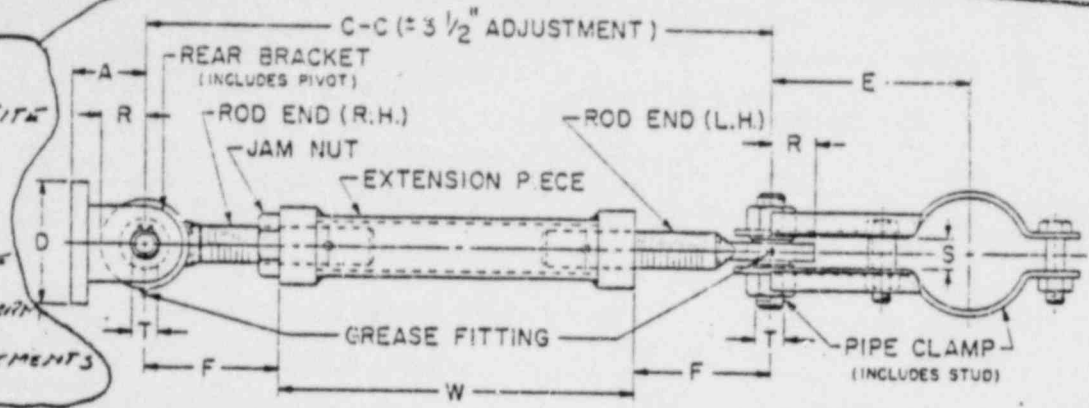
fig. 211

DELIVERED TO JOBSITE  
FIGURE 211 CLAMP  
WITH FLAT BAR  
LINER WELDED INSIDE  
THE CLAMP TO CONFORM  
TO THE O.D. REQUIREMENTS

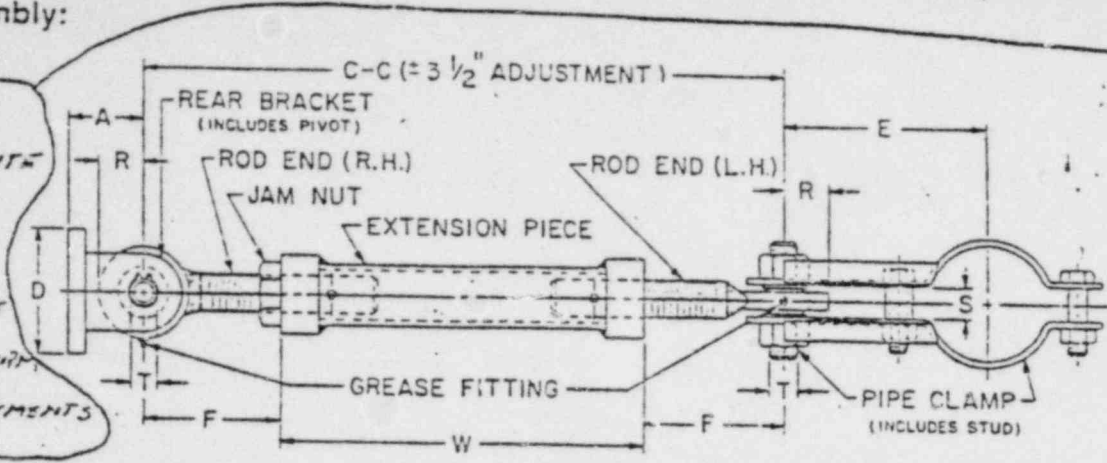
sway strut assembly:  
**ATTACHMENT A**  
 fig. 211

*DELIVERED TO JOBSITE  
 FIGURE 211 CLAMP  
 WITH FLAT BAR  
 LINER WELDED INSIDE  
 THE CLAMP TO CONFORM  
 TO THE O.D. REQUIREMENTS*

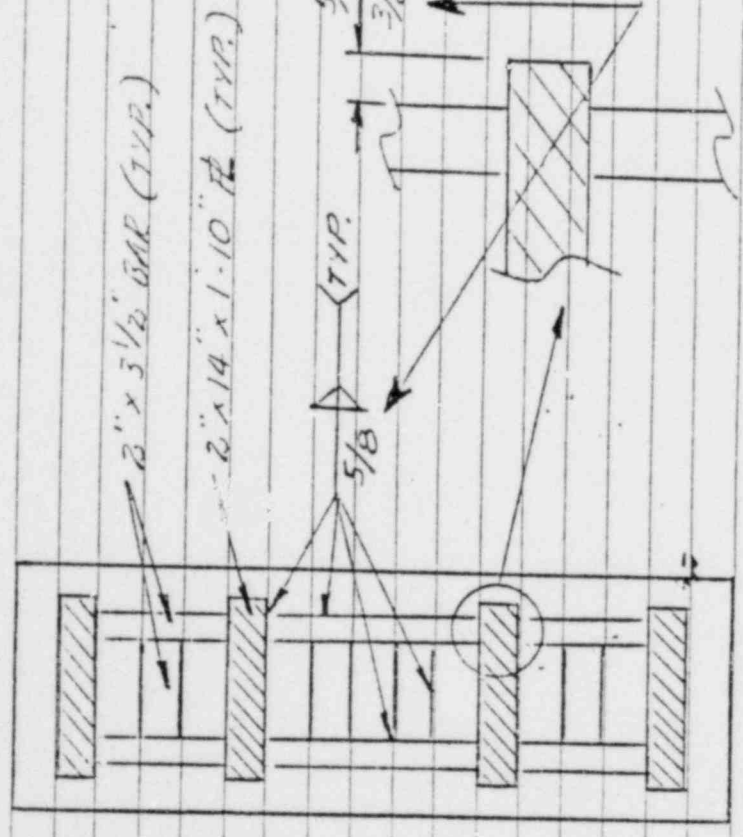
Block 16 continued.

5/8 REQ'D  
3/8 TO 1/2 ACTUAL
