MILLSTONE UNIT 3
PROJECT INSTRUCTION 2 (PI 2)
MP 3-SPECIFIC ASSESSMENT

REPORT TO MP 3 UPM AND MQC
ON PI 2 TEAM FINDINGS
REVISION 2

Prepared by: *[Signature]*
[Signature] 7-1-96
[Signature] 7-1-96
Date: *July 1, 1996*

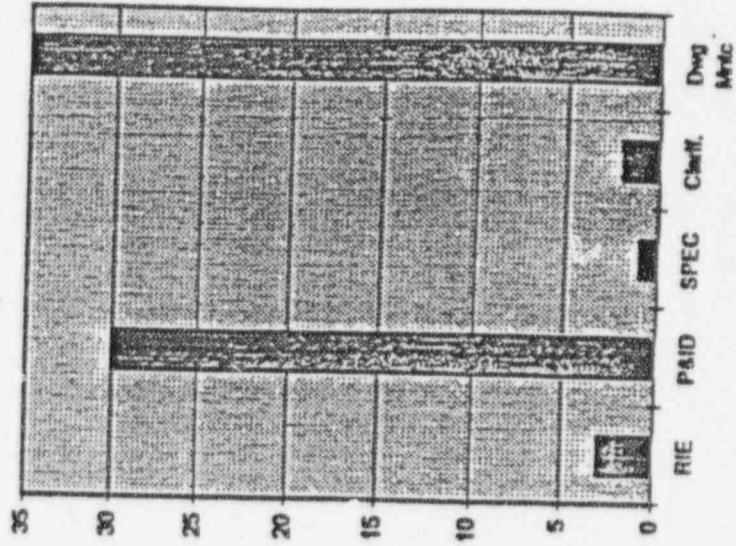
DCN Category Code 08

Types of DCNs

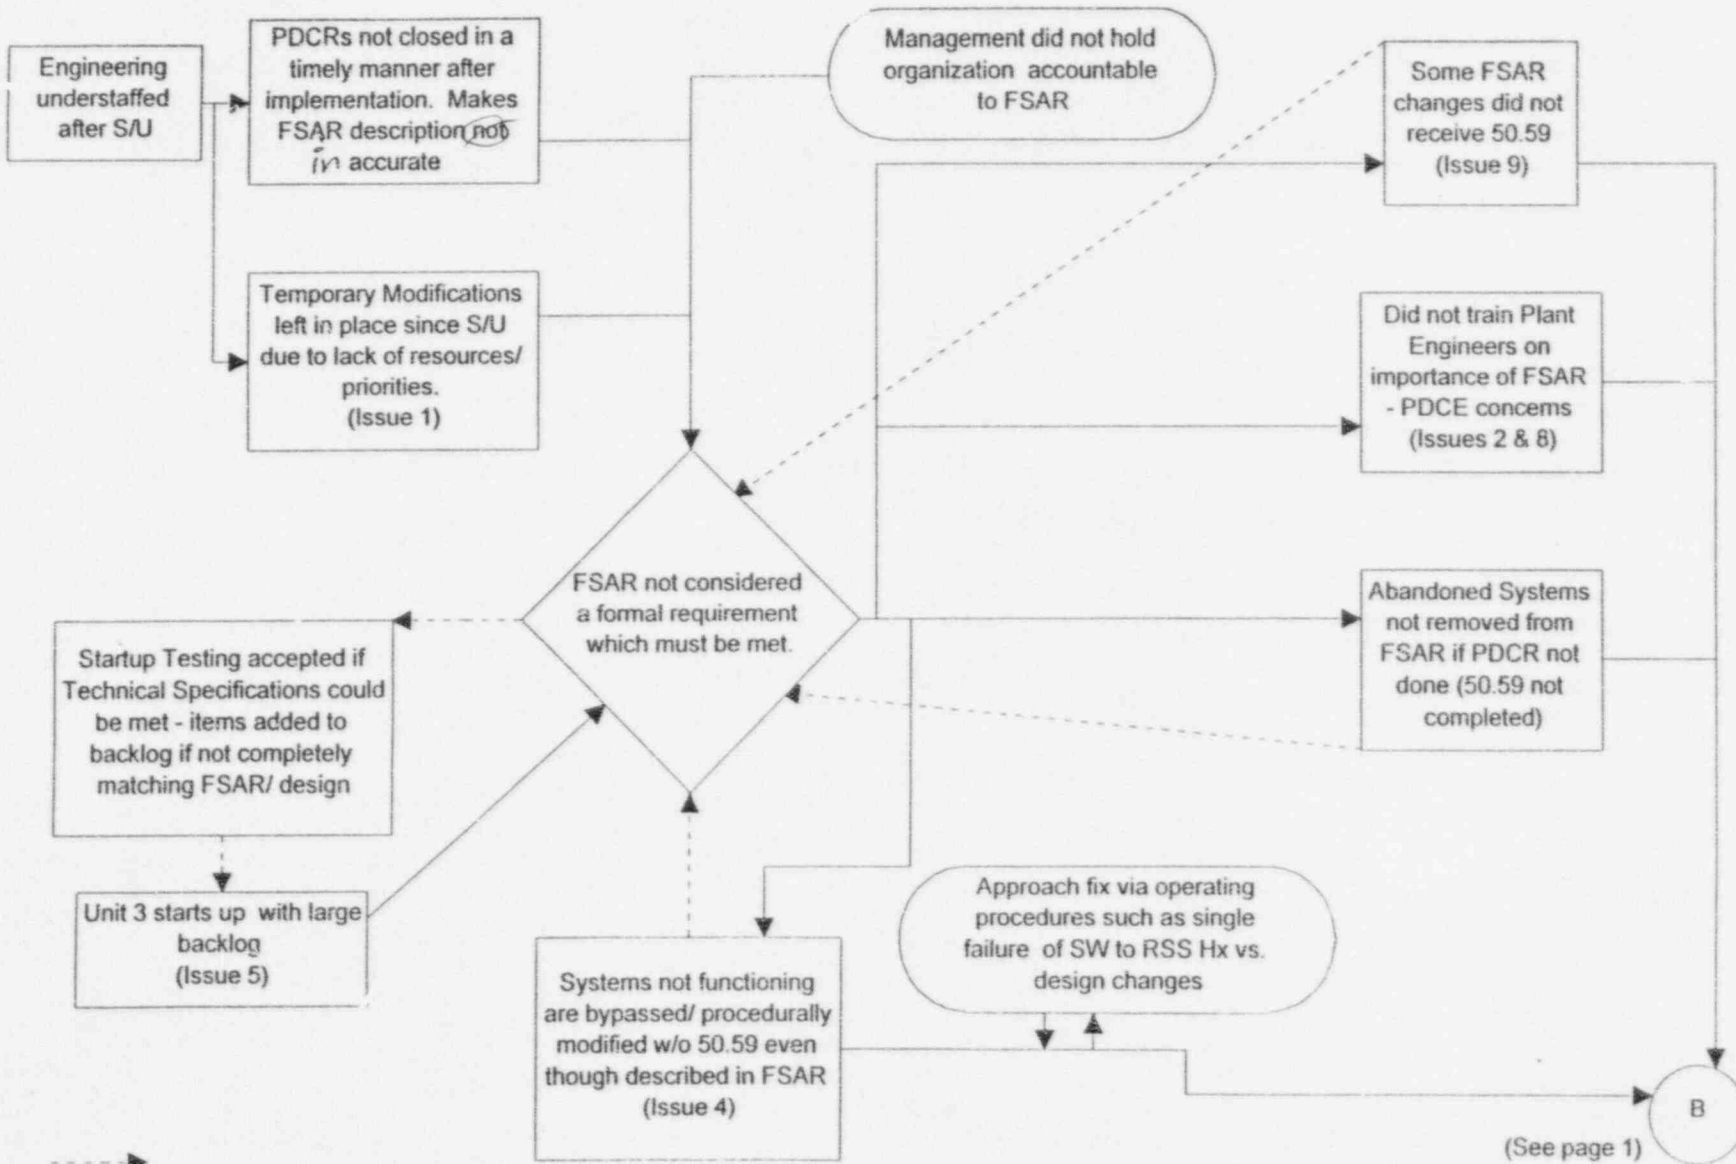
EVALUATION & CAUSAL FACTOR CHART

Dotted lines used to indicate feedback. The result feeds back to strengthen the perception behind the main causal factor.
