Approval <i>W F Kitchens</i> <i>W F Kitchens</i>	Vogtle Electric Generating Plant NUCLEAR OPERATIONS

<b>Georgia Power</b>	Procedure No. 93240-C
Date 3/8/90 3/20/90	Unit <u>COMMON</u>		Revision No. <i>787</i> <i>JFC</i>
			Page No. 1 of 98

REACTOR VESSEL ASSEMBLY/DISASSEMBLY INSTRUCTIONS

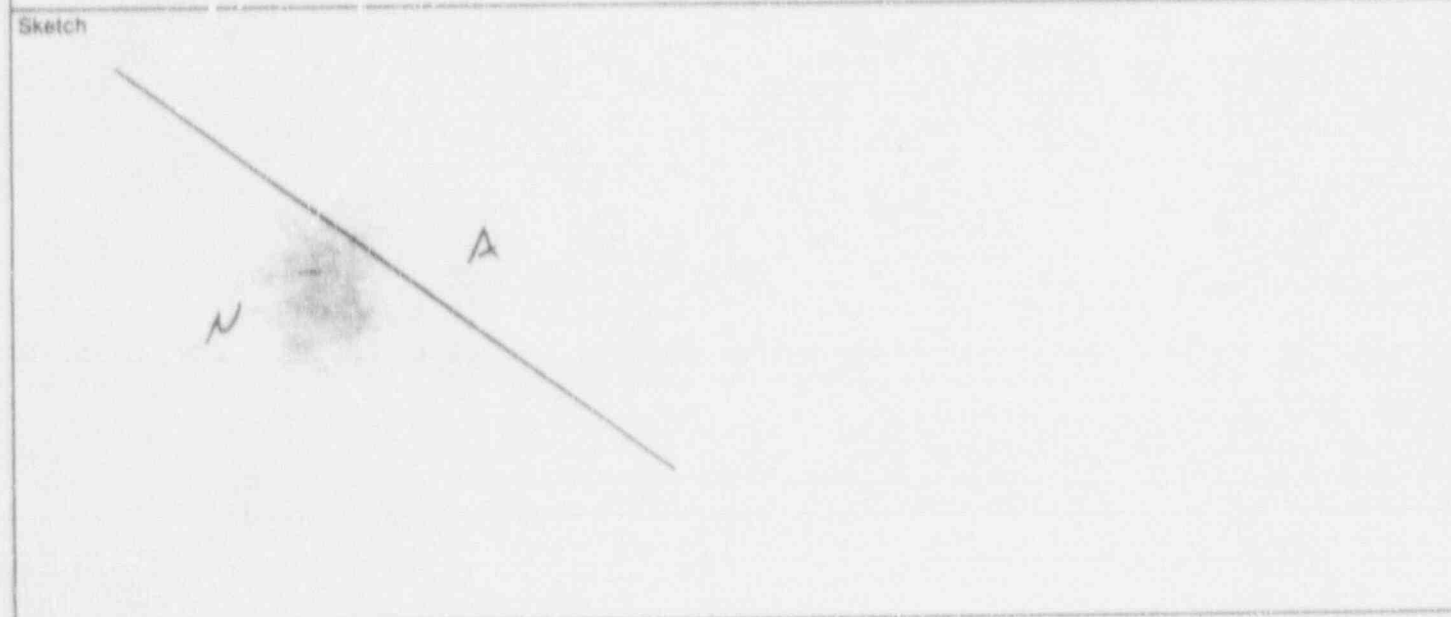
VISUAL EXAM ON BODY EXTERNAL SURFACE @ SEAL WELD REMOVAL AREA REVEALED A GRINDING GROOVE APPROX. 3/32" TO 1/8" IN DEPTH APPROX 200° AROUND BODY, WIDTH OF GROOVE APPROX 1/8"

SAT  UNSAT—ODR/DR NO.(S): 18905286

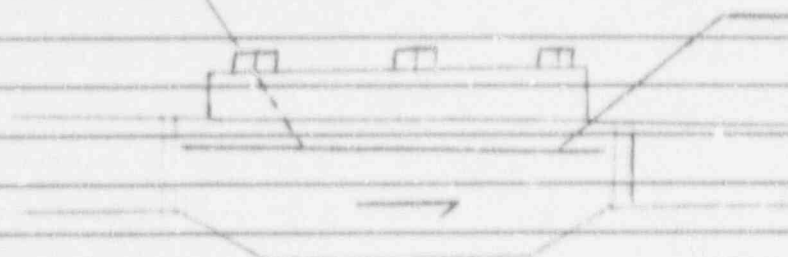
VIEW FACING WALL

Remarks #2  
CONTINUOUS GROOVE ON BACKSIDE  
FOR 20' APPROX SAME DIMENSIONS AS #1

#1  
CONTINUOUS GROOVE  
150' APPROX 1/2 TO  
3/32" IN WIDTH & DEPTH

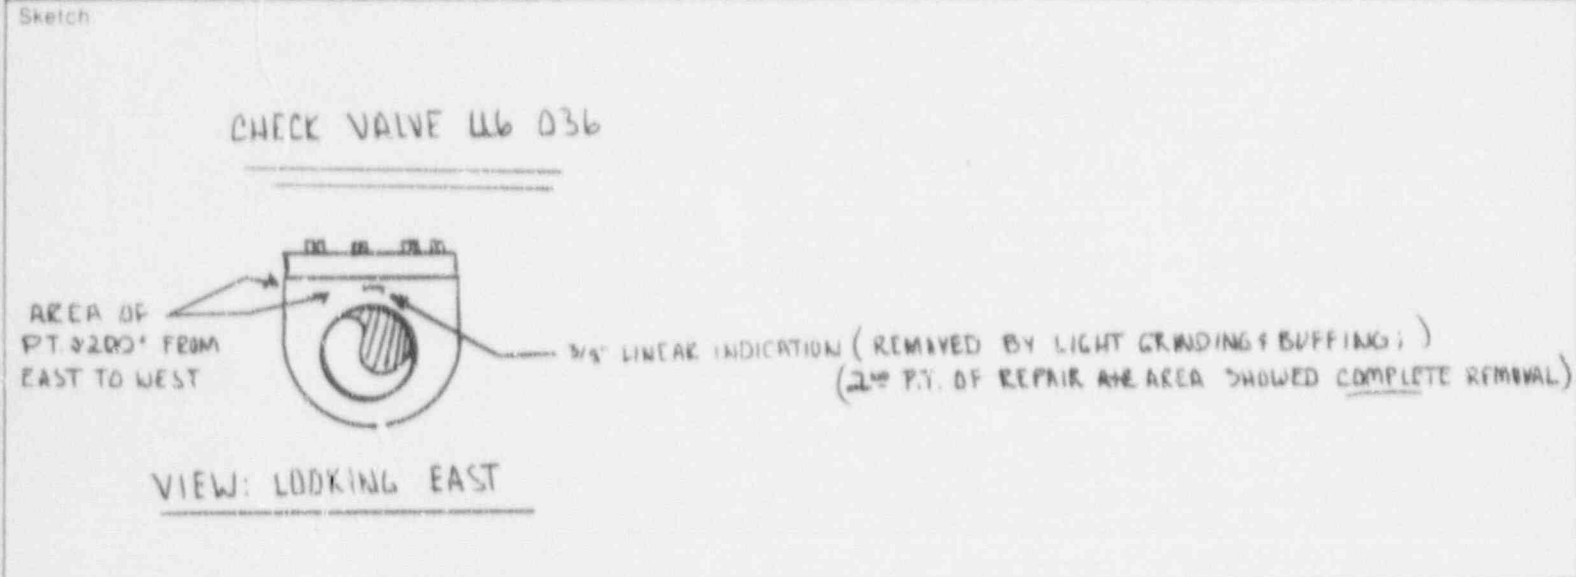
② PERFORMED L.P.T. OF THE REPAIR AFTER WELDING & GRINDING. 3/8" LINEAR INDICATION NOTED.

③ RE-PERFORMED L.P.T. AFTER LIGHT GRINDING AND BUFFING. NO DISCREPANCIES NOTED.
