GEORGIA POWER COMPANY |
PLANT E.1. HATCH |

HATCH 1 AND 2 - AIT FOR LEAK FROM SPENT FUEL POOL
DECEMBER 4, 1986, (E. WEISS, IE)

PROBLEM: 141,000 GALLONS LEAKED FROM SPENT FUEL POOL TRANSFER CANAL

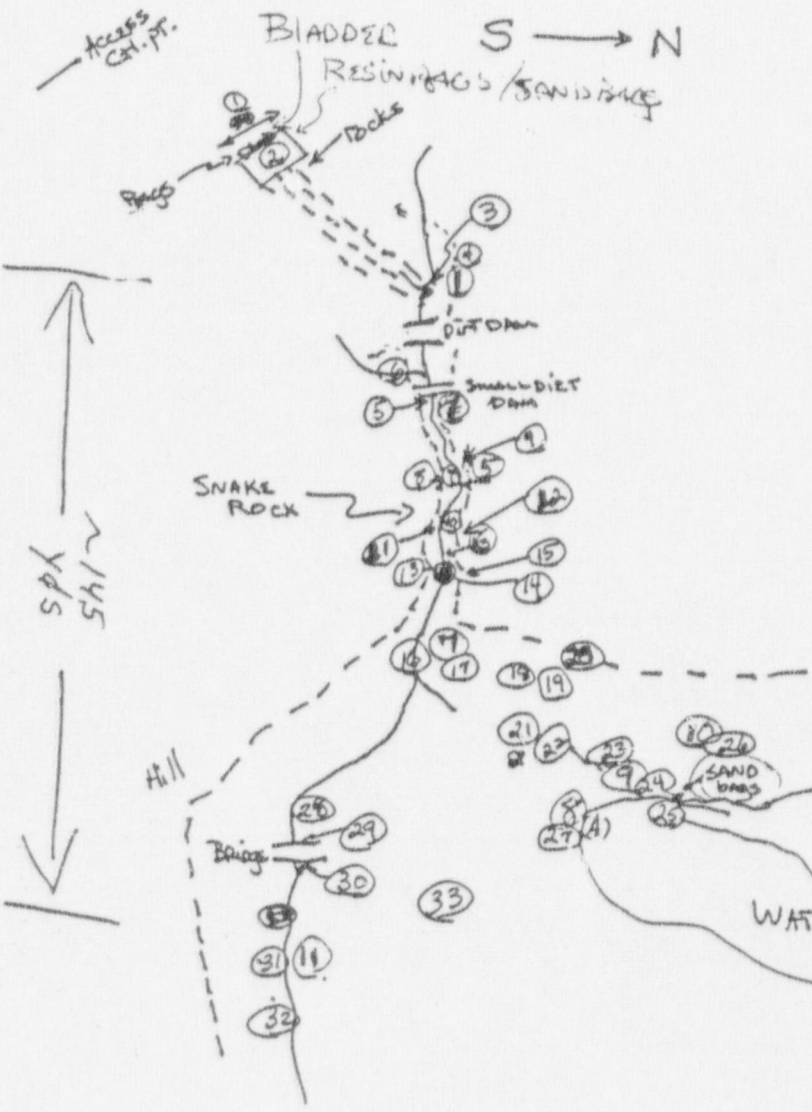
D. & T. Sample Points

uR/hr	COMMENT
① 30	
② 400	
③ 400	ACROSS CREEK - 4ft
④ 300	
⑤ 200	
⑥ 100	
⑦ 250	
⑧ 200	
⑨ 30	
⑩ 800	
⑪ 200	4ft wide (~20ft from C)
⑫ 30	at both BANKS
⑬ 40	
⑭ 600 → 400	
⑮ 20	(at MAD ribbon)
⑯ 280	
⑰ 200	20ft from 16
⑱ 220	" " 17
⑲ 1800	" " 18
⑳ 150	
㉑ 600	20ft from 19
㉒ 80	10ft from 21
㉓ 40	
㉔ 60	
㉕ 120	(at #9) ㉖ 40
㉗ 25	
㉘ 600	ctr of CREEK 2ft wide
㉙ 500	UNDER BR
㉚ 1500	
㉛ 100	
㉜ 16	
㉝ 16

- No migration overnight
- A seepage path into & from the river
No detectable activity on river side
- No flow from outfall
- No contamination in "clean" outfalls
