OAKLAND COMMUNITY COLLEGE
A VISION OF EXCELLENCE IN THE 21st CENTURY

FIVE YEAR CAPITAL OUTLAY MASTER PLAN

Facility & Utility Condition
Assessments

R1-2016-175 | December, 2016 | Condition Appraisal Report

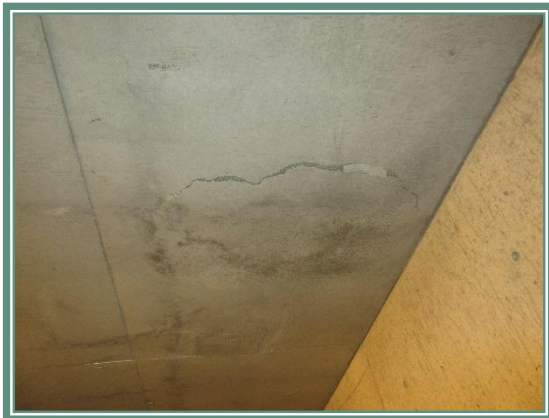
In general, the cast-in-place concrete slab is in good condition. The chain drag survey indicated that the cast-in-place concrete floor delaminations are mostly confined to the areas above the beams. Top of slab delaminations totaled 4,300 square feet, which is approximately 3.5% of the total supported slab area. The delaminated areas noted were of various sizes ranging from 2 square feet to 360 square feet. The majority of delaminations (88%) were located at Level 2.

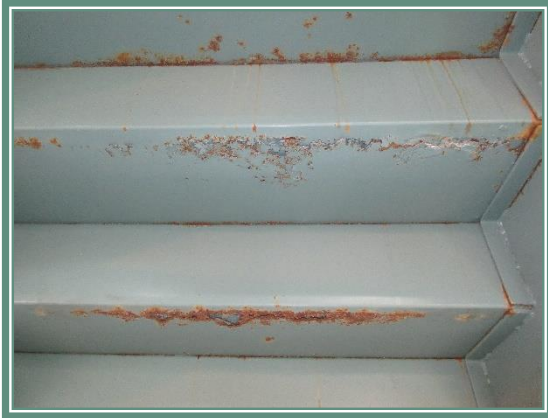
The northwest stairtower is in fair condition whereas the southeast and southwest stairtowers are in good condition. The northwest stairs consist of metal pans with concrete infill and the southeast and southwest stairs consist of precast concrete. The southeast and southwest stairtowers are discussed in more detail in the South Parking Structure Report.

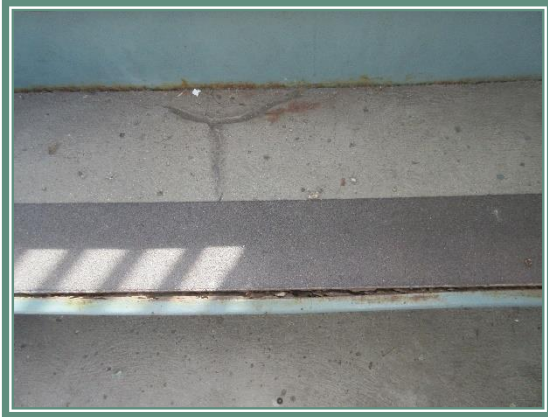
Corrosion of the steel was noted at the underside of the stair pans in the northwest stairtower, particularly on the south side at the upper levels. There is an open gap between the deck and the Northwest stair tower that may be allowing moisture and chlorides to enter the stairtower and cause corrosion of the steel. An enclosure could be installed at the roof level to cover the gap and prevent the infiltration of moisture and chlorides. Deck coating the stairway would also help protect the steel from moisture and chlorides.

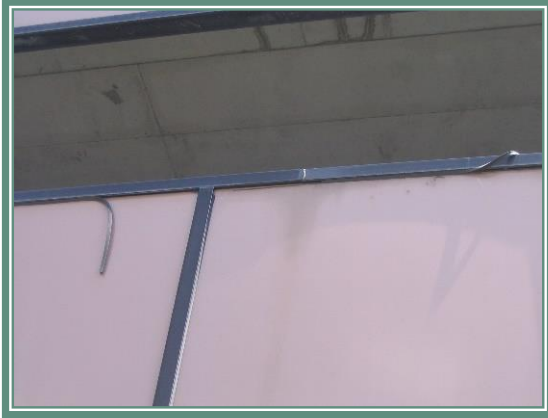
The ribbon seals between the deck and the entrances to the stairtowers have failed at the supported levels. The seals need to be replaced.

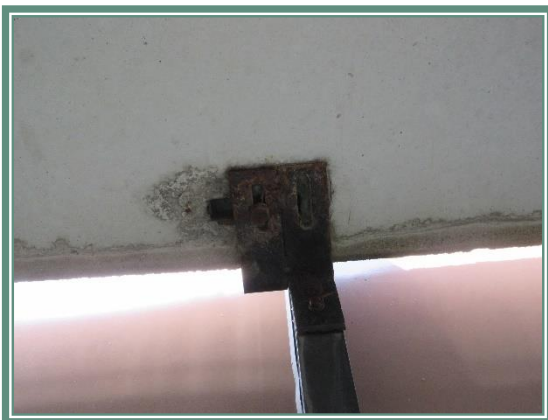
Corrosion was noted on a few of the metal façade plates. These were localized to the Grade Level in the southwest corner of the structure. The plates should be repaired or replaced.

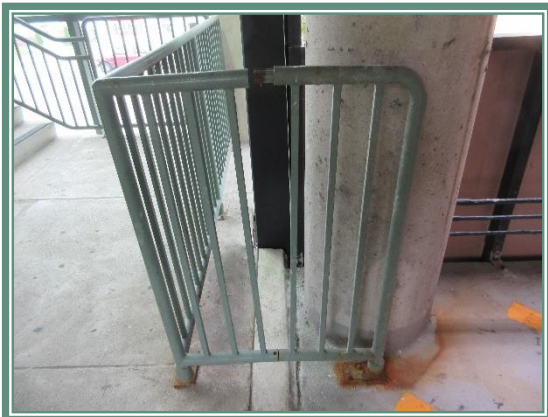
The metal guardrails located at the south perimeter of each supported level was noted to have damage painting.

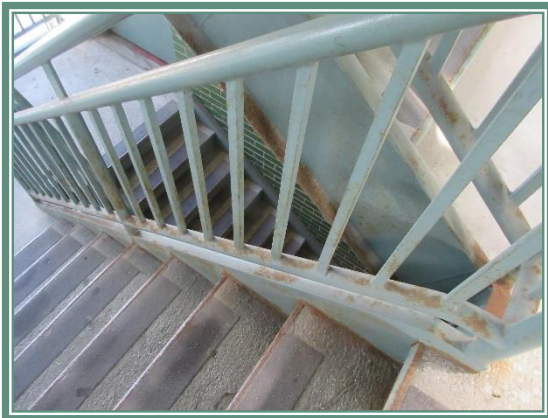
Handrails leading into the southwest stairtower across the expansion joint at Levels 2 and 3 are pulling apart and corroded. These need to be repaired.

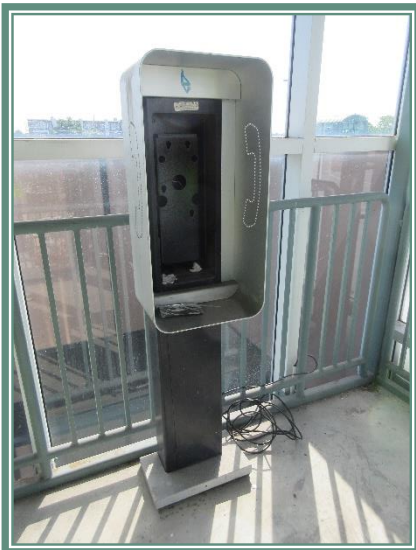
There is an old pay phone stand at Level 4 in the north stairtower. The stand could be removed since the phone has been removed.

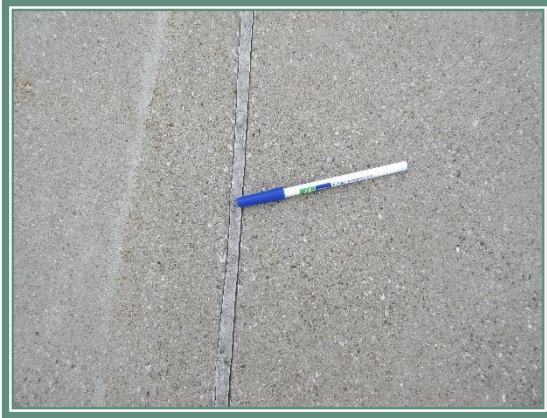
The tee to tee joint sealants vary in condition. At the Roof Level the sealants are in poor condition. At the lower levels the sealants are in fair condition. Failed joint sealants allow the infiltration of moisture and chlorides which can lead to deterioration of the precast elements. The joint sealants are 12 years old, much more than their estimated service life of 8 to 10 years. The sealants need to be completely replaced.

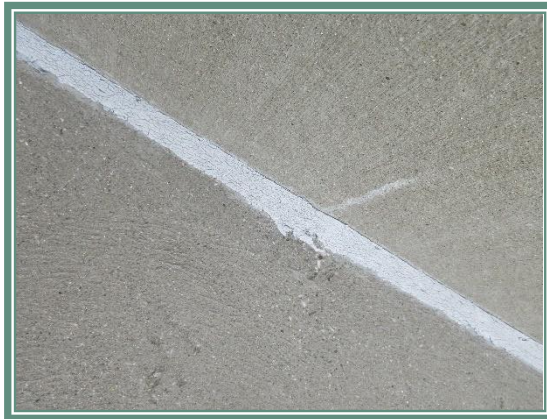
The cove joint sealants vary in condition. At the Roof Level the sealants are in poor condition. At the lower levels the sealants are in fair condition. Failed cove sealants allow the infiltration of moisture and chlorides which can lead to deterioration of the precast elements. The cove joint sealants are 12 years old, much more than their estimated service life of 8 to 10 years. The sealants need to be completely replaced.

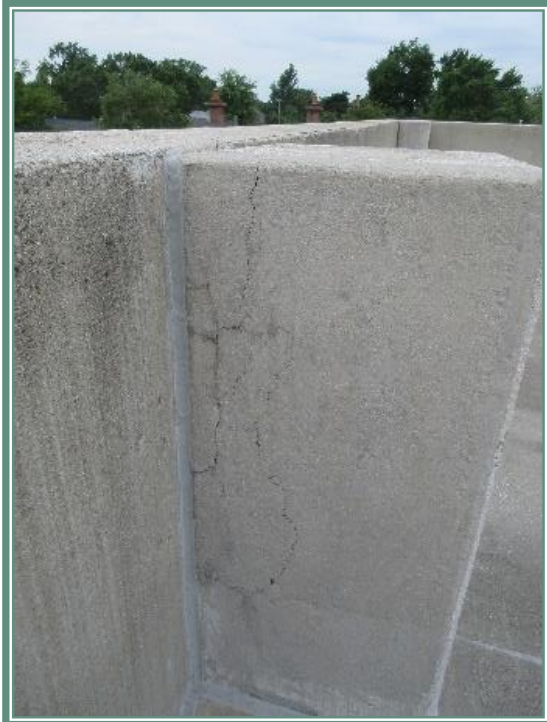
Wall sealants along the edges of the columns on the roof level are in poor condition. The sealants are 12 years old, much more than their estimated service life of 8 to 10 years. The sealants need to be completely replaced.

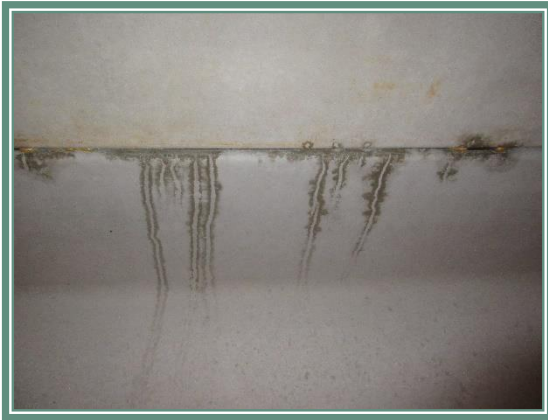
Leaks from the tee to tee joints were noted in various spots, indicating that the joint sealants had failed. These joints need to be replaced to prevent infiltration of water and chlorides.

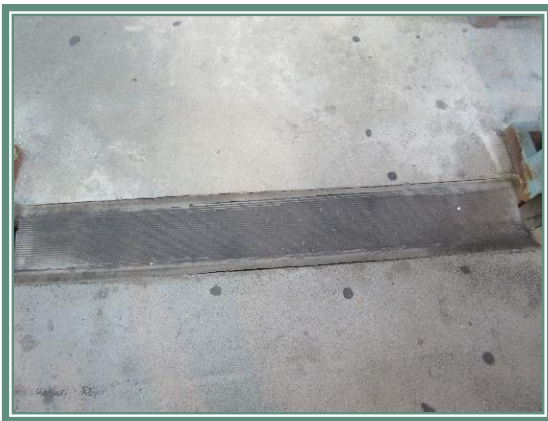
The ribbon seals between the stairtowers and the deck have failed at the entrances to both stairtowers from each supported level. These need to be removed and replaced to protect the structure from water and chlorides.

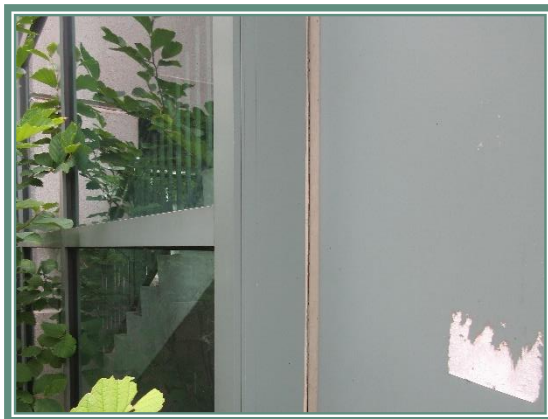
The exterior metal-to-metal sealant on the corners of both of the stairtowers have failed. These joints should be replaced to protect the stairtower from moisture related deterioration.

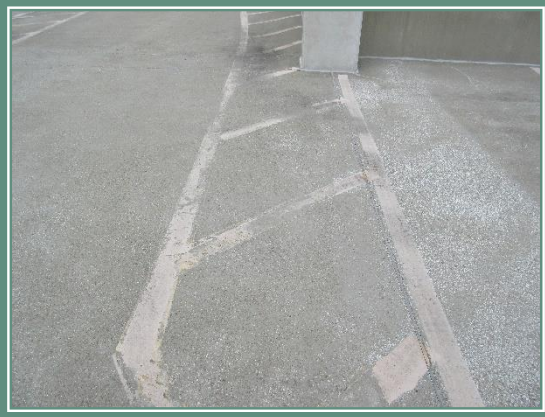
The traffic striping on Level 4 is worn in many spots and needs to be repainted.

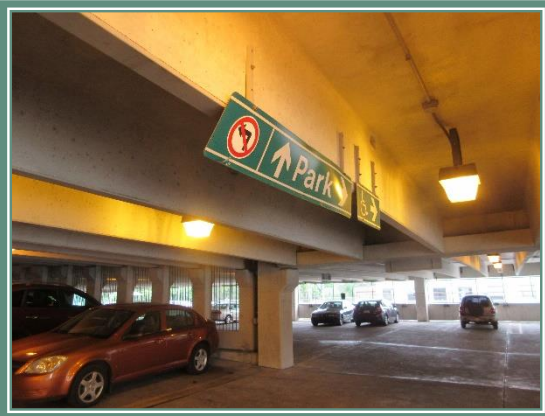
Several signs are damaged and need to be replaced.

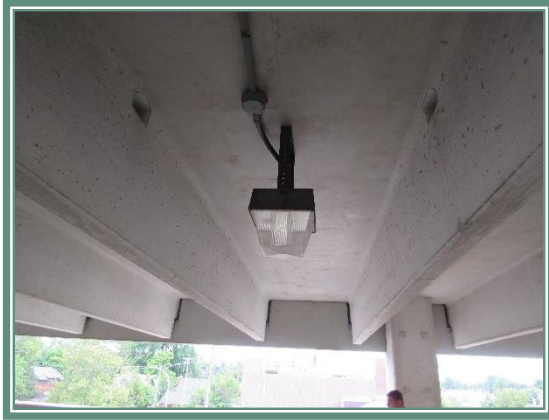
The lighting system appears to consist of older light fixtures serviced by an external conduit. The lights are typically placed alternatingly between one and two lights per bay per column bay with pole-mounted lights on Level 4. The lighting system appears to be in good condition.
