Subject: URGENT MEDICAL DEVICE CORRECTION

Affected Product: ROSA One 3.1 Brain application

ROSA One 3.1 Brain Application

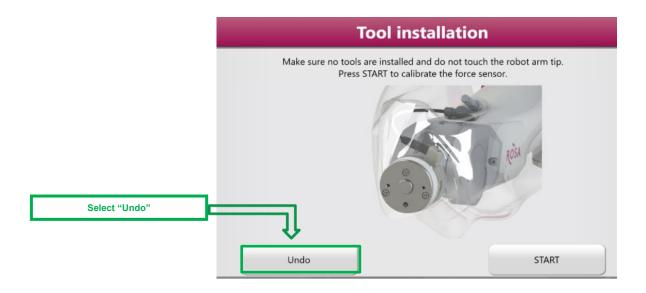
After the registration of the patient during the ROSA One 3.1 Brain application procedure, the issue may occur when the device shuts down either manually or unexpectedly. After reboot, if the trajectory is interrupted by deactivating the pedal, the device gives the user an option to "Return to HOME", "Clear the robotic arm", or "Continue". If the user chooses to "Clear the robotic arm", the device prompts the user to perform an empty device calibration. If the user performs this step and presses start, the issue will occur, which results in the device driving to an incorrect trajectory.

If a shutdown occurs during guidance mode, any empty calibration window that would subsequently appear during the session should be closed by pressing UNDO.

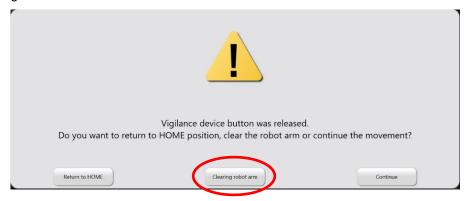
- 1. Launch ROSA One 3.1 Brain application.
- 2. Perform patient registration.
- 3. Go in guidance with a surgical tool mounted on the robot arm.
- 4. Shutdown the device while in guidance mode (the shutdown may occur unexpectedly or could be performed by the user).
- 5. Restart the device.
- 6. During movement of the robot arm, the vigilance device is released or a collision is detected by the software.
- 7. Select "Clearing robot arm".
