## Improving Bandwidth and Risetime in 174x Oscilloscopes

*Doug Moloney, Hewlett-Packard*

## More On Printed Circuit Board Rework, Repair, and Cleaning

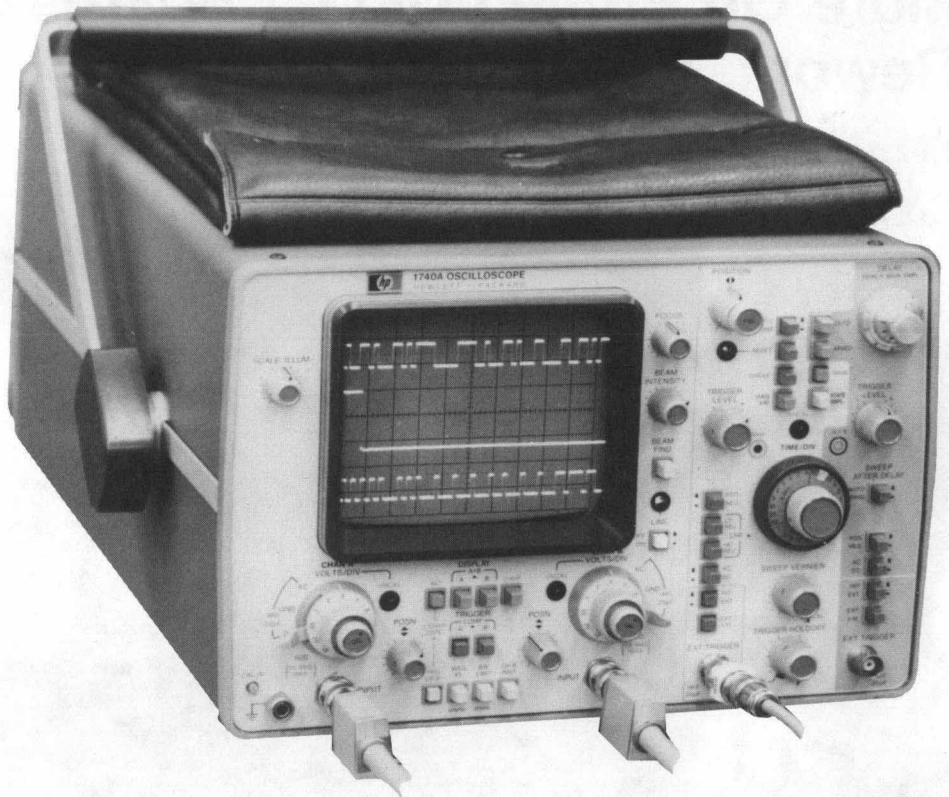
Low bandwidth and slow risetime problems in your 174X series of oscilloscopes may be caused by corrosion of the delay line's braided shield. What HP has discovered is that under extreme operating conditions (wide ambient temperature variations) the braid becomes corroded from gasses emitted by the outer PVC (polyvinyl chloride) jacket of the delay line.

Since the delay line is rarely moved once it is installed in the scope, the PVC contamination may continue to build until the braid's conductivity decreases to the point where high-frequency attenuation becomes significant. This process can occur in a relatively short time if the scope is subjected to repeated and radical changes in ambient temperature (extreme heating and cooling of the delay line). On the other hand, if the

1. Remove the scope's bottom cover.
2. Input a fast risetime pulse or 100 MHz sine wave and note the risetime or amplitude.
3. Locate the delay line (accessible from the rear of the A1 preamp assembly) and squeeze it several

Or, if desired, a new delay line can be installed that is no longer susceptible to the PVC contaminants. The new delay line part numbers are:

- 01740-61633 (for all 174X except 1743)
- 01743-61613 (1743 only)

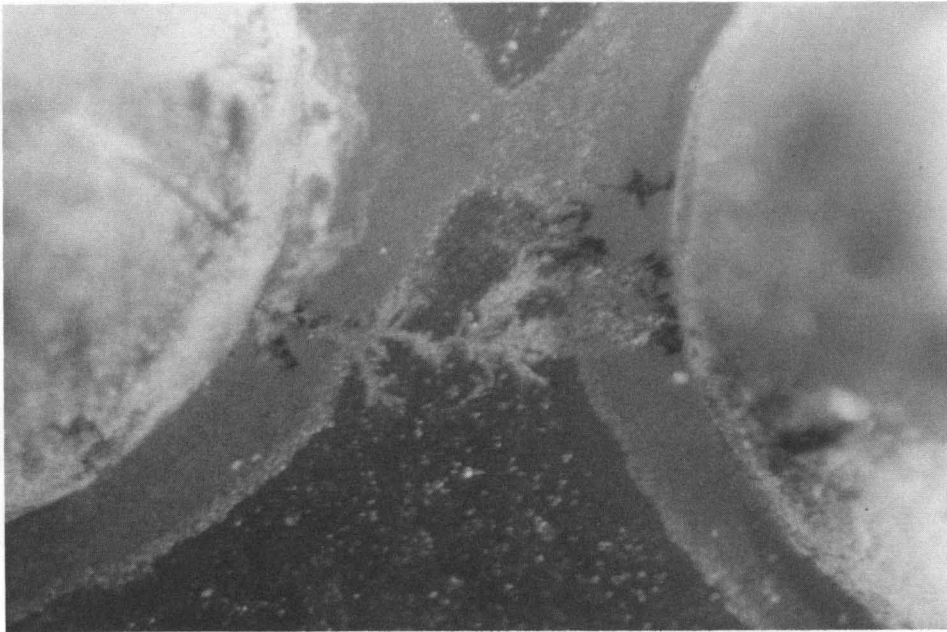
A dendrite, as shown in the photo, is a resistive short between these two solder nodes.

The previous issue of *Bench Briefs* showed a picture of a dendrite formed between two circuit traces and indicated that the cause was excessive use of circuit cooler. It's true that using the circuit cooler helped cause the dendrite, but it was mainly the moisture condensed out of the atmosphere that gave the dendrite its start. The water causes a bridge across the circuit traces, and the difference in voltage potential forms an electrolyte corrosion cell. Since corrosion is electroplating in reverse and gold is a noble metal, it becomes a cathode and the copper trace under the gold becomes the anode. The copper anode is depleted and the metal follows the water path to the gold.
