## IN-SERVICE PERFORMANCE OF STRUCTURAL DETAILS

FINAL TECHNICAL REPORT  
on  
Project SR-1232  
"Structural Details Failure Survey"

IN-SERVICE PERFORMANCE OF STRUCTURAL DETAILS

NEWPORT NEWS SHIPBUILDING

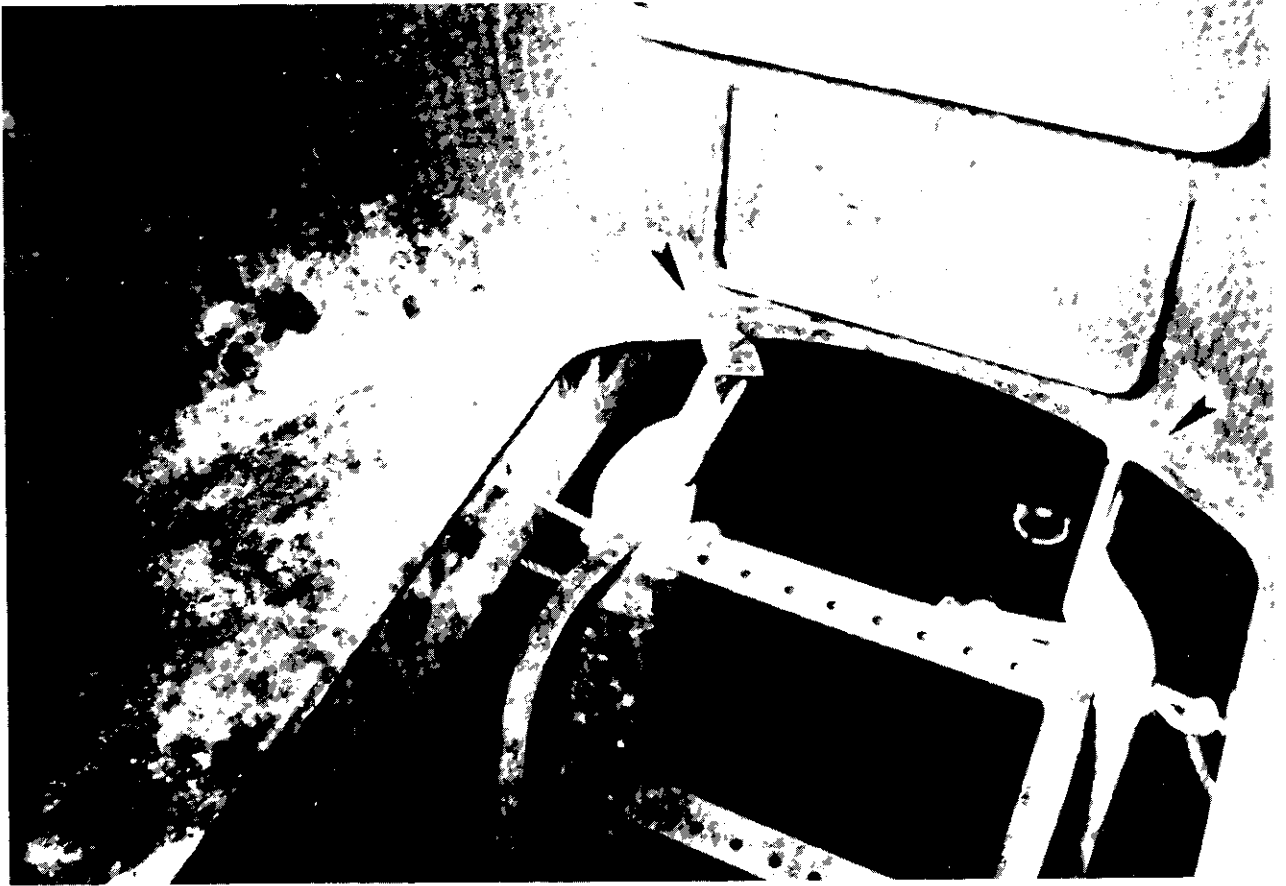
FAILED CARGO TANK LADDER CLIPS

The flat bar clips are welded to the underside of the deck and to the ladder frame. A square piece of cardboard has been inserted in the crack in the left-hand clip.

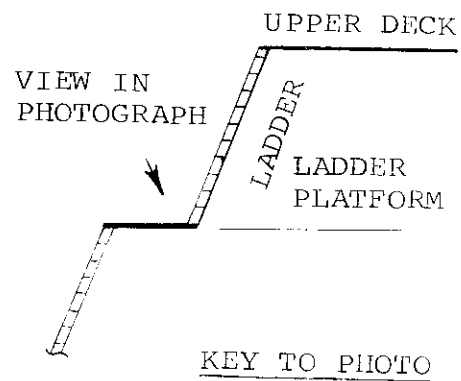
CRACKS IN LANDING PLATFORM  
FOR CARGO TANK LADDER

The cracks are encircled by white paint in order to aid location by repair men. The platform was still intact enough to hold the ladder.

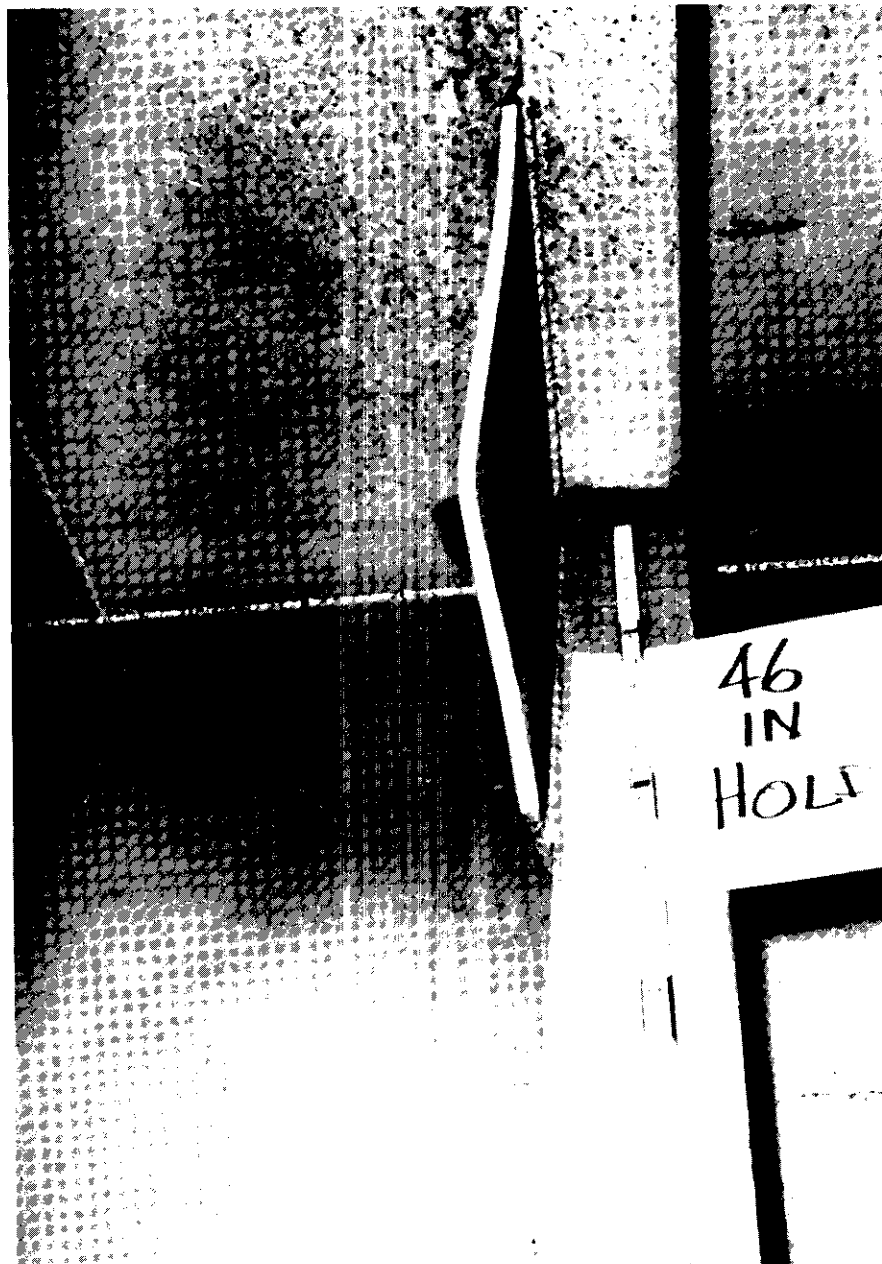
FAILED FLAT PLATE CORNER  
BRACKET ON A CONTAINERSHIP

The buckled bracket is similar to detail 1-C-1.

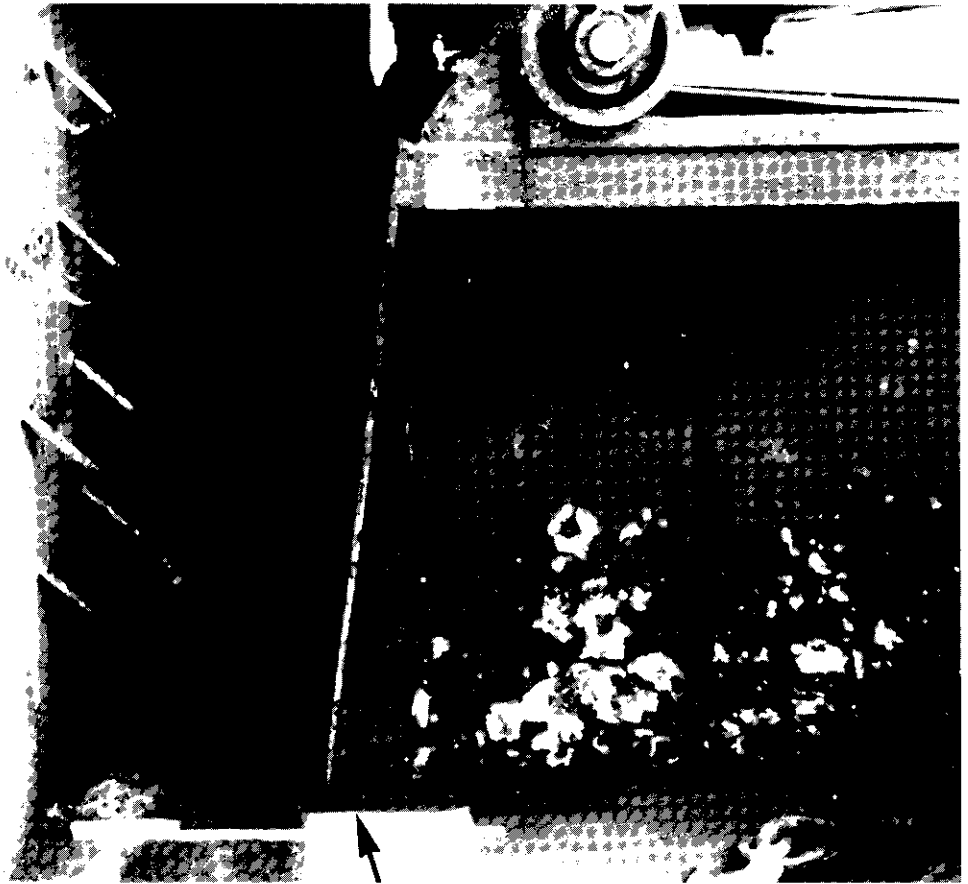
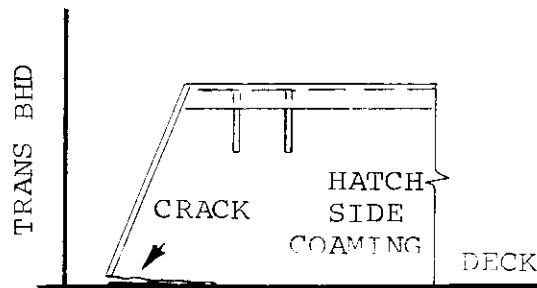
FAILED END BEAM BRACKET  
ON A COMBINATION CARRIER

This photograph shows the end of a hatch side coaming (detail 1-J-3) on weather deck. The ruler is oriented fore and aft and parallels the crack in the heat affected zone of the weld to the deck.

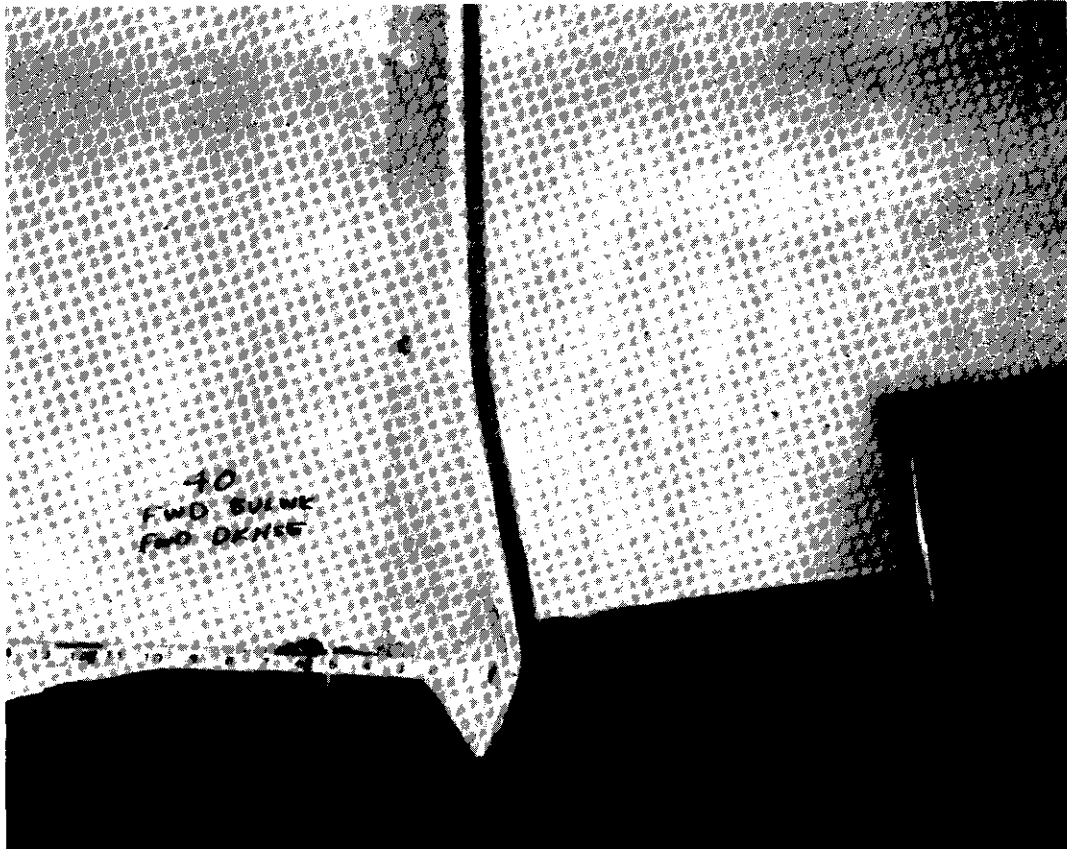
FAILED TRIPPING BRACKET SUPPORTING  
A DECK-HOUSE BULWARK ON A TANKER

The bulwark is on the forward side of a deck-house. The buckle in the bracket is due to an impact load on the bulwark. A crack also exists at the corner weld clearance cutout where the bottom of the bracket connects to the bulwark and to the deck.

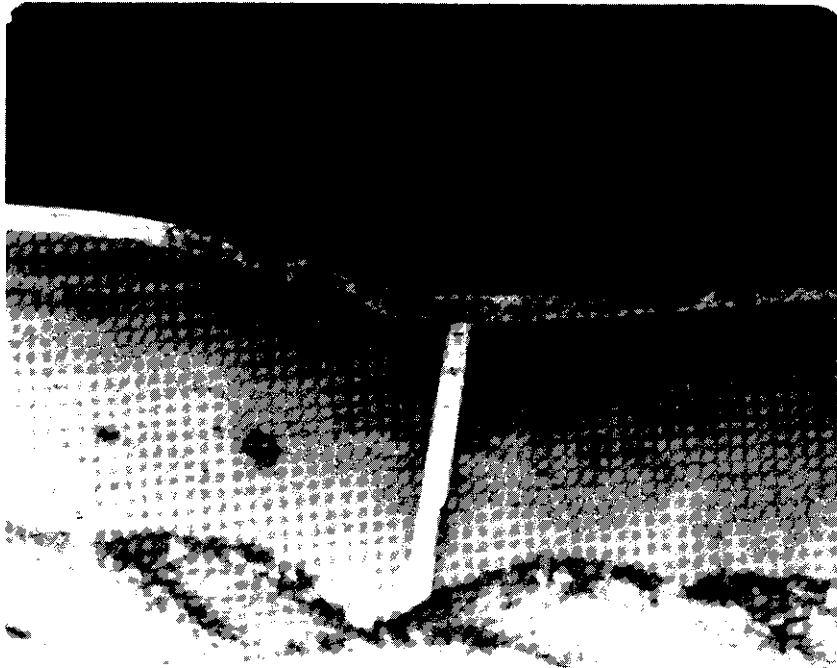
FAILED GUNWALE CONNECTION  
ON A MISCELLANEOUS VESSEL

Photographer is standing on main deck looking down at the gunwale. These out-of-plane displacements occurred in several places along the length of the gunwale on both sides of the vessel. Cracks were not observed in the detail which is similar to 5-B-8. The upper part of the picture shows part of a rope above the ruler.

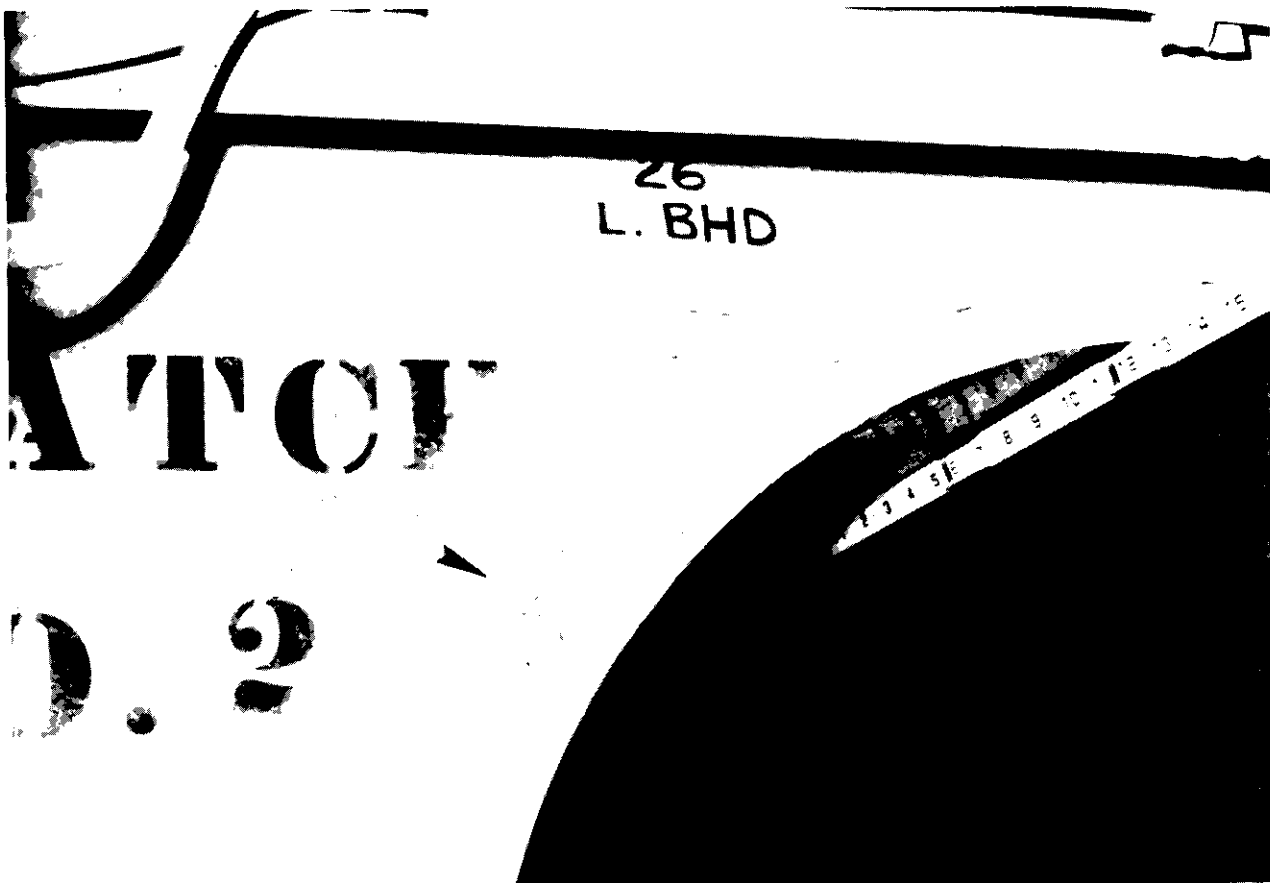
DEFECT AT AN ACCESS OPENING  
IN A CONTAINERSHIP

The access opening similar to detail 7-A-6, is near the forward end of the cargo space and in the longitudinal bulkhead of the box girder. The defect is a four inch crack in the weld of the coaming to the bulkhead plating. This detail has a history of repairs - see text.

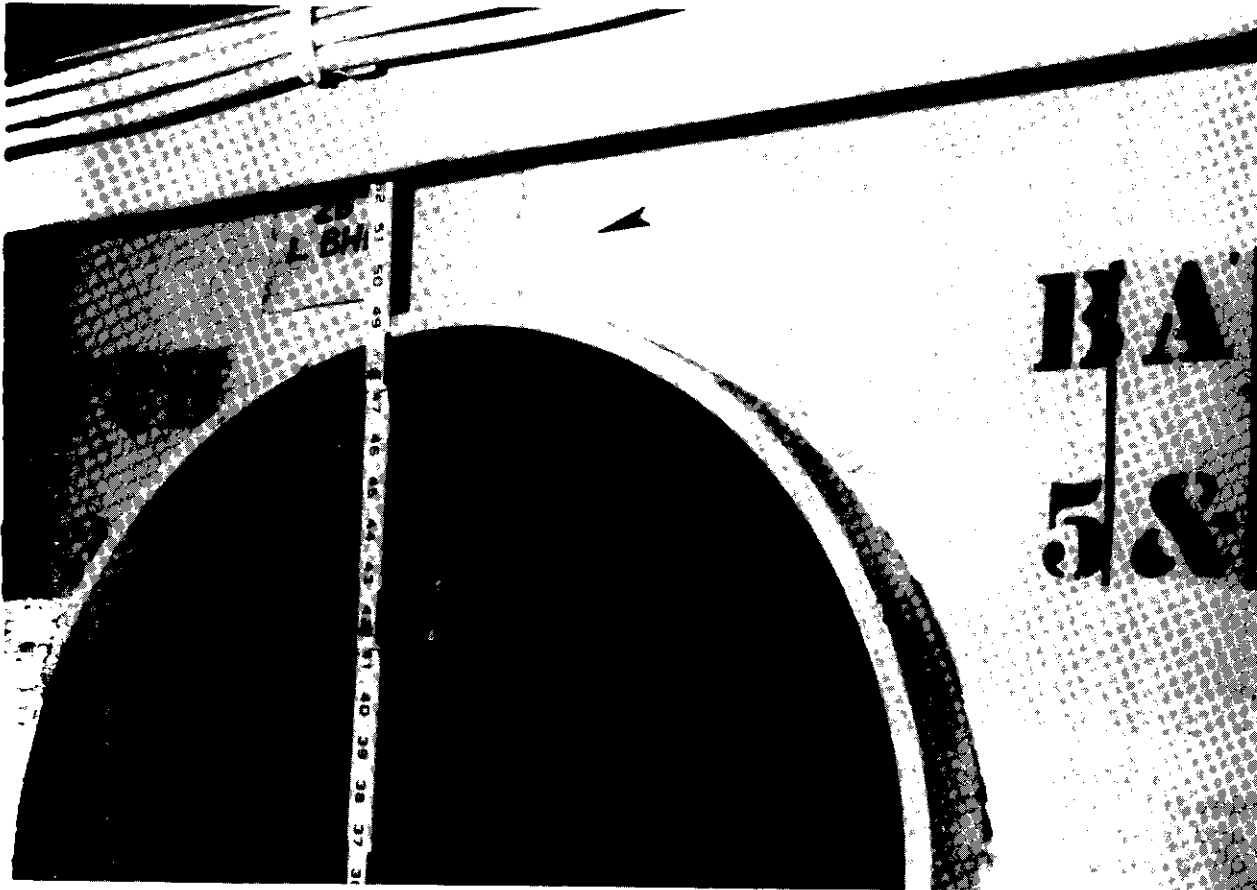
HISTORICAL DEFECT AT AN ACCESS  
OPENING IN A CONTAINERSHIP

The access opening is in the same box girder as the opening in Figure 21. Similar to detail 7-A-6, this opening has intermittent welds connecting the face plate to the longitudinal bulkhead of the box girder. The face plate is smaller than the one in Figure 21. The vertical weld centered above the opening repaired a crack that had developed in the bulkhead plating.

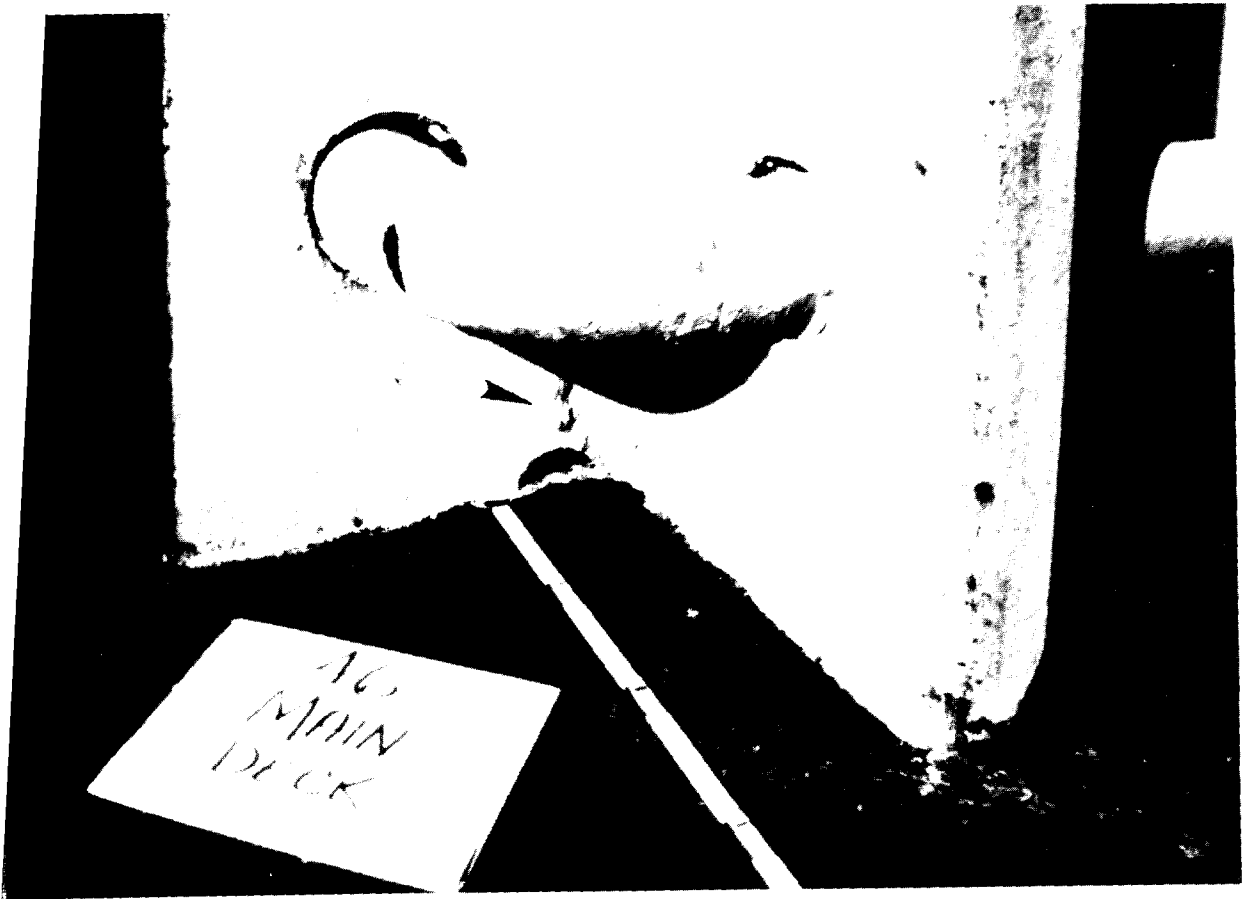
FAILED WELD CLEARANCE CUT ON A CONTAINERSHIP

The crack has been rewelded above the clearance cut at the end of the folding rule. The cut is in a bracketed end of a hatch side coaming on main deck.

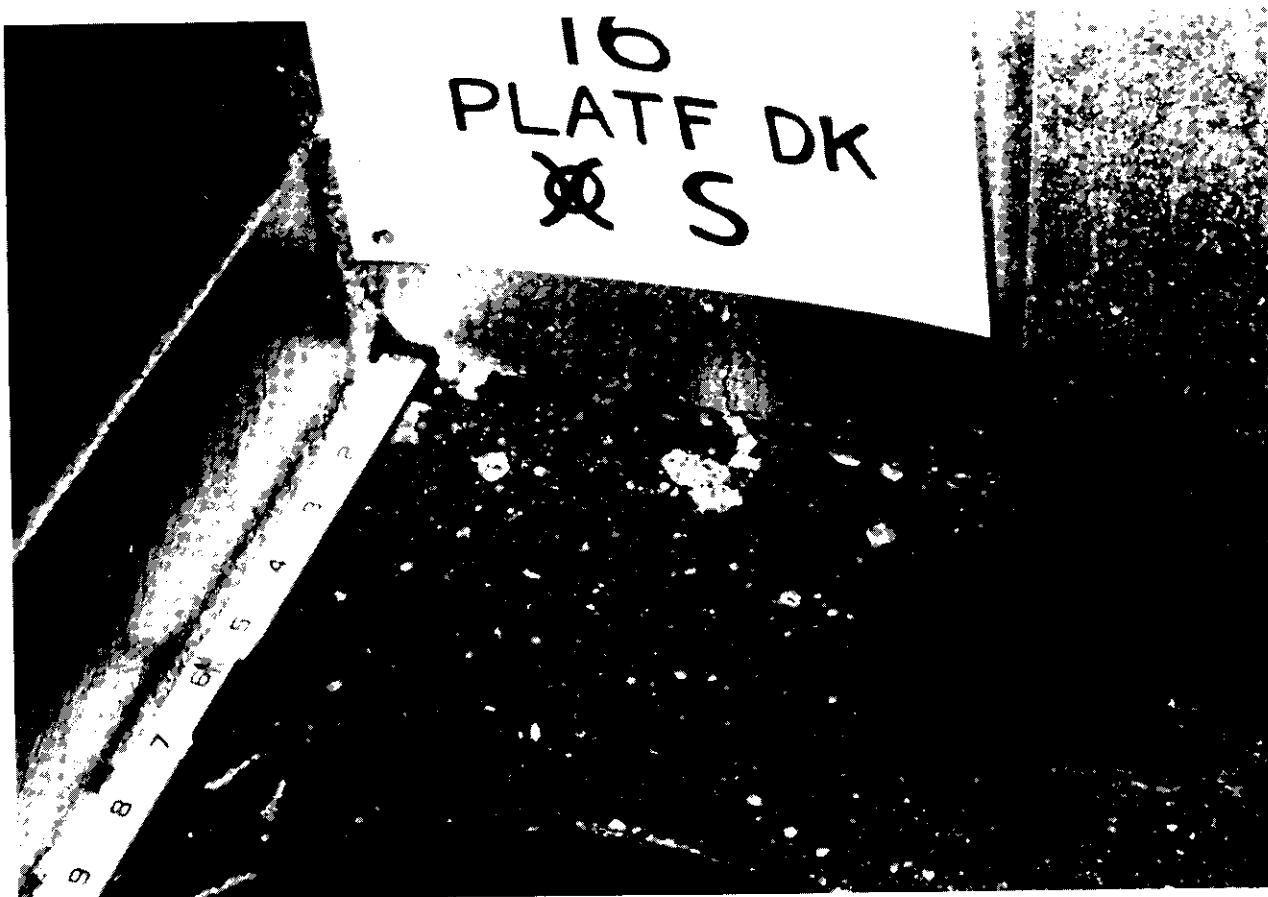
FAILED CLEARANCE CUT AT AN ACCESS  
OPENING ON A COMBINATION CARRIER

The view is looking down at the side of an access opening in a platform deck aft but forward of the machinery space. The crack is between the clearance cutout, detail 8-B-2, and the larger access opening.

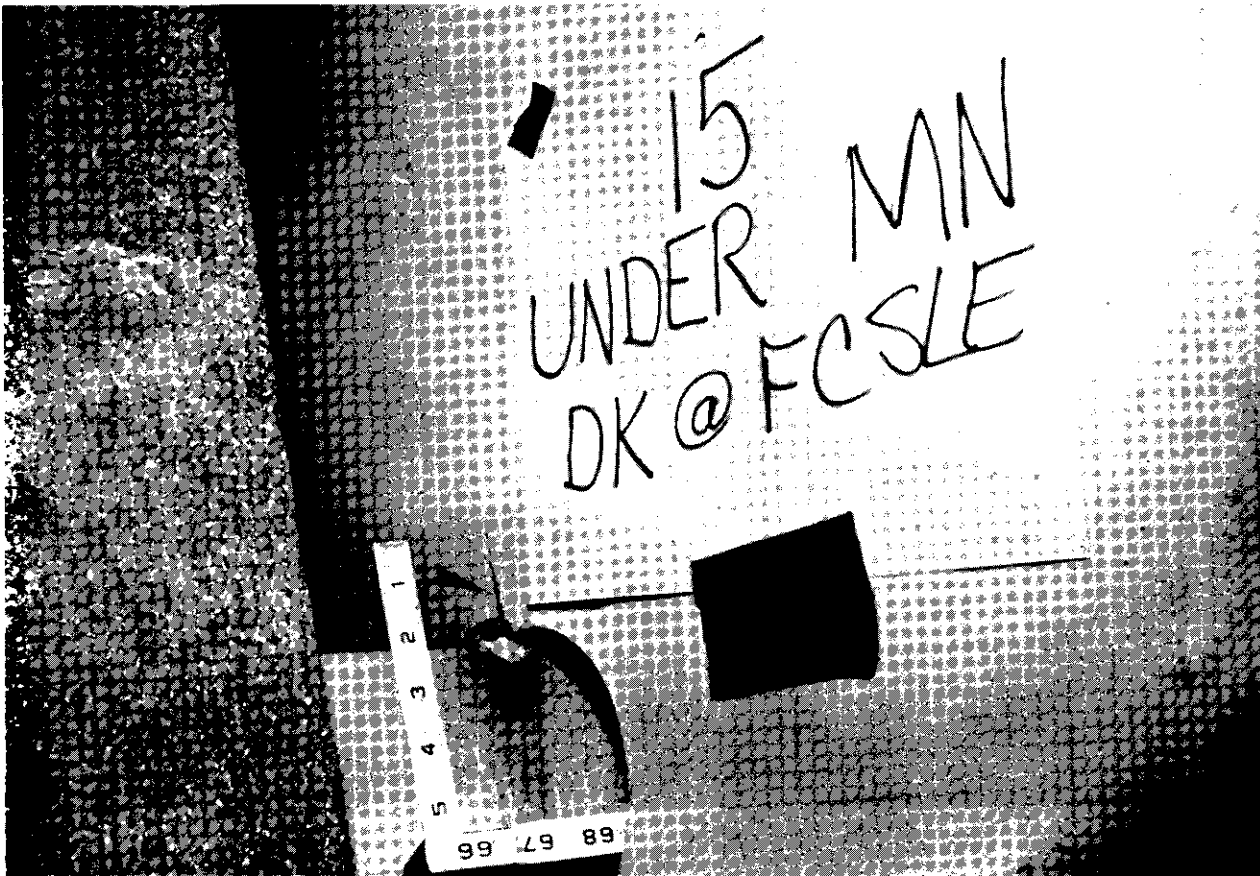
FAILURE MODE FOR GROUP "D" CLEARANCE  
CUTOUTS ON A COMBINATION CARRIER

The view is of a detail 8-D-6 cutout around a shell longitudinal piercing a transverse web frame. The cracks at these cutouts are invariably in the plating at the through stiffener heel.

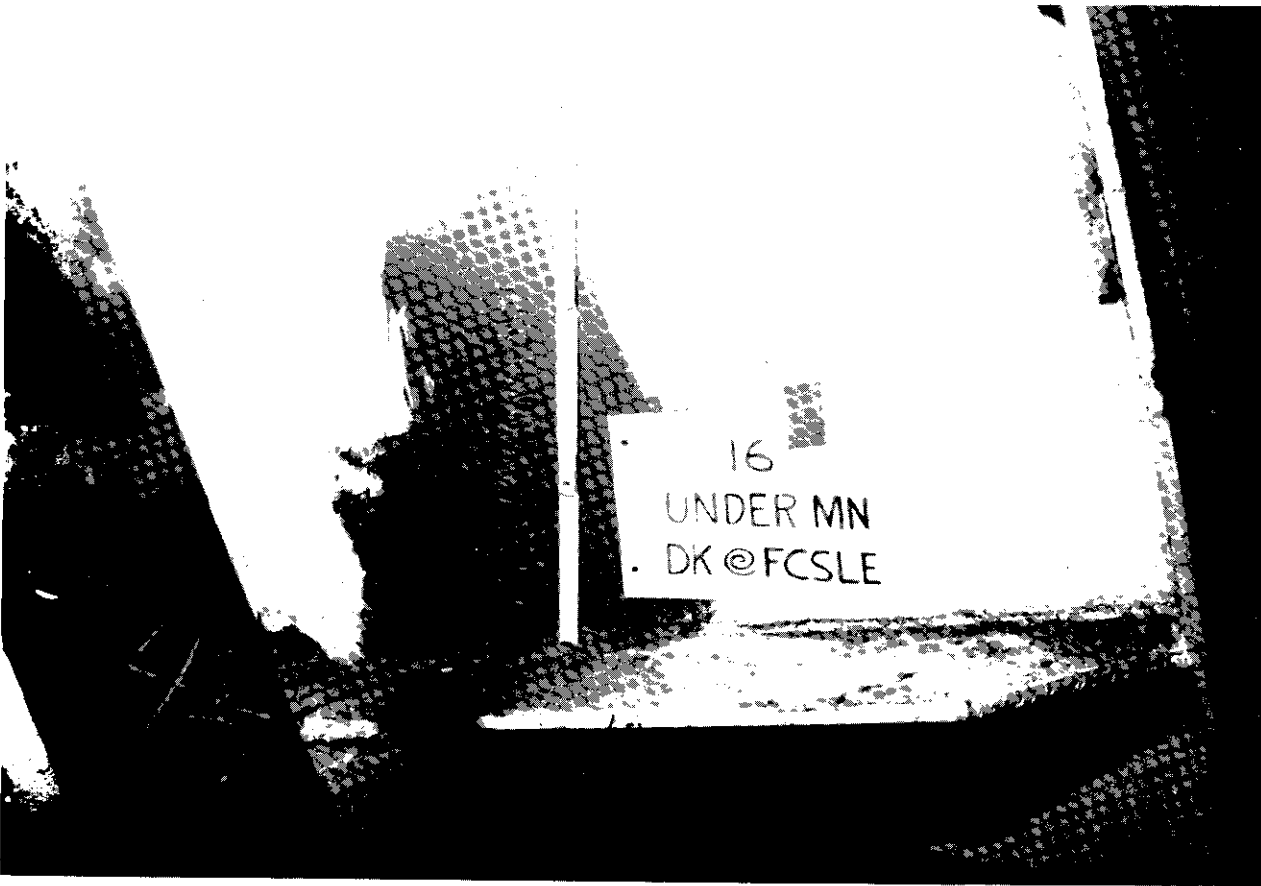
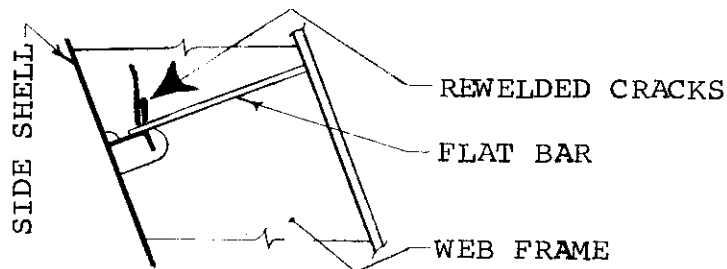
REPAIRED CLEARANCE CUT FAILURE  
ON A COMBINATION CARRIER

Photograph shows rewelded cracks in web of side shell web frame in forward cargo hold - combination carrier, (see key plan below). Item with 45 chalk number is a wooden batten over shell longitudinals.

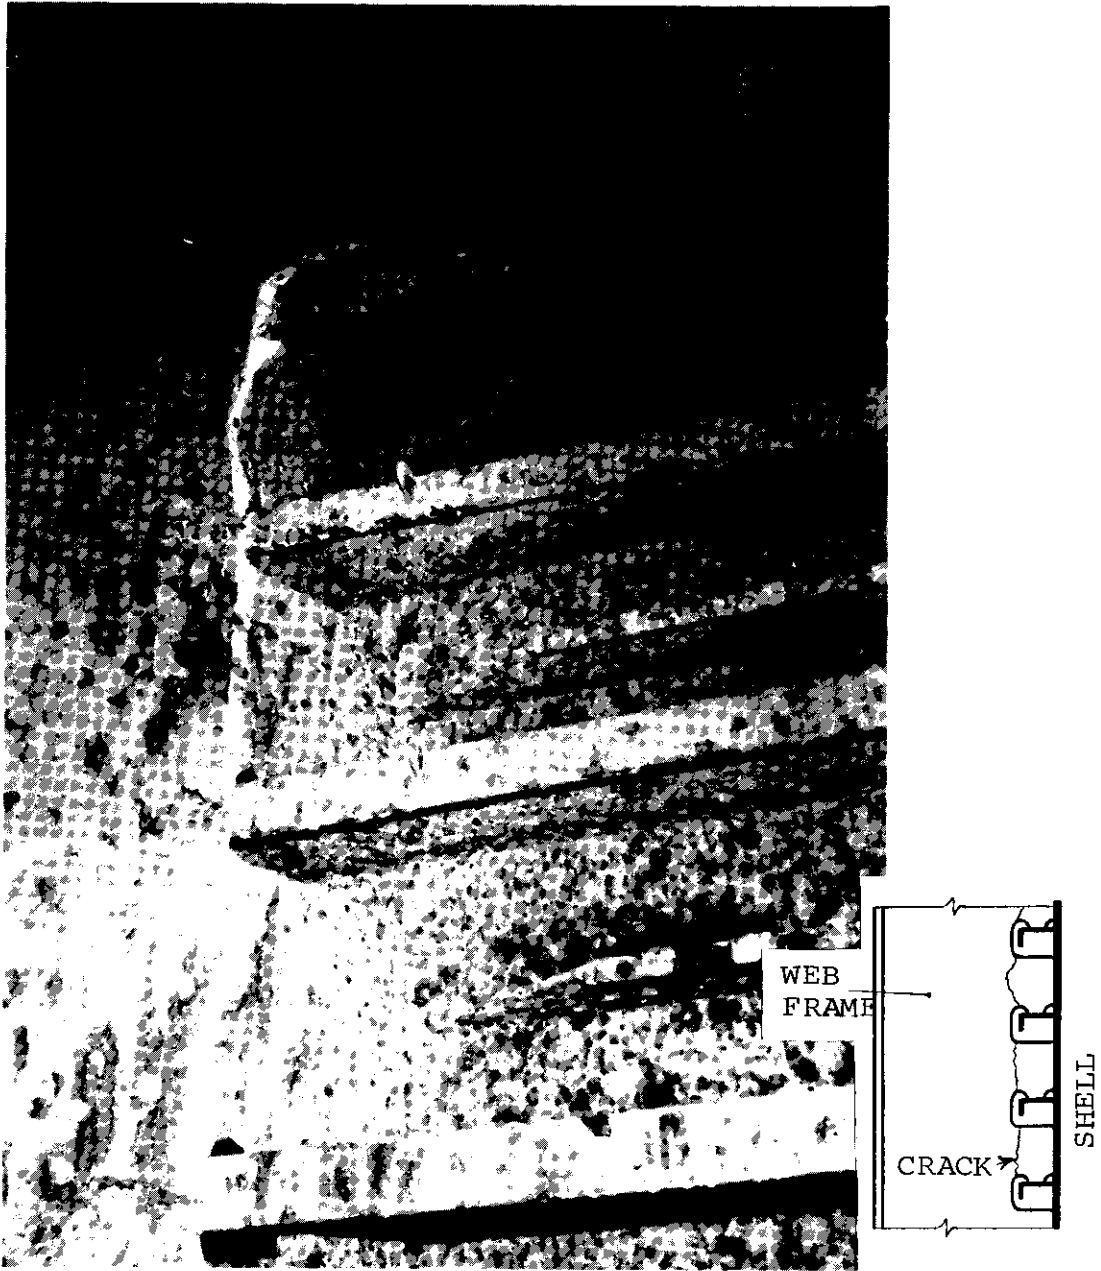
FAILED GROUP "E" CLEARANCE  
CUTOUTS ON A BULK CARRIER

The view is of detail 8-E-2 cutouts in a side shell web frame which allows passage of the through shell longitudinals in the forward deep tank. Cracks that continue from cutout to cutout parallel the paint marks.

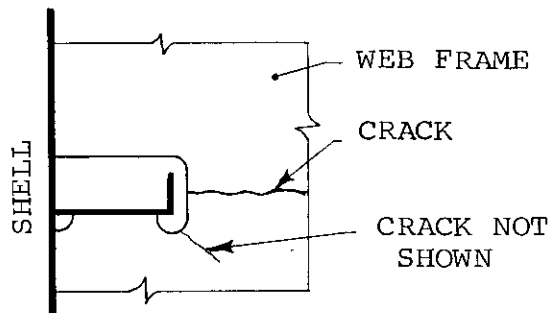
UNUSUAL CRACK AT A GROUP "E"  
CLEARANCE CUTOUT ON A BULK CARRIER

The fourteen inch crack is in a side shell web at a detail 8-E-2 cutout in the same forward deep tank as in Figure 34. Note the deterioration due to corrosion.

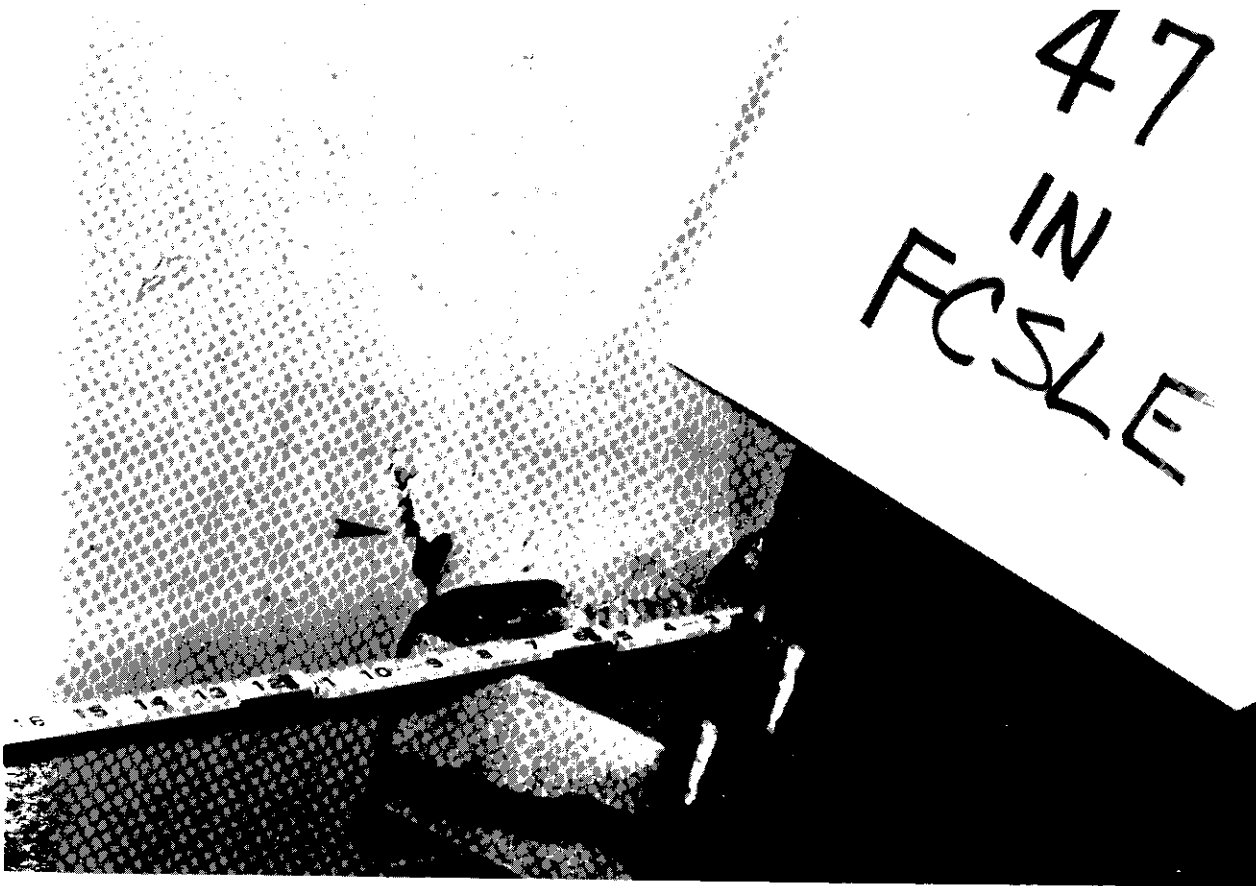
FAILED GROUP "E" CLEARANCE  
CUTOUT ON A TANKER

The cutout is in a shell web frame between upper and forecastle decks. Flaked paint indicates the crack in the web plating at the through angle heel.

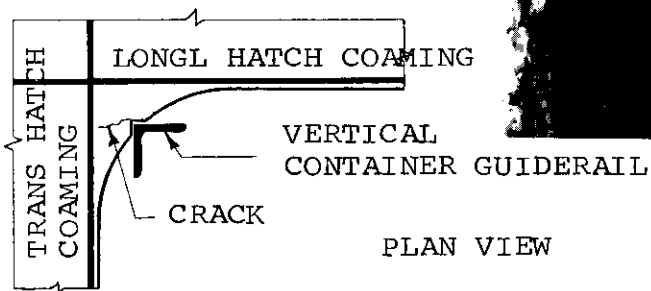
FAILED HATCH CORNER ON A COMBINATION CARRIER

This view is looking down at a radius hatch corner similar to detail 9-C-2. A notch has been cut in the deck plating to accommodate the vertical container cell guide. A ten inch crack in the plating originated at the notch.

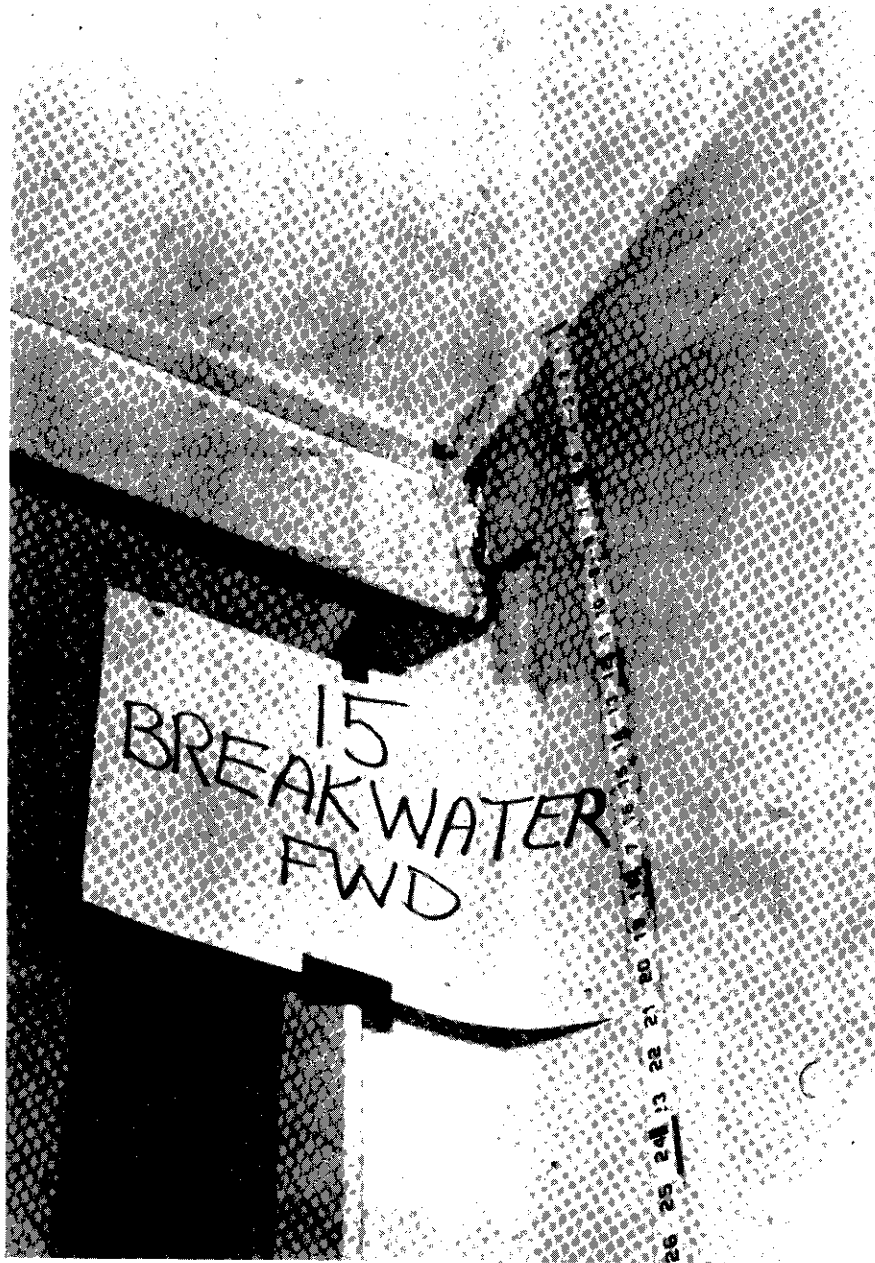
FAILED STIFFENER END ON A COMBINATION CARRIER

The view is looking forward with the deck above as forecastle deck. The crack in the horizontal stiffener's web completely detached the stiffener from the longitudinal bulkhead plating. Note that the stiffener's flange is sniped as in detail 11-A-7.

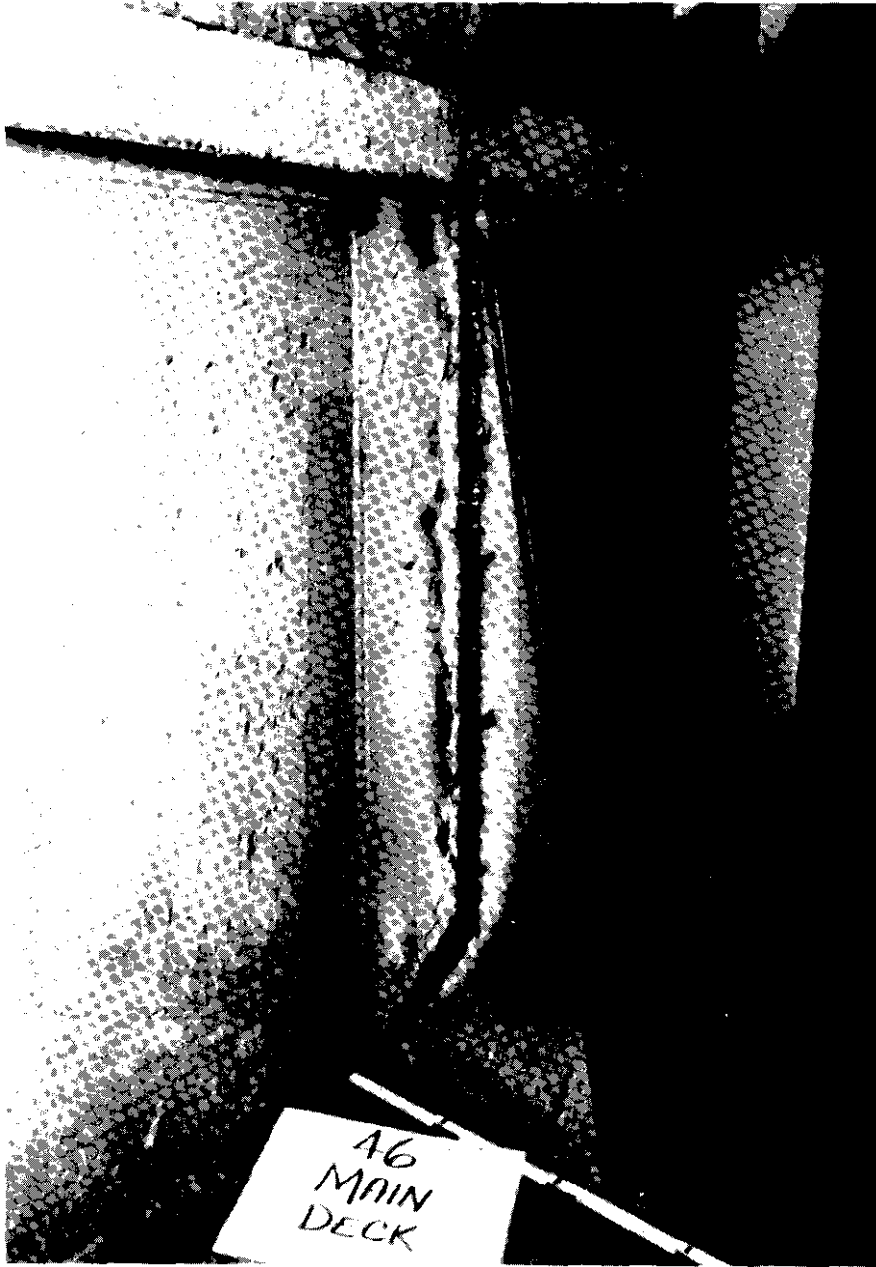
REINFORCED PANEL STIFFENER  
ON A CONTAINERSHIP

The vertical sniped flat bar panel stiffeners are on a transverse hatch side coaming. Reinforcement of the panel stiffeners to alleviate cracks at the ends was by an addition of a flanged plate which makes the detail into a tripping bracket. Visible in the upper right corner of the picture is a horizontal crack in the hatch cover side immediately below two attached container tie down fittings.
