GREEN SWAMP NO. 2

PHASE I INSPECTION REPORT

NATIONAL DAM SAFETY PROGRAM

NJ 00210

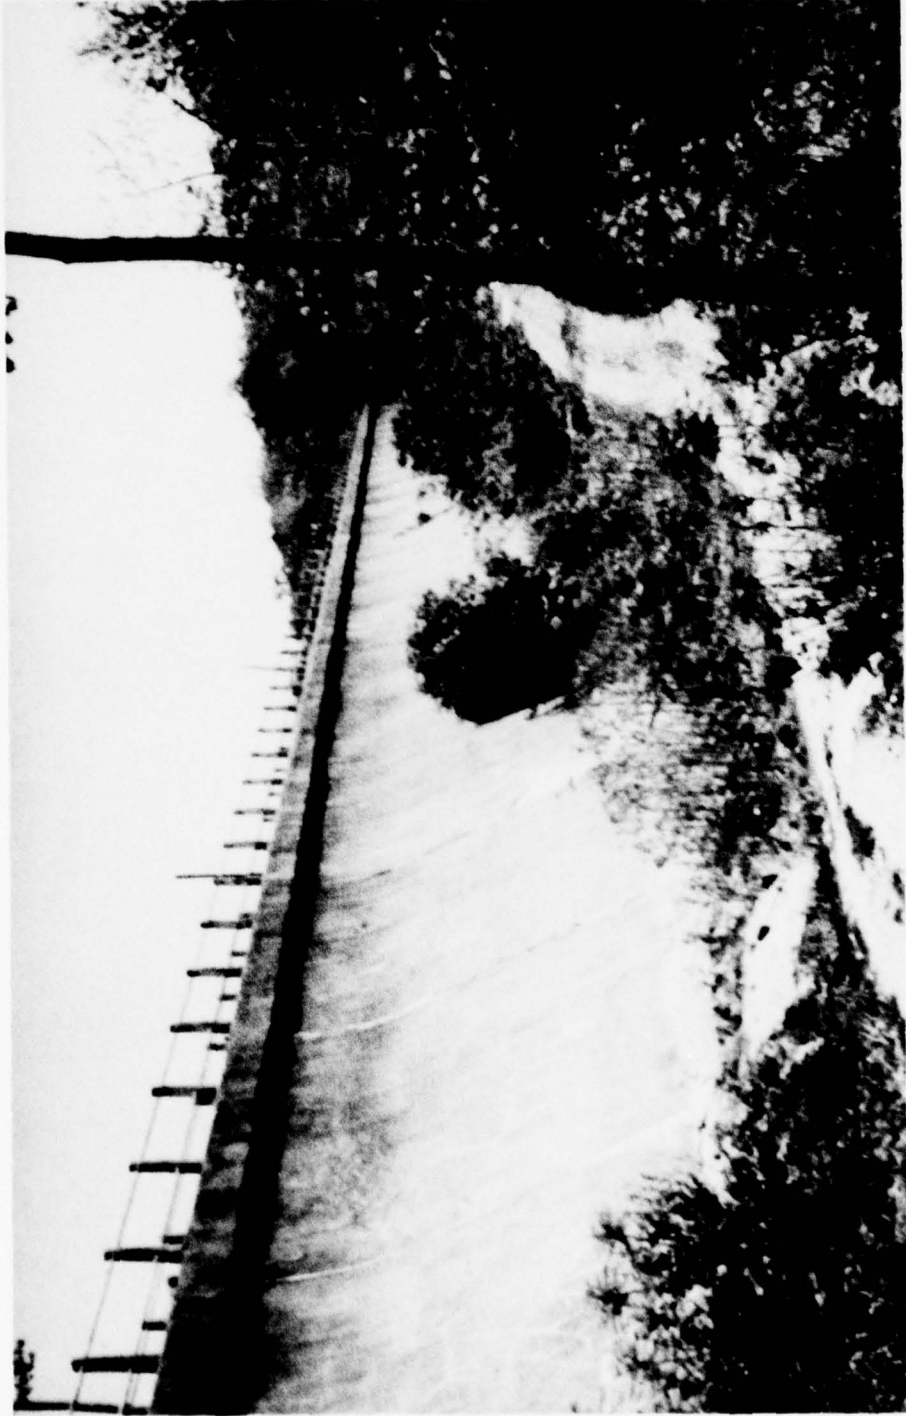
OVERVIEW PHOTO - GREEN SWAMP 2
(DOWNSTREAM VIEW OF DAM LOOKING EAST)

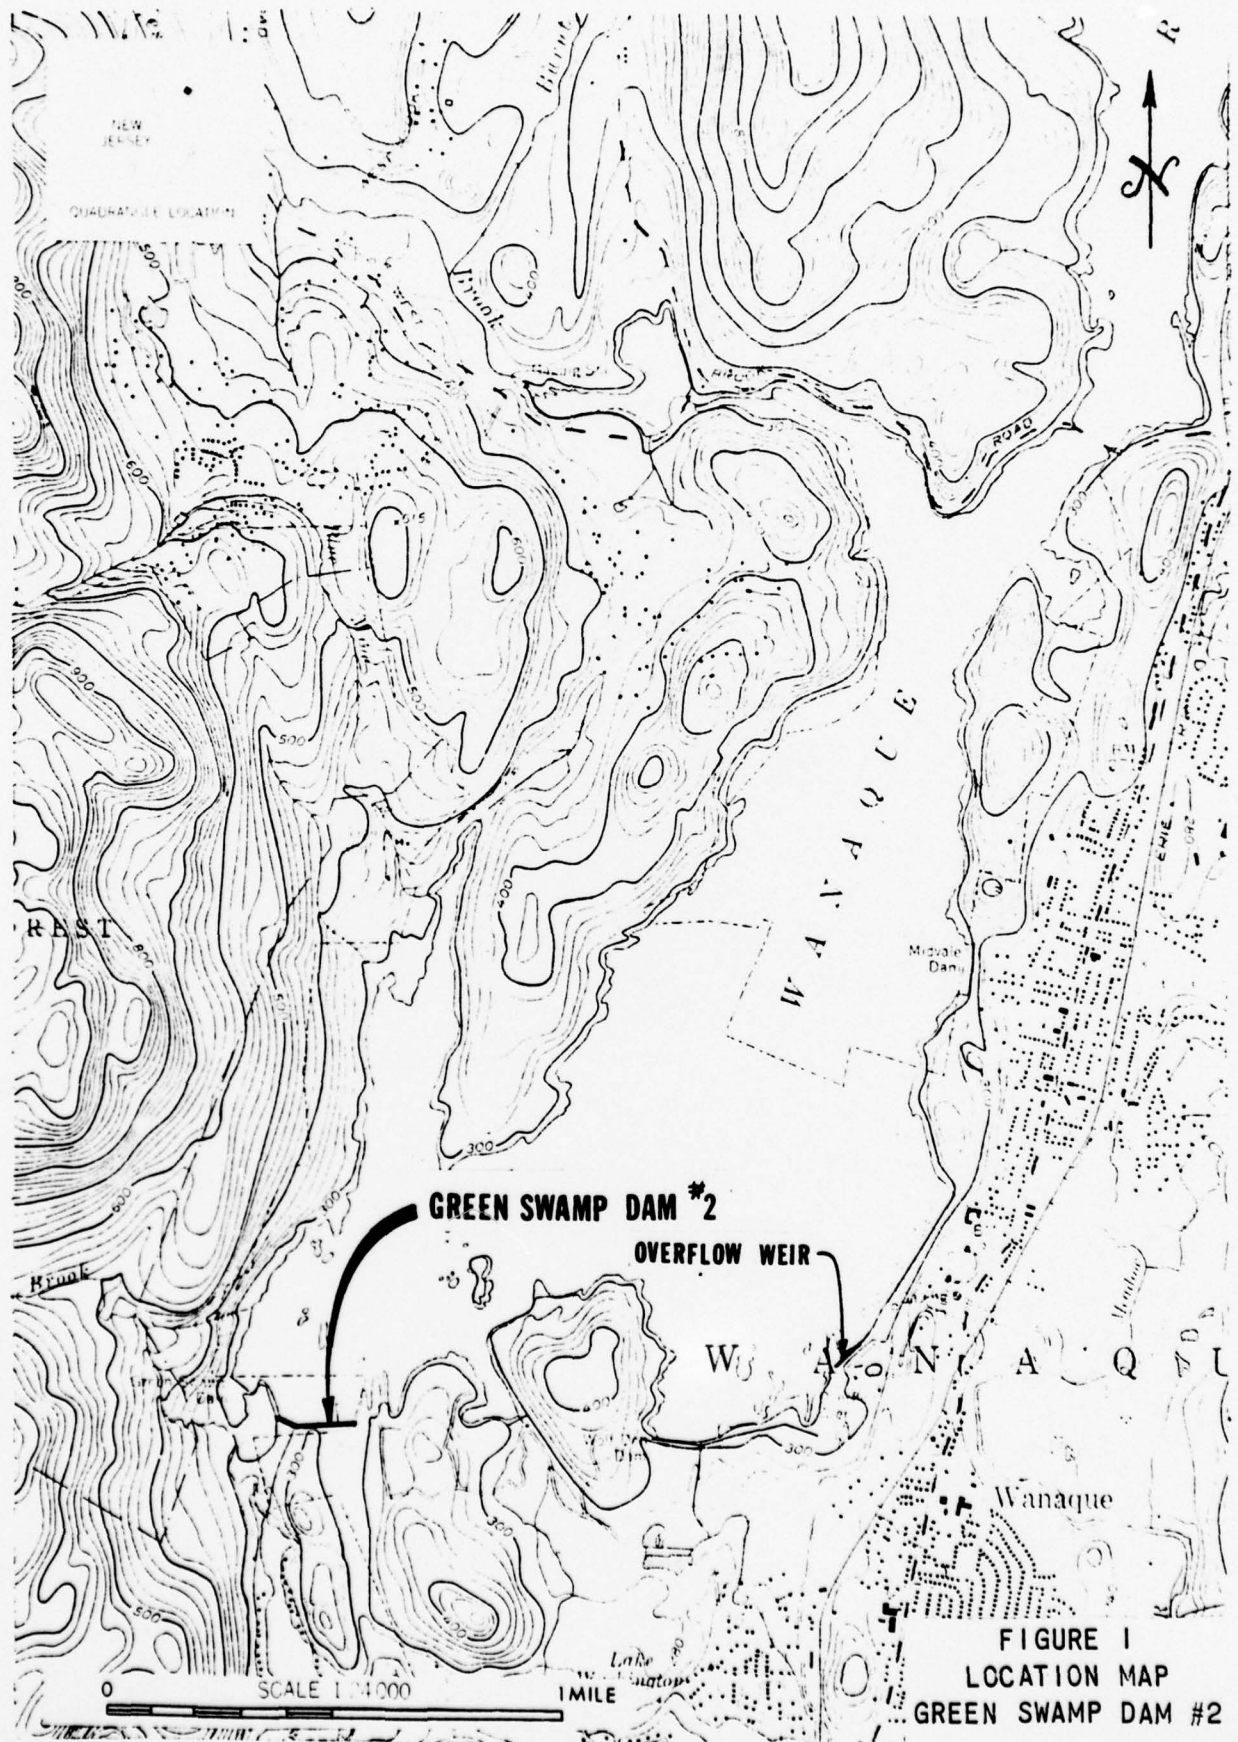
WANAQUE RESERVOIR
 GREEN SWAMP DAMS NOS. 2 AND 4
 PLANS, PROFILES AND SECTIONS

Record drawings, sheet 45 in a set of 61 (see Figure 2), indicate that the deepest point of the foundation excavation extends down to 28 feet below original ground giving the dam a maximum height of 66 feet.

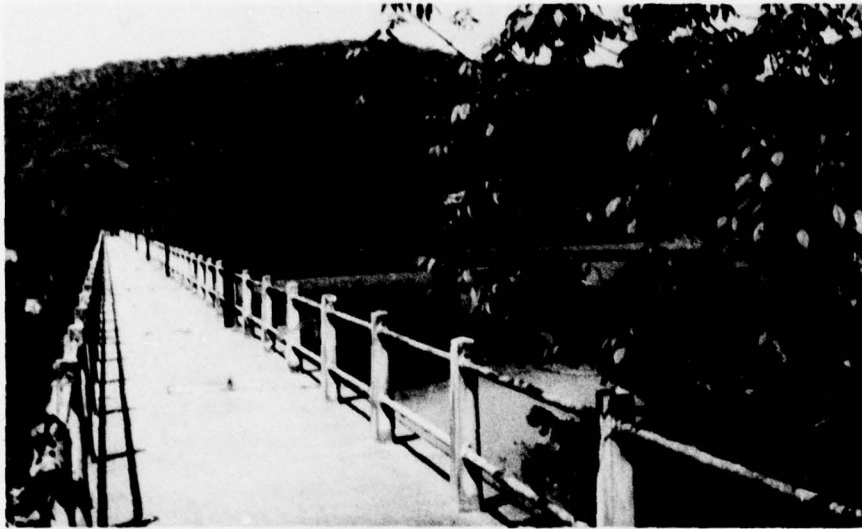
TOP OF DAM LOOKING TOWARDS RIGHT ABUTMENT

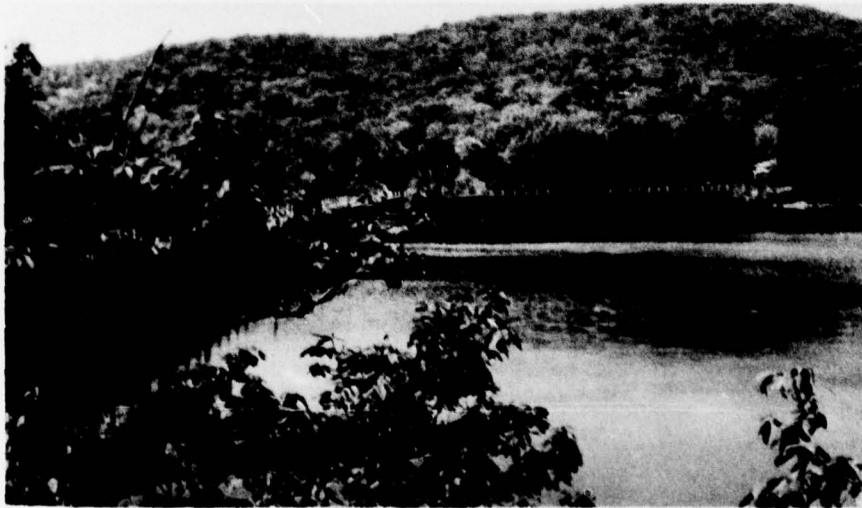
UPSTREAM VIEW

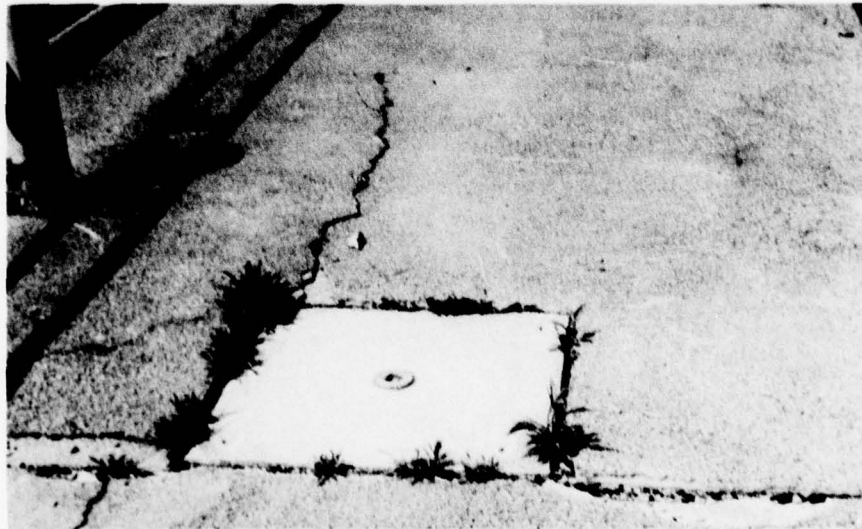
At every vertical expansion joint the gunite had cracked with some spalling and cracking of the underlying concrete. In two locations longitudinal cracking up to 1-3/4 inches deep was observed on the top of the dam in the middle of the block. The gunite on the downstream slope is starting to separate from the underlying concrete, and this has resulted in numerous random cracks, some of which are wet and exhibit exudation. The gunite has cracked and buckled at the expansion joints, and broken off in several places.

CRACKED SURFACE ALONG TOP OF DAM STA 4+55
(FROM BEGINNING OF CONCRETE DAM AT RIGHT ABUTMENT)

- a. All cracked and loose gunite be replaced.
- b. The gunite at expansion joints be cut away.
- c. The concrete covers of the vertical drains be freed and removed to allow inspection of both vertical and horizontal drains, and to determine the extent of longitudinal cracking in the dam crest where applicable.
- d. Trees growing within 20 feet of the dam be removed.
- e. The owner design and construct water release structures that will allow lowering of the water level within an acceptable period of time.
