NEWTOWN DAM, BUCKS COUNTY  
PENNSYLVANIA

6 National Dam Inspection Program - Newtown Dam  
(NDS I.D. ~~PA 01964~~ PA 01964, NUMBER  
DER I.D. No. 9-178, NUMBER  
SCS PA 621) NUMBER  
Delaware River Basin, Newtown Creek,  
Bucks County, Pennsylvania.  
PHASE I INSPECTION REPORT,  
NATIONAL DAM INSPECTION PROGRAM

WOODWARD-CLYDE CONSULTANTS  
5120 Butler Pike  
Plymouth Meeting, Pennsylvania 19462

DEPARTMENT OF THE ARMY  
Baltimore District, Corps of Engineers  
Baltimore, Maryland 21203

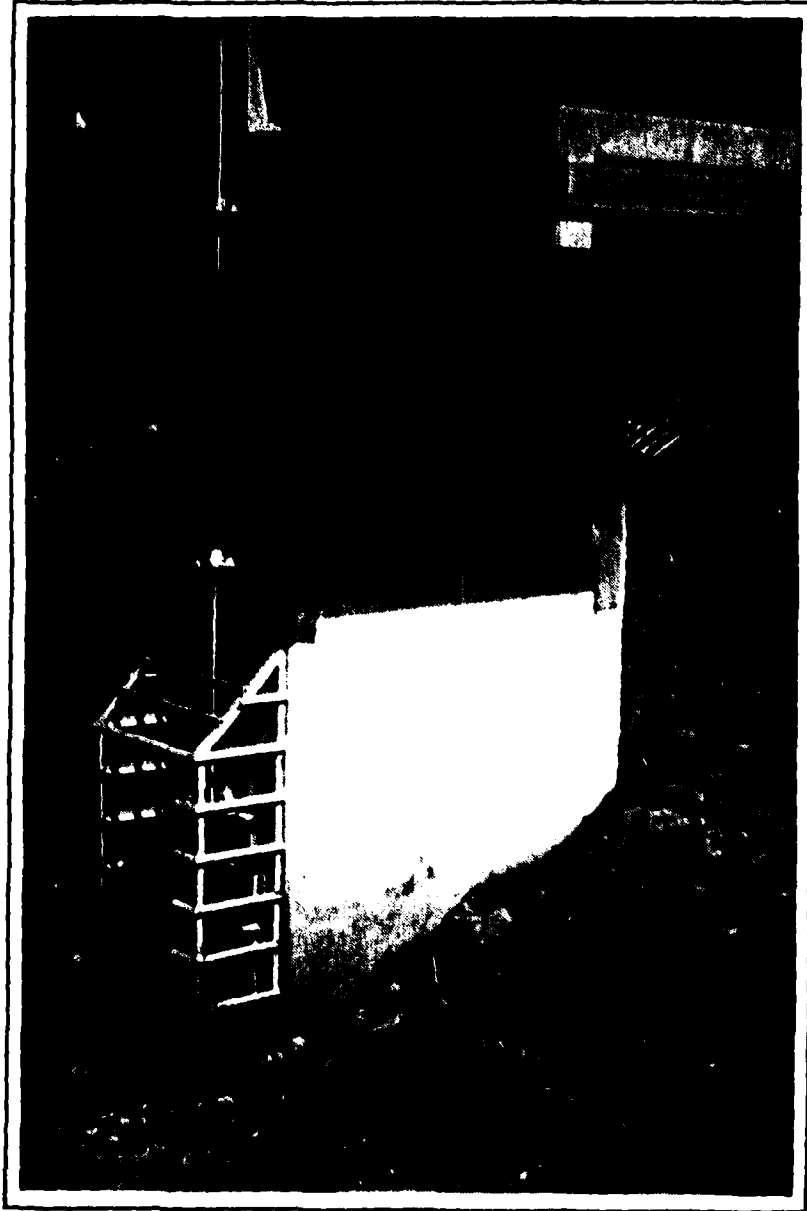
PHOTOGRAPH NO. 4

1. Principal Spillway. As shown on the plates, the riser is located at the upstream toe of the embankment. The exposed portions of the riser were inspected and evaluated to be in good condition with no signs of concrete deterioration, spalling or other structural deficiency or defects, Photograph

4. An angle in the low stage trash rack is slightly bent. The impact basin at the downstream toe was inspected and found to be in good condition, Photograph 5, with no cracking or spalling of the concrete or erosion adjacent to the structure. The embankment drains outlet through the walls of the impact basin and were dry. The downstream channel was also inspected and found to be in good condition, with no significant erosion or deterioration.

PRINCIPAL SPILLWAY RISER AT UPSTREAM  
TOE.

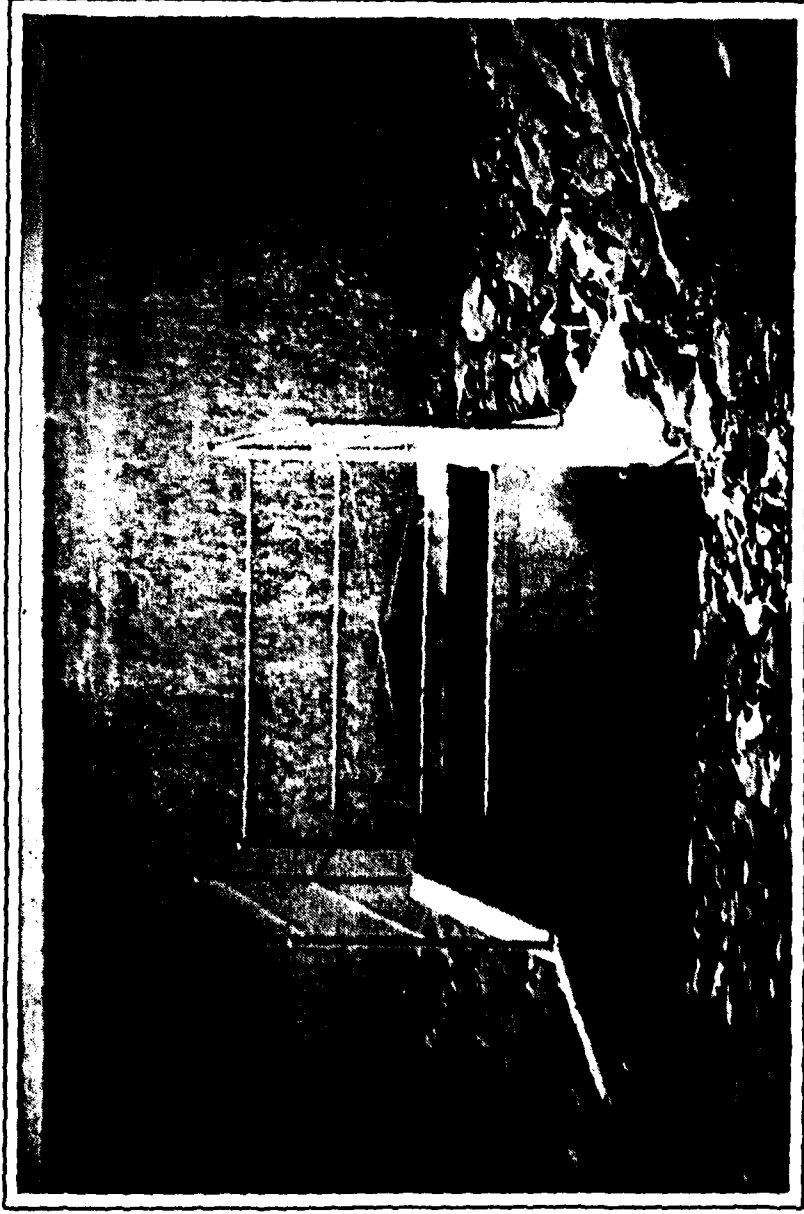
PHOTOGRAPH NO. 5

IMPACT BASIN AT DOWNSTREAM TOE.

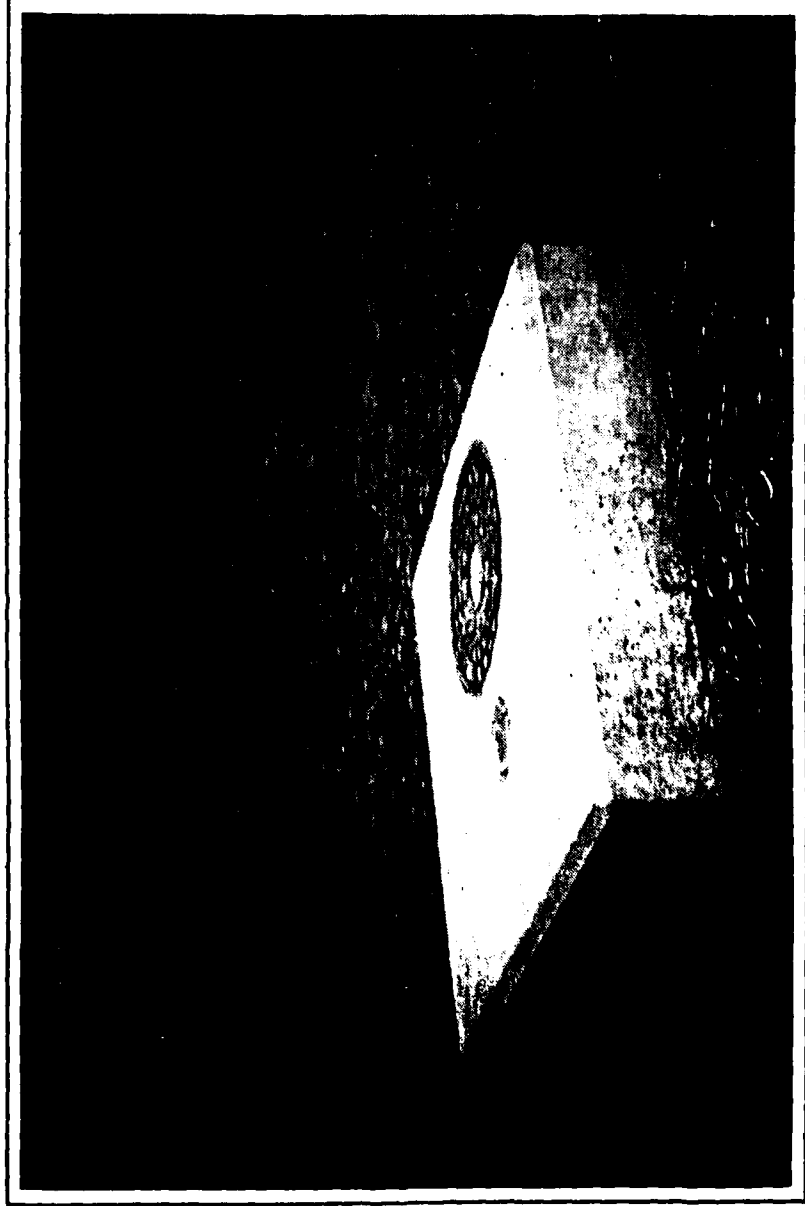
PHOTOGRAPH NO. 9

SANITARY SEWER MANHOLE. SEWER IS  
UNDER EMBANKMENT.
