CONNECTICUT RIVER BASIN
WEST HARTFORD, CONNECTICUT

**HARTFORD RESERVOIR NO.2 DAM
CT 00003**

**PHASE I INSPECTION REPORT
NATIONAL DAM INSPECTION PROGRAM**

DECEMBER 1980

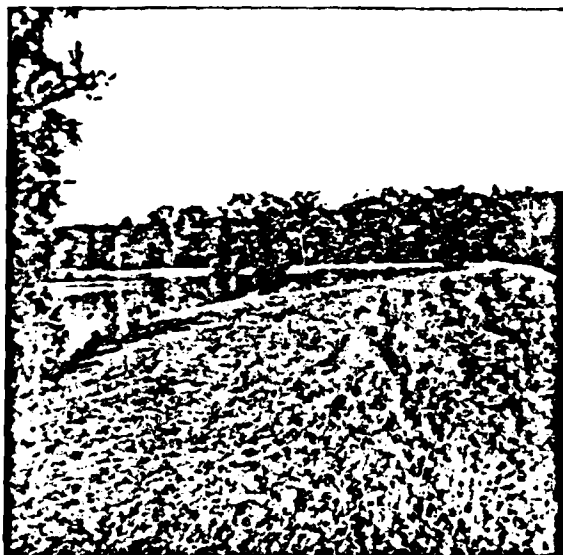
#2. Grass crest in generally good condition. Downstream face overgrown.

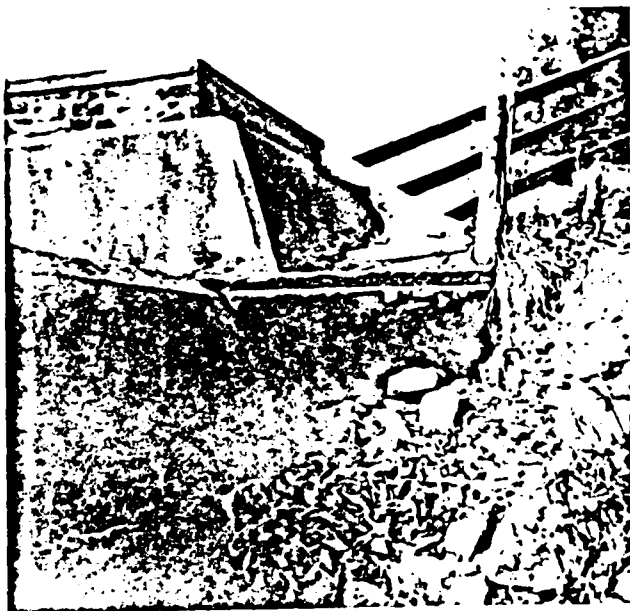
#3 Walkway slab at spillway is undermined

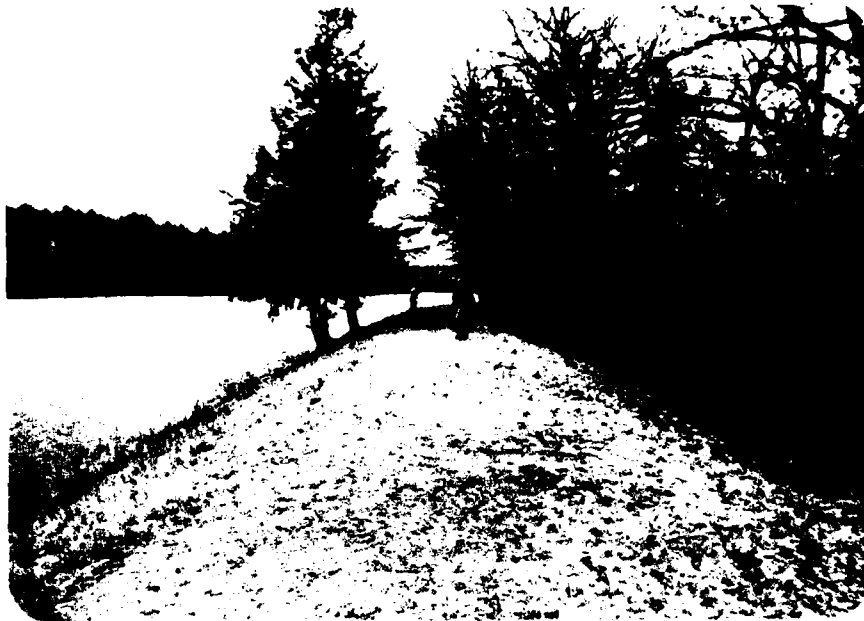
PHOTO NO. 1

The crest of the dam is grass-covered, Photos 1 and 2, and appears to be fairly level and in good condition with several bare spots noted. The upstream slope is protected by a layer of riprap, Photo 3, which in most areas extends approximately 2 feet above the normal waterline and is overgrown with vegetation. The majority of the upstream slope above the riprap is grass-covered, although erosion of one area was noted where grass is missing and riprap did not extend above the waterline, Photo 4. Several large trees, up to 18-inches in diameter, were present at the waterline, Photos 1, 2 and 4.

DAM CREST

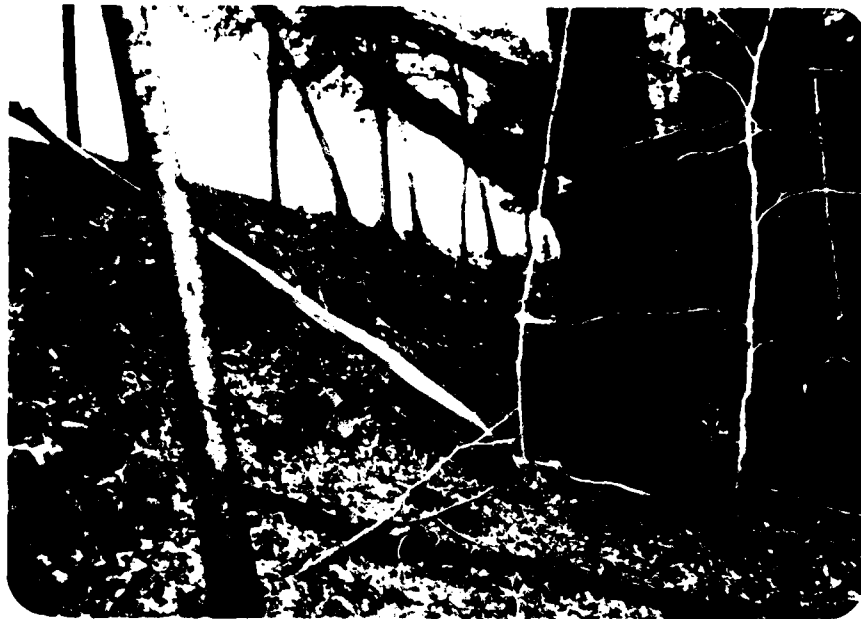
PHOTO NO. 6

DOWNSTREAM SLOPE AT LEFT END OF DAM.
NOTE RIPRAP ON SLOPE AND TREES ON SLOPE AND AT TOE.

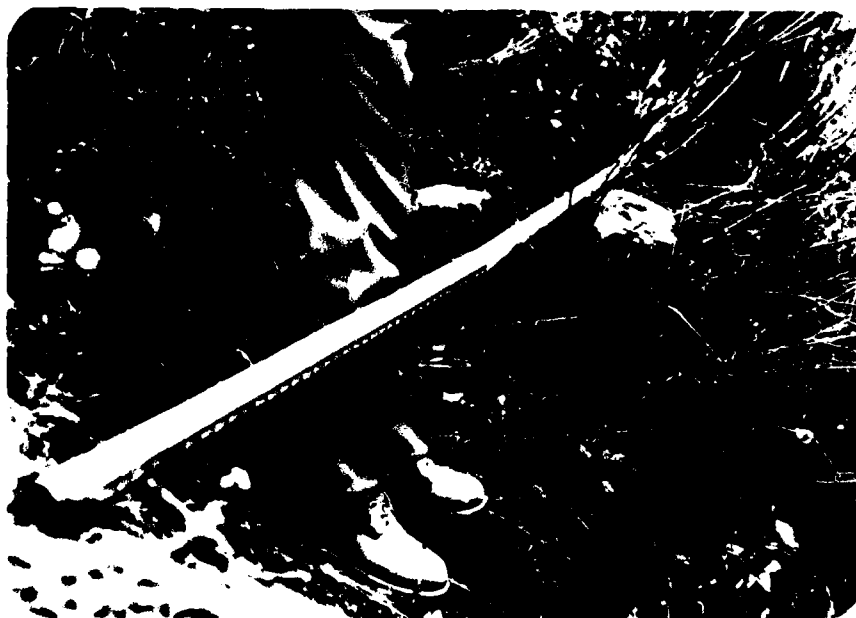
PHOTO NO. 7

DEPRESSION ON DOWNSTREAM SLOPE.
NOTE TREE STUMP AT RIGHT.

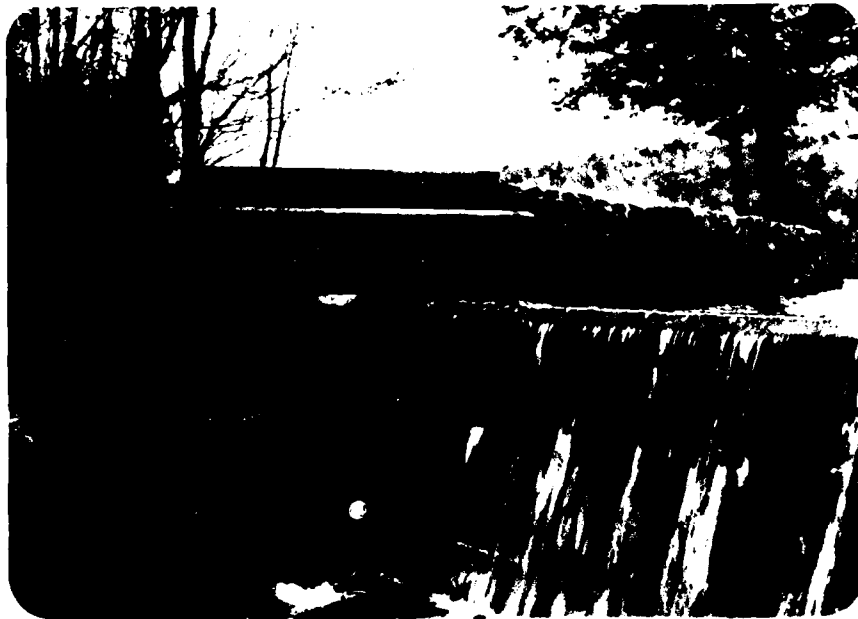
PHOTO NO. 11

The overflow spillway consists of a concrete weir founded on rock with concrete and stone masonry training walls, Photos 10, 11 and 12. The concrete weir and training walls appear to be in good condition with the exception of a hairline crack noted in the right training wall at the downstream face of the weir. The right upstream stone masonry training wall appears to be bulging out approximately

7. <u>Outlet Works - & Discharge Channels</u>	<u>RH,DLS,RGL</u>	<u>right training wall concrete cracked and stone masonry bulging</u>
8. _____	_____	_____

RIGHT TRAINING WALL AND SPILLWAY WEIR.
 NOTE EFFLORESCENCE PRESENT ON WEIR, BULGING OF
 UPSTREAM TRAINING WALL, AND EROSION OF DOWNSTREAM EMBANKMENT.

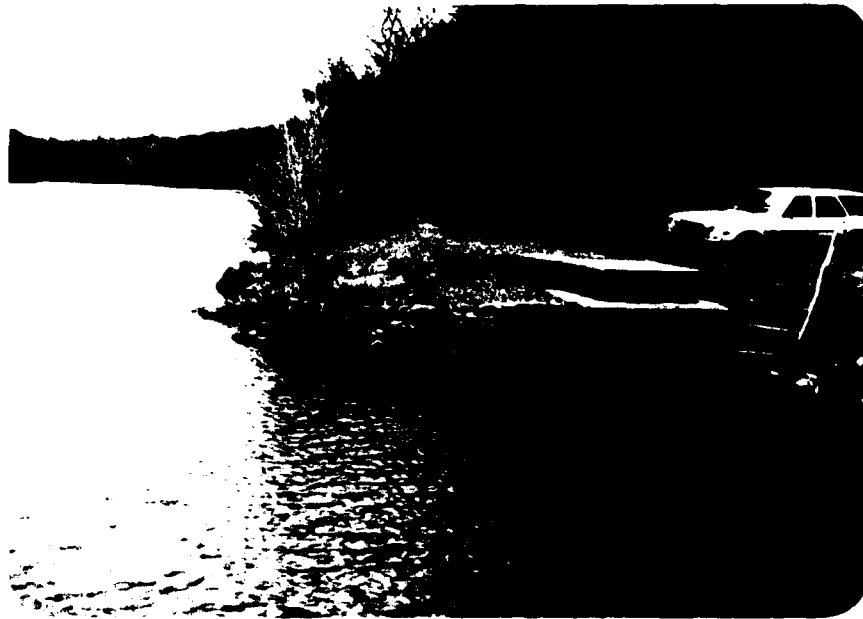
PHOTO NO. 12

LEFT TRAINING WALL
