HOUSATONIC RIVER BASIN

**EAST MOUNTAIN RESERVOIR DAM
CT 00032**

**PHASE I INSPECTION REPORT
NATIONAL DAM INSPECTION PROGRAM**

DECEMBER, 1979

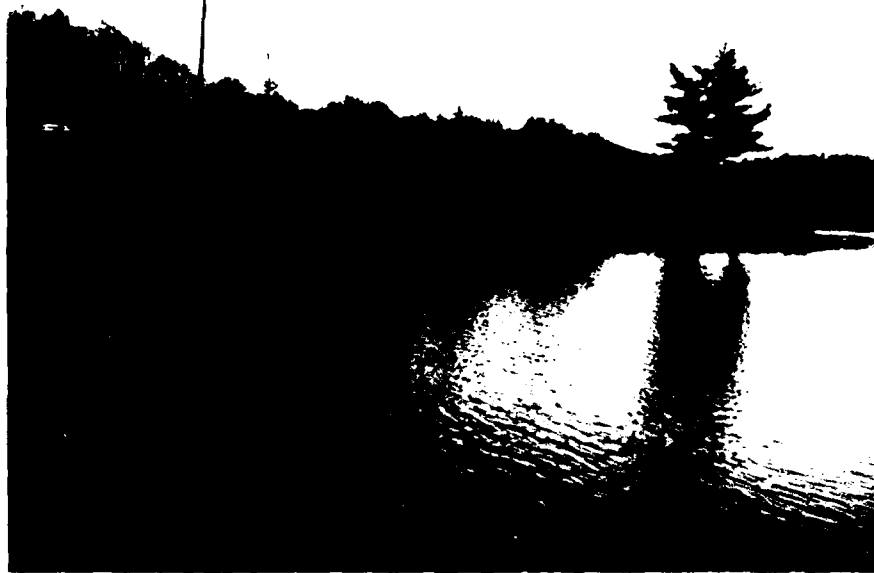
d. Reservoir Area - The area surrounding the reservoir is substantially developed and about 40% open. Route 69 runs along the eastern shore of the reservoir adjacent to the dam. There are several erosion zones along this portion of the shore where the masonry retaining walls constructed for bank reinforcing are cracked and falling into disrepair.

Photo 3 - Right shore of reservoir adjacent to dam

3. A comprehensive program of inspection by a registered professional engineer qualified in dam inspection should be instituted on a biennial basis.
4. Areas exposed by loss of riprap on the upstream slope of the dam and at the right bank of the reservoir adjacent to the dam, as well as the stone wall at the left side of the reservoir should be repaired to prevent erosion in the future.
