*Lab*  
NRL Report No. R-2225  
BuShips Prob. S347T-C  
(X-108C)

Report on  
TESTS OF MODEL SC-2 RADAR EQUIPMENT

Contractor:  
General Electric Company  
NAVAL RESEARCH LABORATORY  
ANACOSTIA STATION  
WASHINGTON, D. C.

5 January 1943 to 15 April 1943

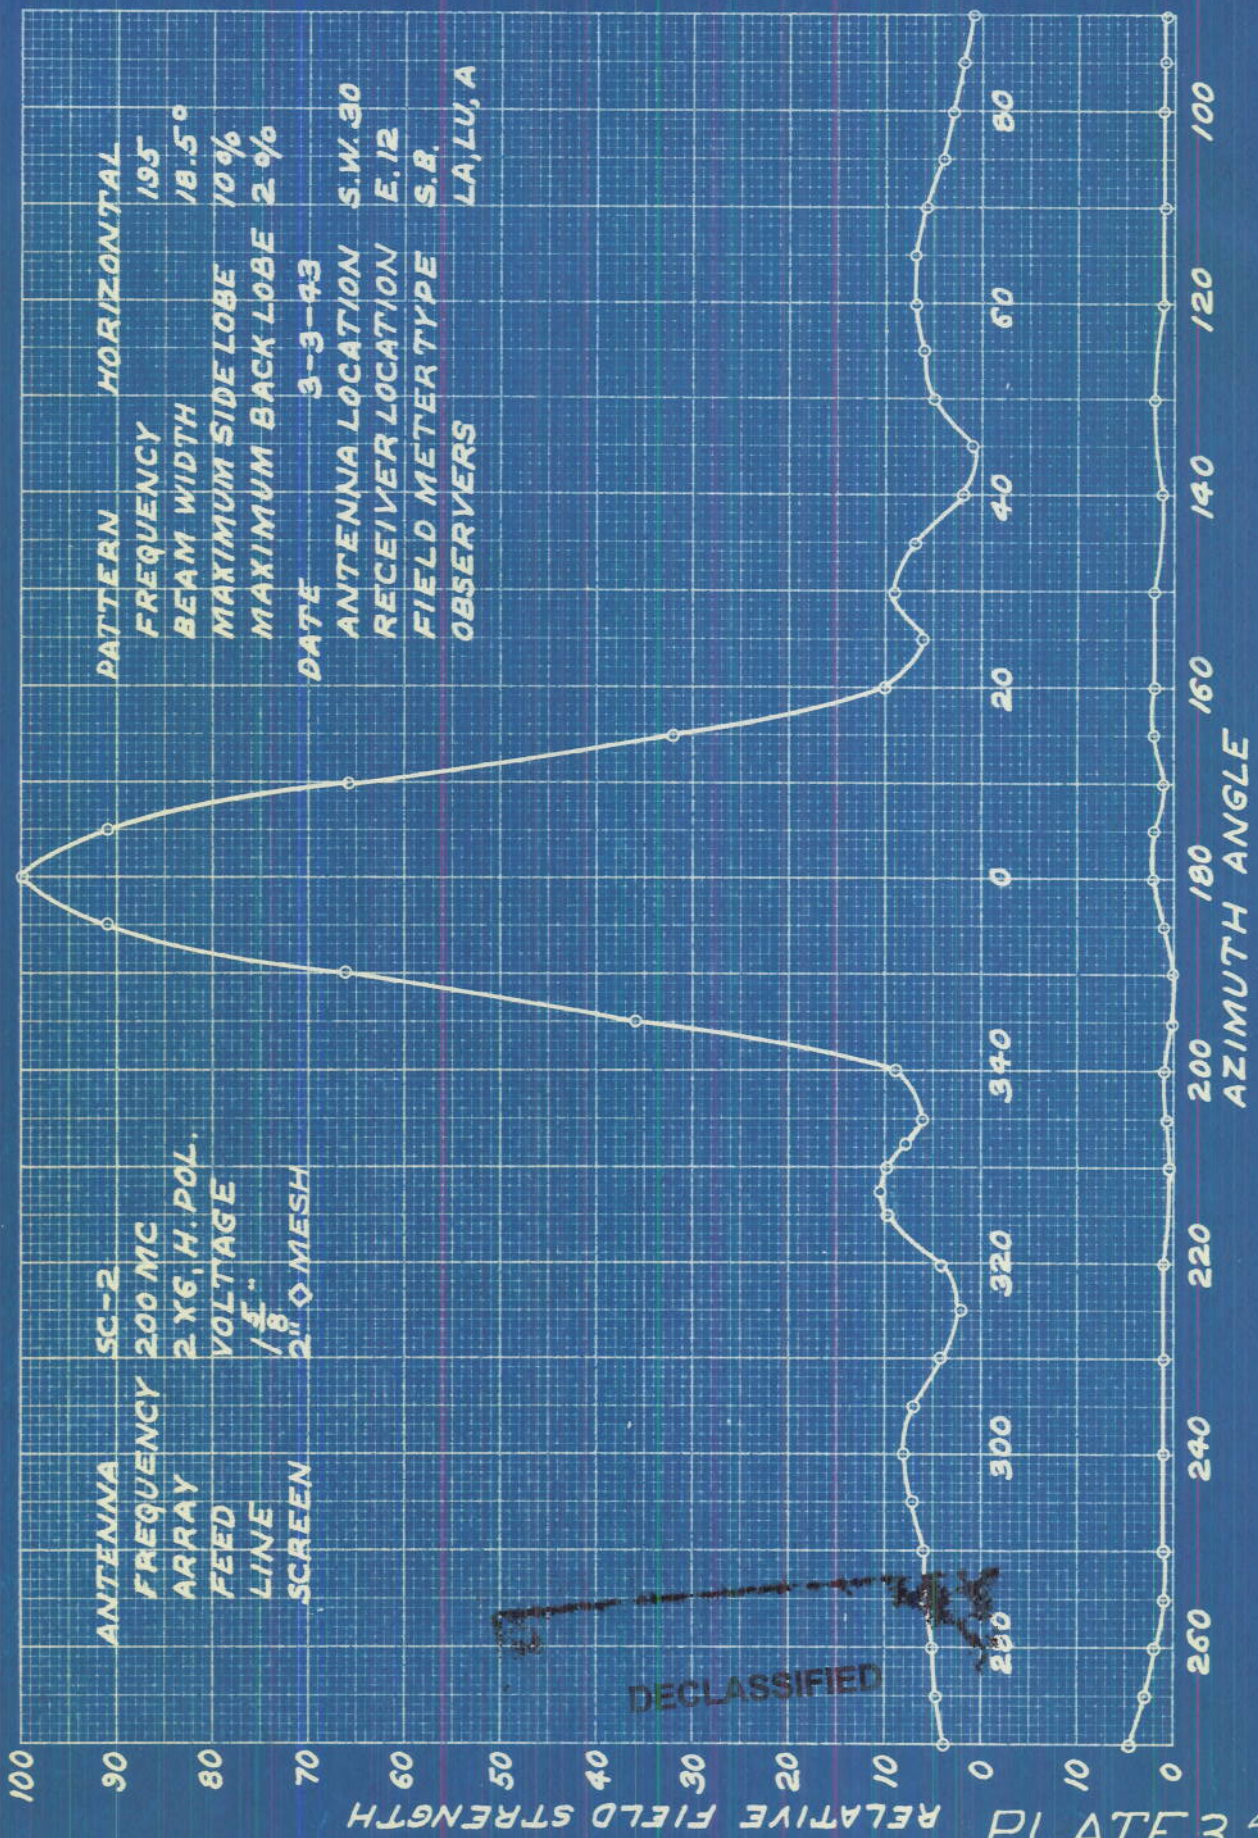
**PATTERN** HORIZONTAL  
**FREQUENCY** 195  
**BEAM WIDTH** 18.5°  
**MAXIMUM SIDE LOBE** 10%  
**MAXIMUM BACK LOBE** 2%  
**DATE** 3-3-43  
**ANTENNA LOCATION** S.W. 30  
**RECEIVER LOCATION** E. 12  
**FIELD METER TYPE** S. B.  
**OBSERVERS** LA, LU, A

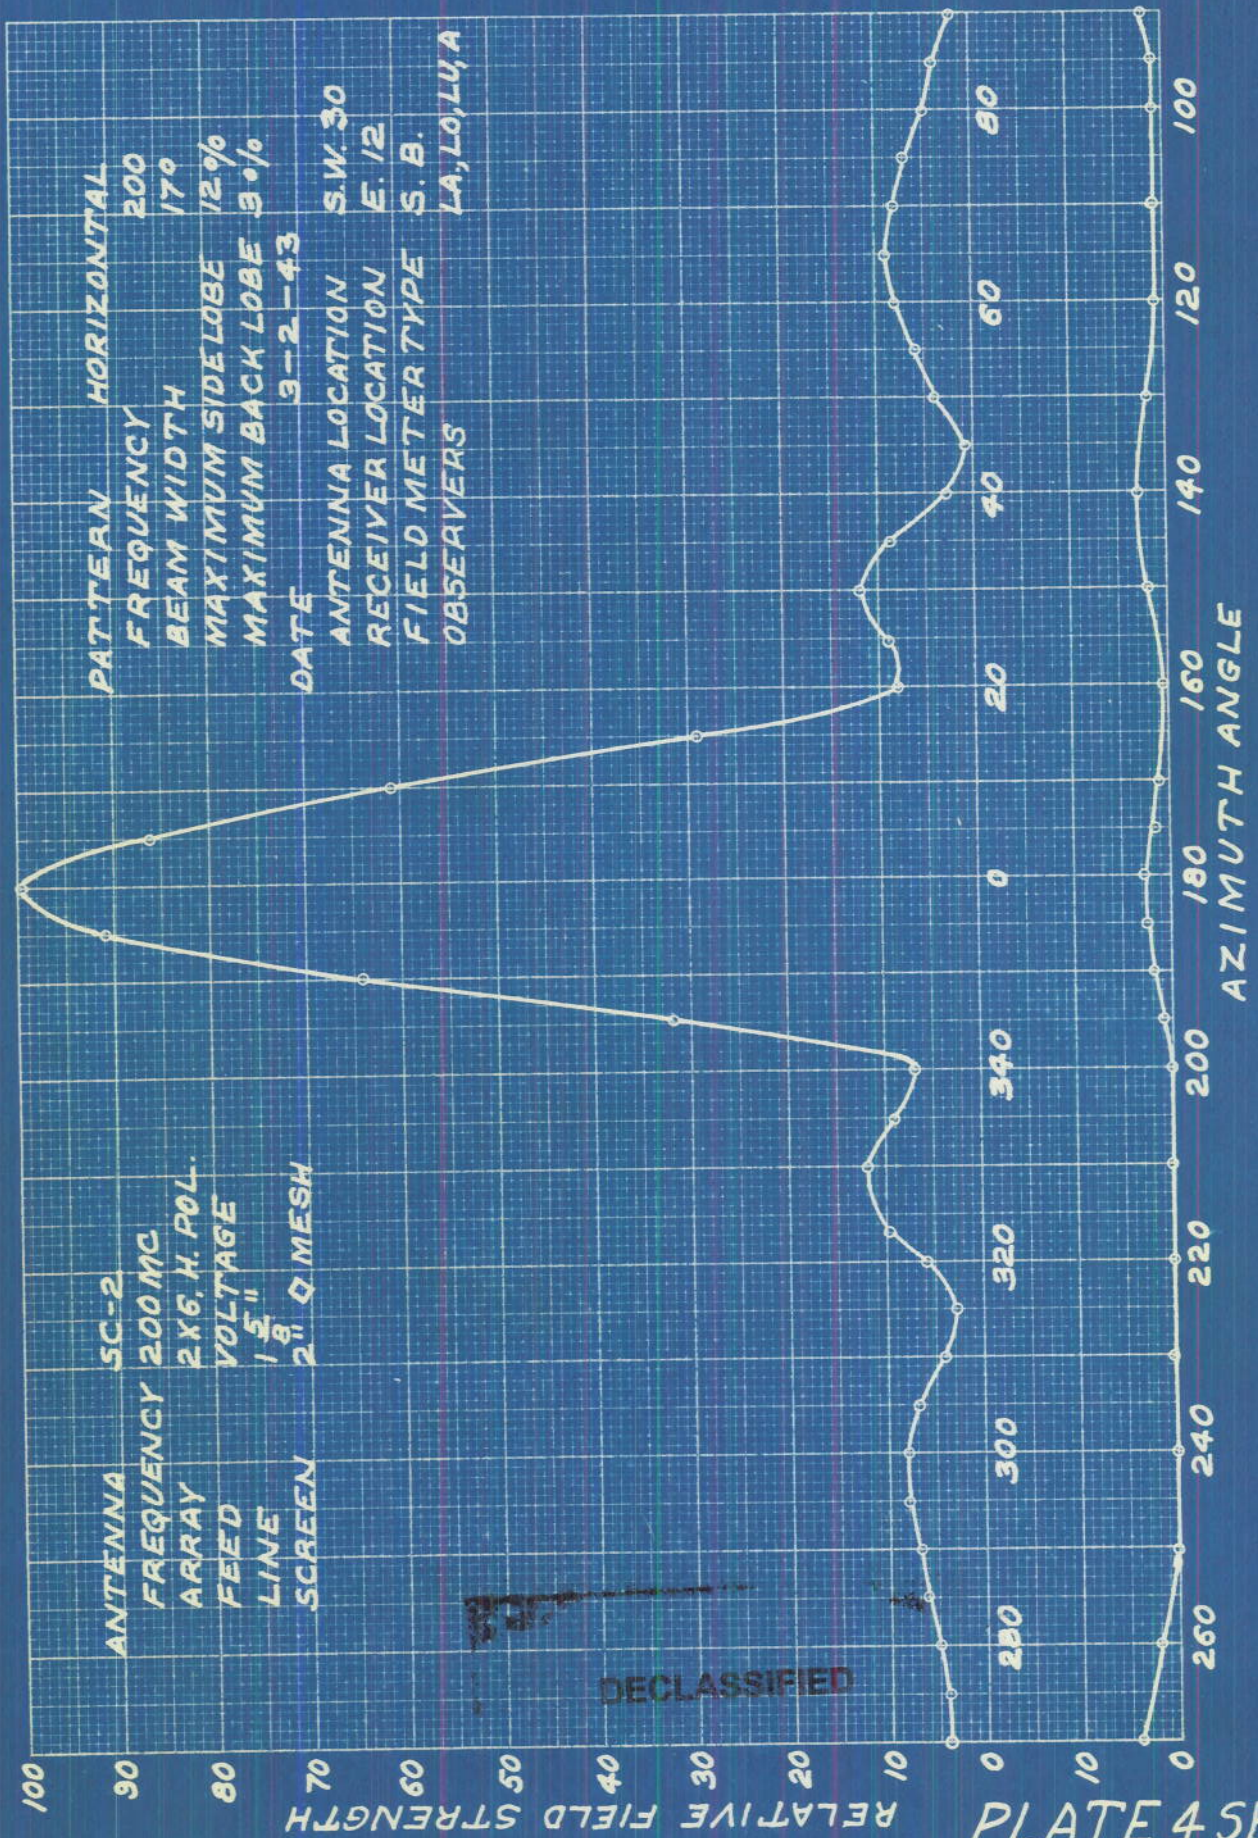
1-2-6. The SC-2 antenna has a beam width of  $17^\circ$  at 200 mc.; its side lobes measure only 11% of the field strength of the main beam. This is a result of unequal current distribution among the radiator elements. In general the electrical features of this antenna appear to be entirely satisfactory. It was observed, however, that a heavy coating of ice makes two of the side lobes very prominent and reduces the maximum range and sensitivity of the system.

PATTERN HORIZONTAL  
 FREQUENCY 200  
 BEAM WIDTH 17°  
 MAXIMUM SIDELobe 12%  
 MAXIMUM BACK LOBE 3%  
 DATE 3-2-43  
 ANTENNA LOCATION S.W. 30  
 RECEIVER LOCATION E. 12  
 FIELD METER TYPE S. B.  
 OBSERVERS LA, LO, LU, A

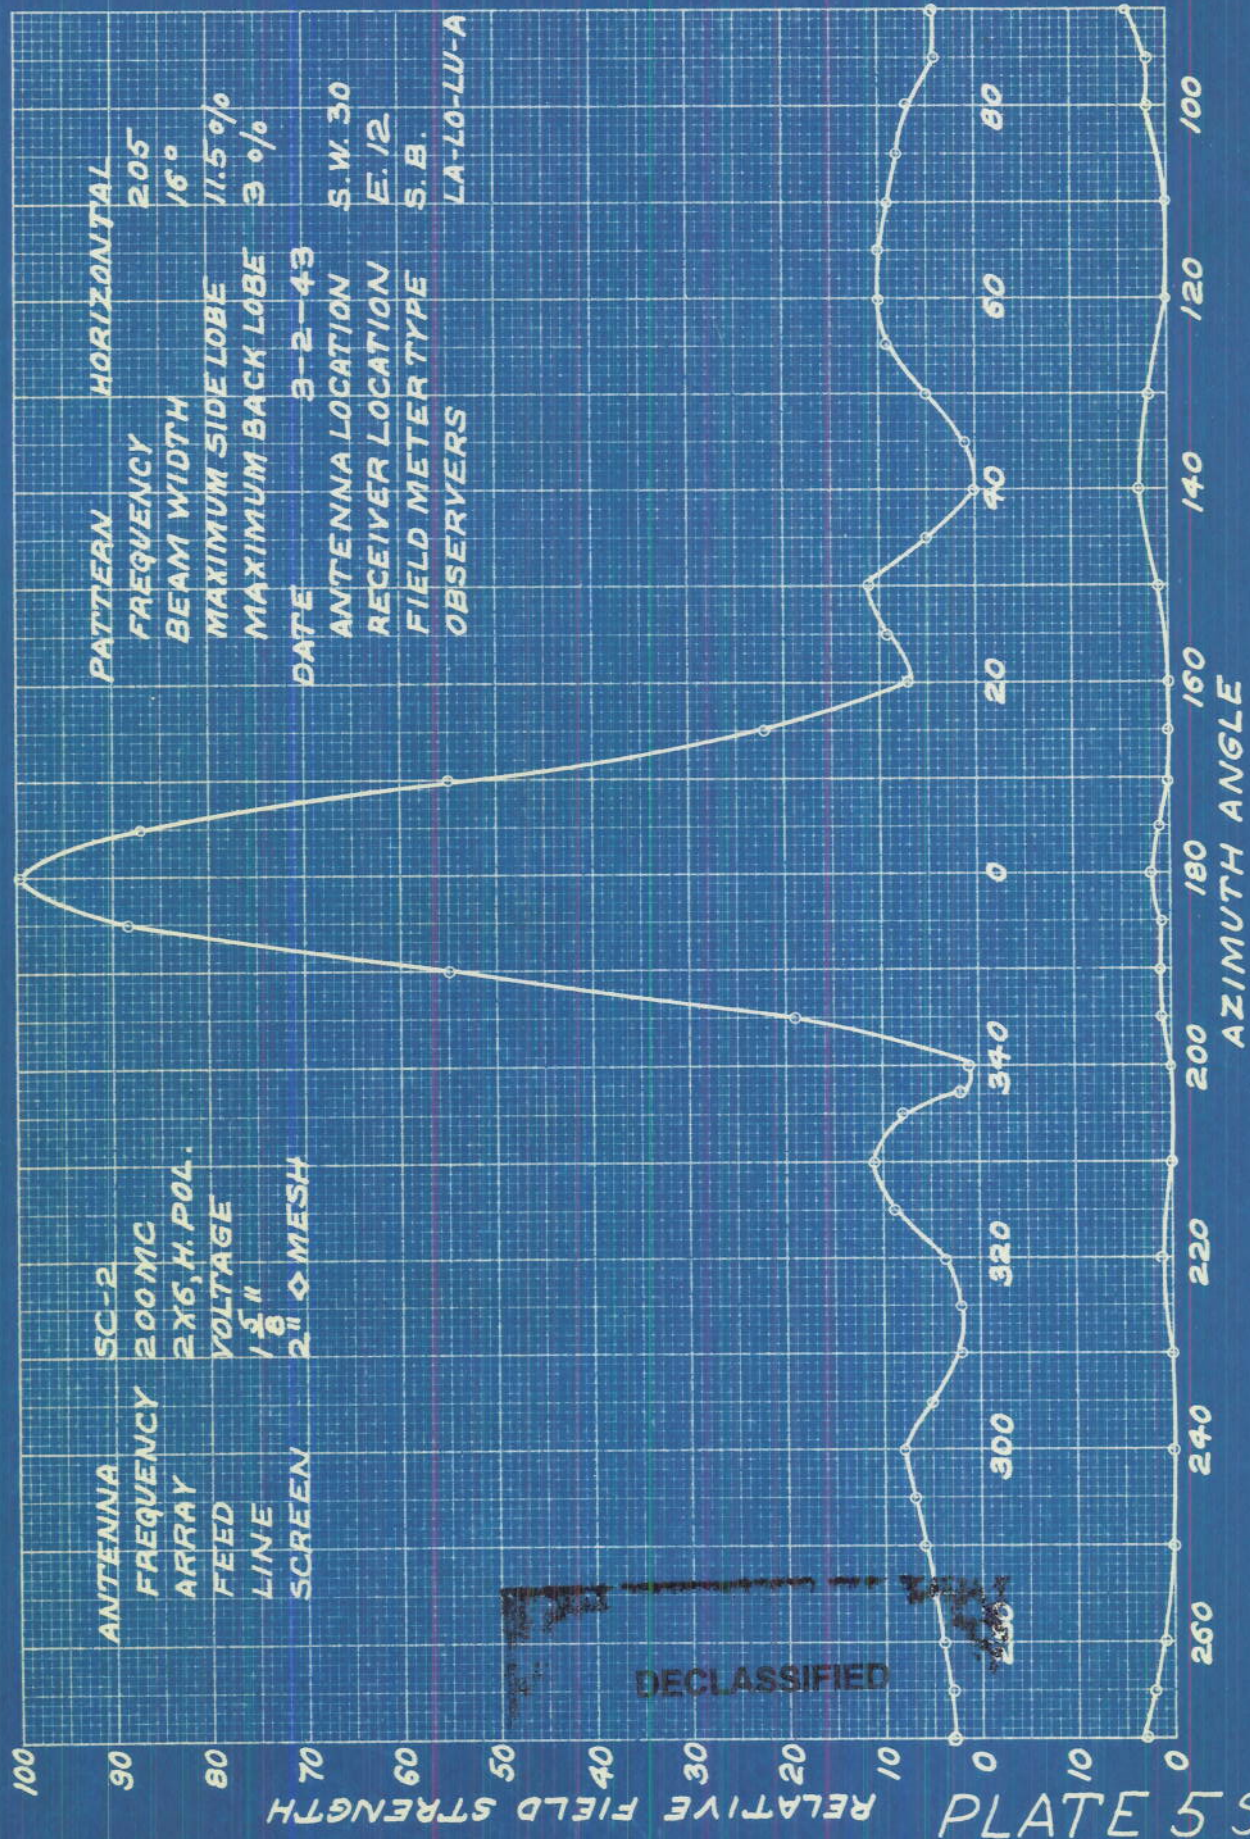
PLATE 5 SEC. I

1-17-2. ELECTRICAL TESTS OF SC-2 ANTENNA. Plates 3, 4, and 5 of Section I are radiation patterns obtained with a slide back type field strength meter at a distance of 120 feet and at frequencies representing the two ends and center of the yellow band. The beam width at half power is 18.5° at 195 mc., 17° at 200 mc., and 16° at 205 mc. Side lobes were observed 30° and 60° on either side of the main beam, with relative field strengths averaging 11 and 8 per cent respectively. Back radiation did not exceed 3 per cent at any of these frequencies. The pattern is considered quite satisfactory for an array of this type. Plate 6 of Section I represents the variation of standing wave ratio (i.e.,  $E_{min}/E_{max}$ ) with frequency. It is better than 50% from 195 to 205.5 mc., which is an acceptable band width. This particular antenna is aligned for 203 mc., where the standing wave ratio is 87%. It is interesting to note that it could also be used in the red band, since it matches the line sufficiently well in the region 173 to 190 mc.

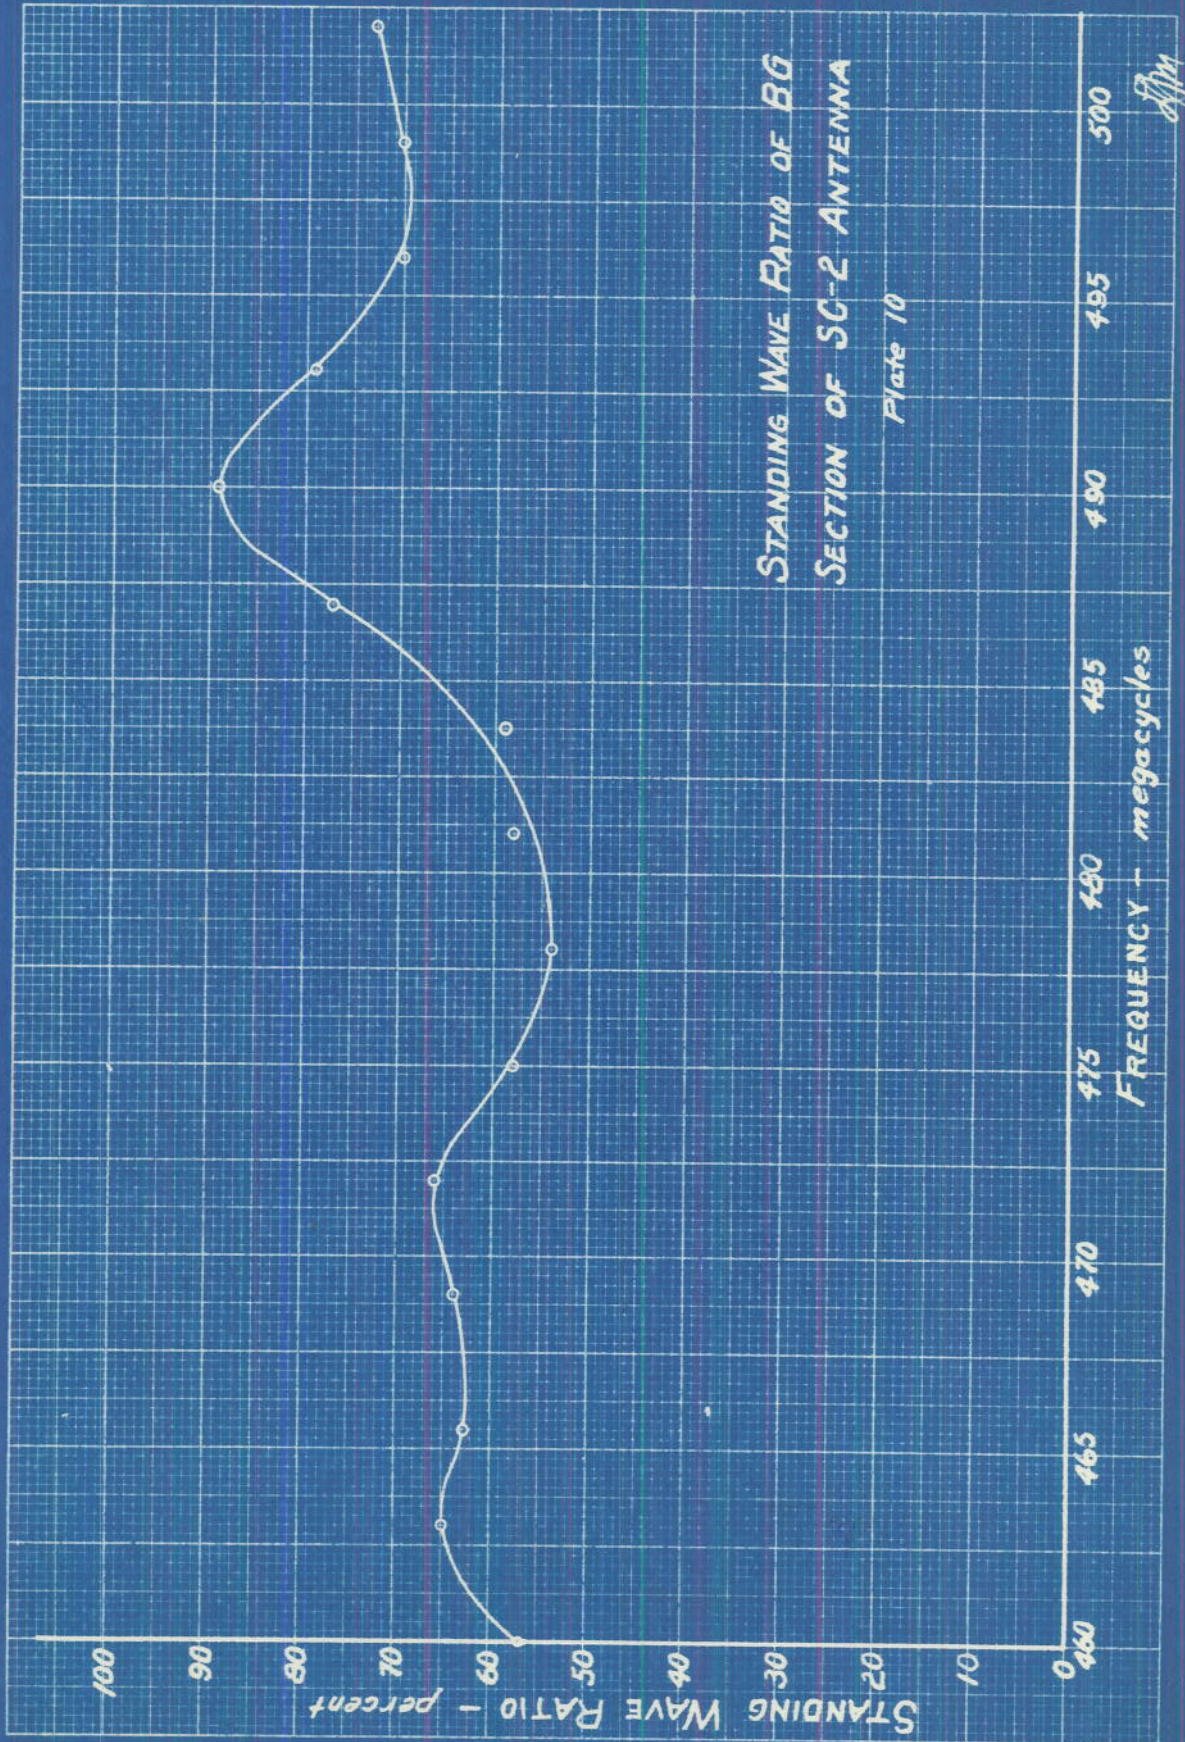
STANDING WAVE RATIO OF BQ  
SECTION OF SC-2 ANTENNA  
Plate 10

1-17-7. SUMMARY OF ANTENNA TESTS. The results of the antenna tests are summarized in Table 12 of Section I. There do not seem to be any serious defects in the electrical characteristics of the SC-2 antenna system. As mentioned in paragraph 1-17-3, it might be worth-while to provide for a more careful alignment of the BL recognition section.

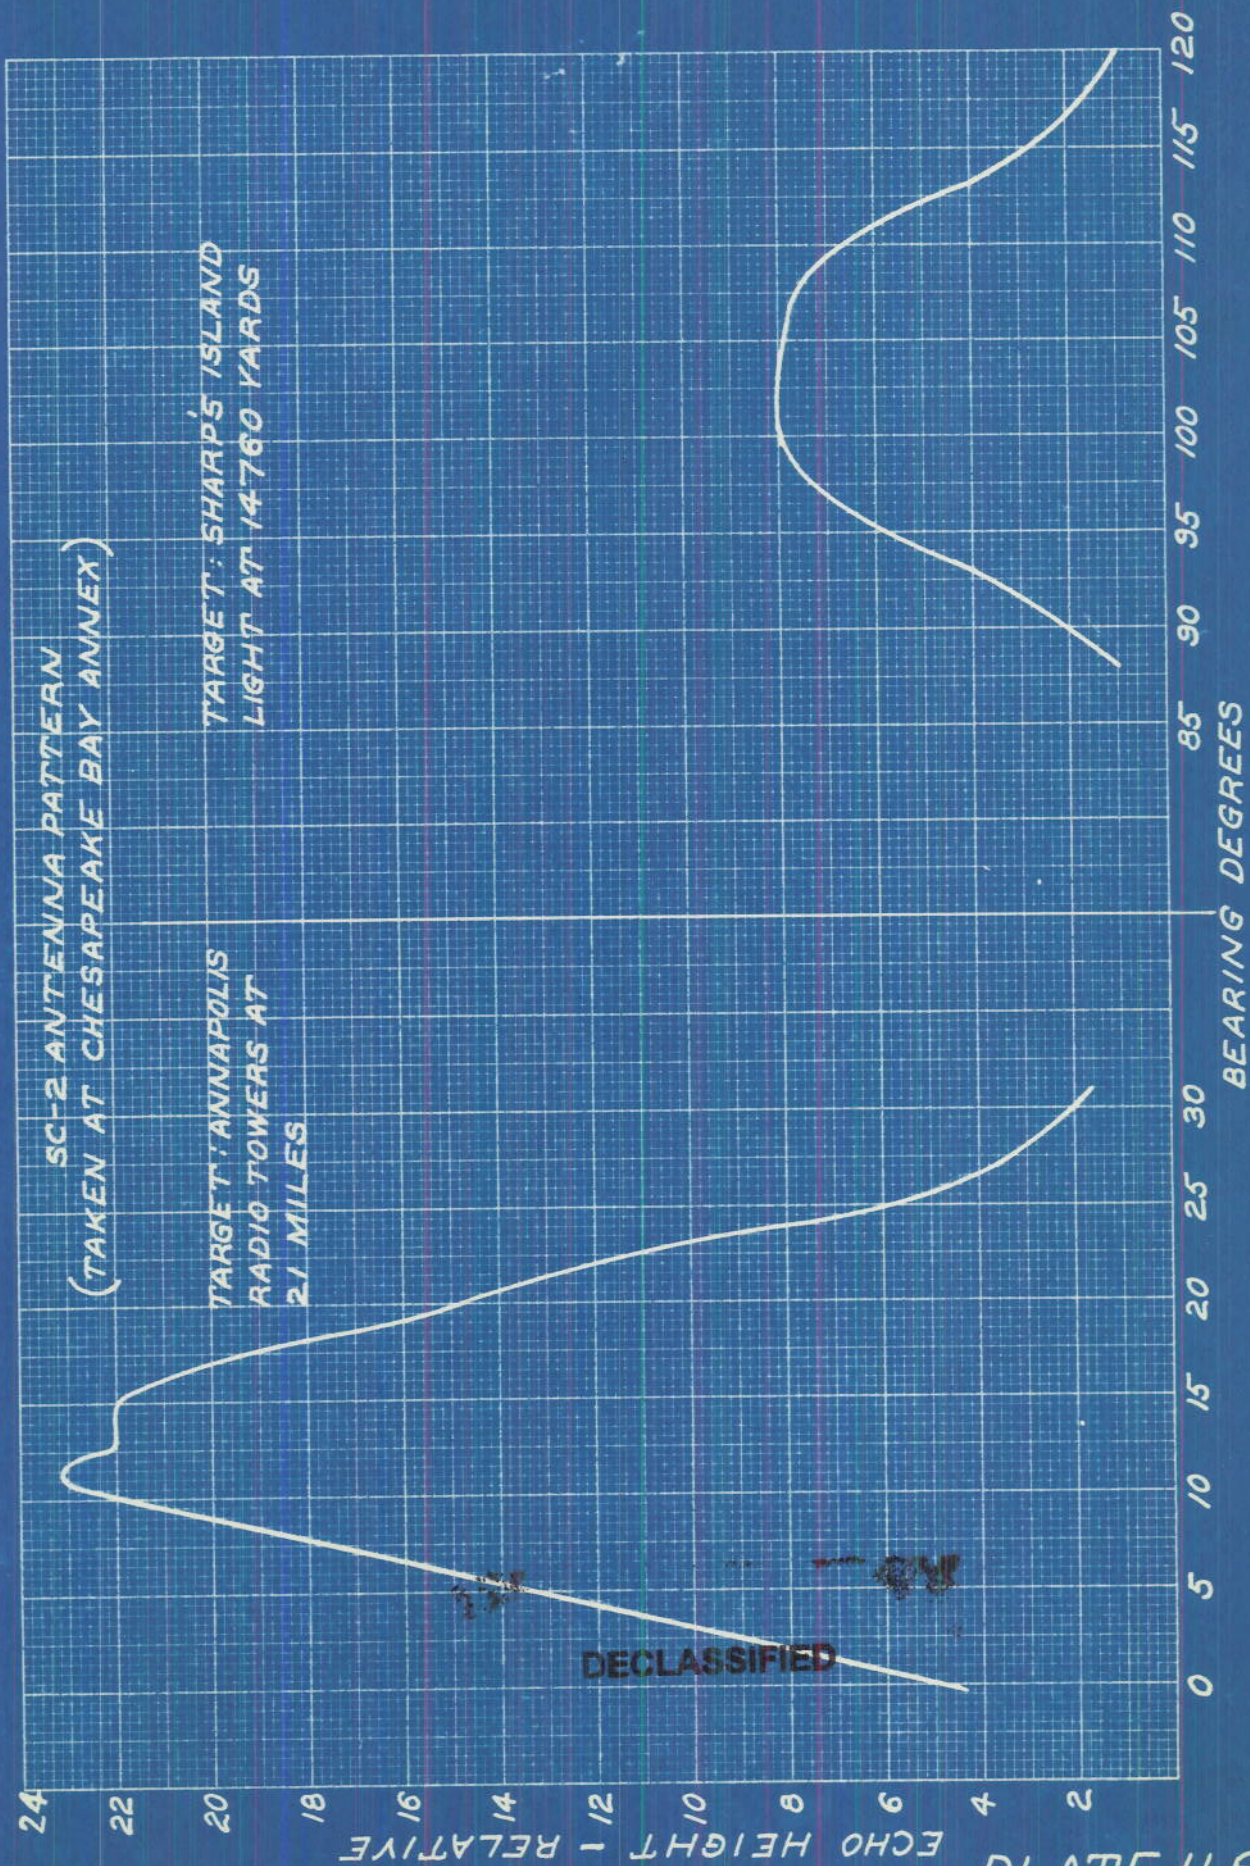
PLATE II SEC.

1-17-5. ROUGH ANTENNA PATTERN. During the operational tests, rough antenna patterns were made with the Annapolis Radio Towers and with Sharps Island Light as the targets. Plate 11 of Section I shows the curves which were obtained when relative echo heights were plotted against bearing readings. At the half-maximum points the beam-width was  $18.5^{\circ}$  for the Annapolis Towers and  $20^{\circ}$  for Sharps Island Light. As noted in paragraph 1-8, a plane flying at 1,000 feet altitude was followed in to 6,200 yards. This corresponds to an elevation angle of  $32^{\circ}$ .
