REPORT OF INVESTIGATION

Surface Nonmetal Mine
(Cement)

Fatal Machinery Accident

March 23, 2005

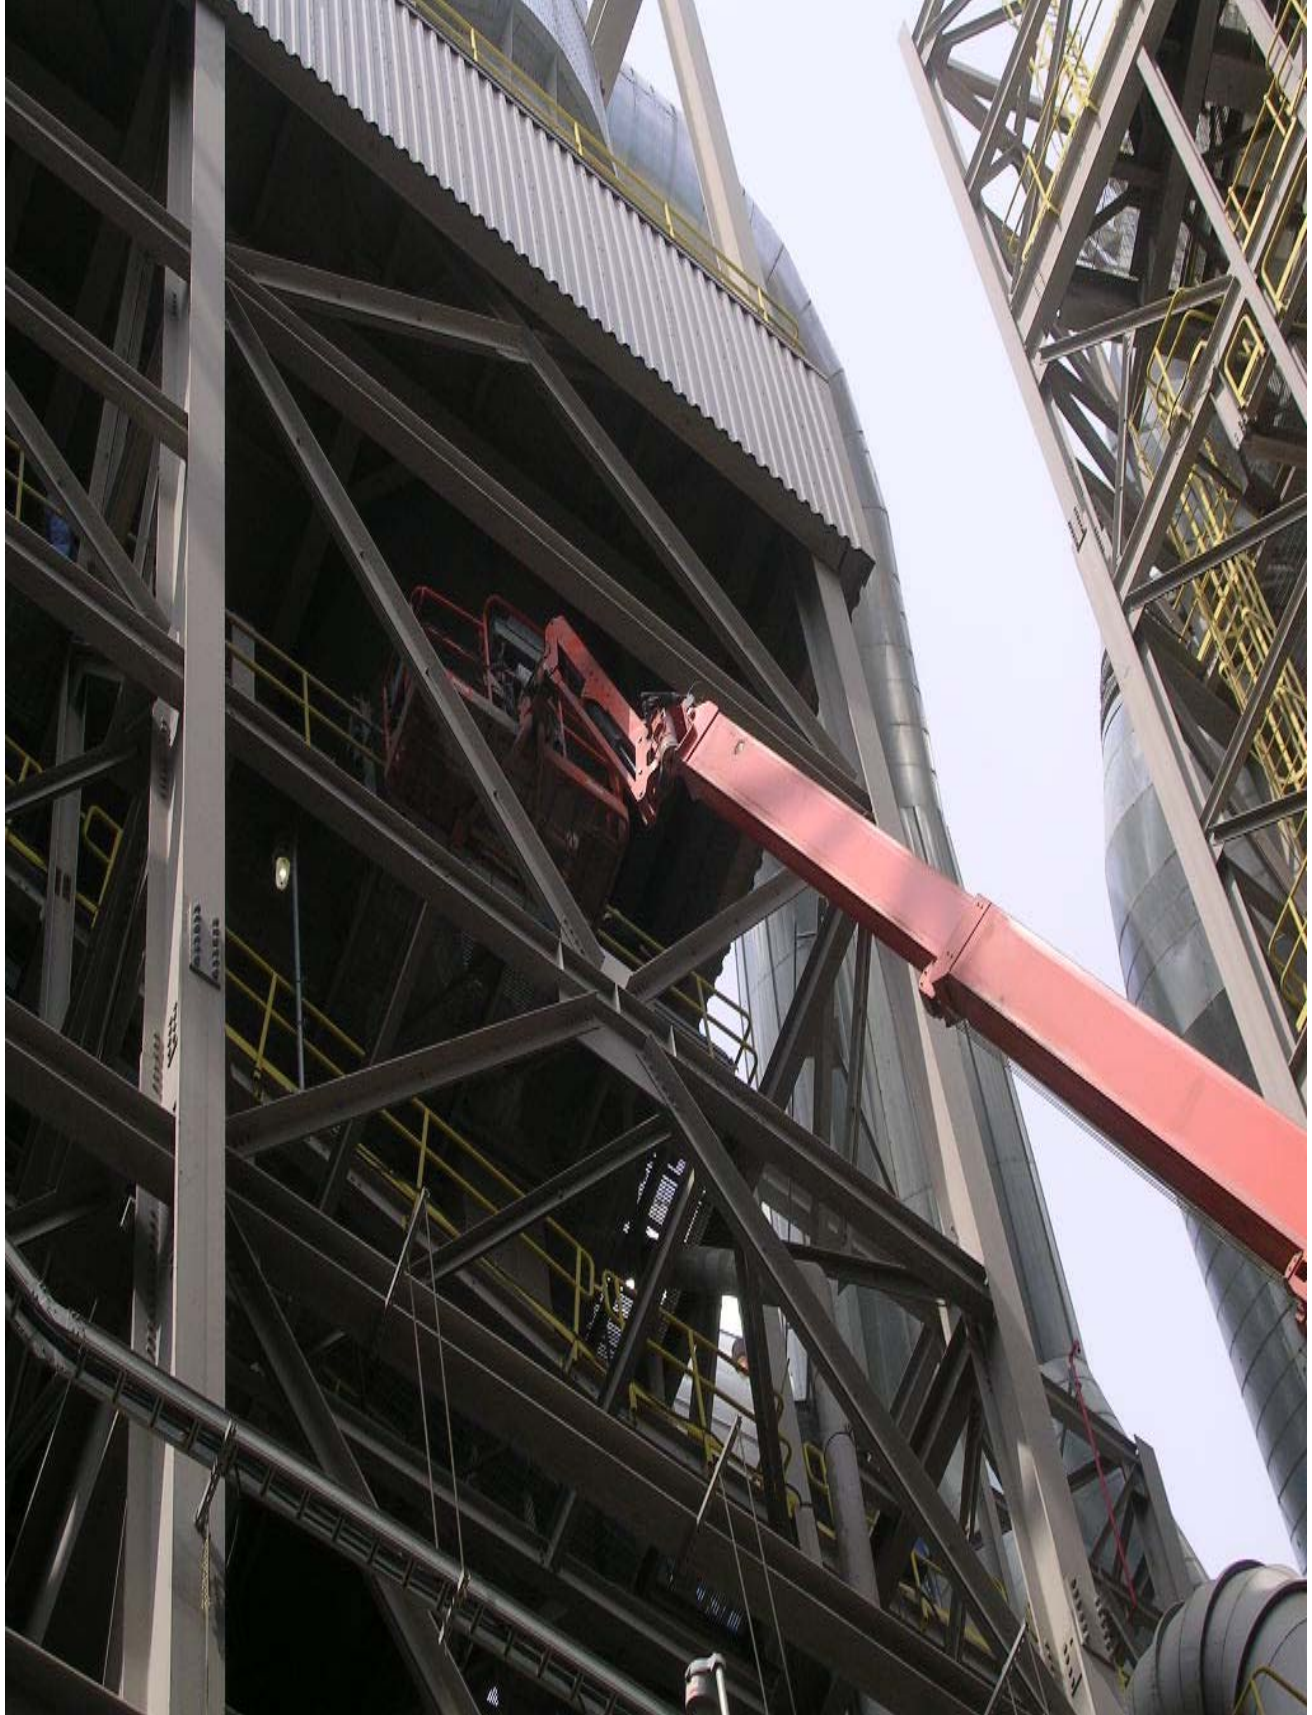
Terry L. Pierce, laborer, age 34, was fatally injured On March 23, 2005, while operating an aerial platform. He was struck by a support beam and was pinned against the basket controls.
