ALERT SERVICE BULLETIN

206L-17-180
3 March 2017

MODEL AFFECTED: 206L-1 and 206L-3

SUBJECT: MAGNETIC BRAKE ASSEMBLY 204-001-376-003,
INSPECTION AND REPAIR OF.

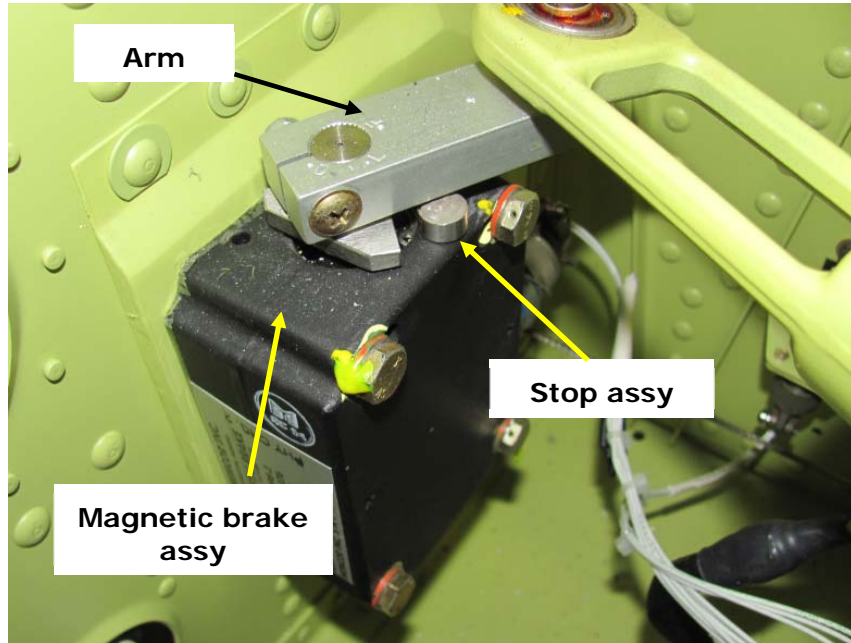
**Figure 1. Magnetic brake assembly.
(204-001-376-003 in Bell 412 directional control shown as an example)**

1. Prepare the helicopter for maintenance.
2. Gain access to the fore and aft and lateral magnetic brake assemblies located under the co-pilot seat.
3. Perform a detailed visual inspection of the stop assemblies (Figures 1 and 2). (Figures 3 and 4) show a stop assembly found disbonded.

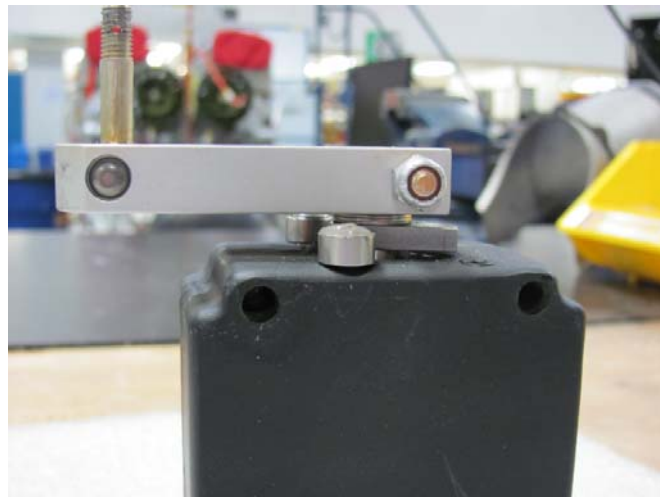
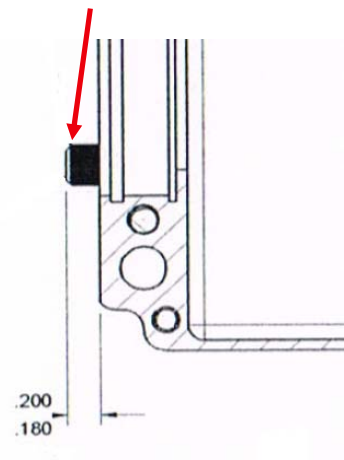
Figure 2. Magnetic brake assembly with stops properly installed.

Shaft correctly installed

9. The shaft should protrude from the housing surface between 0.180 inch (4.57 mm) and 0.200 inch (5.08 mm). (Figure 2).
10. Allow sufficient time for the adhesive to cure (24 hours at 21° to 35°C (70° to 95°F)) and return the magnetic brake assembly to service. Verify/adjust stop limits to achieve the arm assembly shaft travel. (Figures 5 and 6).

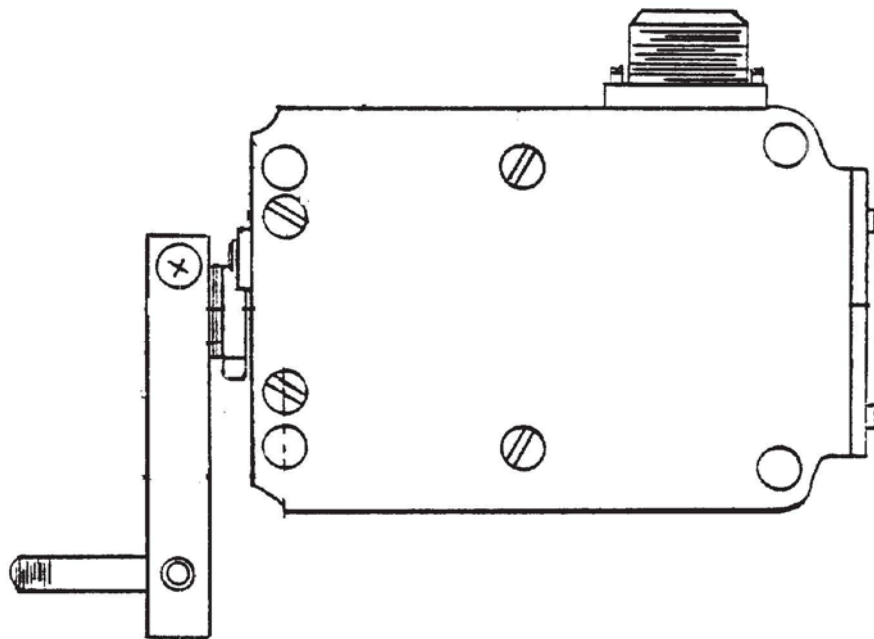
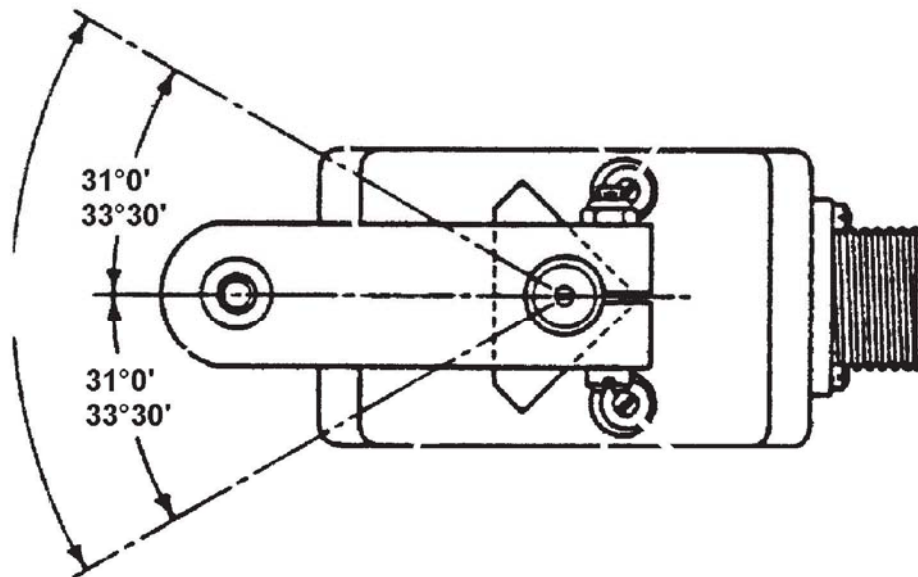
Figure 6. Arm total travel.

Regardless of arm letter indexing, total travel of the arm in relation to the stops is the same.
