Product and Service Issues and Answers

Today's program has 6 parts:

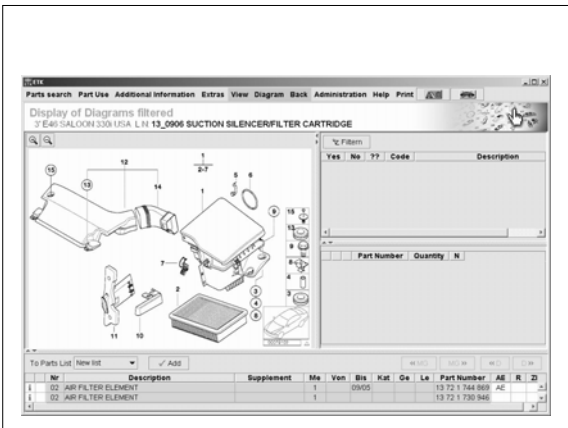
- E46 (3 Series) with M54/M56 from 8/00 to 8/06
- E85 (Z4) with M54 from 3/02 to 11/05
 - EPC shows incorrect air filter application:
 - P/N 1 744 869 - correct filter (with fleece)
 - P/N 1 730 946 - incorrect filter (without fleece)

- Use only air filter with P/N 1 730 869
- EPC will be corrected with the Nov '07 release (10/22/07)
- SI B12 20 07 will be published soon

- Length of the Filter should be between 241-245mm

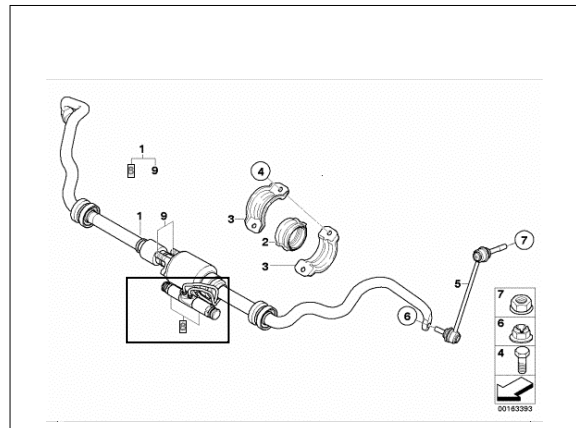
- E70 (X5) with Sport Pack ZSP
 - Clunking noise from front axle over bumps

- Accumulator for front ARS sway bar

- For noises related to the front/rear axle of vehicles with ARS, refer to Repair Instruction RA 37 90... for general troubleshooting
- If the noise is coming from the front sway bar, replace the accumulator (P/N 37 11 6 783 314) as per Repair Instruction RA 37 11...
- SI B37 01 07

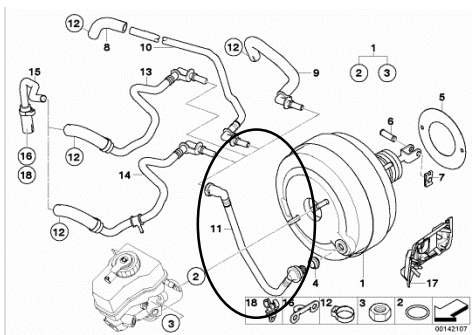
- E9x (3 Series) up to 9/07
- Brake pedal hard to press on initial start

- Leakage at the check valve for the vacuum booster

- Replace the check valve with integrated hose P/N 34 33 7 577 336
- Refer to Repair Instruction RA 34 33 051
- SI B34 06 07

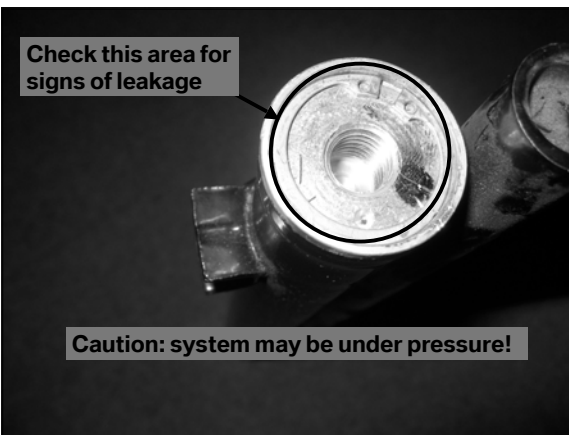
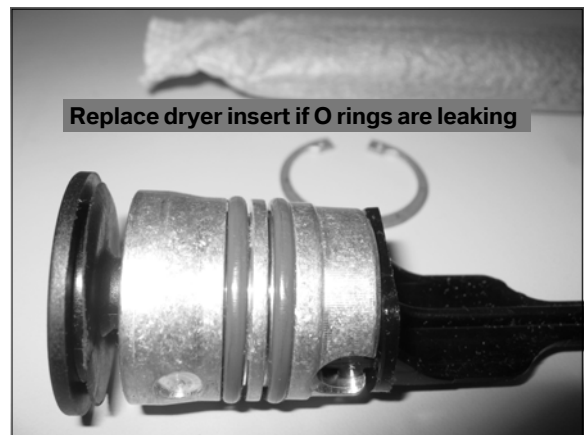
- Air conditioner does not cool

- Condenser dryer insert leaking
(one possible area to inspect)

- Leak test system using approved tracer dye as per SI B04 14 04
- Check the area of the integrated dryer
- Remove the plastic cap on the dryer insert
- Always follow safety precautions when working on A/C systems

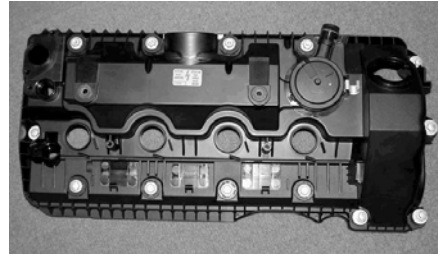
- Possible engine (hydro lock) or valve damage can occur in low ambient temperature

- Install an optimized 1-4 cylinder head cover with insulated hoses

- P/N 11 12 7 563 474 – Valve cover

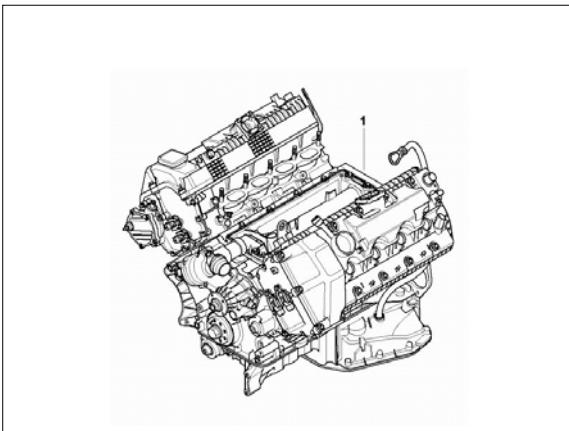
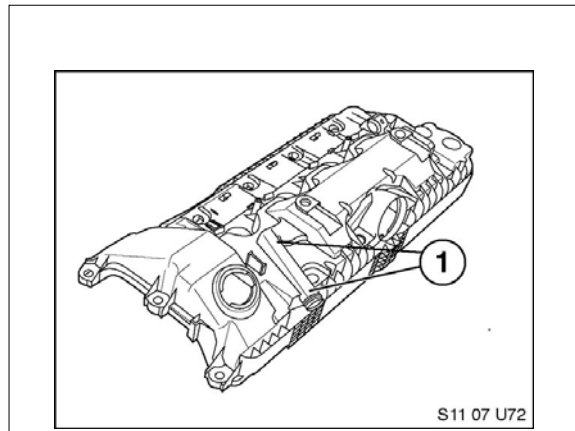
- It is possible a replacement engine is fitted with a cylinder head cover that does not have a integral crankcase ventilation valve

- When replacing the engine it may be necessary to install additional hoses with integrated crankcase ventilation valve
- Failure to install the new hose may cause oil consumption or excessive whistling from the intake area

- Refer to EPC for complete list of part numbers, a vin number must be used to obtain correct part numbers
- Refer to SI B11 12 07 for additional pictures and descriptions of parts needed
