EUROPEAN ORGANIZATION FOR NUCLEAR RESEARCH
European Laboratory for Particles Physics

Task Force Report

Safety of Personnel in LHC underground areas following the accident of 19th September 2008

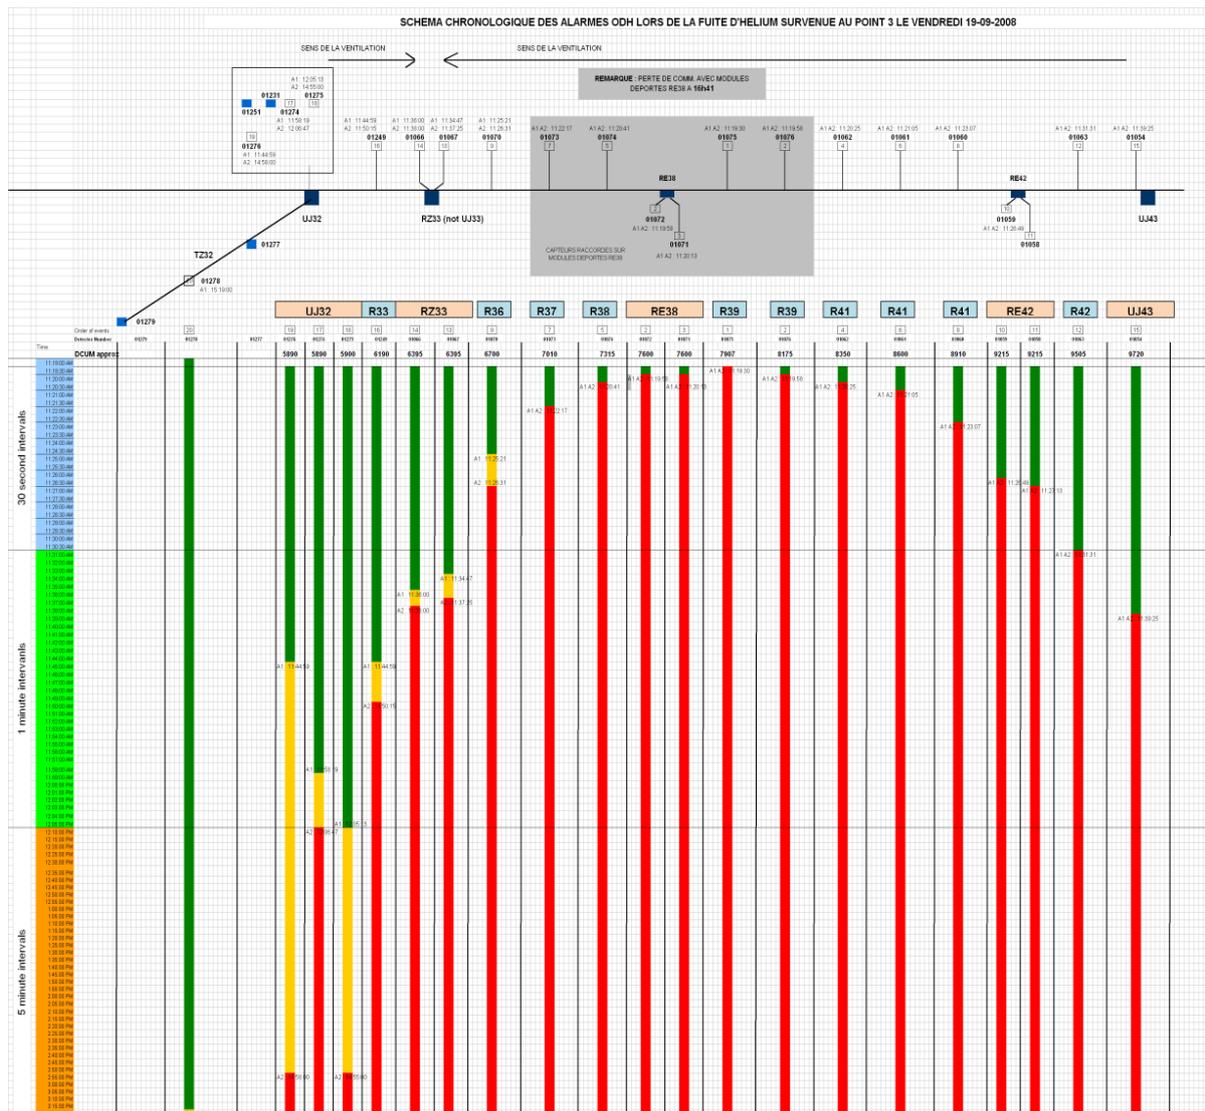
- The Oxygen Deficiency Hazard (ODH) sensor closest to the first release points triggered immediately; the time stamp given by the system is 11:19:05 (see Fig 1).
The Automatic Fire Detection system (AFD) sensor closest to the first release points triggered a few seconds later due to the helium/water cloud; the time stamp given by the system is 11:19:10 (see Annex A).

Fig. 1: Chronological scheme of the ODH alarms in sector 3-4 after the accident on 19th September 2008. Time runs vertically from top to bottom. The horizontal axis gives the localisation of the detectors in the area. The colour coding indicates values as follows: green = O₂ level above 19%, yellow = O₂ level between 19% and 18%, red = O₂ level below 18%.

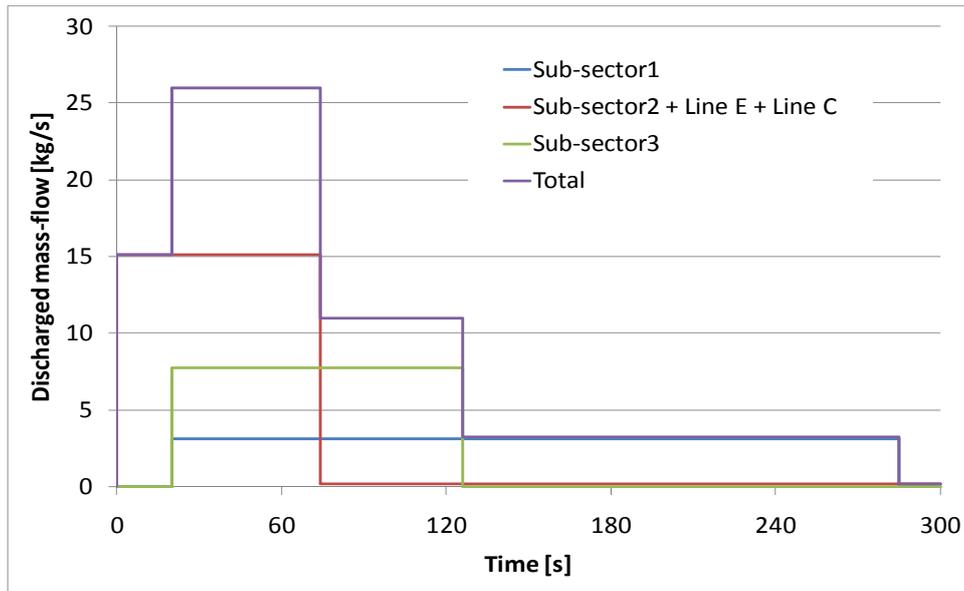
Fig. 2: Helium mass flow due to the discharge of the different vacuum sub-sectors.

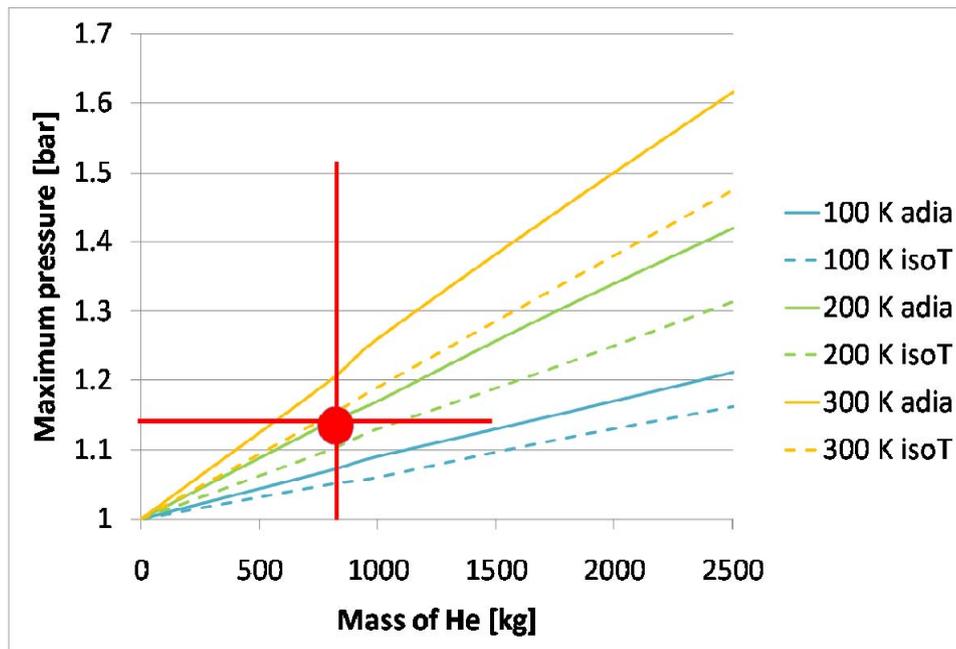
All the above given assumptions and information correspond to a worst case scenario giving a maximum attainable pressure of 135 mbar for ~820 kg of helium discharge, a temperature of 200 K for the helium in the tunnel and a total volume of 33'000 m³ for sector 3-4.

Fig. 3: Estimated pressure development in sector 3-4 assuming the flow rates given in Fig. 2.

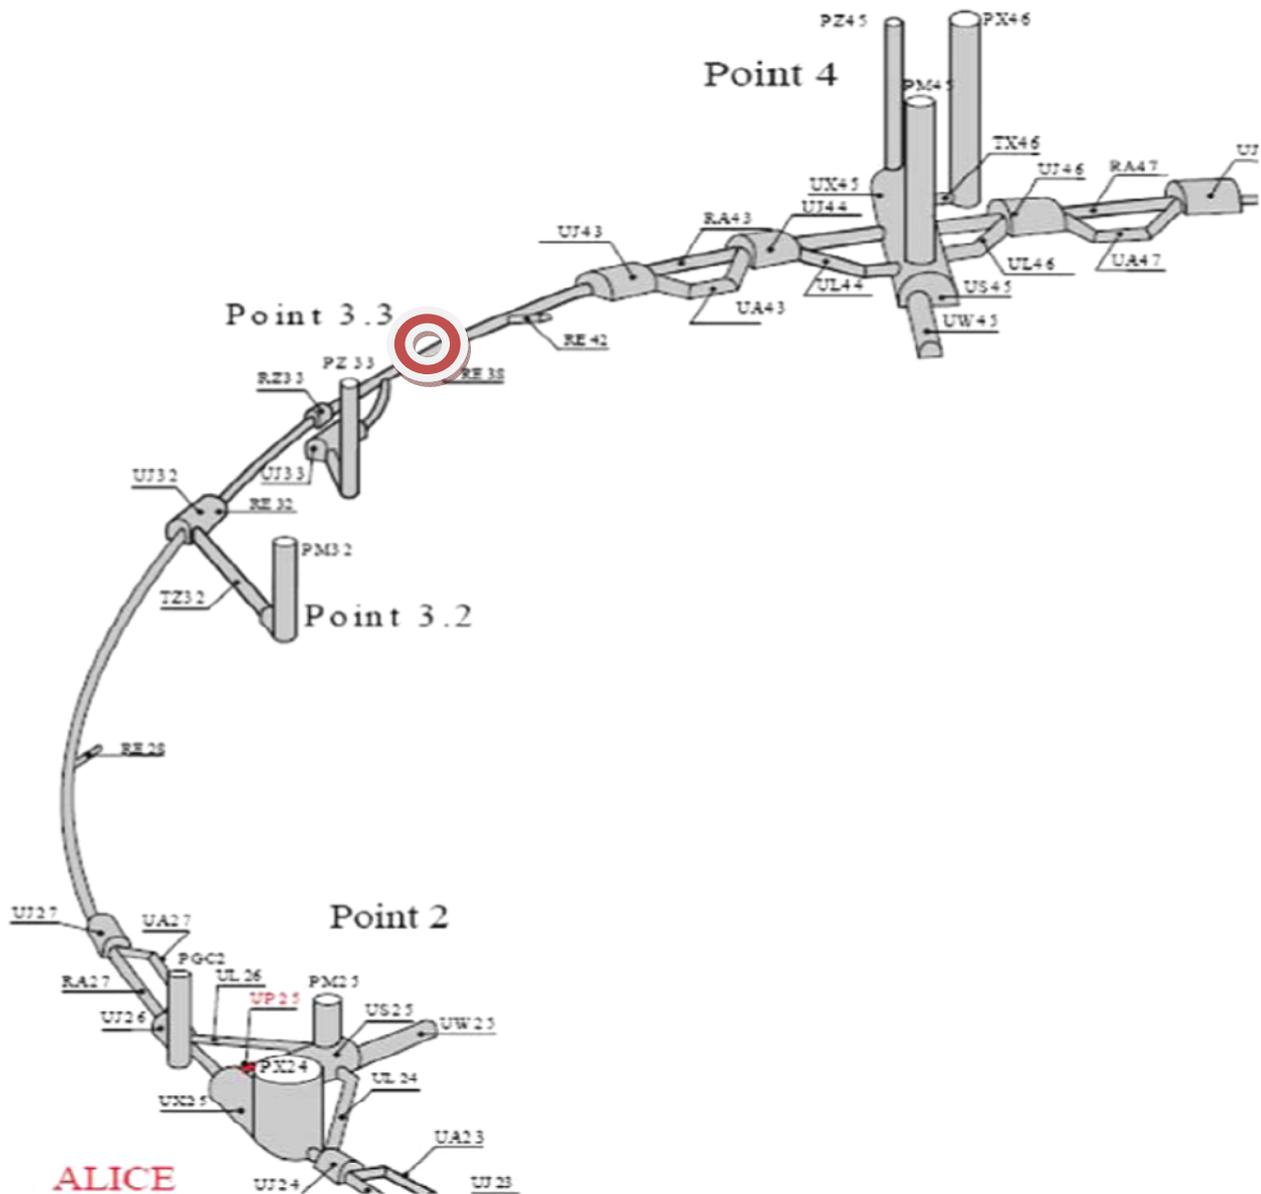
Fig. A1: Schematic layout of the LHC tunnel of sector 3-4. The red dot indicates the approximate position of the accident.

During the accident of 19th September 2008, a total of six safety valves opened and released helium into the LHC tunnel. The positions of the outermost safety valves were DCUM 7536 and DCUM 8060. The *damaged area* (D-area) was defined by the Technical Task Force by the position of the 3 damaged cryogenic sub-sectors stretching from DCUM 7477 to and DCUM 8119, i.e. covering a length of 642 m.

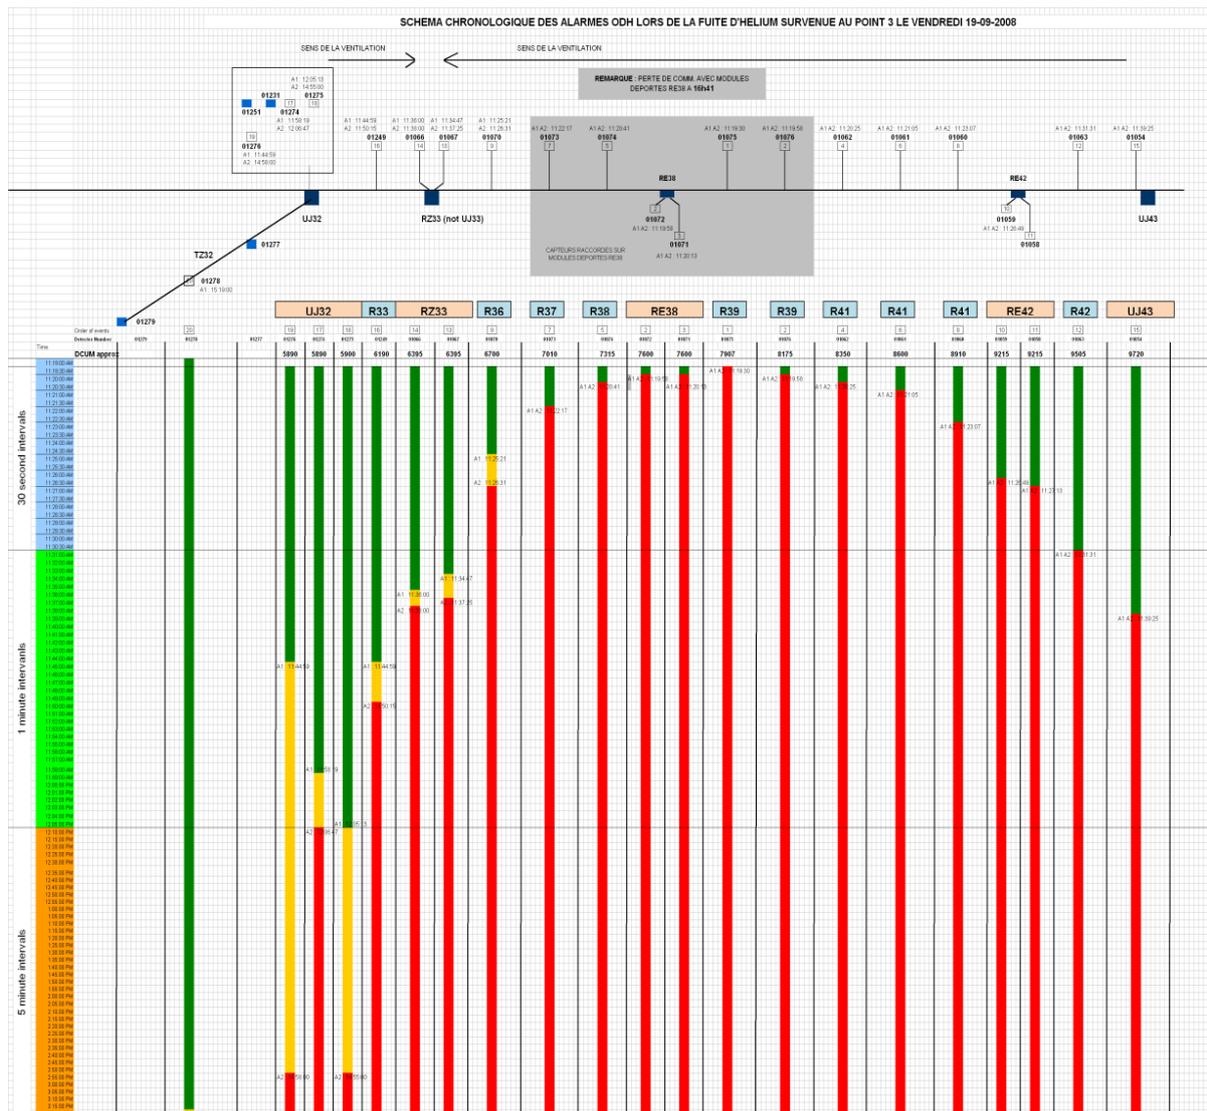
Fig. A2: Chronological scheme of the ODH alarms in sector 3-4 after the accident on 19th September 2008. Time runs vertically from top to bottom. The horizontal axis gives the localisation of the detectors in the area. The colour coding indicates values as follows: green = O₂ level above 19%, yellow = O₂ level between 19% and 18%, red = O₂ level below 18%.

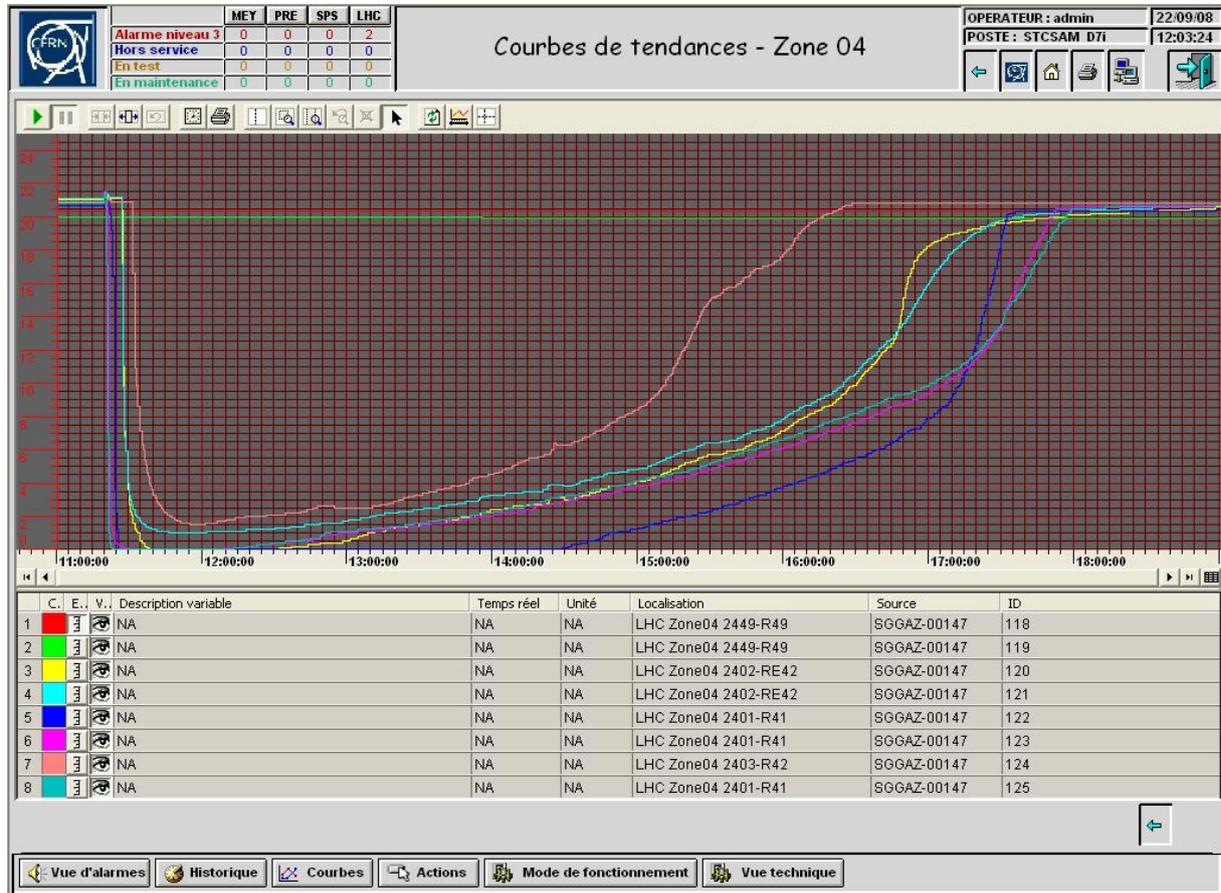
Fig. A3: Oxygen concentrations as a function of time for the ODH sensors of the half sectors 4-3

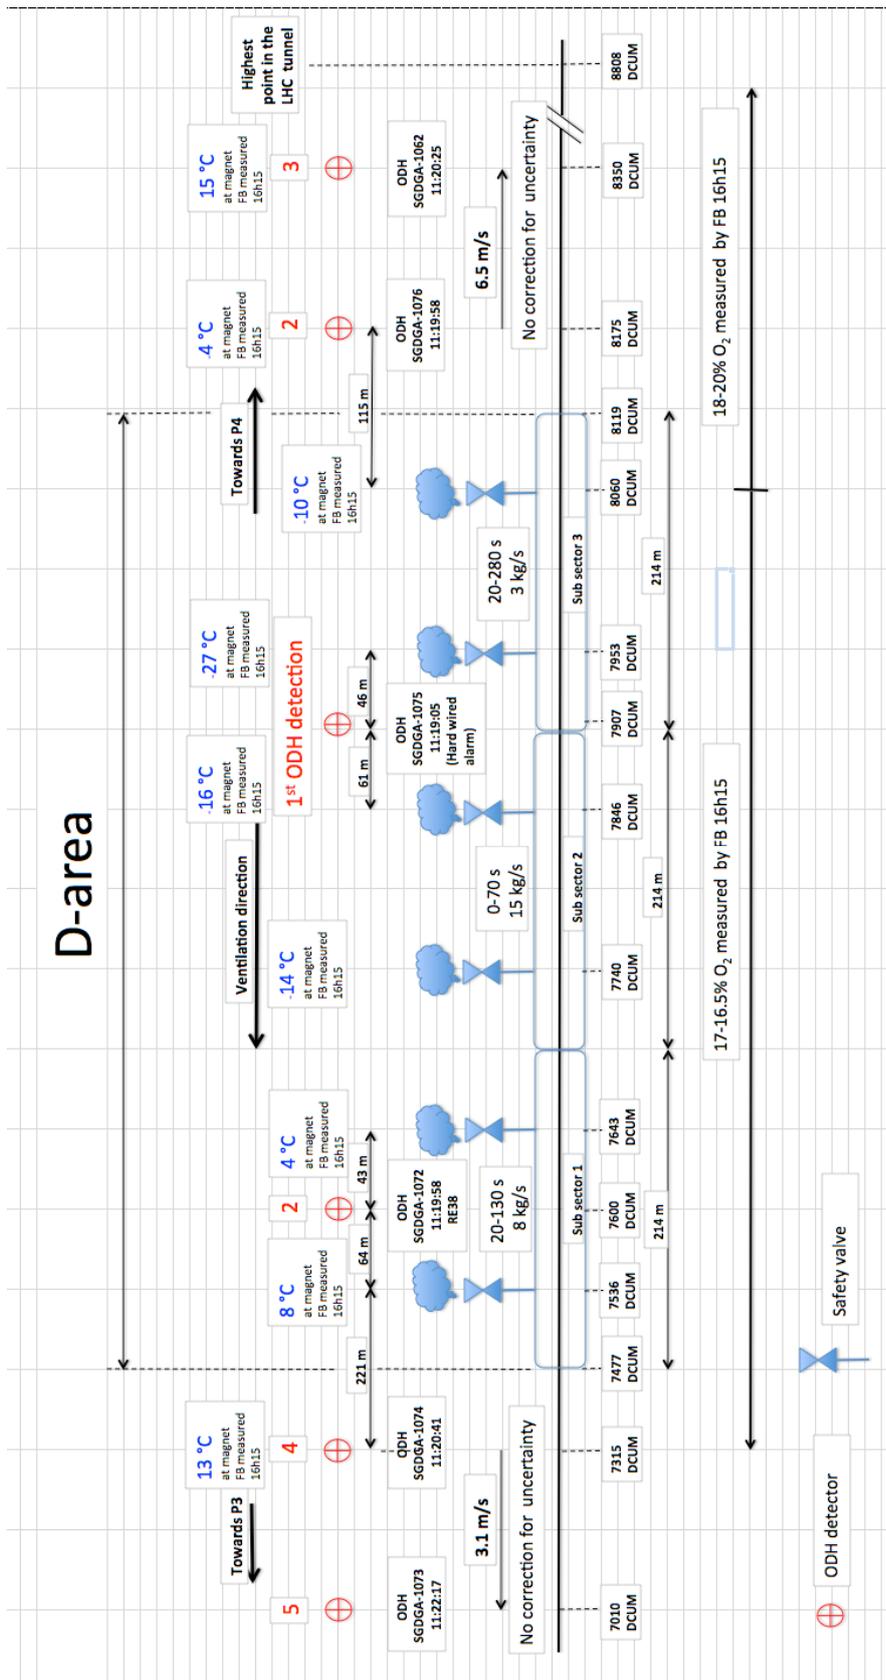
Fig. A4: Summary of the data for the D-area including ODH data and observations by the fire brigade

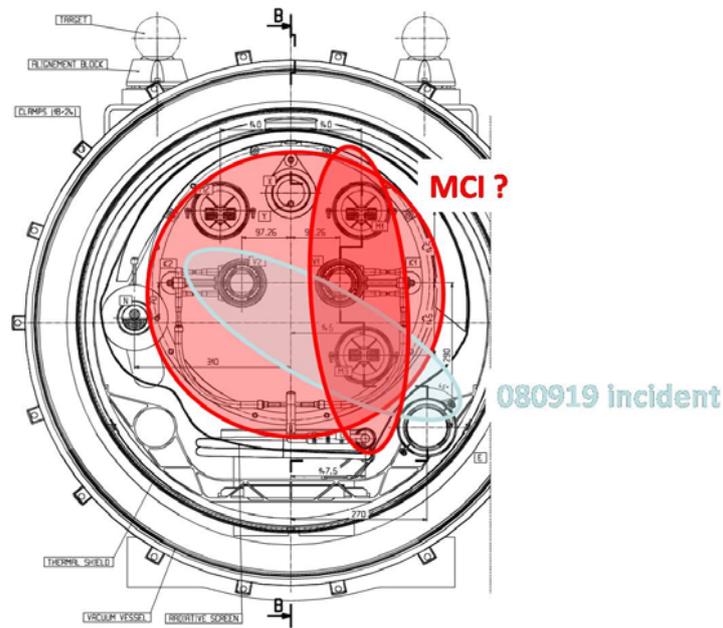
On 19th September 2008, the initial electrical arc has fully destroyed the interconnection line M3 and the beam vacuum line V2, and has perforated the line E (thermal shield cooling) and the beam vacuum line V1 (see Fig. B3). A similar electrical arc with a different development could potentially destroy two bus-bar lines, opening breaches of 4 x 32 cm² (i.e. 128 cm² in total). It should also be remembered that the accident on 19th September 2008 occurred at a current of 8.7 kA, lower than the nominal value. Therefore, it is credible to envisage that an electrical arc at nominal current (~12 kA) could destroy the three bus-bar lines of the magnet interconnection, thus opening breaches of 6 x 32 cm² (192 cm² in total).

Fig. B3: Damages caused by an electrical arc

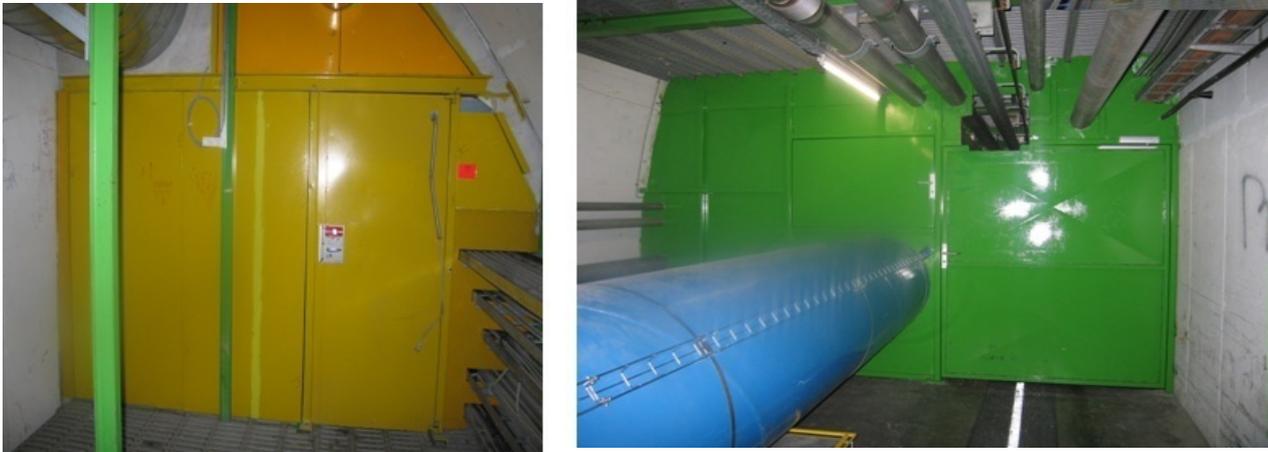
Fig. E1: Pictures of the UJ32 doors

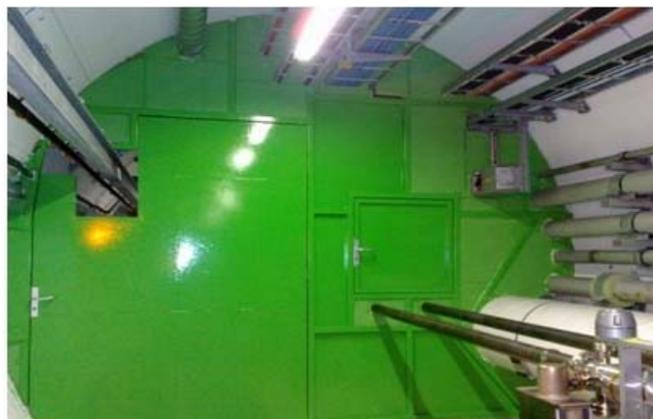
Fig. E2: Picture of the RB44 door

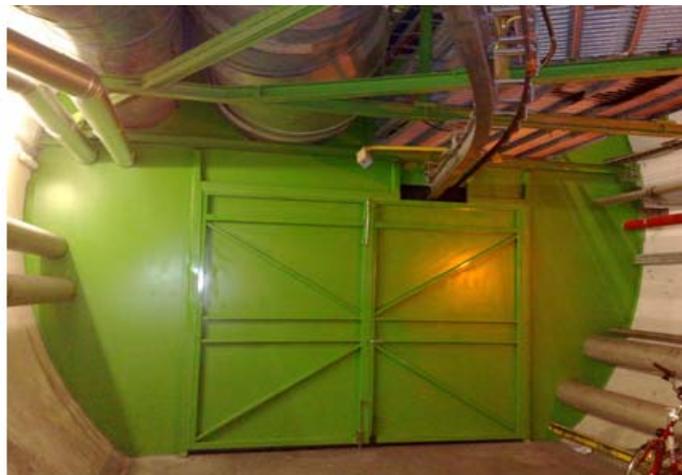
- When a maximum static overpressure of 135 mbar was reached, the ventilation sectorisation door in UL44 gave in resulting in a release of the overpressure (air and helium) via UL44, US45 and the PM shaft into the SD4 surface building and further to the environment through the open door of the building.

Fig. E3: Picture of the UL44 door

7. As an intermediate measure, the Safety Task Force recommends to use existing ventilation doors as relief devices or to equip them with relief valves to allow a pressure release like in 19th September 2008 via the UL area and a shaft to the surface building. This implies in case of an incidental large helium release that the ventilation sector concerned expands beyond the machine tunnel and includes the service areas. The consequences of this short term approach for the accessibility of the LHC underground areas and the PM shafts as well as the SD buildings are explained in greater detail on a specific example in the Annex D.
