2005 Annual Inspection of the Monticello Mill Tailings (USDOE) and Monticello Radioactively Contaminated Properties Sites

December 2005

U.S. Department
of Energy

Office of Legacy Management

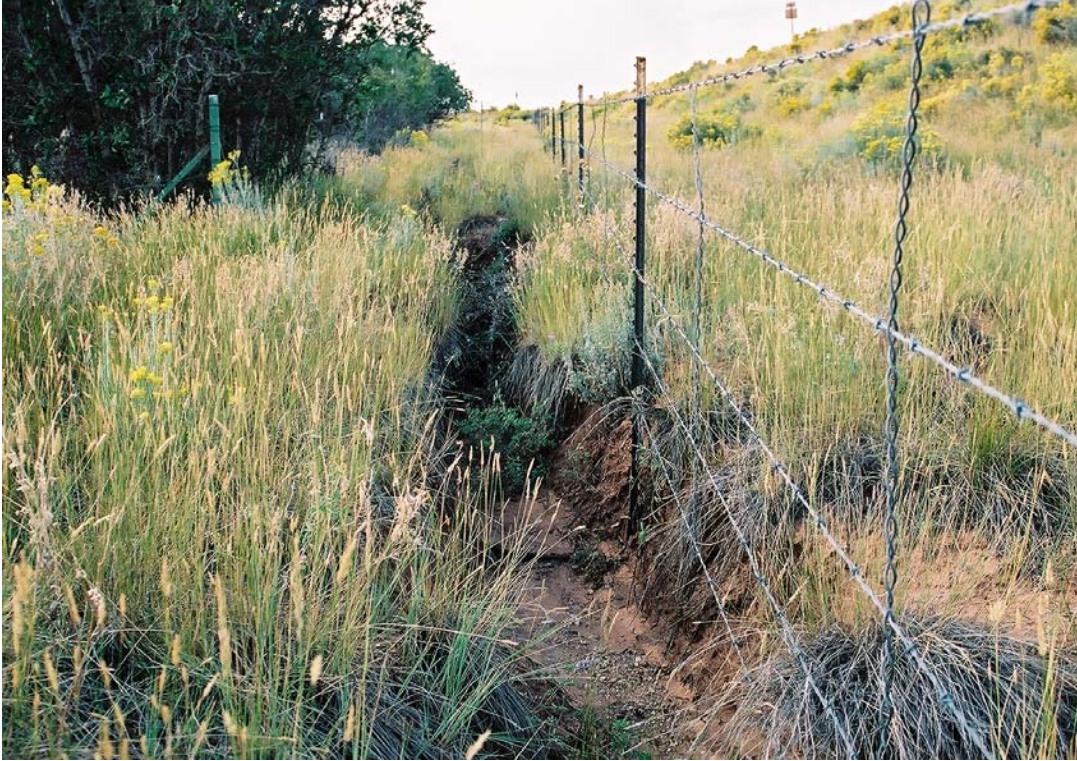
MNT 9/2005. PL-1. Gully erosion near perimeter sign P1.

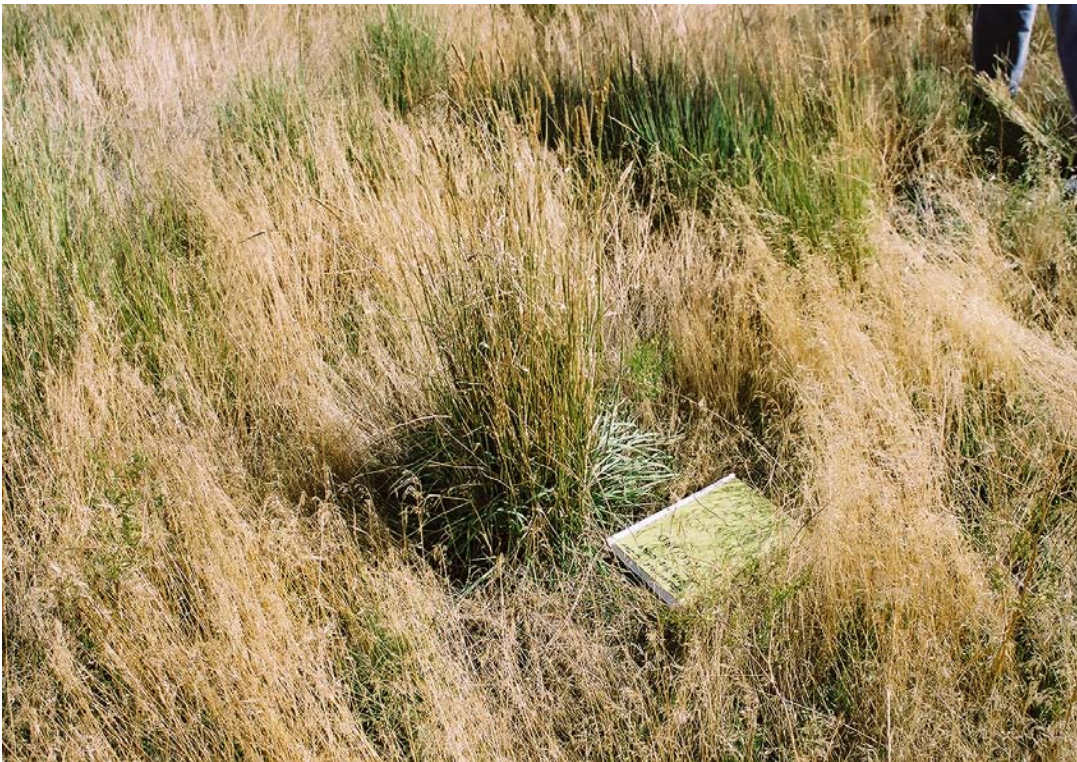
MNT 9/2005. PL-2. Perennial grass (crested wheatgrass) surrounded by an area containing no cheatgrass.

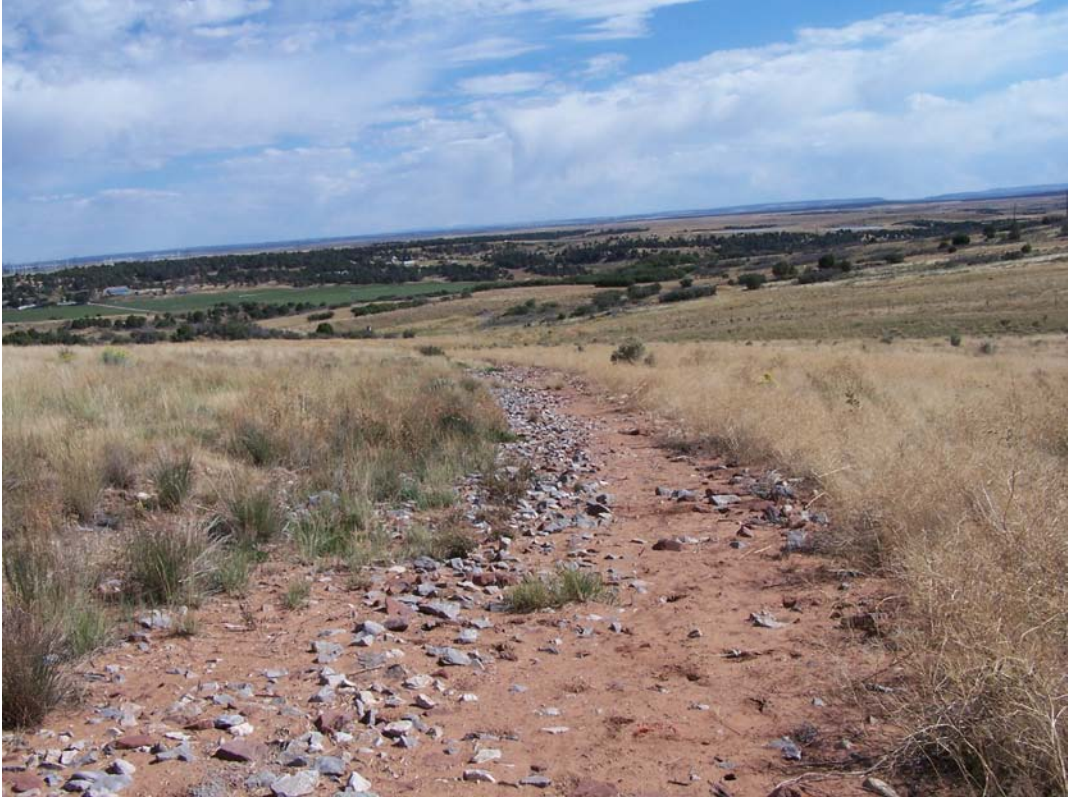
MNT 9/2005. PL-3. Repository toe channel.

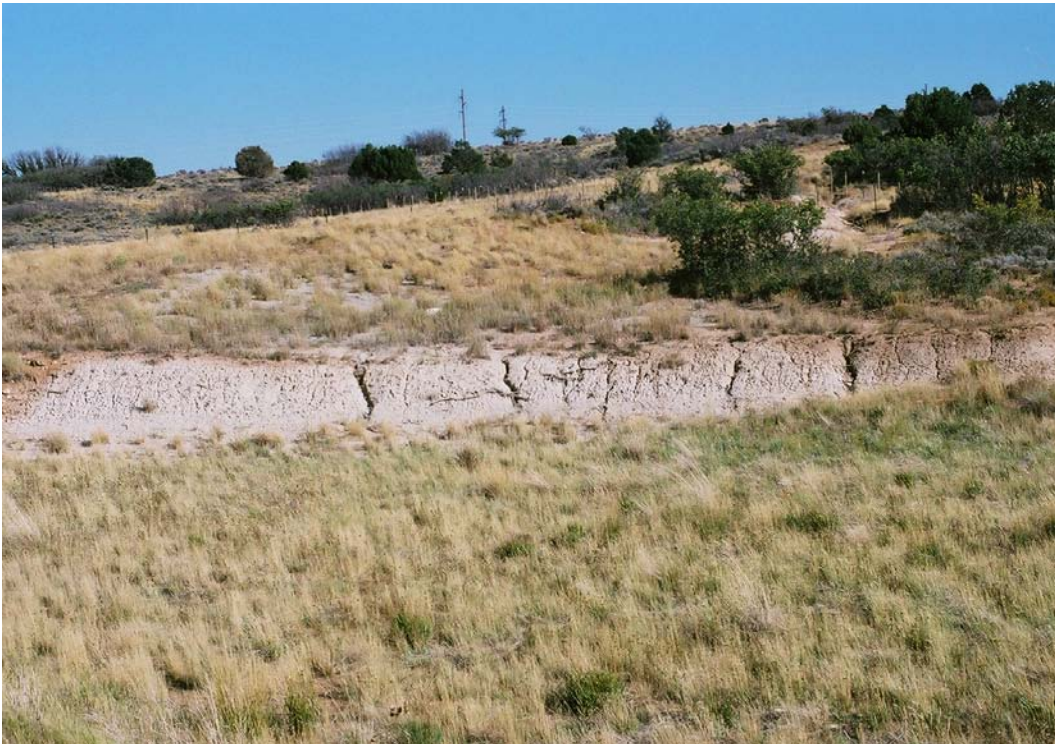
Gullies were noted on the south side of Sediment Pond A and the southeast side of Sediment Pond B. Inspectors noted these gullies in previous years and have determined that they will continue to be monitored but that intervention is not yet warranted. To facilitate monitoring of these gullies, baseline photographs of the gullies were taken in 2004. Photographs from these same locations were obtained in 2005. A comparison of the photographs from 2004 and 2005 demonstrate that the gullies are stable (PL-4 through PL-7) and repair is not needed at this time. Monitoring of these gullies will be conducted in subsequent annual inspections.

MNT 9/2005. PL-4. Baseline photo taken in 2004 from center of Sediment Pond B dam documenting erosion on south side of pond.

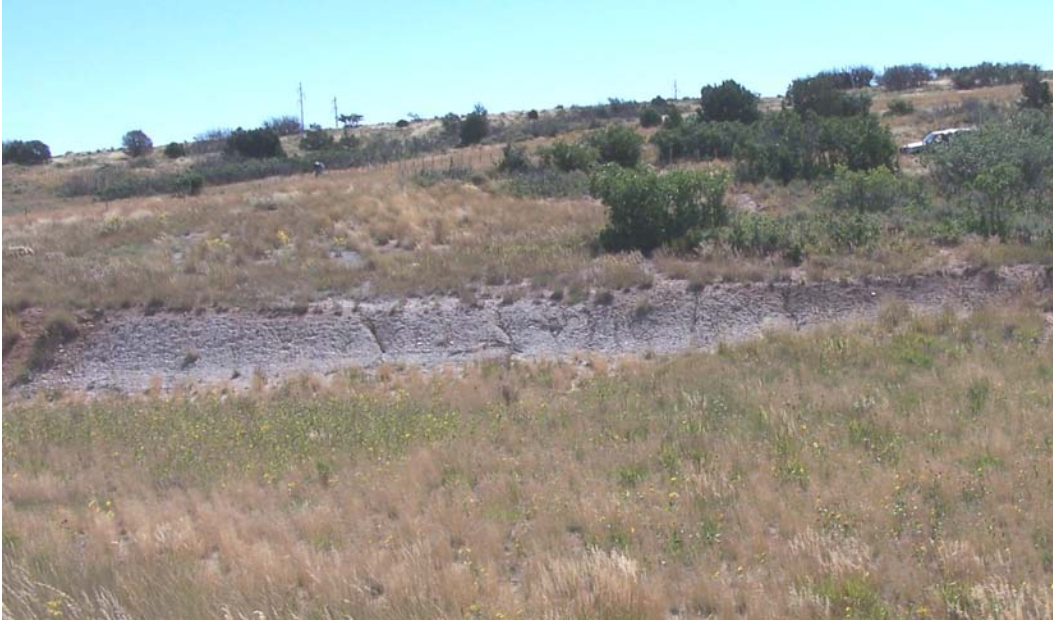
MNT 9/2005. PL-5. Sediment Pond B photo taken in 2005.

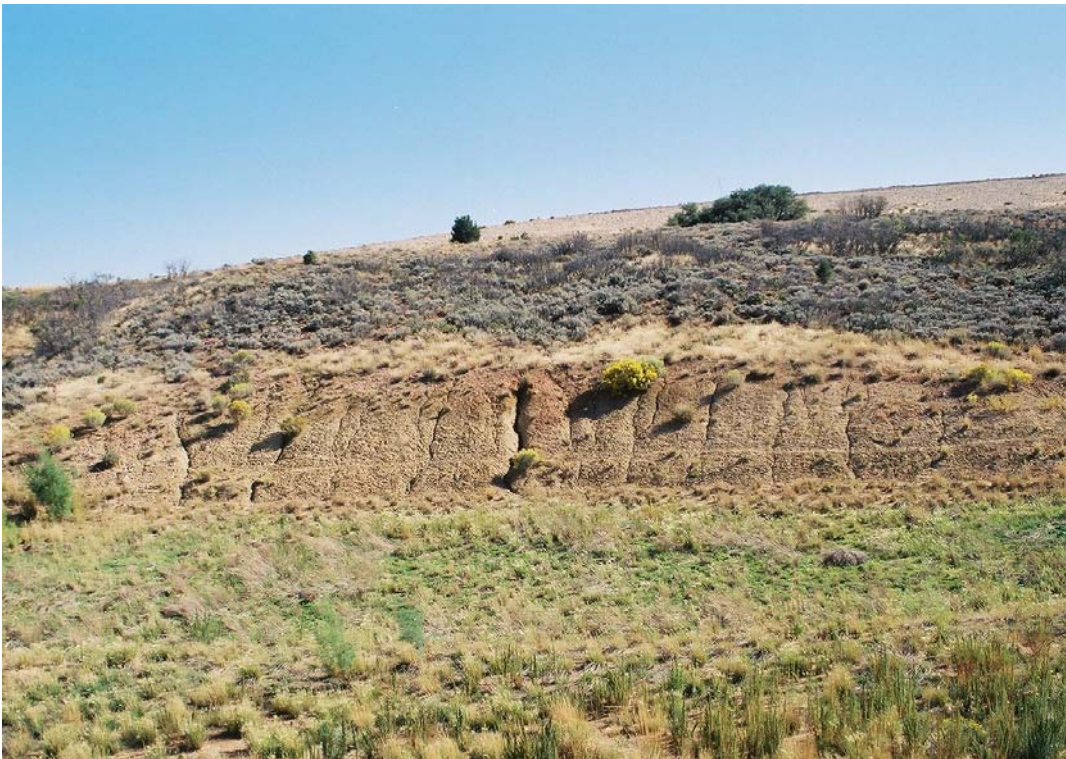
MNT 9/2005. PL-6. Baseline photo taken in 2004 from center of Sediment Pond A dam documenting erosion on south side of pond.

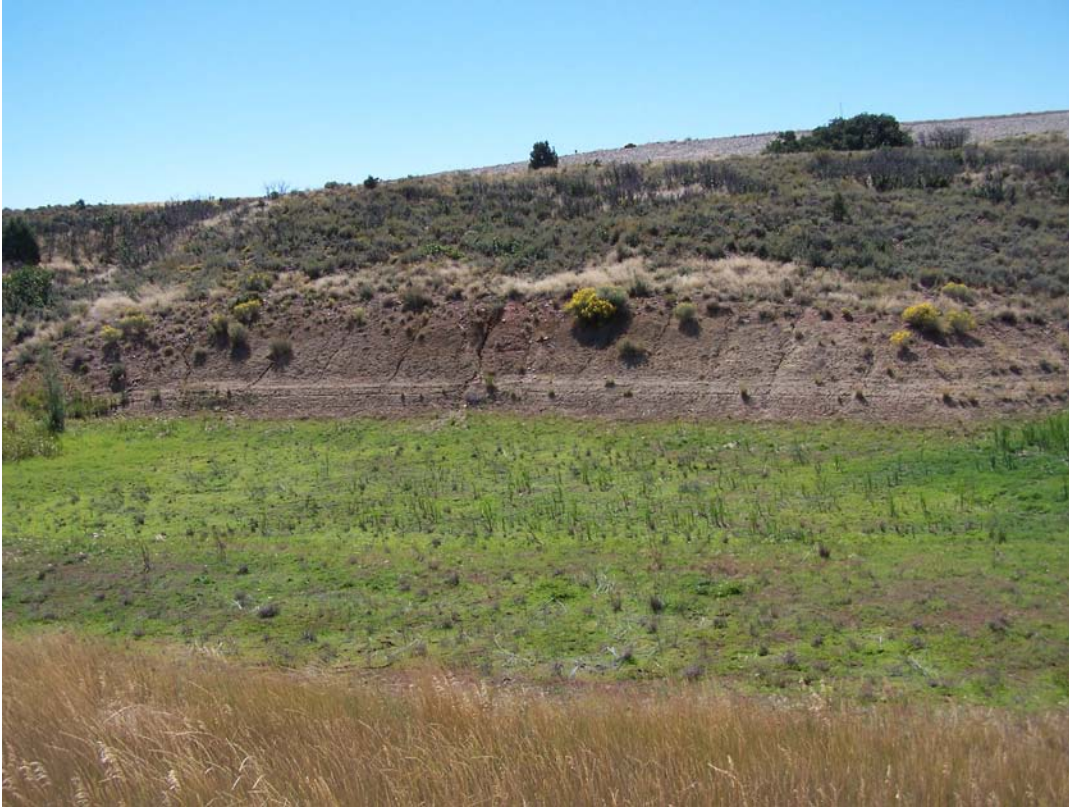
MNT 9/2005. PL-7. Sediment Pond A photo taken in 2005.

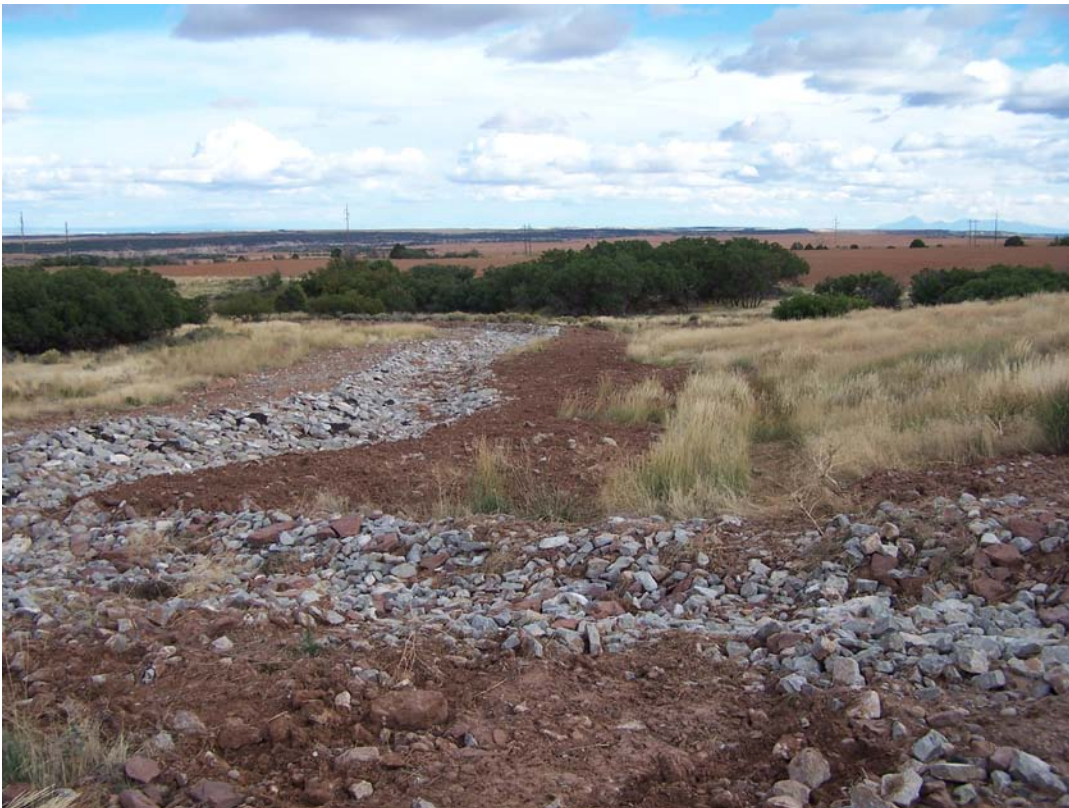
MNT 9/2005. PL-8. Reconstructed channel leading to Sediment Pond C.

Previous inspections noted that the south drainage channel outside the repository fence was inadequate but DOE had not committed to reconstructing the channel. During the 2005 inspection, DOE agreed to reconstruct the channel during the current fiscal year. A track hoe was mobilized to the site on September 26, 2005. The channel was reconfigured into a trapezoidal shape and widened at the top to capture runoff water originating south of the repository fence. The rebuilt channel is shown in PL-8.

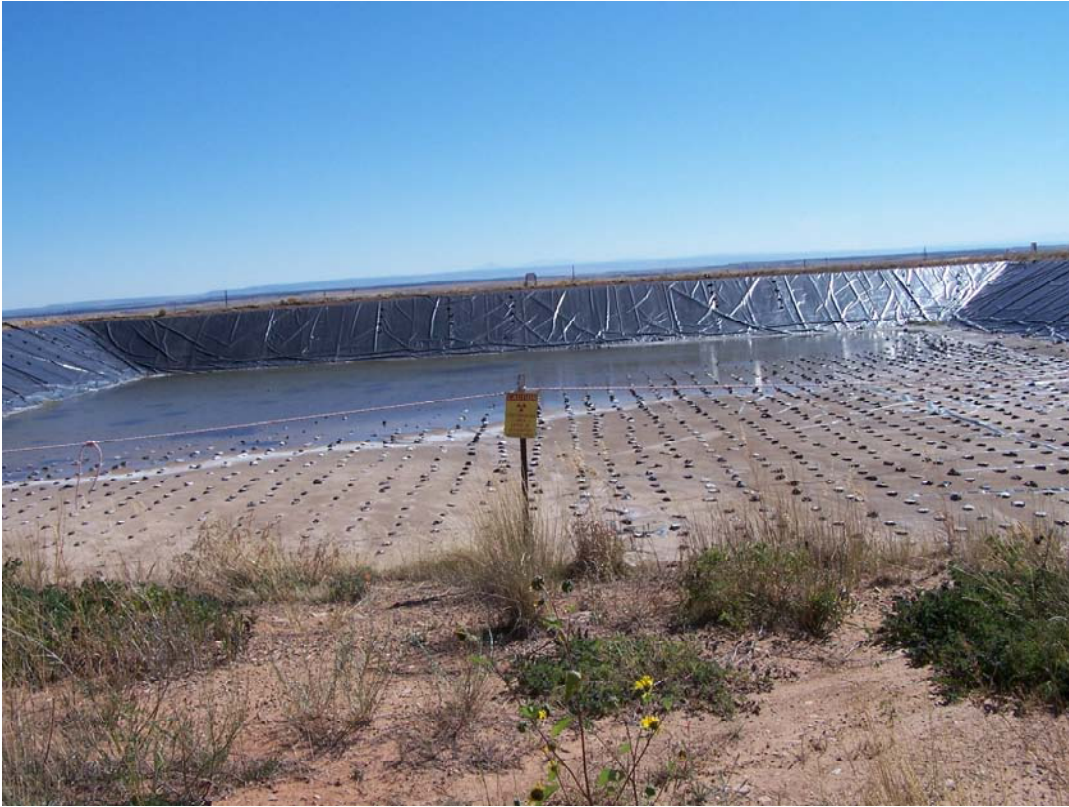
No holes or evidence of holes in the pond liner were observed. The water level in the pond is low with only about one-half of the pond floor under water (PL-9).

MNT 9/2005. PL-9. Pond 4.

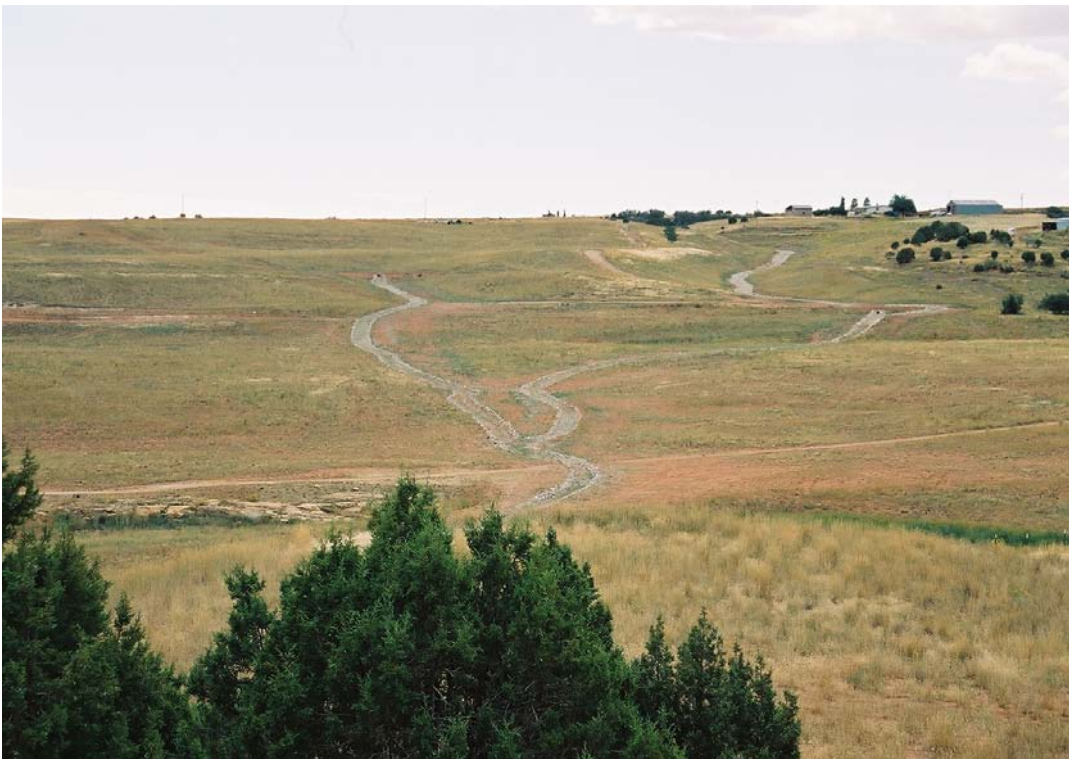
MNT 9/2005. PL-10. View of millsite drainage ditches from Clay Hill Drive.

In June 2005, these channels were reconstructed into a trapezoidal channel (PL-10) and a new entrance (see Figure 3, IRL 10) into Montezuma Creek was established in lieu of rebuilding the former entrance into the creek. The culverts in the walking path were removed. Repair of the channels is complete with the exception of installing a bridge over the footpath. Installation of the bridge is the City’s responsibility.

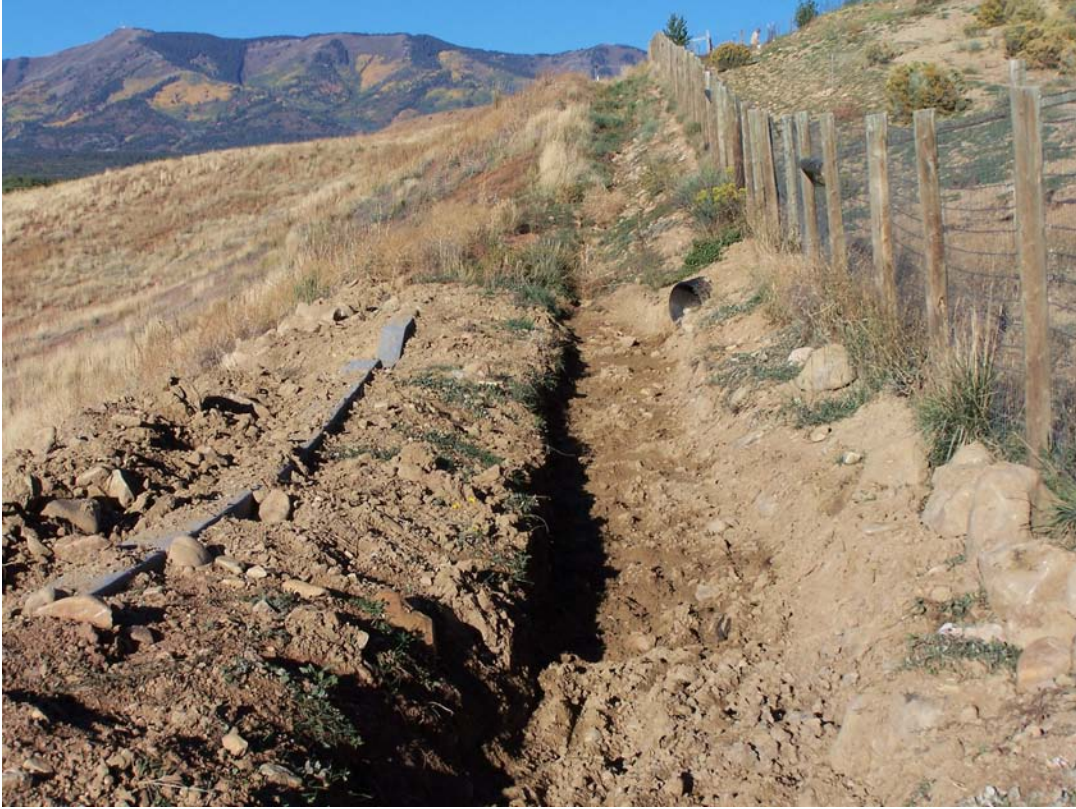
MNT 9/2005. PL-11. Trench and concrete structure below Frost Property culvert.

In June 2005, the ditch was reconstructed with a concrete retaining wall and an overflow spillway leading to a rock-lined channel. A 24-inch pipe also was installed on Frost's property to carry water to the concrete retaining wall. Inspectors noted that rocks and trash obstructed the ditch just east of the concrete retaining wall. The obstruction and silt were removed from the ditch by September 30, 2005 (PL-11). Repair items have been completed at this location. Keeping the ditch clean is an on-going maintenance item that is the responsibility of the City.

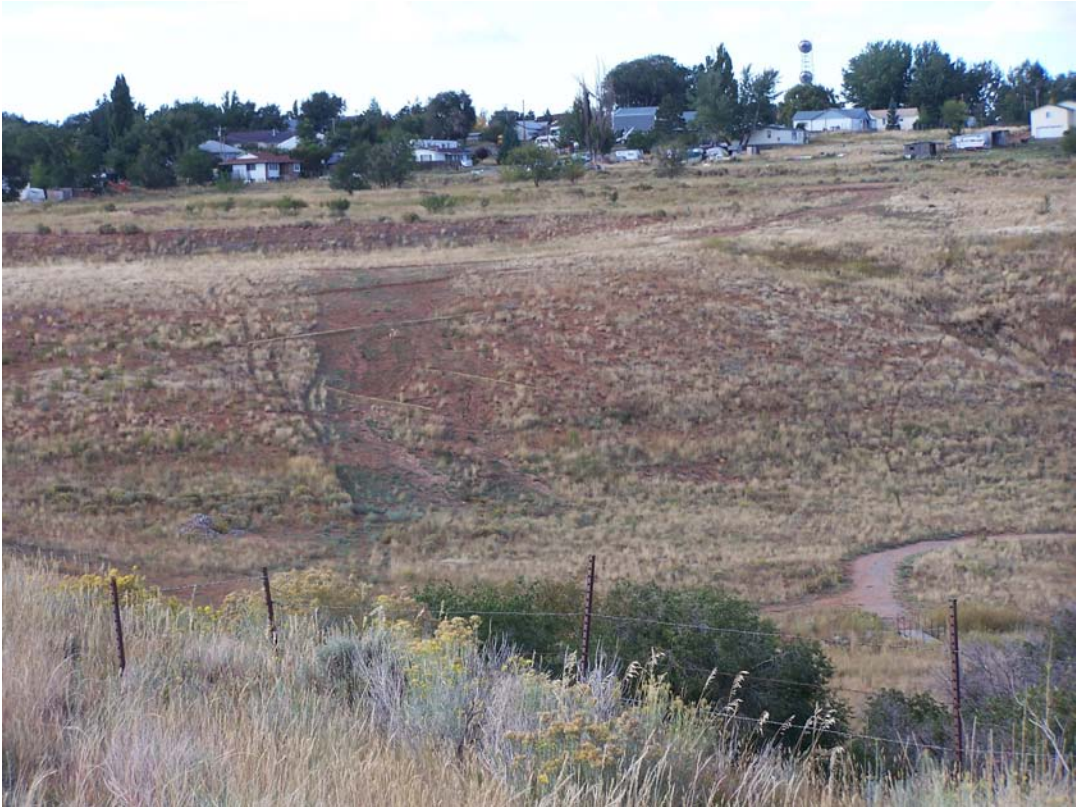
MNT 9/2005. PL-12. Straw Bales on MP-00181.

In June 2005, the ditch from 2nd East to Highway 191 was rebuilt, and the gullies were filled and reseeded. Inspectors noted new gullies forming in the same locations. Ditches were placed at the top of the hill in September 2005, and straw bales were placed across the steep slope to divert water to areas with established vegetation (PL-12 and PL-13).

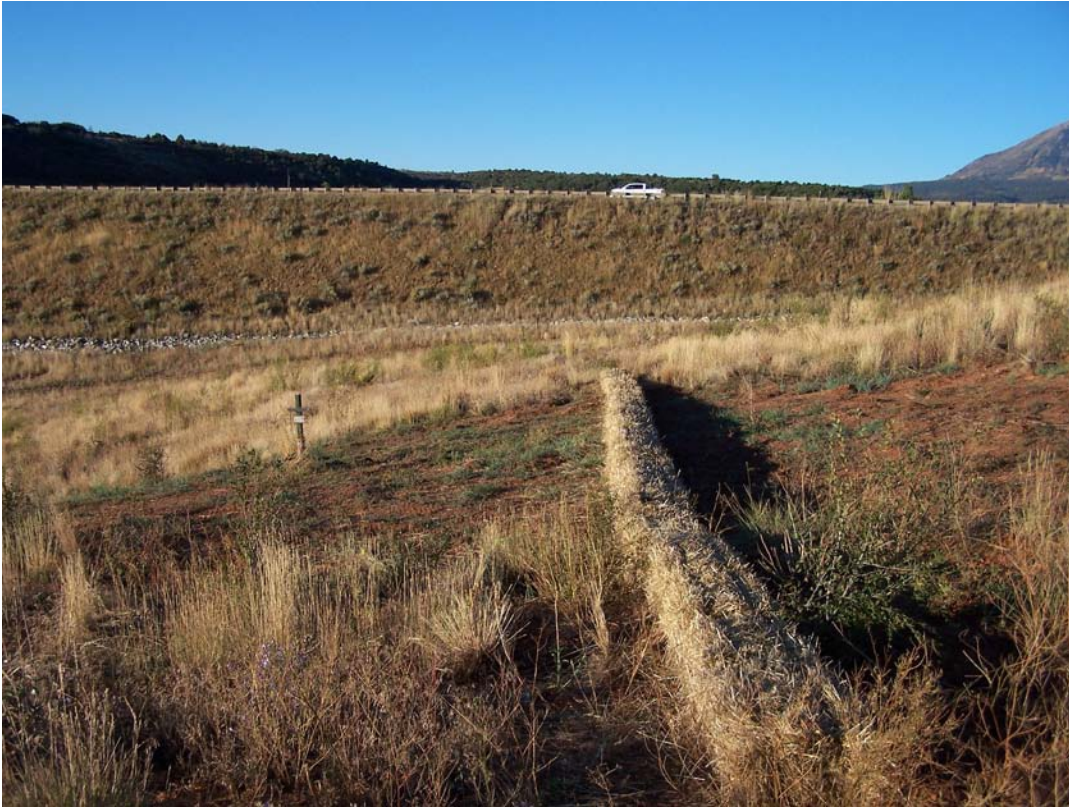
MNT 9/2005. PL-13. Straw Bales controlling erosion west of Goodknight Spring.

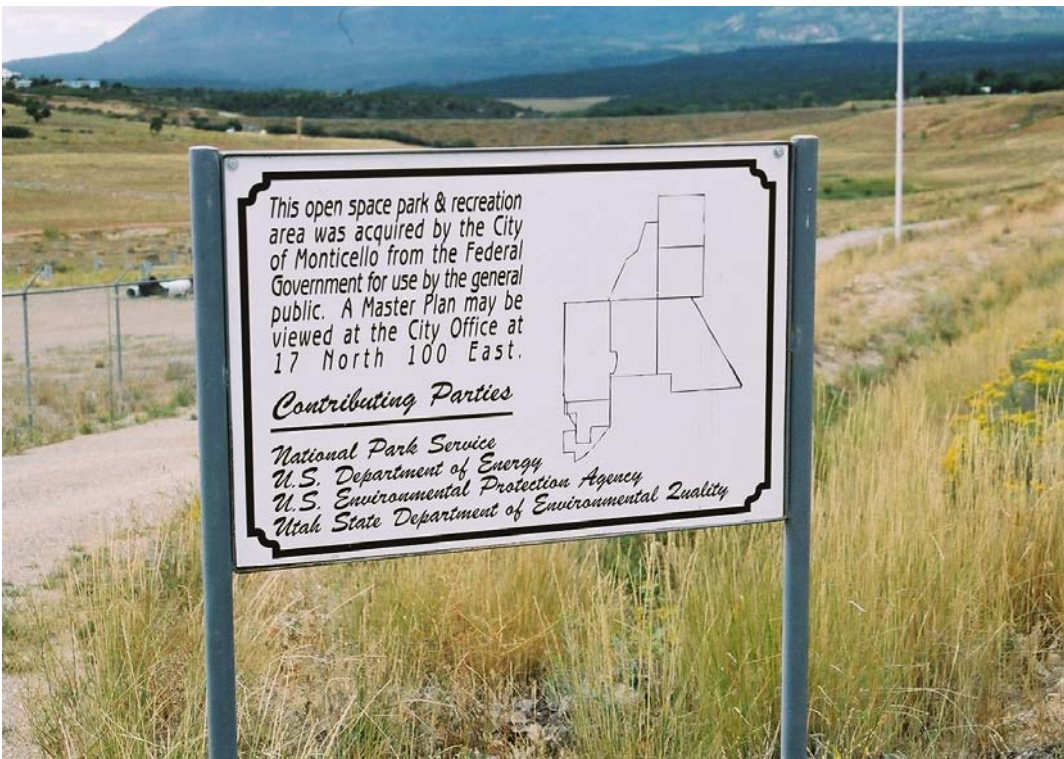
MNT 9/2005. PL-14. New "park" sign at millsite entrance.
