**Number:** 777-78A0094  
Original Issue: July 29, 2014  
ATA System: 7830

**SUBJECT:** EXHAUST (Trent 800 Engines) - Thrust Reverser System - Thrust Reverser Inner Wall Replacement

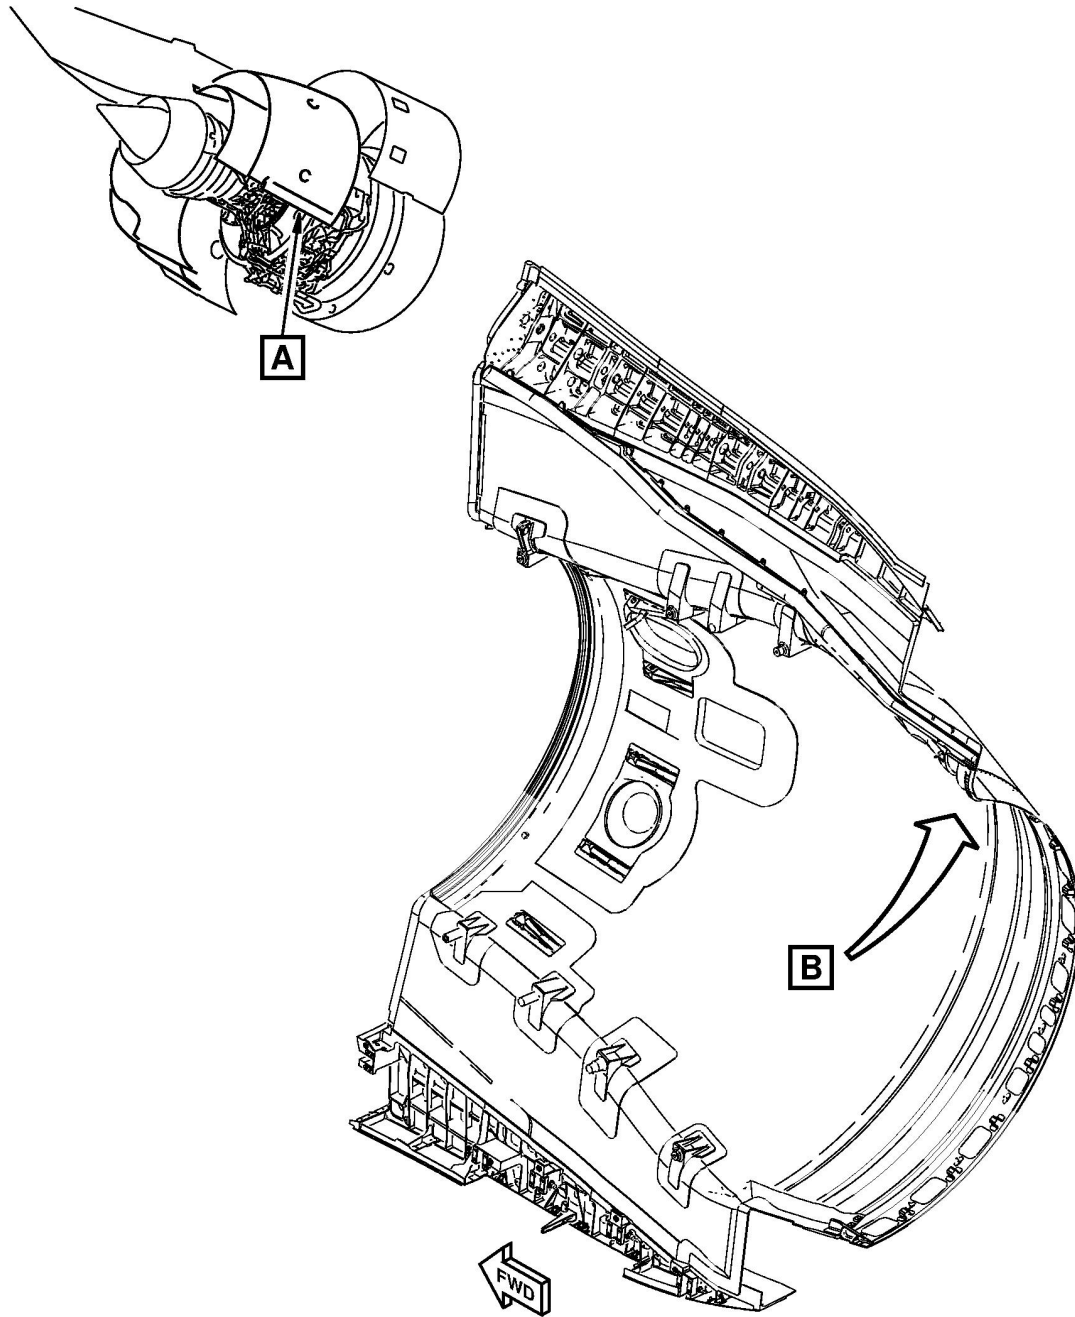
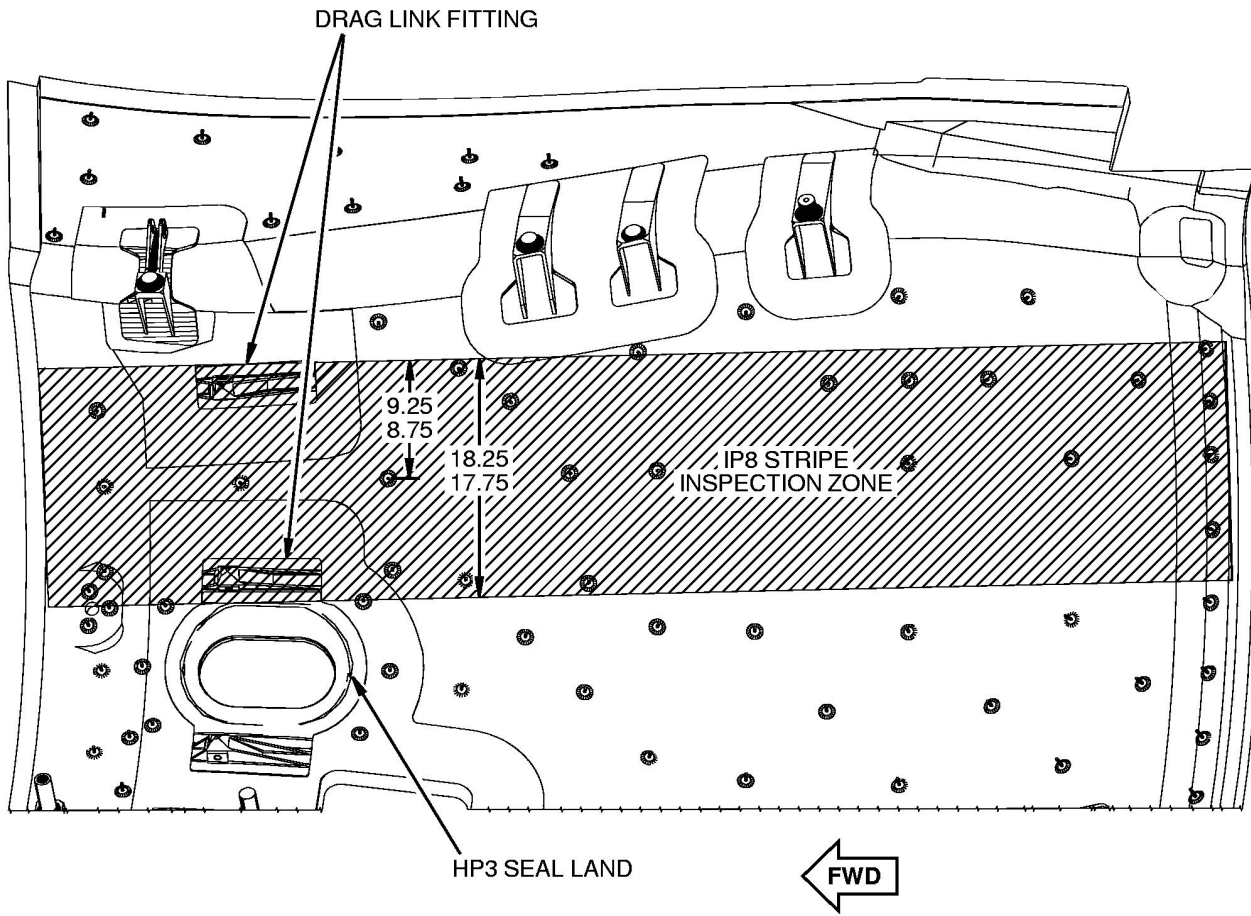
THRUST REVERSER INNER WALL SURFACE COLOR INSPECTION IP 8.2 ZONE

- a. If the inner wall primer of all the inspection zones are lighter in color than the Color Chip Standard after completion of the Thrust Reverser Inner Wall Surface Color Inspection on the TR half inner wall, it is considered that the inner wall passed the Thrust Reverser Inner Wall Surface Color Inspection.

- b. If the inner wall primer of any inspection zone is darker in color than the Color Chip Standard after completion of the Thrust Reverser Inner Wall Surface Color Inspection on the TR half inner wall, it is considered that the inner wall failed the Thrust Reverser Inner Wall Surface Color Inspection.

The following illustration shows the IP8.2 zone to be inspected using the Thrust Reverser Inner Wall Surface Color Inspection. Refer to 777 AMM 78-31-01 for inspection requirements.
