CF34-8E ALERT SERVICE BULLETIN - 72- A0115 R03
Revised:  
12/09/2016SB 72-A0115 R03 ENGINE - FAN ROTOR ASSEMBLY (72-21-00) -  
INTRODUCTION OF FAN BLADE BUSHING REPAIRIssued:  
11/05/2010**GE PROPRIETARY INFORMATION**

TRANSMITTAL INFORMATIONREVISION 3 TO SERVICE BULLETIN 72-0115

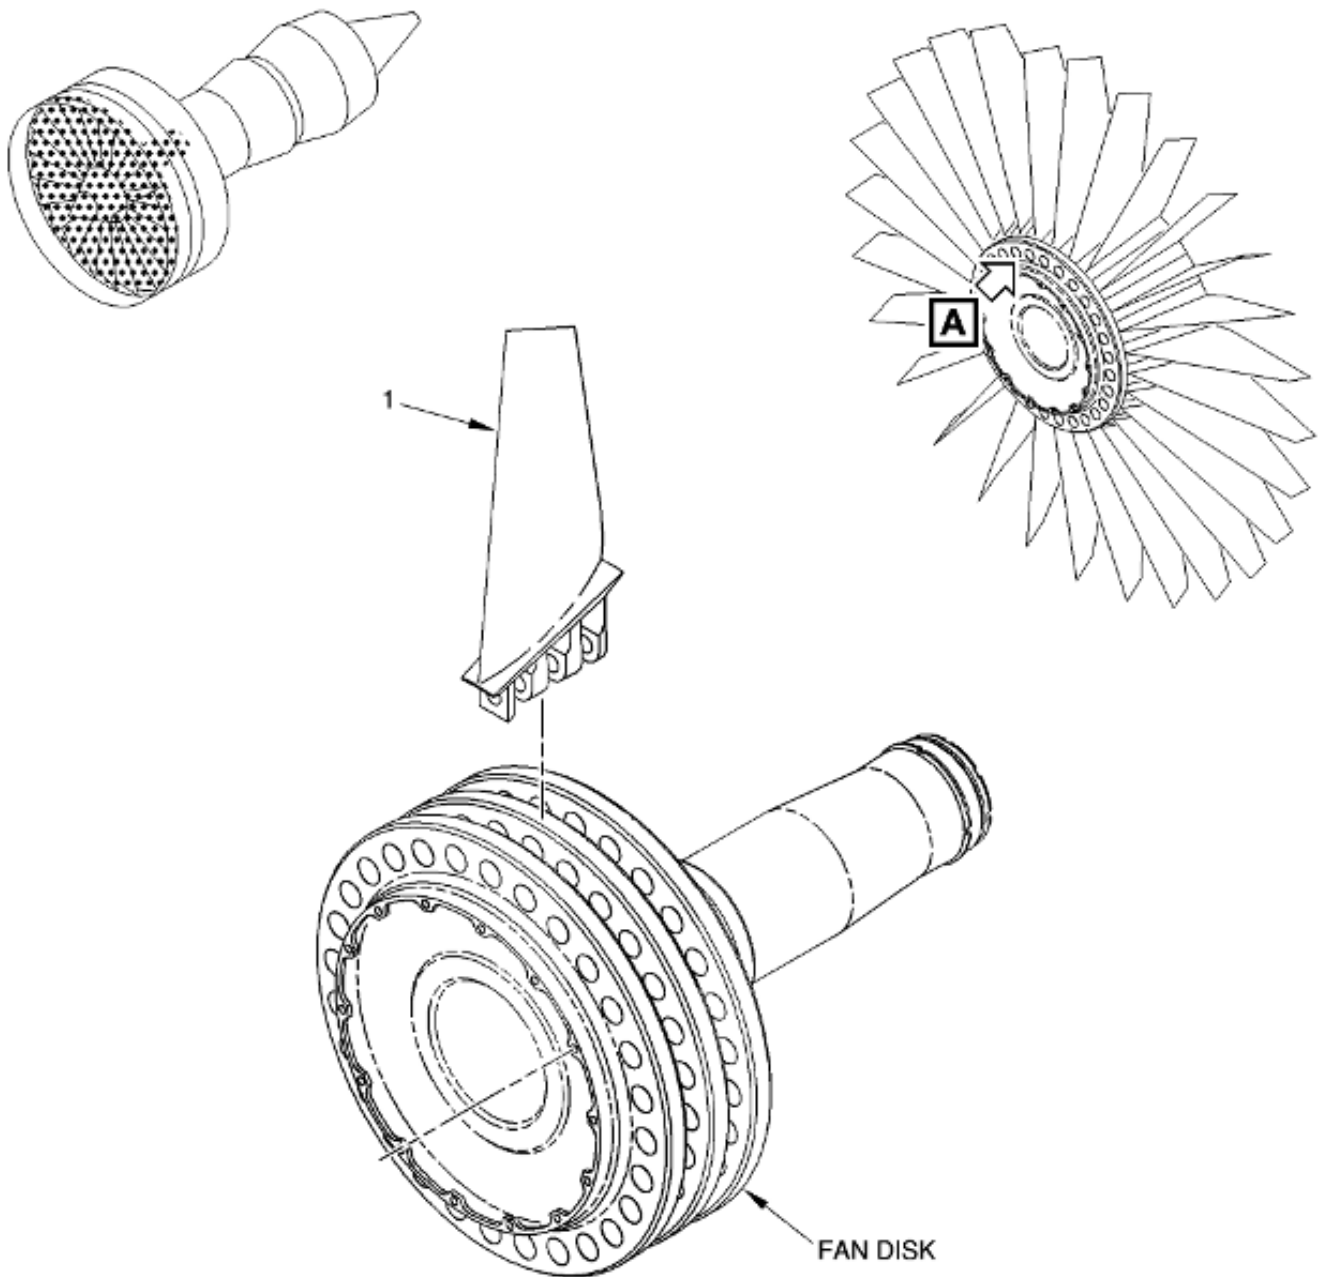
Fan Blade Location  
Figure 1

To introduce a repair procedure for the pin holes of the fan blade bushing. The repair will allow the reuse of the fan blade(s) for an additional 28,000 maximum engine cycles of service limit from the time of the repair. An unbushed fan blade can be repaired anytime up to the service time limit. The fan blade(s) can also be repaired if the pin holes are found to be worn up to the maximum repairable limit and within the allowable service limit of the fan blade(s). After the reworked fan blade(s) accumulates 28,000 cycles, it needs to be removed and discarded.

- (1) Remove the affected fan blades (1, Figure 1). Refer to GEK 112031, 72-00-21, REMOVAL.
- (2) Send the removed fan blades (1, Figure 1) to an approved repaired source to be reworked per RD 830-623. Refer to the APPROVAL OF REWORK SOURCES NOTICE below for contact information.

- (3) Install the reworked fan blades (1, Figure 1). Refer to GEK 112031, 72-00-21, INSTALLATION.
- (4) After you comply with this Service Bulletin, do as follows:
  - (a) Once the reworked fan blades (1, Figure 1) reach 28,000 engine cycles since fan blade bushing repair, replace it as follows:
    - 1 Remove the affected reworked fan blades (1, Figure 1). Refer to GEK 112031, 72-00-21, REMOVAL.
    - 2 Discard the removed reworked fan blades (1, Figure 1).
    - 3 Install new fan blades (1) of the same part number (P/N 4114T15P02). Refer to GEK 112031, 72-00-21, INSTALLATION.
